EXPERIMENTAL PROJECTS CONSTRUCTION REPORT

CENTERLINE CONTRAST STRIPING AND THE ADDITION OF HIGH-VISIBILITY STRIPING MATERIAL FOR ADDED CONSPICUITY IN NIGHTTIME AND WET DRIVING CONDITIONS

Project Name: Pavement Markings – Reserve St.

Experimental Project No. MT-14-07

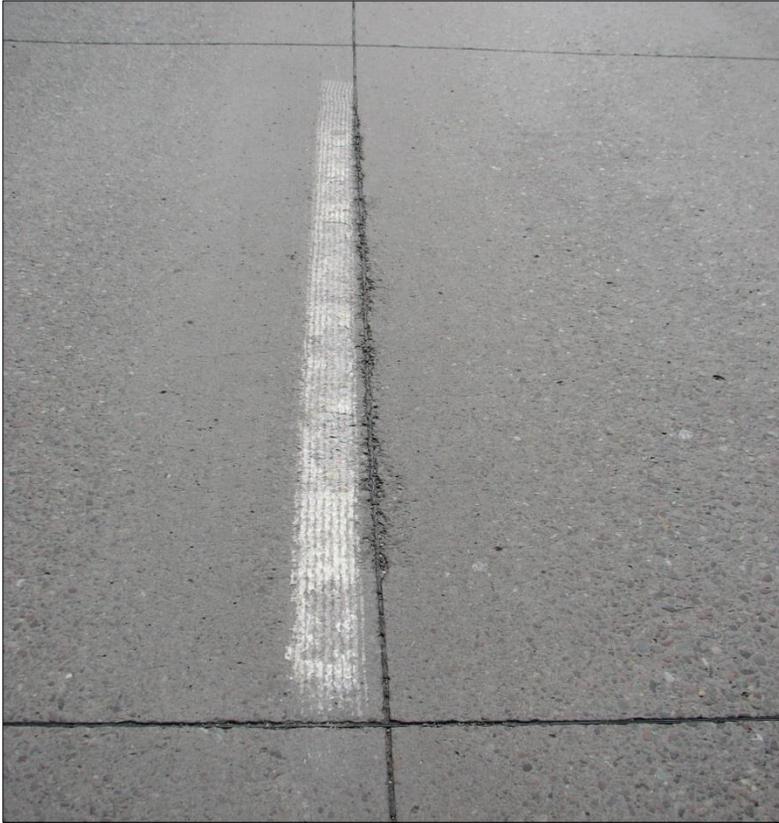
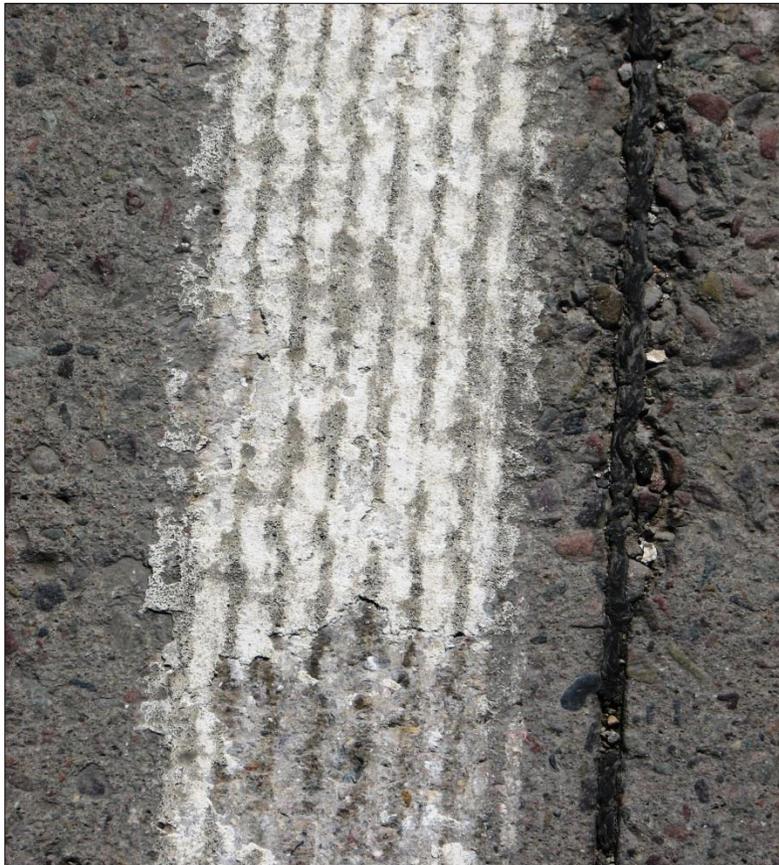
↙↘ Representative images of the existing stripe after the grinding phase.

Consistency of the amount stripe removed from pavement varied throughout the project.

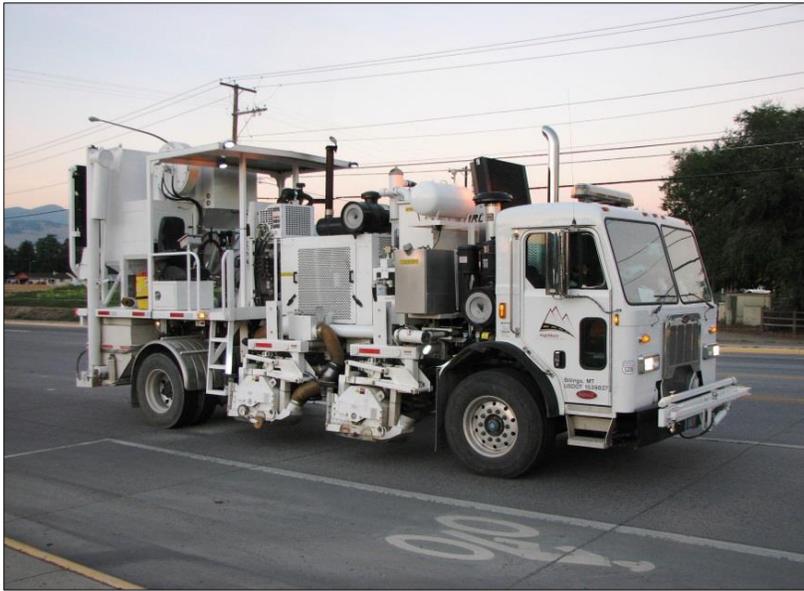
← Image of Highmark's Model 3-410 grooving truck used on the project.

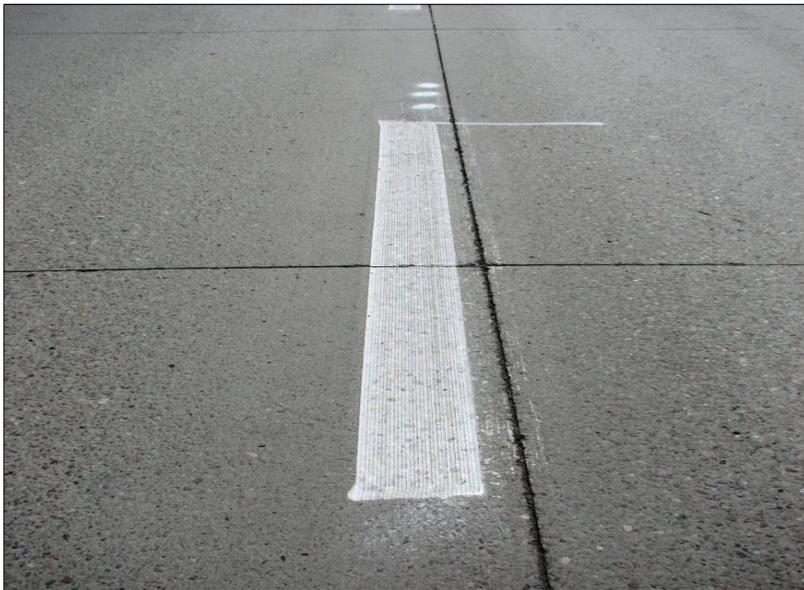
← Representative image of completed diamond grind groove.

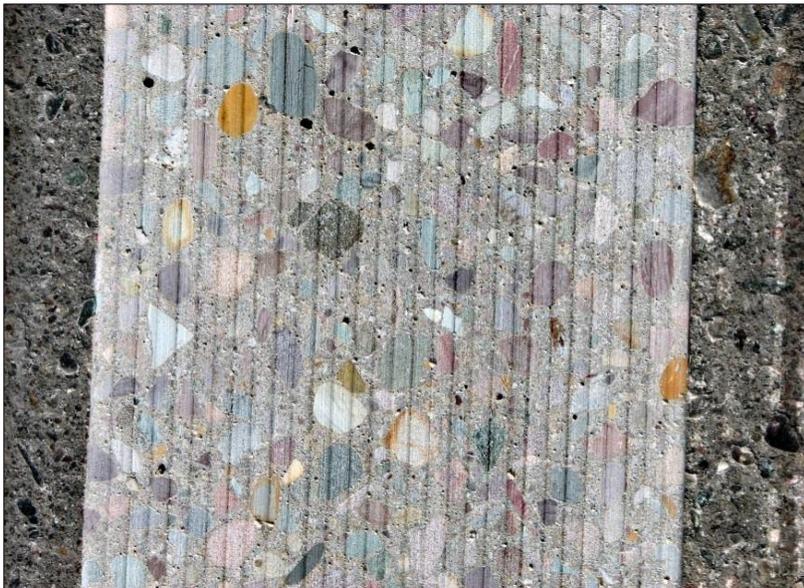
← Close-up of diamond grind. Groove relief represents a quality cut and clean definition.

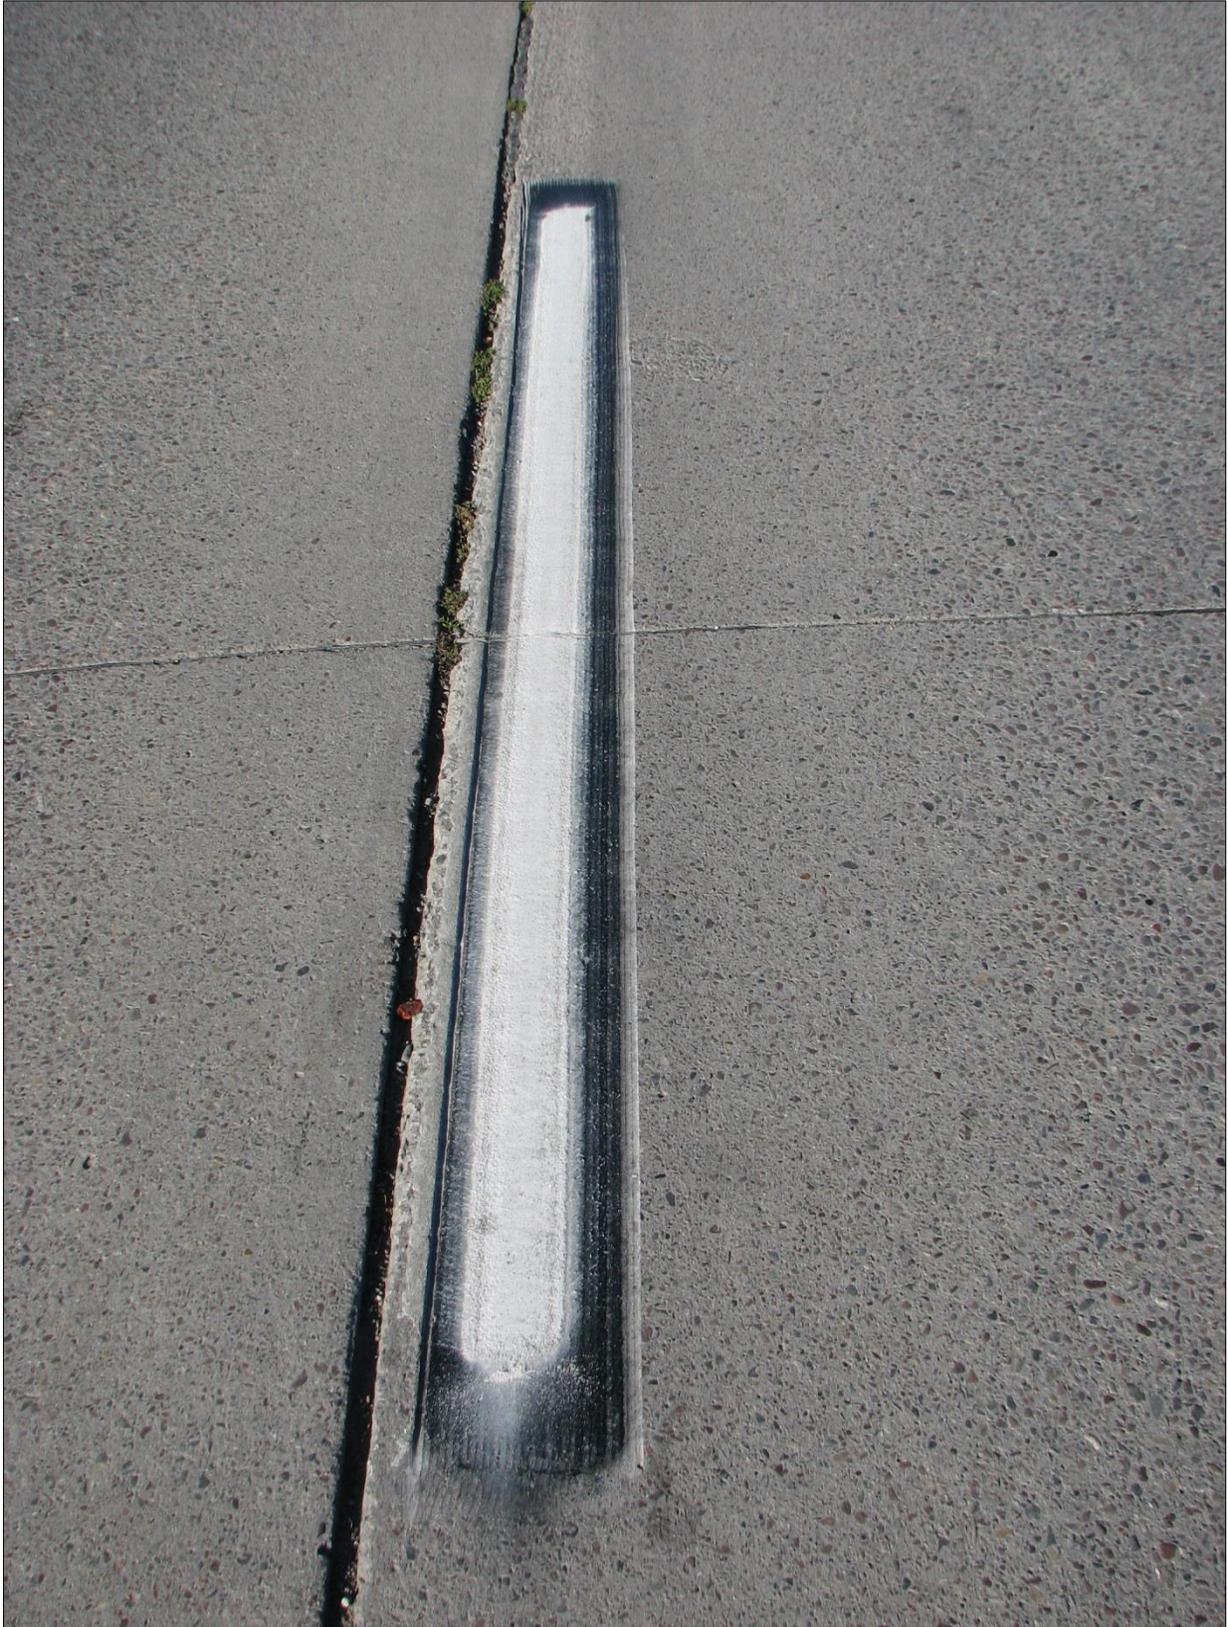
↑ General representation of completed white on black epoxy box contrast (9') stripe relative to all sections within the project.

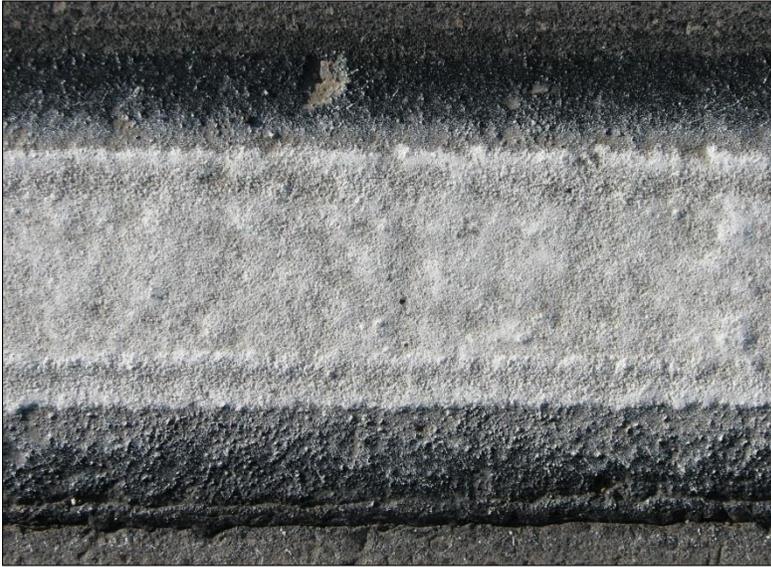
← Section3: Type 2 Glass Bead (RP 3.64 – 5.40), Union Pacific St. to I-90.

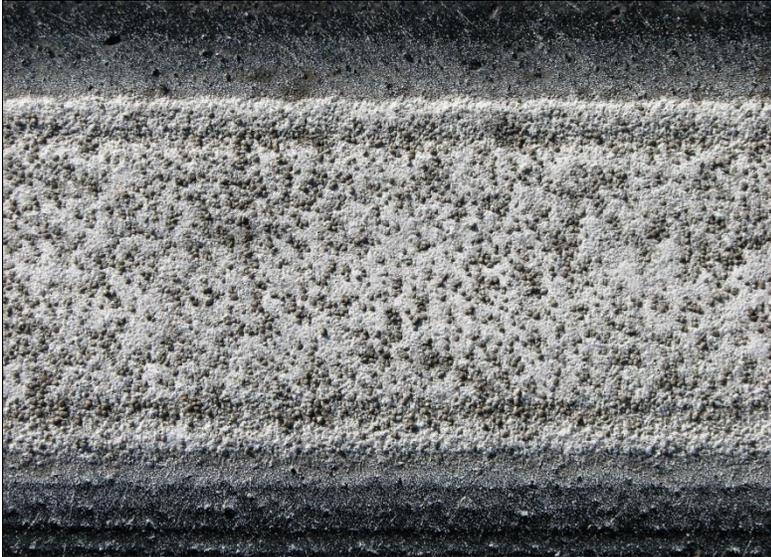
← Section 2: 3M Reflective Elements (RP 1.82 – 3.64), Seventh St. to Union Pacific St.

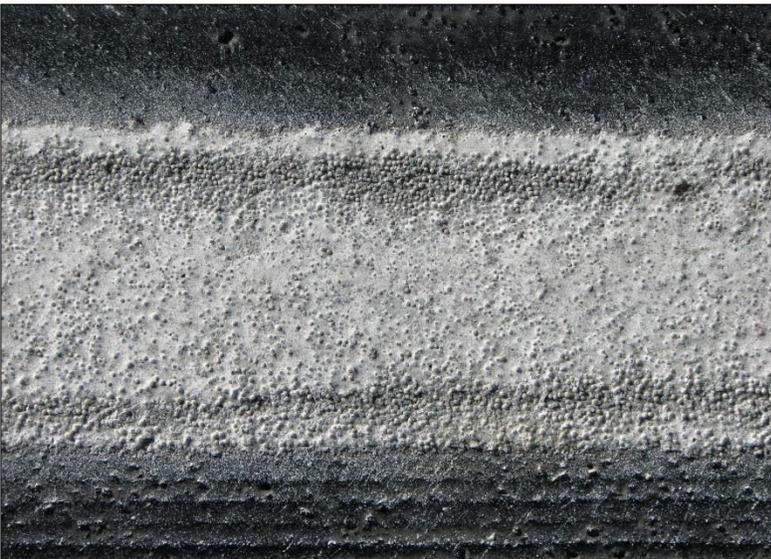
← Section1: Potters Visimax Plus (RP 0.0 – 1.82) Brooks St. to Seventh St.

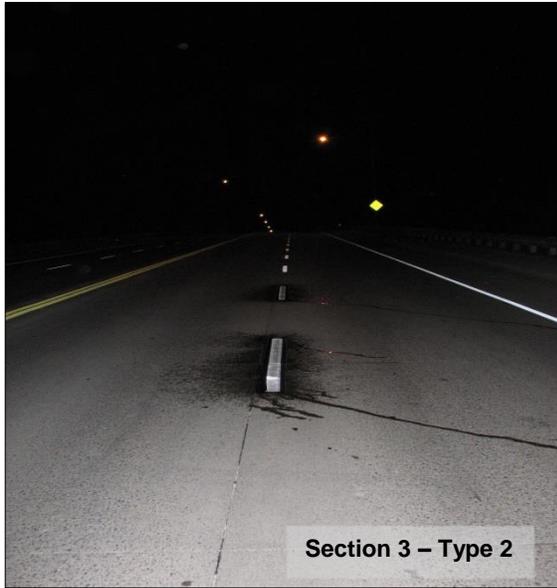
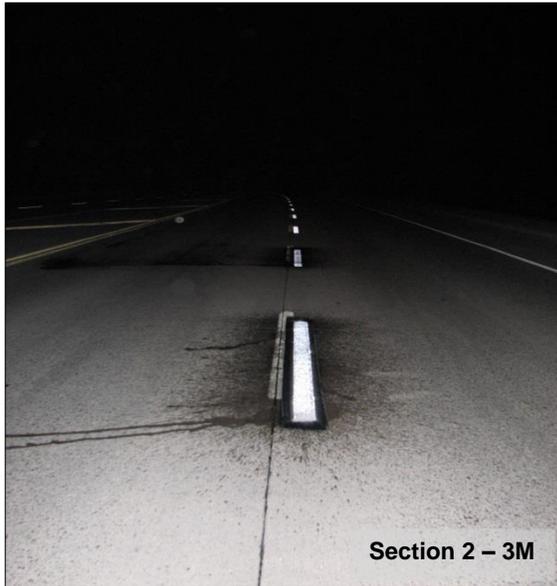
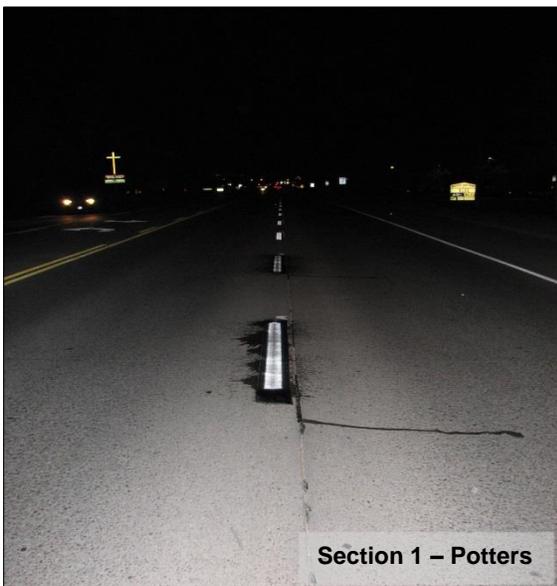
← ↓ The intent of incorporating the 3M & Potters marking materials in sections 2 and 1 was to improve driver conspicuity.

What you see in these images was the (simplistic) attempt to compare each treatment by wetting down several of the skips during darkness with the vehicle lights aimed directly center of the travel lane approximately 100' behind the skips.

The top image is section 3 using only type 2 glass beads. A coating of water on type 2 beads has a reduced effect on retroreflectivity.

Although subjective, sections 2 & 1, with the added wet reflective material, appear visually to have greater luminescence than the control section 3.

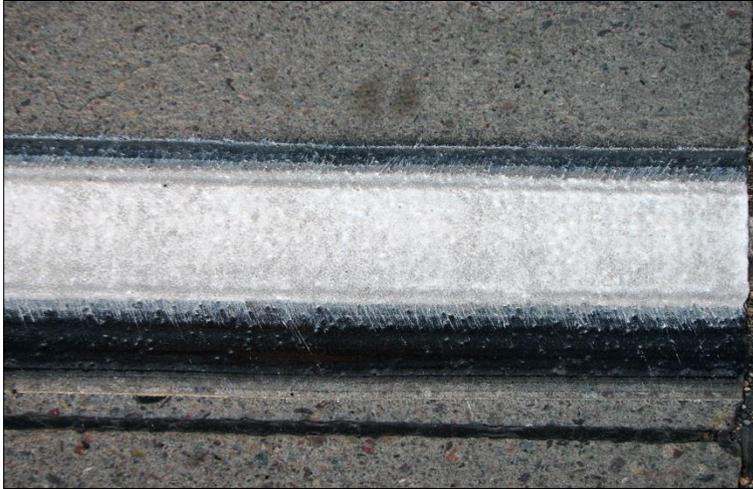
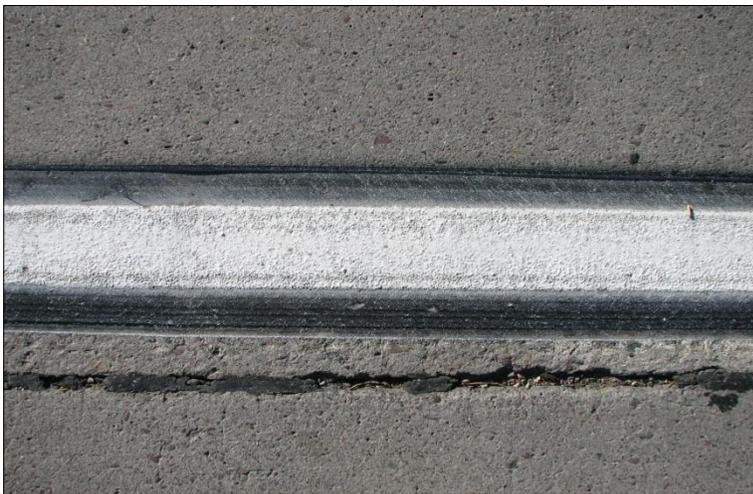
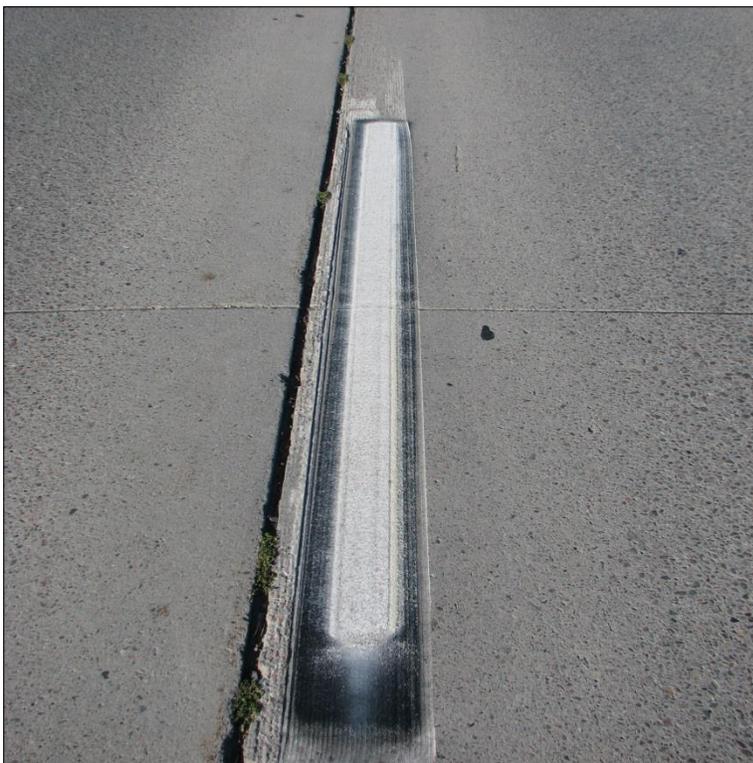
Installation Issue: White Epoxy Overspray

↙ ↓ Representative images of overspray of the white stripe to underlying black stripe which may reduce clarity of the contrasting colors.

The District will present these issues to the contractor and determine if remedial actions may be required and to what extent. If a corrective action is required this report will be updated to that effect.

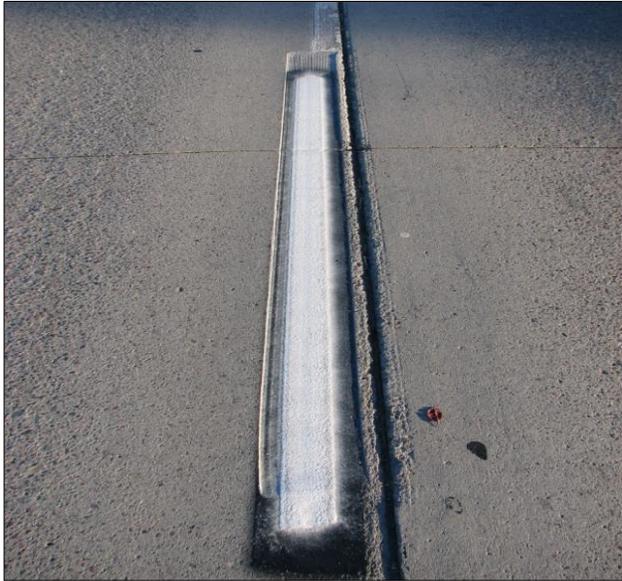
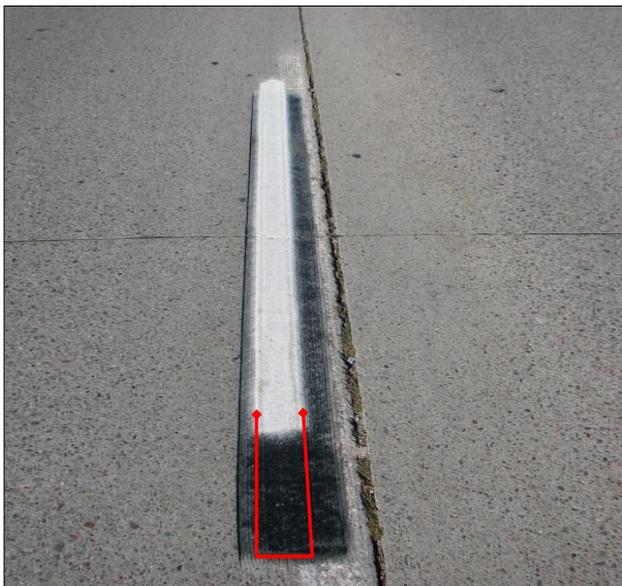
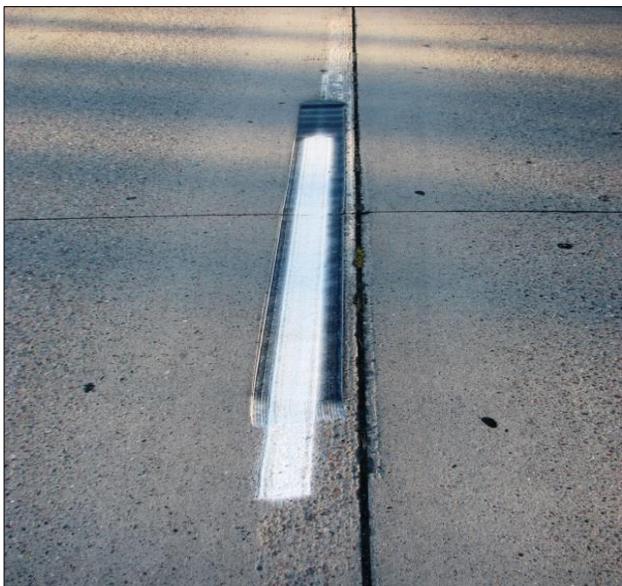
Installation Issue: Poor Pavement Marking Alignment to Prepared Groove

↔ Sample images of poor calibration during striping phase.

Some installations both stripes missed the recessed groove and in other skips the white stripe extended beyond the groove.

In addition, the contractor had a difficult time keeping the top stripe aligned equal side distance on the base stripe (center image example).

As compared to the total number of skip markings to the project, these anomalies of practice are statistically small but to a level of occurrence that requires documentation.

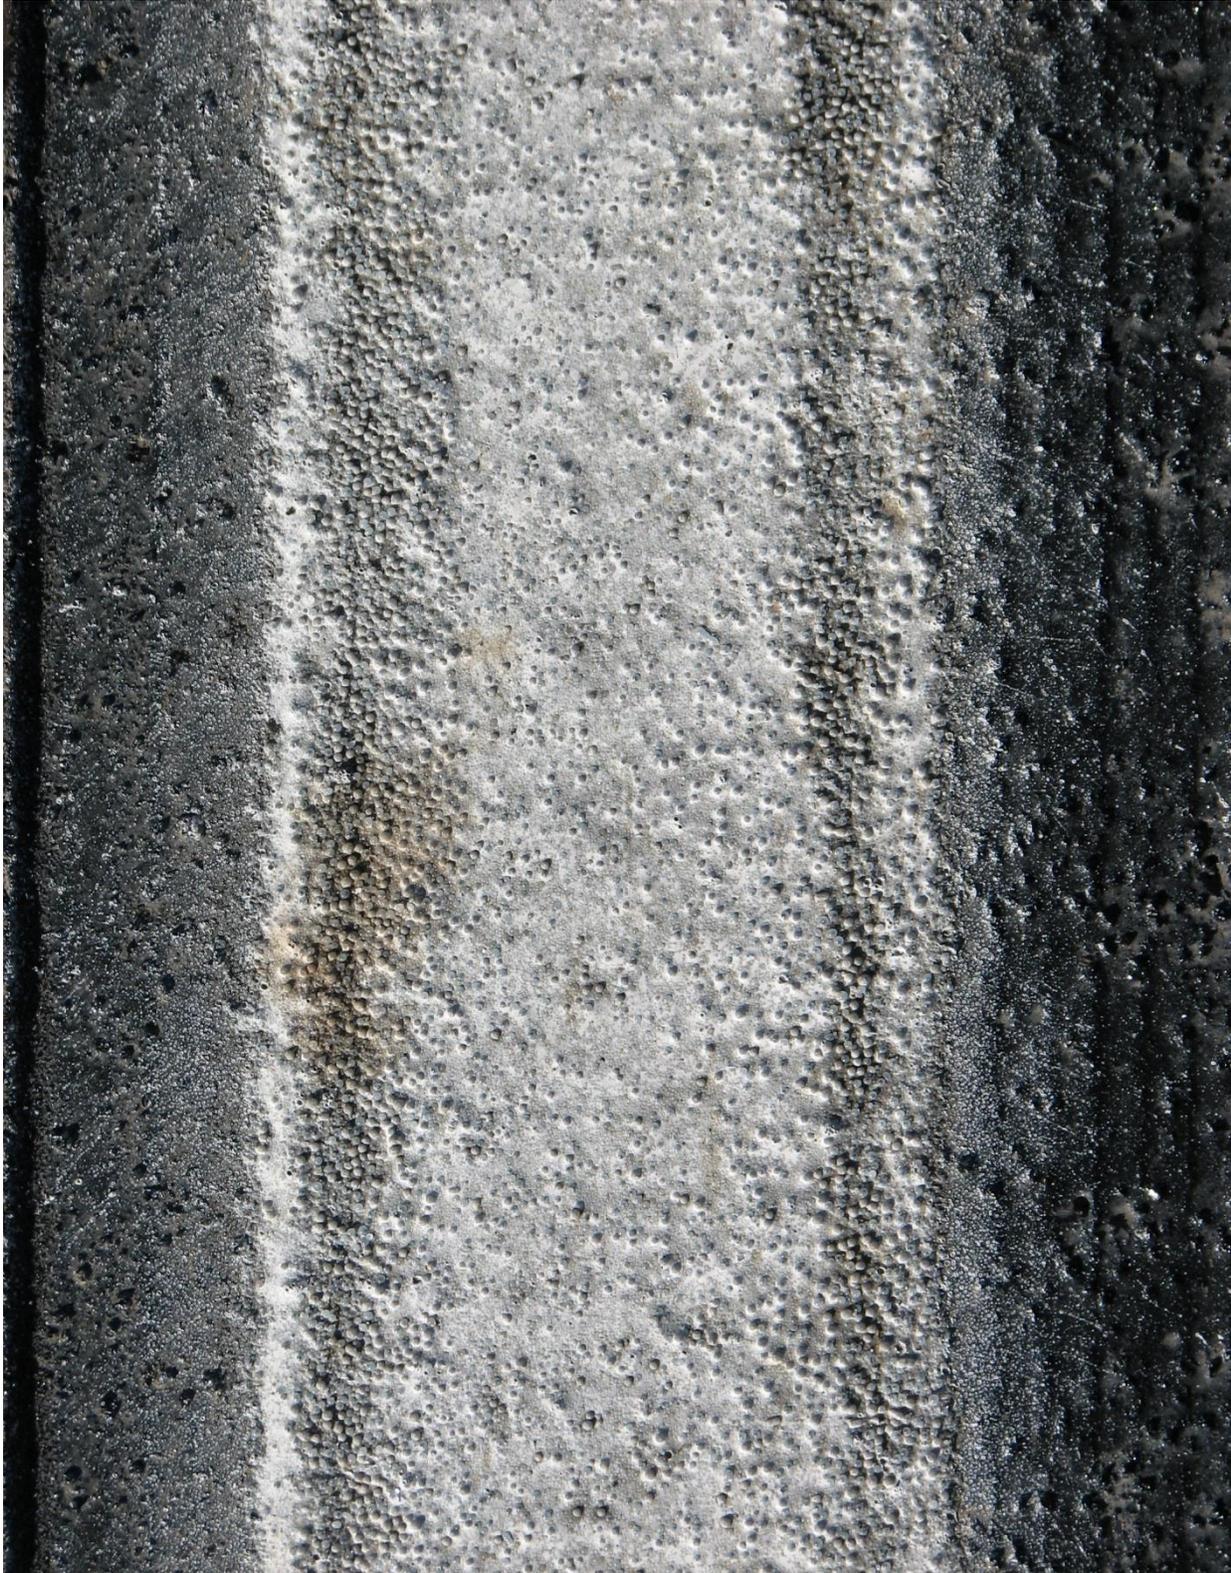
Installation Issue: Inadequate Bead Distribution - Potters Visimax: Section1

↑ By visual examination, Visimax bead population distribution was applied at a higher percentage near the edges of the stripe than the interior. Also, due to this edge clustering, may not have adequately embedded the bead to the binder and possibly will be a performance issue in the future.

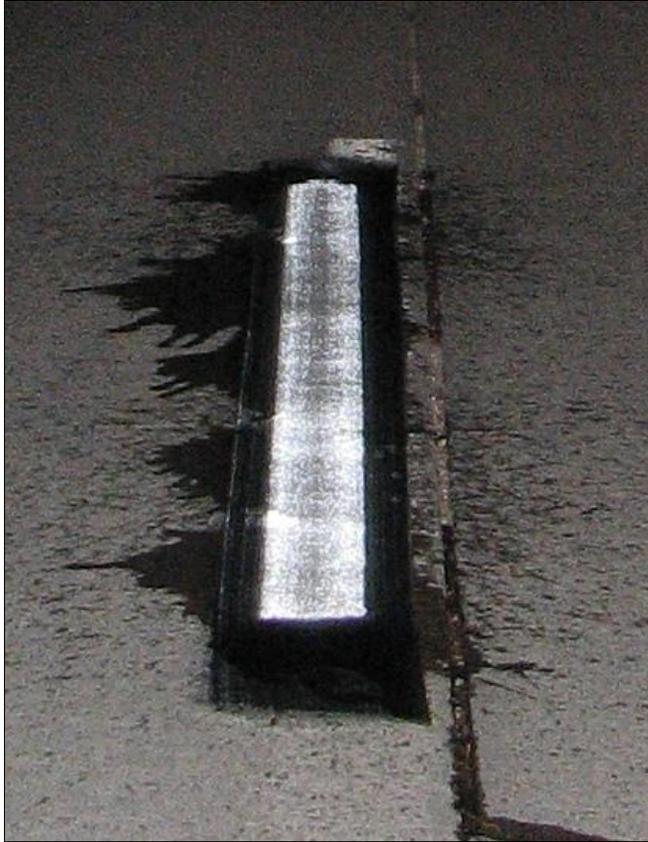
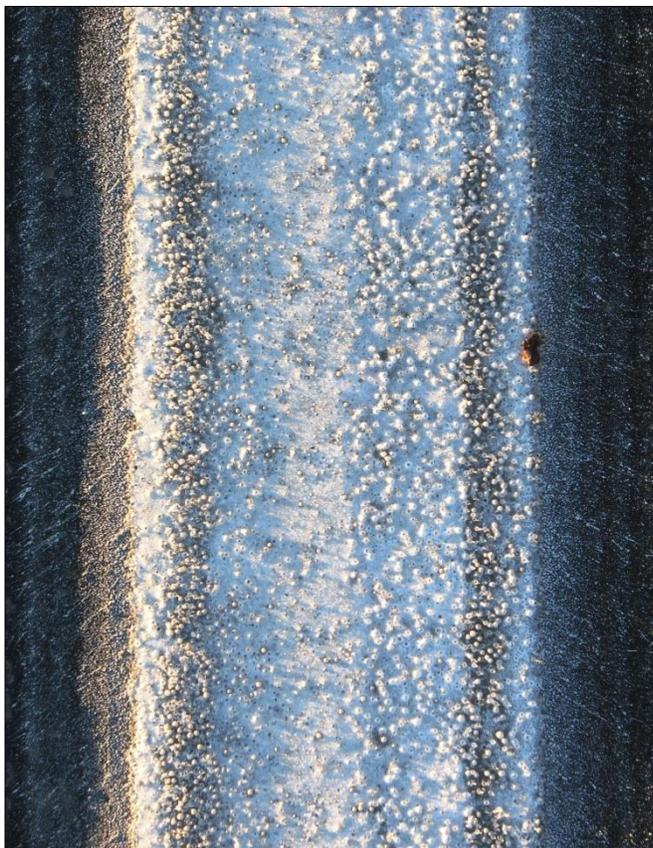
↙ Section1-Potters Visimax: The top image was a skip line taken at night with water poured within the recessed groove.

As shown, the darker shade, predominantly through the center of the white stripe, is due to an inadequate distribution of the Visimax beads. This is compared to the edges of the stripe, which display greater luminosity.

The lower image is a sample of the bead distribution within the stripe.

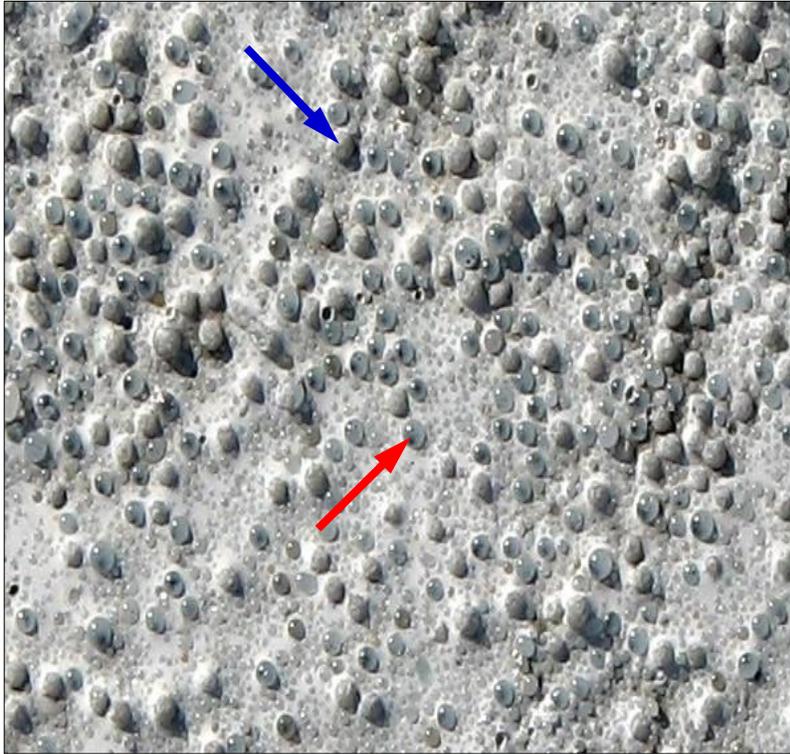
← Visimax Plus Blended Beads:

The blend consist of larger type 4 beads (red arrow).

The blue arrow denotes spheres that have thousands of high index beads laminated to an outer shell.

The proportion of blend with Type 2 beads is approximately 50/50.

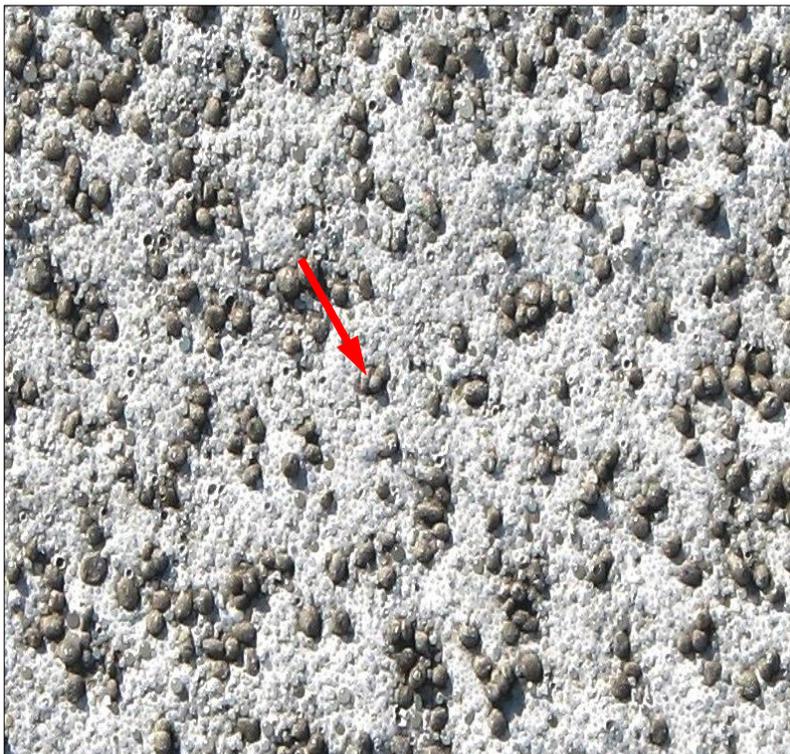
← 3M Reflective Elements:

The elements consist of microcrystalline ceramic beads embedded on a center core (red arrow).

The proportion of blend with Type 2 beads is approximately 30/70.
