MONTANA
Department of
Transportation

Project Summary Report: FHWA/MT-21-006/9577-607

ALKALI-SILICA REACTIVITY IN THE STATE OF MONTANA

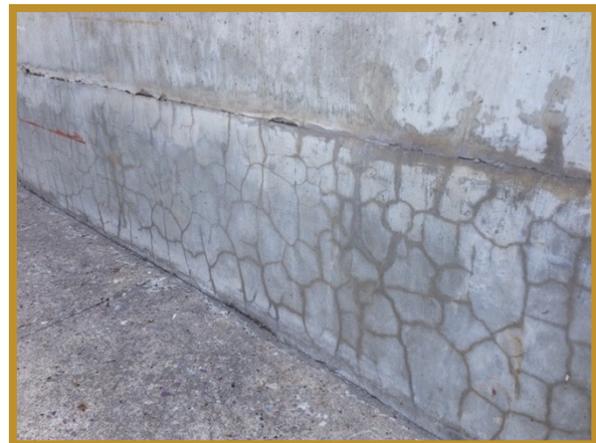
Figure 1: Typical ASR Crack Pattern

This damage is initiated by the swelling (in the presence of water) of a gel that forms on the surface of the reactive aggregates, and typically results in map cracking similar to that shown in Figure 1.

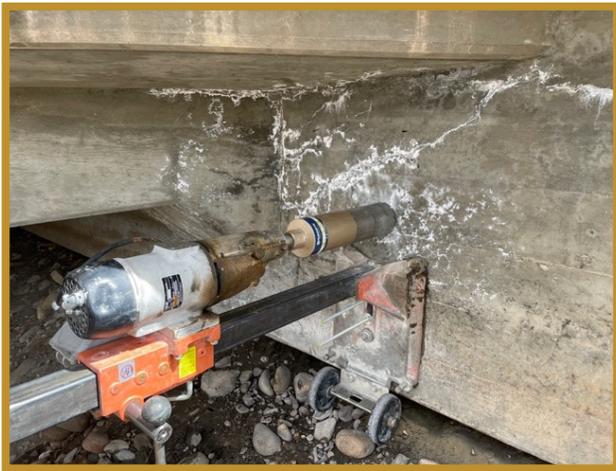
Figure 2: Coring of Backwall on Belt Creek Bridge

aprons at the Billings Logan International Airport, a bridge on US-87/US-89/MT 200 near Belt (Figure 2), and the spillway for the Willow Creek Dam.

Concrete cores were obtained from the sites and further examined in a laboratory
