MONITORING ANIMAL USE OF
MODIFIED DRAINAGE CULVERTS ON
THE LOLO SOUTH PROJECT

FHWA/MT-01-004/8117-15

Final Report

November 2001

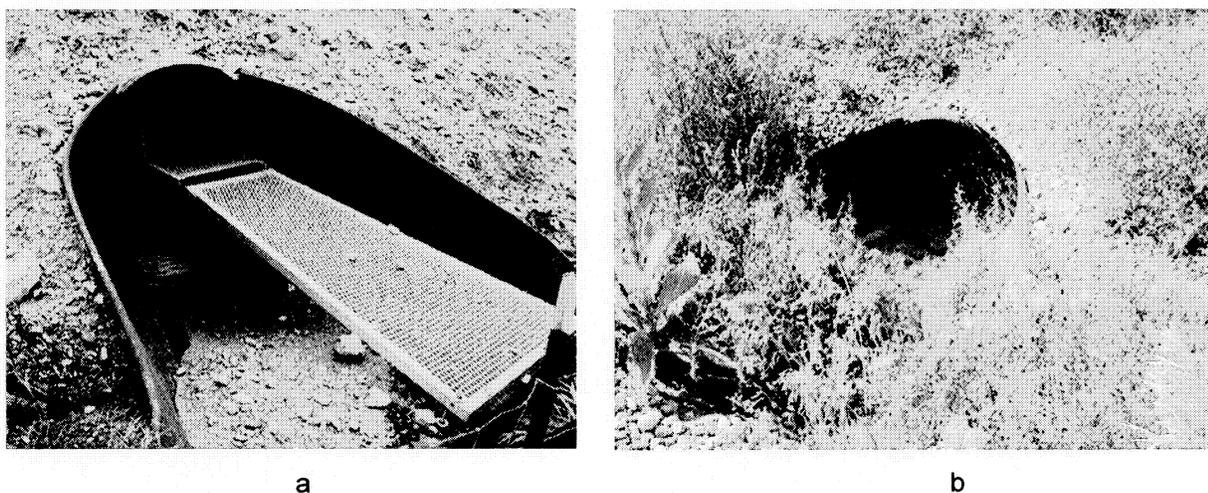
Figure 1. (a) Example of a culvert containing a ramp/shelf animal walkway (Carleton Creek experimental), and (b) one not containing a walkway (Carleton Creek control).

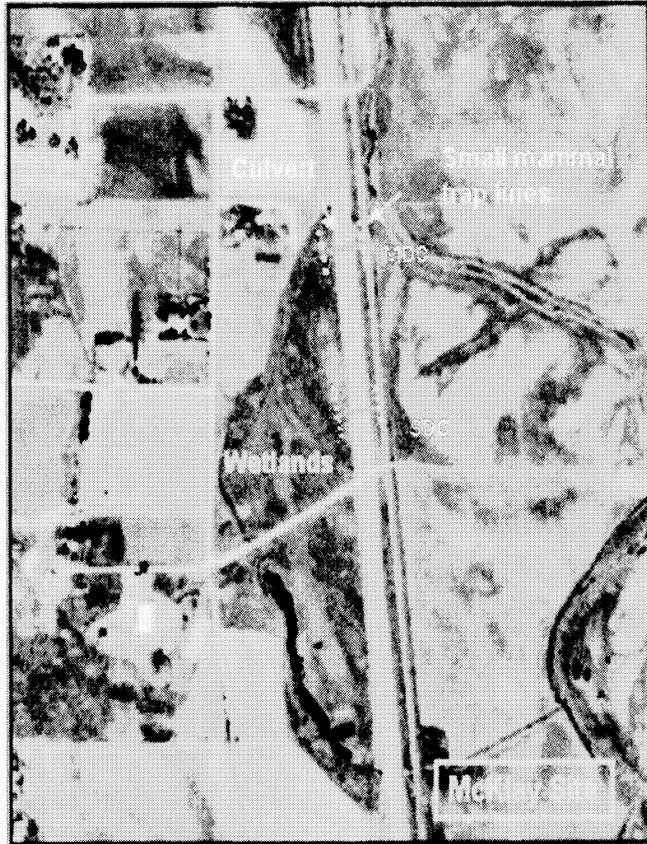
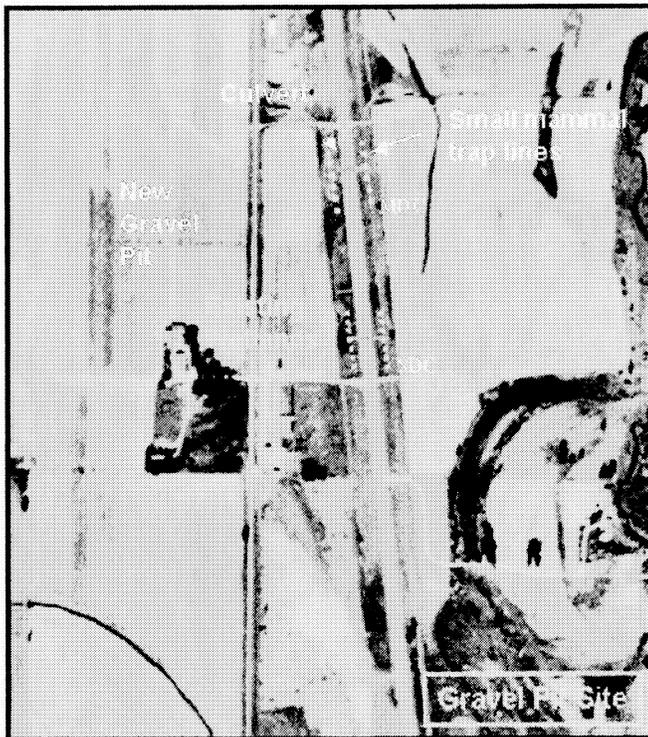
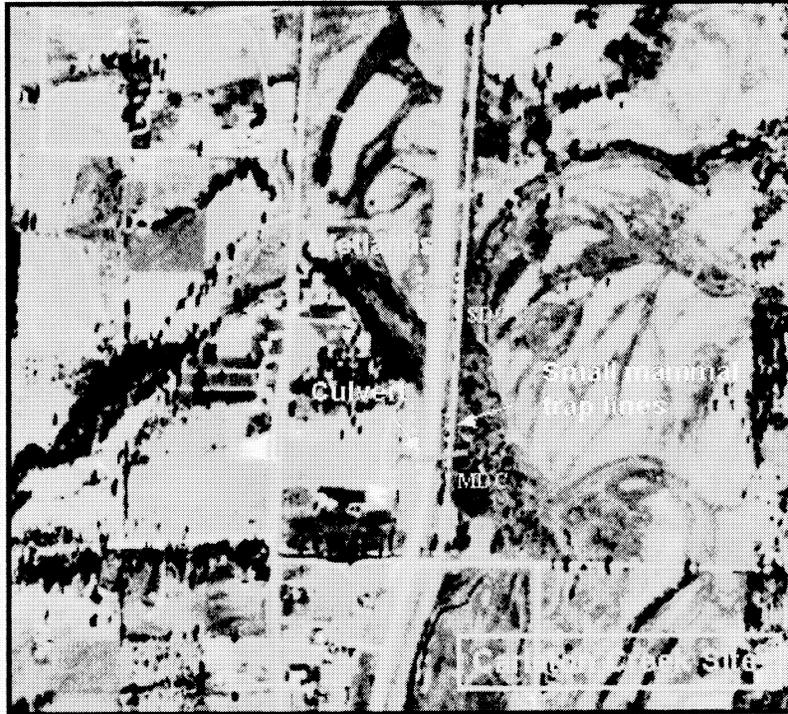
Figure 2. Paired culverts spaced along U.S. Highway 93 between Lolo and Florence, Montana (this page and following two pages) (a) Overview of study sites, and closeup (b,c, & d) images of individual pairs illustrating placement of trap transects.

During January, February, and March, the snow levels were too deep to permit small mammal sampling with the transect lines. On March 31st, live-trap transects were placed at a 90° angle along both entrances of 4 culverts (2 control and 2 experimental; Carleton Creek and Gravel Pit sites) as well as at the west entrance of a 3rd experimental culvert (McKlay Creek). The east entrance to this last culvert was adjacent to a residence and was not sampled. The remaining control culvert was completely filled with ice when the study was initiated and it was thought that the water levels would drop during the summer months making this culvert accessible. However, the water levels remained high during the entire study rendering this culvert inaccessible so these entrances were also not sampled. Traps transects were run for a 3-day period from late March through August. Animals captured were identified to species, sexed, weighed, and their reproductive condition noted. All animals were temporally marked for population assessment. Deer mice were marked with colored ear tags beginning in June, in conjunction with one undergraduate study, so that it could be determined from which population (east or west of the highway) individuals originated. A total of 7,650 trapping opportunities were recorded during the study [1 trapping opportunity = 1 trap accessible over a 12 h period. Traps were checked each morning and evening (March - June sampling) to minimize mortality thus during this period each trap recorded 2 trapping opportunities per day. During July and August traps were only opened in the evening and closed during the day due to extreme heat; thus only one 12 h period was sampled each day. This was not thought to alter trapping information since the species being captured were essentially nocturnal]. A total of 1,017 captures were recorded representing 7 species (Table 2). Four of 7 species (deer mice, meadow voles, vagrant shrews, and short-tailed weasels) were captured on both sides of the highway; the house mouse and Columbian ground squirrels were captured only on the west side, while the single capture of the western jumping mouse occurred on the east side. Some variation in total number of captures occurred between sites most likely as a result of vegetative differences, but, in general, eastern sides were similar to one another and western sides were similar to one another. Sixty-two percent of the total captures were on the east side, while 38% were on the west.

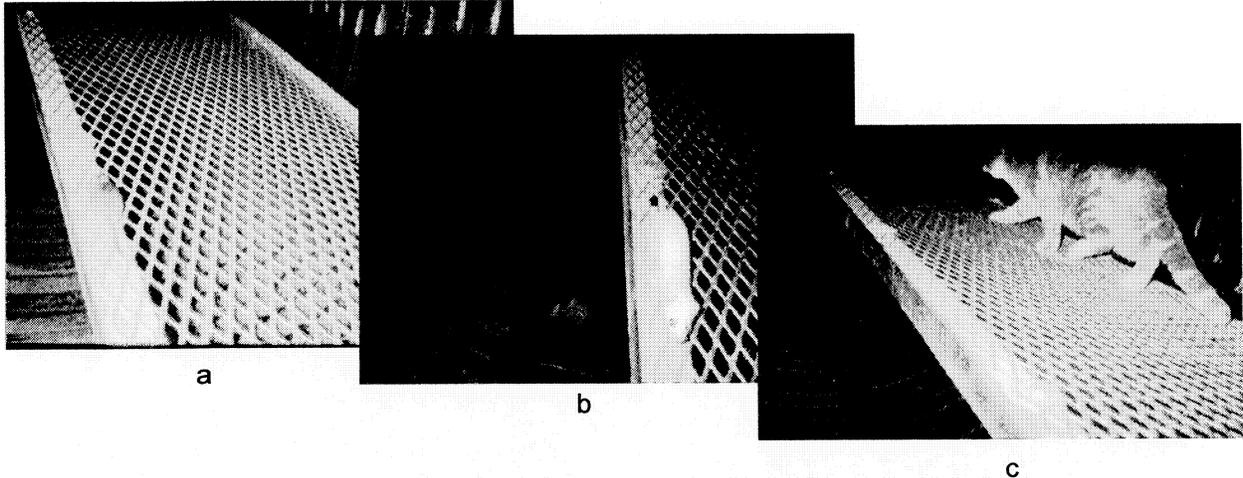
Figure 3. Deer mouse (a), short-tailed weasel (b), and domestic cat (c) use of shelves when culverts were carrying water. (Note use of frame by deer mouse and weasel)

The purpose of the animal walkways is to provide use of the culverts even when they are carrying water. Three species [deer mouse (*Peromyscus maniculatus*), short-tailed weasel (*Mustela erminea*), and domestic cat (*Felis catus*)] were documented using these shelves when water was present; when these same culverts were dry, these species as well as 2 others [raccoon (*Procyon lotor*) and striped skunk (*Mephitis mephitis*)] moved along the floor (Figs. 3 & 4). The smaller species to use the shelves, deer mice and short-tailed weasels, did so by carefully walking along the outside frame rather than over the shelf mesh surface (Fig. 3 a,b). This is an important observation as it suggests that a more solid floor surface may be preferred by these smaller animals. Muskrat (*Ondatra zibethicus*) were observed not only walking through a dry culvert but also swimming through culverts when water was present (Fig. 5).

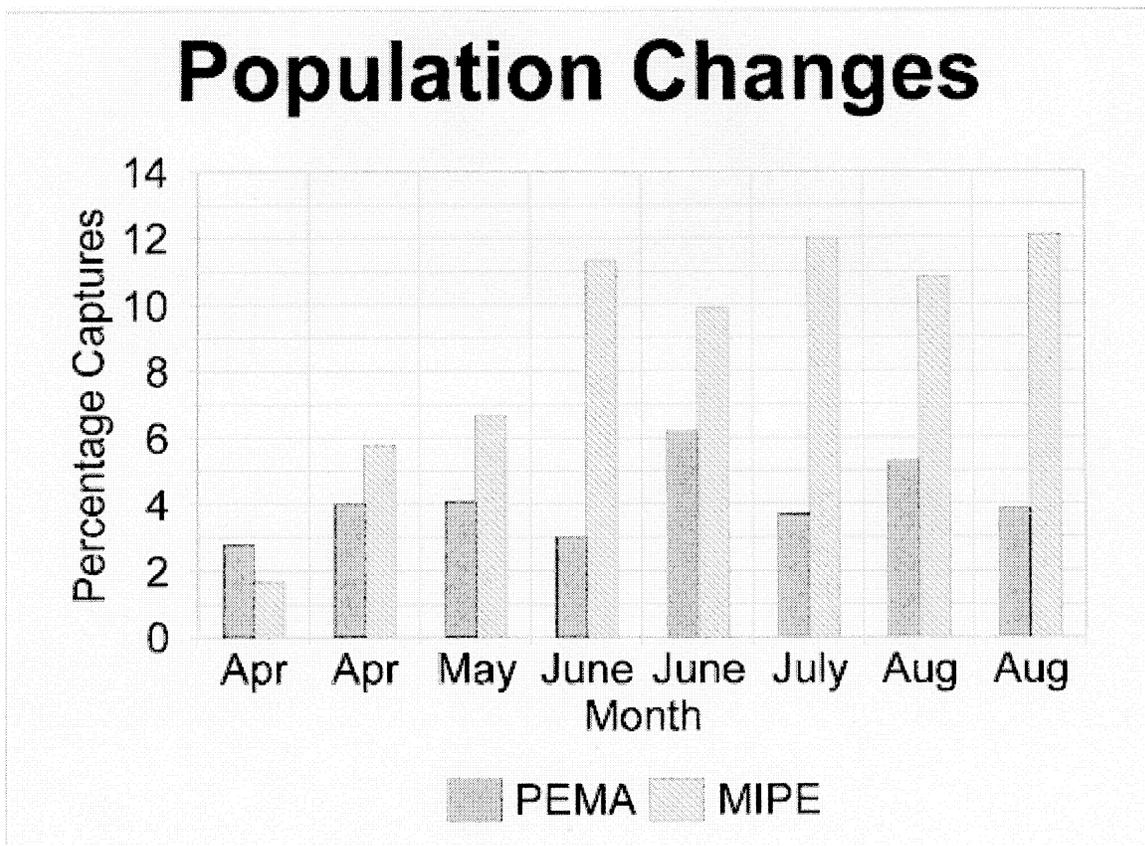
Figure 7. Population changes observed in deer mice (PEMA) and meadow voles (MIPE) during the spring and summer expressed as percentage of captures.

Though population estimates for deer mice and meadow voles (the only two species with enough captures for analysis) were not calculated due to incomplete recapture records, general trends in population size can be interpreted from overall trapping numbers. Population numbers for both species increased from spring to summer, though a much more significant increase was observed in meadow voles (Fig. 7).

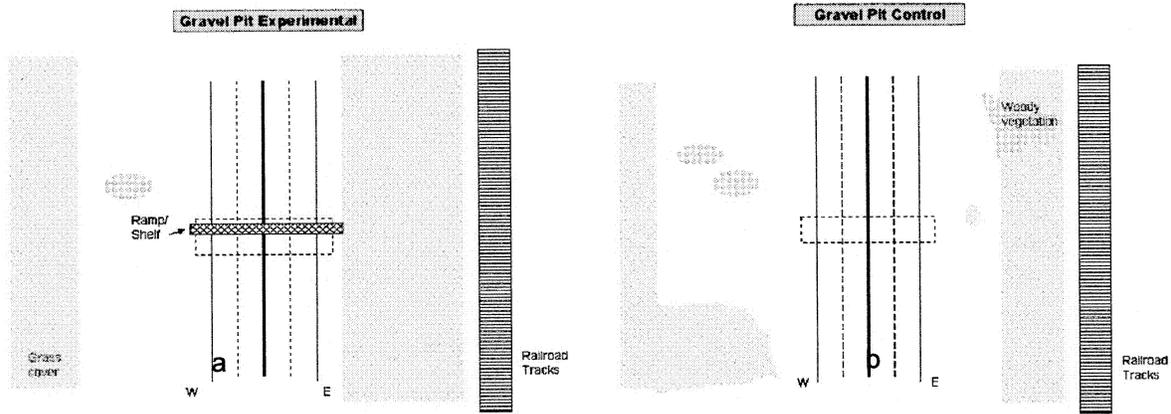
Figure 10. Example of vegetative maps developed for experimental (a) and control (b) culverts.

Initial vegetative maps were constructed for each site so that the relationship between vegetative cover and animal populations could be assessed (Fig. 10). It became apparent that only a general overview of vegetative cover could be developed since sites particularly along the western side of the highway were greatly disturbed and were being modified throughout the study (grading and reseeding during the spring and early summer; mowing during mid-to-late summer). Considerable vegetative growth occurred, however, at the entrances to the culverts on the western side as well as all along the eastern side during the summer (Fig. 11).

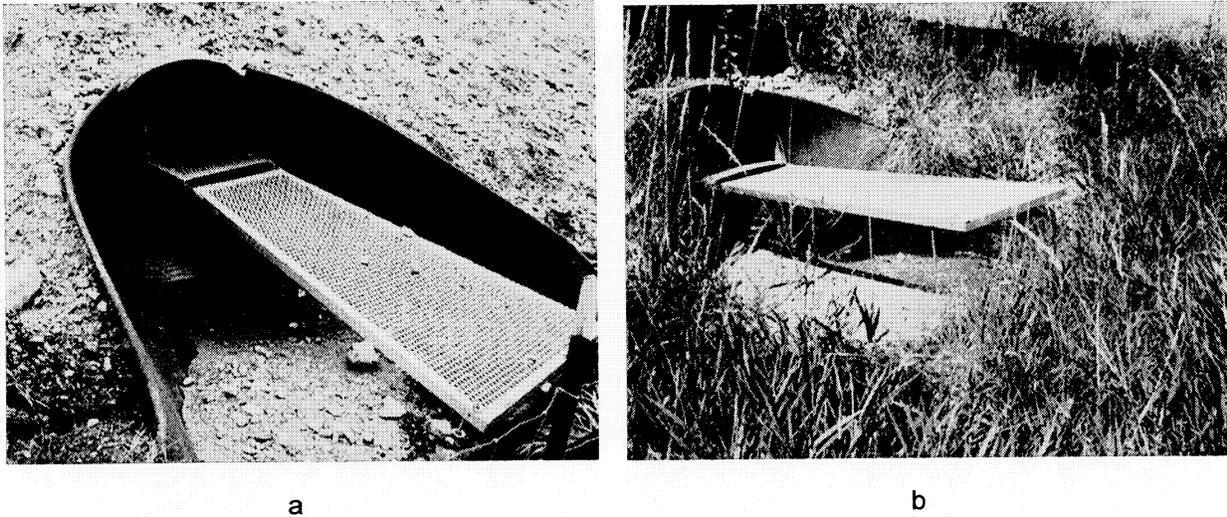
Figure 12. Ramp adjustments made during the study by MDT. (a) Initial ramp placement so that it contacts the ground and (b) final placement so that it sits above the ground surface.

When the ramps accessing the culverts were first put in place, they angled down from the shelves to the ground surface (Fig. 12a). During the summer the ramps were adjusted by MDT and welded in place so that they projected directly outward from the shelves causing them to open approximately 2.5 feet above the ground surface (Fig. 12b). It is unclear why this modification was made, but presumably this was to prevent any debris from being trapped under the ramp during periods of water flow. Obviously when water is moving through the culvert, the ramps, as initially placed, would be covered and thus inaccessible to animals. However, when no water is present the elevated ramps would also prevent most animal use since the ramps are suspended too high above the ground for access. In order to address water flow and debris concerns while at the same time keeping the ramps accessible to smaller animals a modification of the entrance ramps is proposed. The modification would entail expansion of the elevated ramp to the side of the culvert so that it contacts the sloping hillside, while remaining above water level. This modification will be tested in the continuing study.

Thirdly, the final position at which the ramps accessing the shelves were set seems problematic. The assumption is that the ramps were welded in to this position to facilitate movement of debris through the culverts; however, this defeats their purpose to serve as a ramp to the shelf. Species such as the striped skunk, which routinely used the culverts during dry conditions, were never observed using a ramp. It is very possible that they could not jump the required 2.5 feet to the ramp surface. The shelf texture, as described above, may also have contributed to their lack of use. One possible way to modify the ramp so that debris could still freely move beneath while allowing access to small animals would be to extend the ramp surface sideways so that it came in contact with the adjacent hillside.

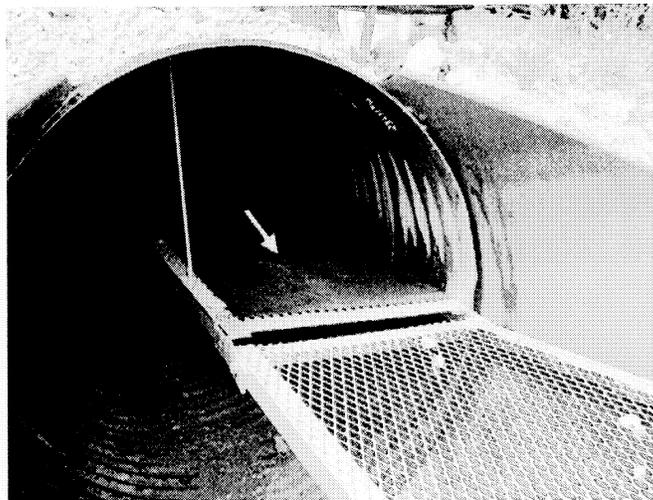
Figure 13. The shelf surface has been covered with heavy gauge plastic (truck bed liner material; yellow arrow) to provide a solid surface for smaller species.

The observations made have raised several issues which need to be addressed in future studies. First is the fact that the shelf surface is probably not appropriate for most of the smaller species. The 1+ inch openings in the shelf grate appear to discourage small mammal movement. Most observations of deer mice and short-tailed weasels illustrated that they preferred to travel along the solid metal frame which supports the shelf. This is not surprising. The grate surface obviously needs to be porous to allow water to flow through during periods of water flux; however, the size of the openings may discourage use by such small species. Even larger species (e.g., dogs) are known to avoid such grate surfaces (personal observation). A solid surface is currently being tested; results will be provided when they are completed (Fig. 13; refer also to

In order to further test the observation that small species seem to prefer a more solid surface, one shelf was covered with a solid, heavy gauge plastic (a polypropylene material used for truck bed liners; refer to Fig. 13 above; Fig. 15 below) on July 15th. A comparison is thus being made between animal use prior to and following this installation. An undergraduate currently has funding through a university-sponsored grants program (IBS-CORE) to study this aspect throughout this summer and fall. As part of this study live-trapped deer mice have been marked with colored ear tags to designate on which side of the highway they were caught.

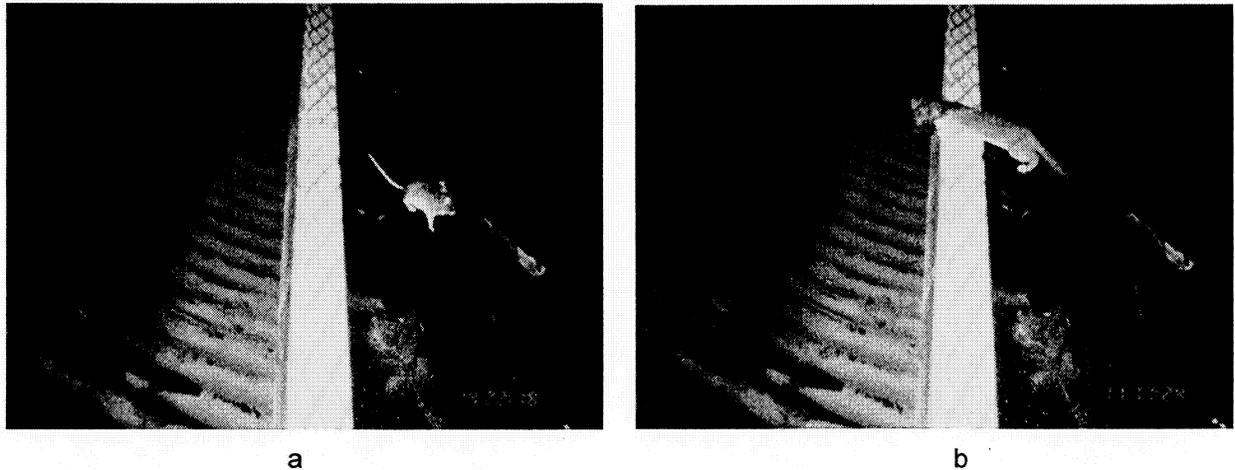
Figure 15. Animals using modified ramp surface. (a) Deer mouse, and (b) short-tailed weasel.

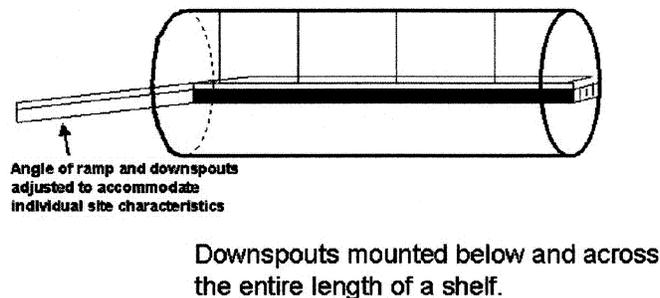
Figure 16. Suggested design of vole tubes to allow for movement under existing ramps.

Tests of a vole tube which could be placed below and supported by the existing shelves that would allow voles to move through the culverts in an enclosed space are being considered. These tubes would extend from the culvert entrances along the existing ramps so that they would open into the vegetation providing adequate cover for this species (Fig 16).
