FISH PASSAGE IN MONTANA CULVERTS: *PHASE II - PASSAGE GOALS*

FHWA/MT-07-010/8181

Final Report

prepared for
THE STATE OF MONTANA
DEPARTMENT OF TRANSPORTATION

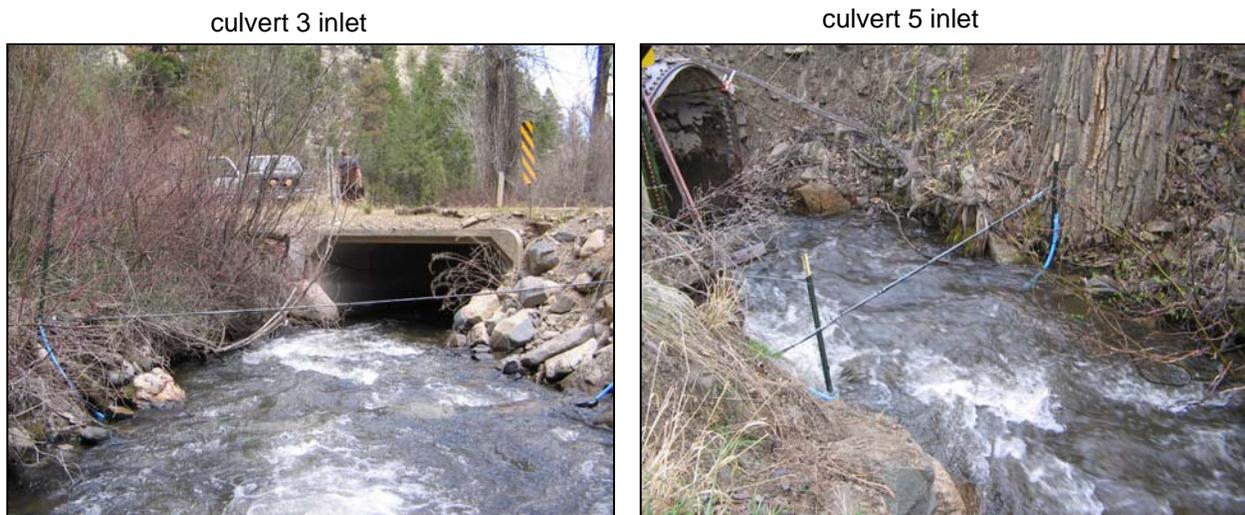
Figure 5. Antenna construction design in cases where the antenna could not be attached directly to a culvert.

Natural stream sections had the upper end of antennas constructed by suspending steel cable across the stream and attaching it to a post on either bank as shown in Figure 5. The antenna wire was attached to the posts and suspended across the stream by attaching it to the steel cable with plastic fasteners. The distance between the lower and upper portions of the antenna loop installed in natural stream channels was 1.2 m. Antennas spanned the entire width of the channel so that fish passing underneath at any point in the channel could be detected.

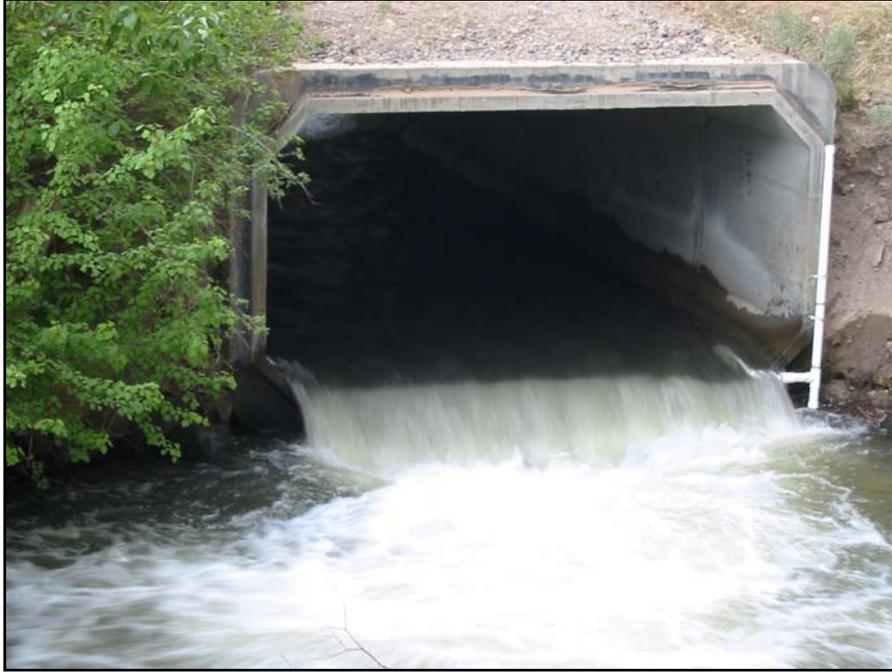
Figure A-1. Culvert 1 outlet. Note the stage recorder installed in the stilling basin on the right-hand side of the photo. The PIT tag antenna was not installed at the time the photo was taken.

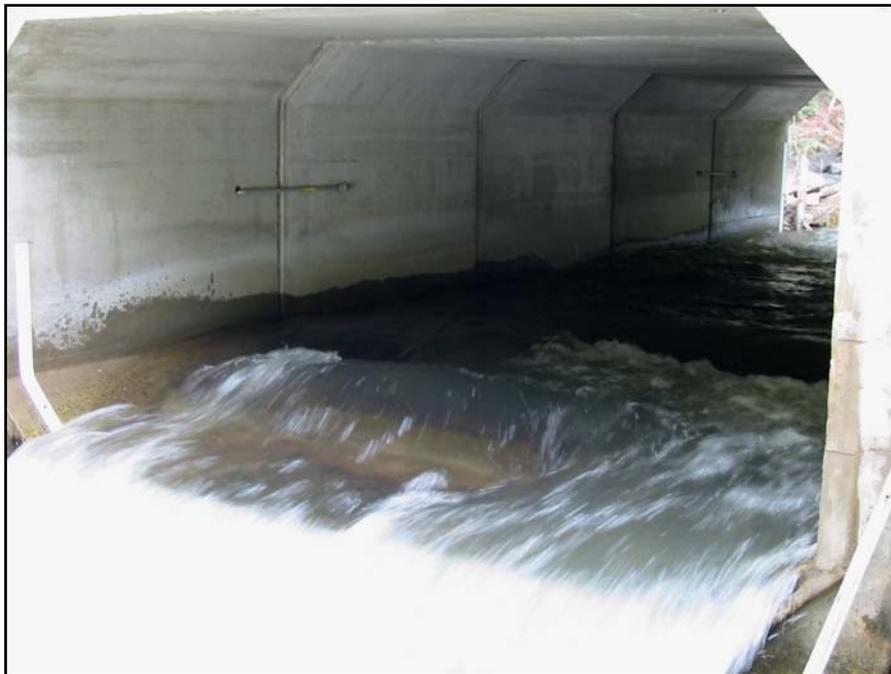
Figure A-2. Culvert 2 outlet. Note the water undulating over the submerged baffles.

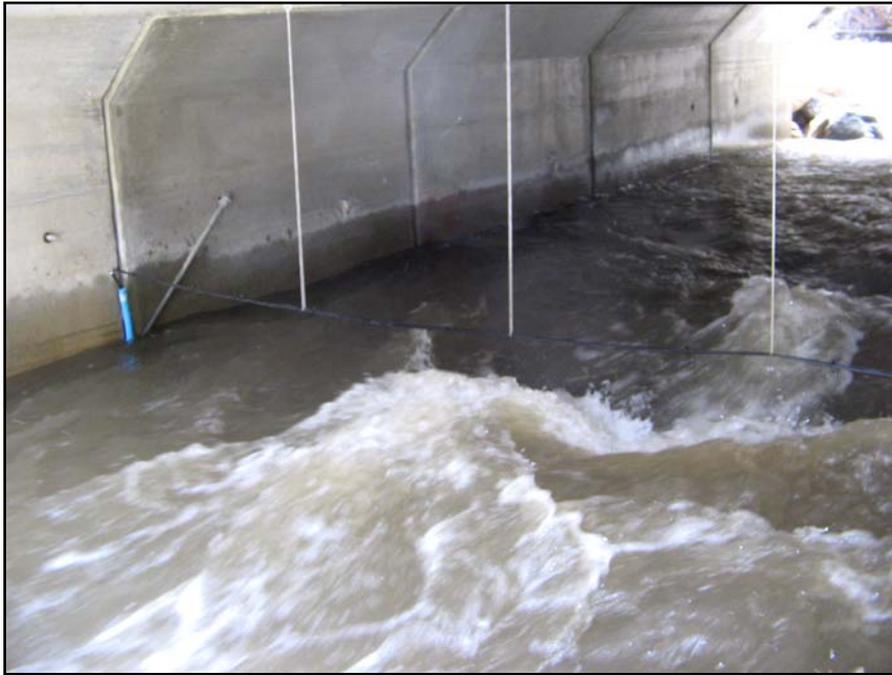
Figure A-3. Inside the barrel of culvert 3, looking upstream. Note the combined effect of baffles and infill of stream bed material on the water surface profile.
