Large-Scale Laboratory Testing of Geosynthetics in Roadway Applications

Third Task Report: Test Section Construction

Prepared by Steve Perkins Department of Civil Engineering & Western Transportation Institute College of Engineering Montana State University – Bozeman

January, 2020

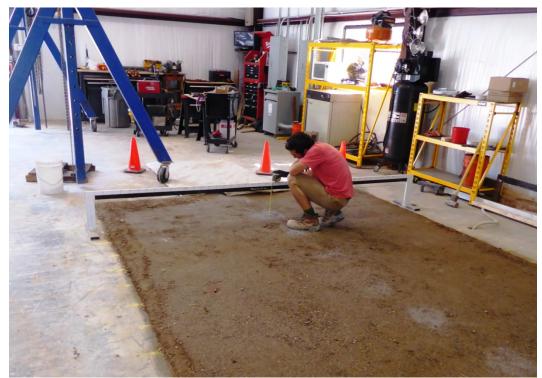
Figure 2-1: Survey measurement technique during construction.

Eighteen survey measurements were made in each test section after each layer was constructed. The position of these measurements is provided in Appendix B. Elevations were taken by measuring down from a stiff steel member that spanned the concrete trench (Figure 2-1).

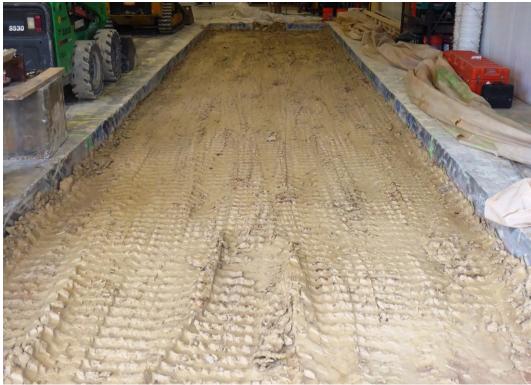
Figure 3-1: Spread and tracked subgrade prior to compaction.

The clay subgrade was built in six layers approximately 6 inches deep. The process began by mixing the subgrade using a skid-steer tractor and adding water to bring it to the target moisture content and shear strength associated with a bearing strength of 2.5% CBR. Periodic measures of moisture content and vane shear strength were taken during the mixing process to ensure uniformity. Once the subgrade had reached the target strength and moisture content, the skid-steer tractor was used to deposit, spread and track the prepared clay in the concrete-lined trench (Figure 3-1). Using this method, it took approximately three batches of clay to make one 6-inch layer across the entire the test area. The clay was kept covered with plastic to maintain its moisture content when not in use. Compaction of the subgrade was accomplished using a 54-inch smooth drum vibrating compactor (Hamm, Model H 5i), as shown in Figure 3-2. The sixth and final layer of the subgrade was leveled by hand to a tolerance of ± 0.20 inches (Figure 3-3). A small double smooth drum roller was used to smooth and finish the final top surface of the subgrade, which is shown in Figure 3-4.

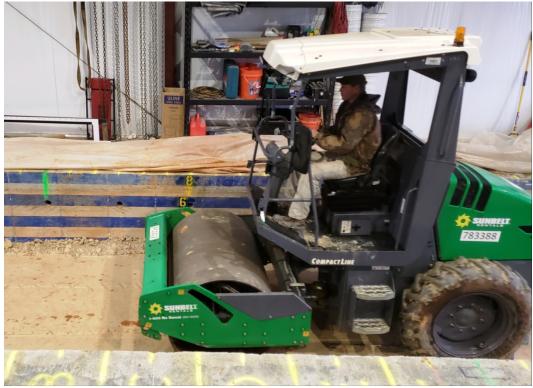
Figure 3-2: Compacting the subgrade.

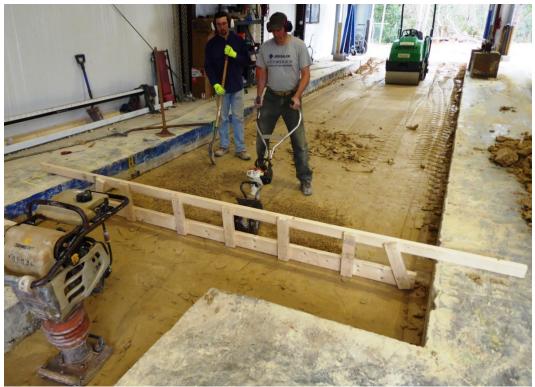
Figure 3-3: Leveling the final surface of the subgrade.

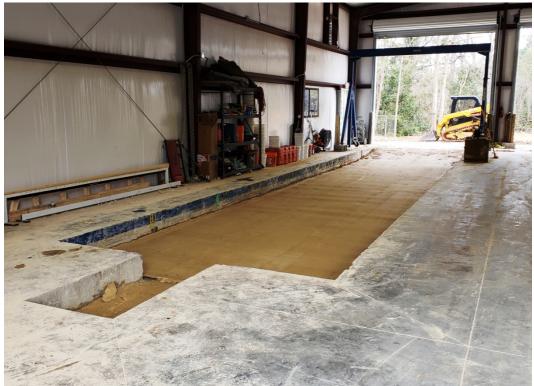
Figure 3-4: Finished surface of the subgrade.

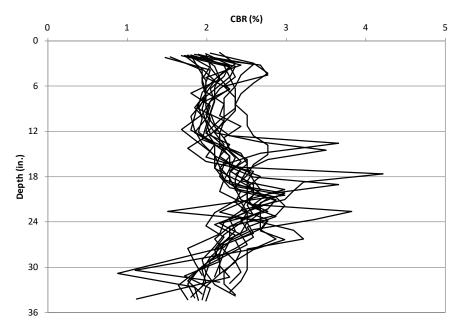
Figure 3-5: Subgrade DCP results as a function of depth

A Kessler Dual Mass Dynamic Cone Penetrometer (DCP) with a magnetic ruler and a 10.1 pound hammer was used to evaluate the strength of the subgrade after it had been fully constructed. Six tests were conducted in each test section, the results of which are shown in Figure 3-5 in terms of CBR. The bearing strength of the subgrade was calculated as a function of depth using Equation 1 developed by Kleyn (1975). As before, the measurements from Test Section 1, sub-section A were not used in the results. Average strengths based on the DCP tests were as follows: Test Section 1 CBR = 2.27%, Test Section 2 CBR = 2.27%, and Test Section 3 CBR = 2.24%.

$$CBR = \frac{292}{(mm/blow)^{1.12}}$$
(1)

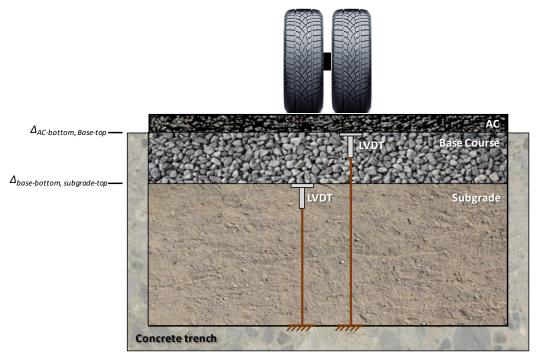
Figure 4-1: Cross-section of LVDT installation in the subgrade and base course.

Linear variable differential transducers (LVDTs) were installed to measure the displacement of subgrade and base course surfaces during trafficking. Three sensors were installed in the subgrade and three sensors were installed in the base course, as shown in the illustrations in Appendix C for each test section. The position of these measurements was designed to capture vertical movements caused by the load wheels during trafficking.

The first step during the installation process was to excavate a hole in the vicinity of the measurement point to allow each sensor to be inserted into the ground. The size of the access holes was kept as small as possible to minimize disturbance of the soil in the anticipated wheel path. All the soil that was extracted from each hole was temporarily stored in a sealed bucket so that it could be replaced once the sensor was in place. The datum for each displacement measurement was the bottom of the concrete trench, as illustrated in Figure 4-1. This was accomplished by driving a steel rod through the subgrade until it reached the trench floor (see Figure 4-2). A small piece of ³/₄ in. thick plastic was placed on the floor prior to constructing the

subgrade in the area where each of the metal anchors was to be located. A small nail was welded to the bottom of the steel rod so that when driven it would penetrate the plastic and keep the anchor from floating upward during construction and trafficking.

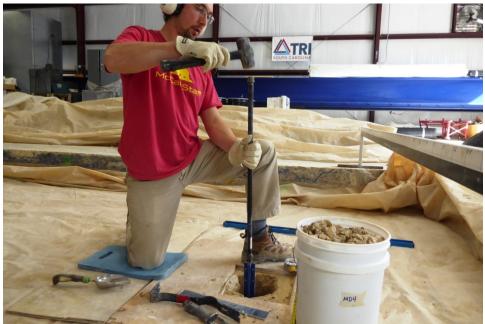
Figure 4-2: Installing LVDT anchor.

The bodies of the LVDTs were attached to the anchors using two u-bolts that extended through a metal plate welded to the top of the anchor. Each LVDT was outfitted with a sealed mechanism that extended the core of the LVDT to a round plate that would be positioned at the point of measurement (top of subgrade or base course layers). This extension mechanism was designed to keep the soil from jamming the LVDT as it allowed free movement of the LVDT core throughout the duration of the test. A photo of a typical LVDT setup is shown in Figure 4-3 prior to installation. The body of the LVDT was positioned on the anchor plate so that the vertical alignment of the plate at the end of the LVDT was level with the surface of the subgrade or base course, as shown in Figure 4-4.

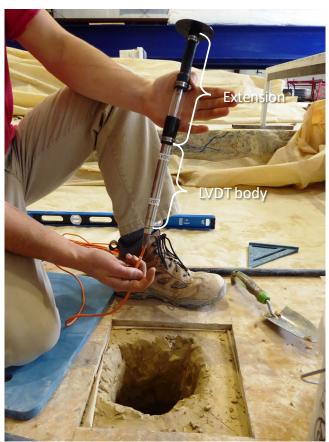
Figure 4-3: LVDT sensor prior to installation.

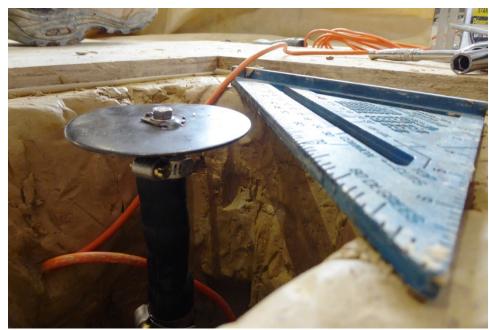
Figure 4-4: Position of the measurement point with respect to the subgrade surface.

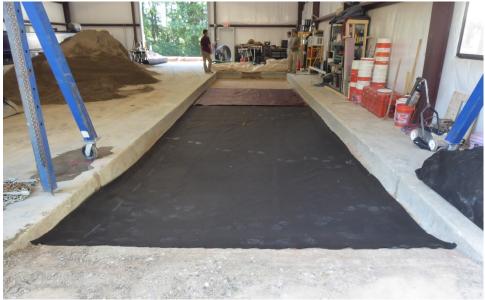
Figure 5-2: Installed geosynthetics.

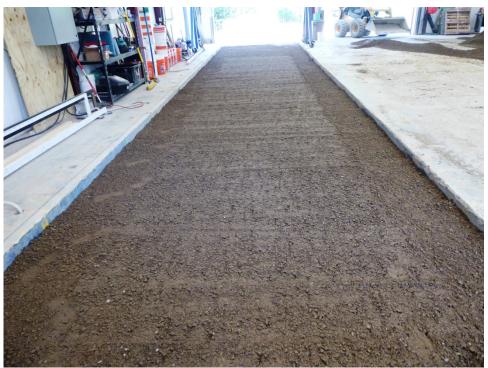
Figure 6-1: First layer of gravel screed to uniform depth.

The base aggregate was shipped from Montana in 3000 lb. super sacks and stored on site until construction of the base course. Preparation of the base aggregate began by unloading three to four bags onto the lab floor, mixing with a skid-steer tractor, and adding water until it reached the target moisture content. The aggregate was deposited on the test area without driving on it and spread across the test sections by hand. The base course was constructed in two layers, each of which was screed to a uniform depth prior to compaction (Figure 6-1). Compaction was accomplished using a 54-inch smooth drum vibrating compactor (Hamm, Model H 5i), and a small double smooth drum roller was used to create a smooth, flat surface on the final lift (Figure 6-2). The final average thickness of the base course layer was 13.29 ± 0.20 inches. The target thickness was 13.5 in.

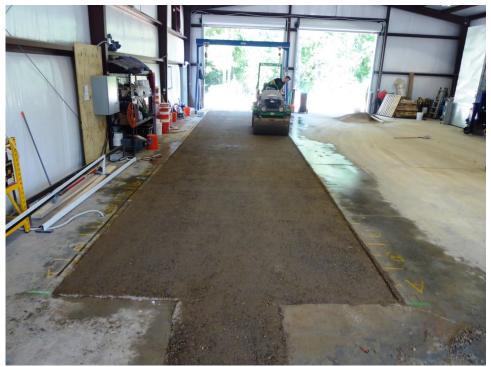
Figure 6-2: Final compacted surface of the base course.

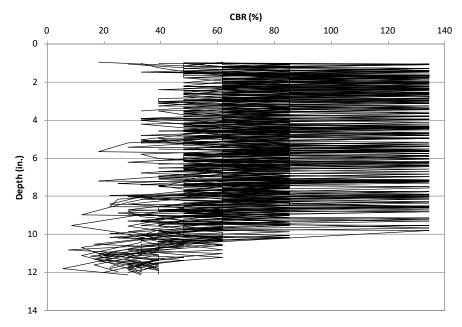
Figure 6-3: Base course DCP results as a function of depth.

Six DCP measurements were taken within each test section using the dual mass DCP device (drop hammer weight of 17.6 lb.) on the finished surface of the base course. These measurements were taken outside of the wheel path to keep from damaging the geosynthetics in the wheel track area.

The results from these tests are shown in the plot in Figure 6-3. The bearing strength (in terms of CBR) as a function of depth was calculated using Equation 1 developed by Kleyn (1975). The measurements from Test Section 1, sub-section A were not used in the results. Average CBR strengths were calculated using values between about 2 and 10 inches of depth to avoid areas near the top and bottom of the compacted layer. The average strengths were as follows: Test Section 1 CBR = 72.4%, Test Section 2 CBR = 73.9%, and Test Section 3 CBR = 73.8%.

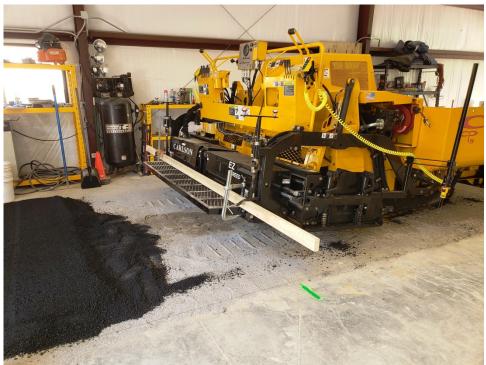
Figure 7-1: Placement of the hot-mix asphalt.

Surface C asphalt, according to the South Carolina DOT mix design, was purchased from a hotmix plant (Rogers Group – Greer, SC) near the TRI Environmental laboratory. Properties of the mix were determined by the QC lab at the hot-mix plant during the morning that the paving was done and these results are provided in Appendix E. The asphalt was placed in a single lift that had an average thickness of 3.37 ± 0.13 in. It was placed using a full-size paving machine (Figure 7-1), and compacted using a tandem roller (Figure 7-2) and pneumatic roller (Figure 7-3).

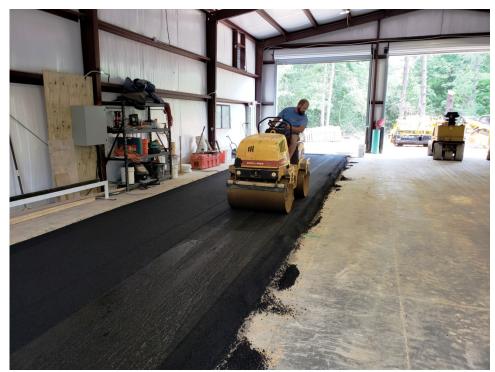
Figure 7-2: Compaction of hot-mix asphalt using a smooth drum roller.

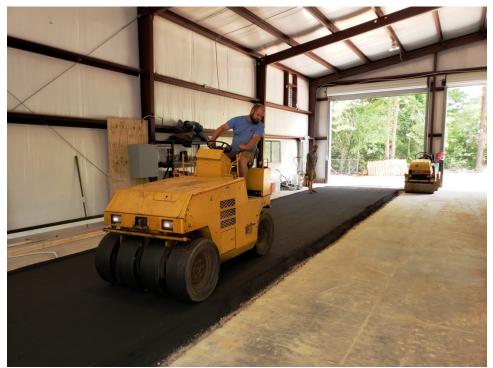
Figure 7-3: Compaction of hot-mix asphalt with a pneumatic roller.
