**Montana US Highway 93 South Wildlife Crossings Research**  
**MDT # HWY – 308445-RP**

**2014 Annual Progress Report**

Prepared for the Montana Department of Transportation

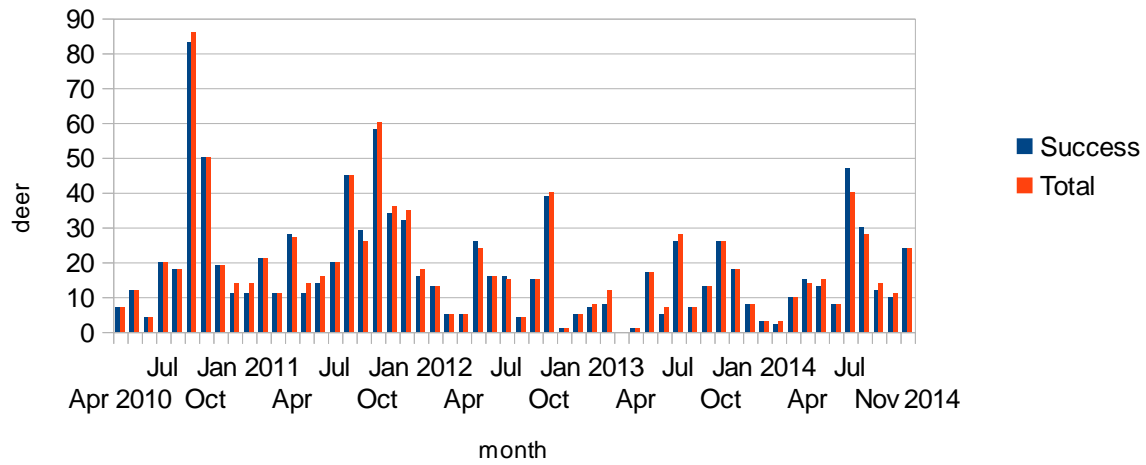
## Blodgett Creek Bridge

### Success and Total Deer per Month

Appendix A contains long-term trend charts indicating success and total deer per month at each wildlife crossing structure.
