# Montana US Highway 93 South Wildlife Crossings Research MDT # HWY – 308445-RP

Patricia Cramer, PhD  
Robert Hamlin

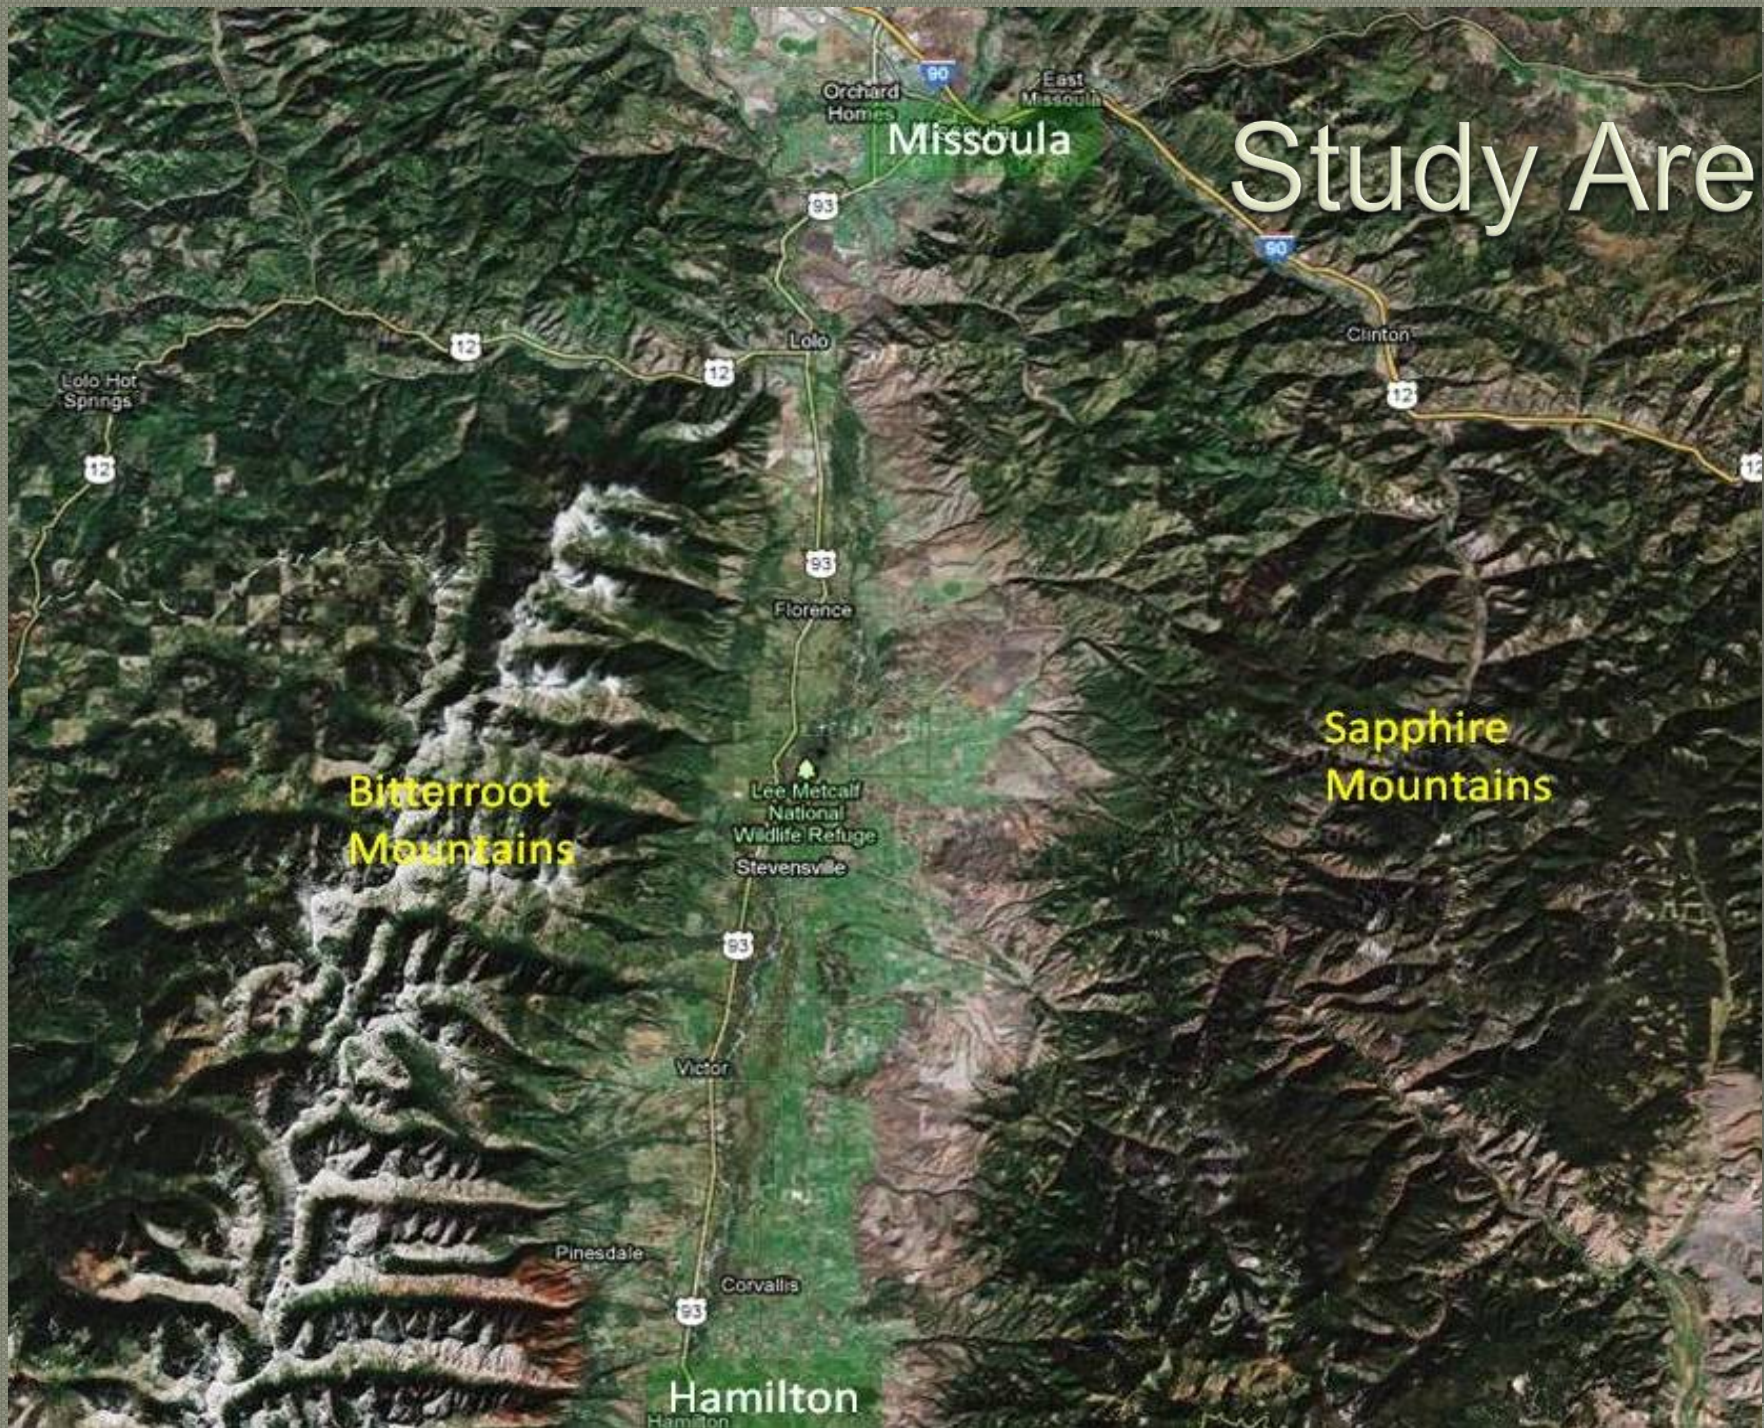
# Study Area

Wildlife  
Crossing  
Structures

**Determine the effectiveness of the 19 wildlife crossing structures by investigating:**

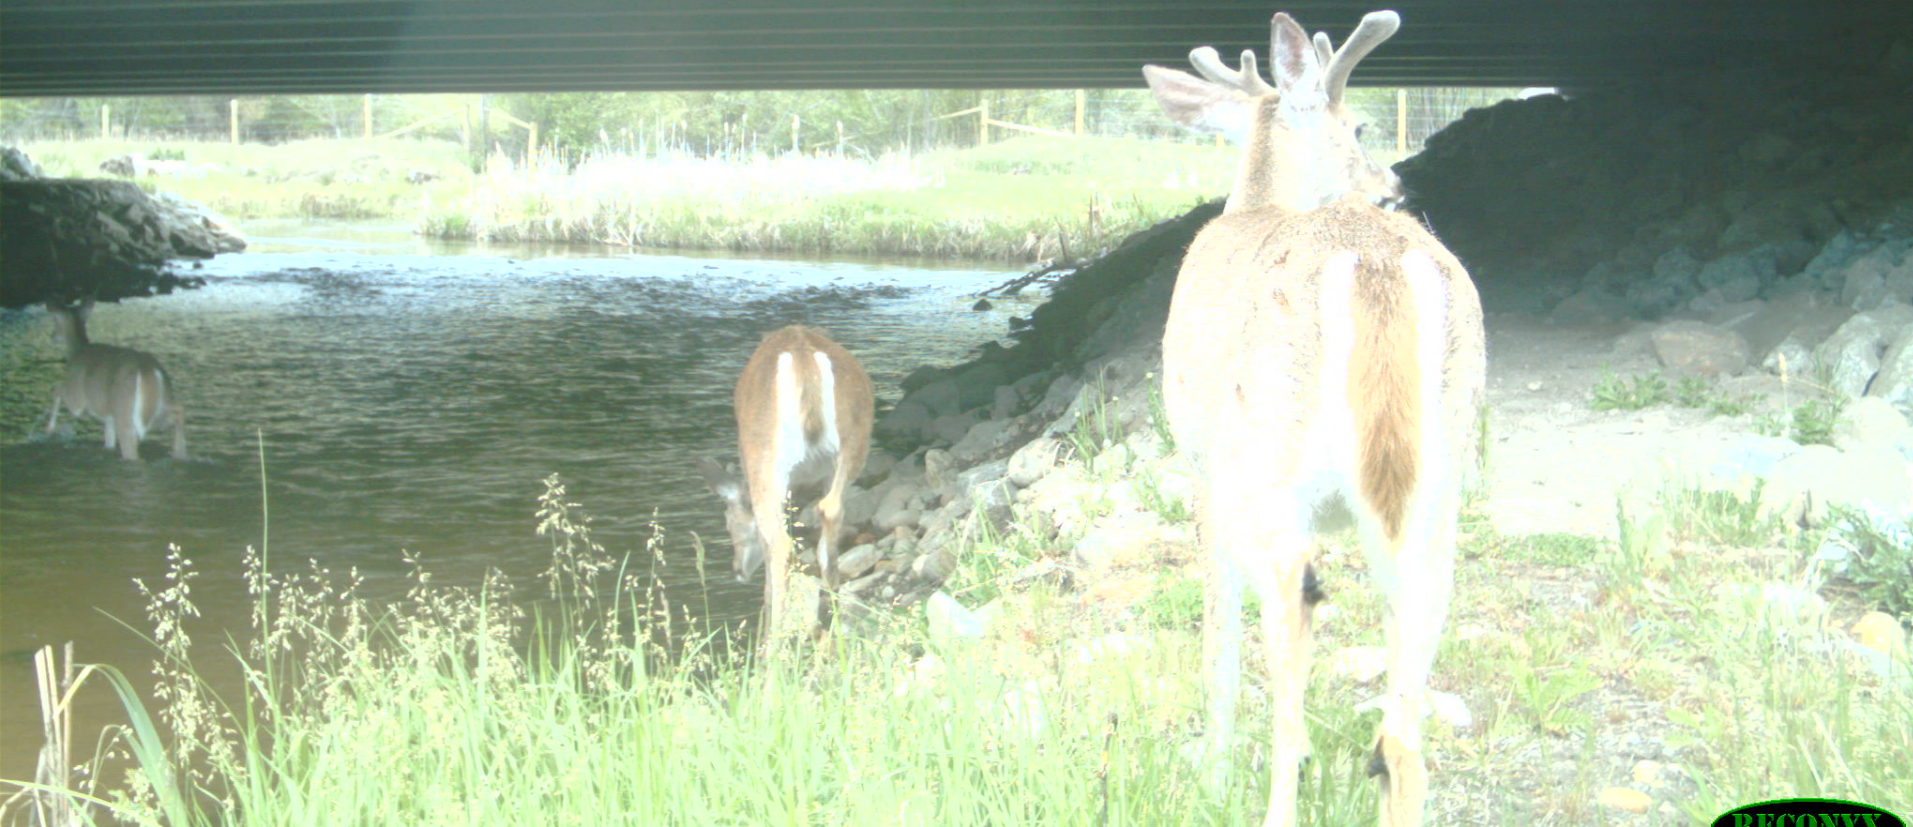
Height, Width, Cover, and Location are Important.

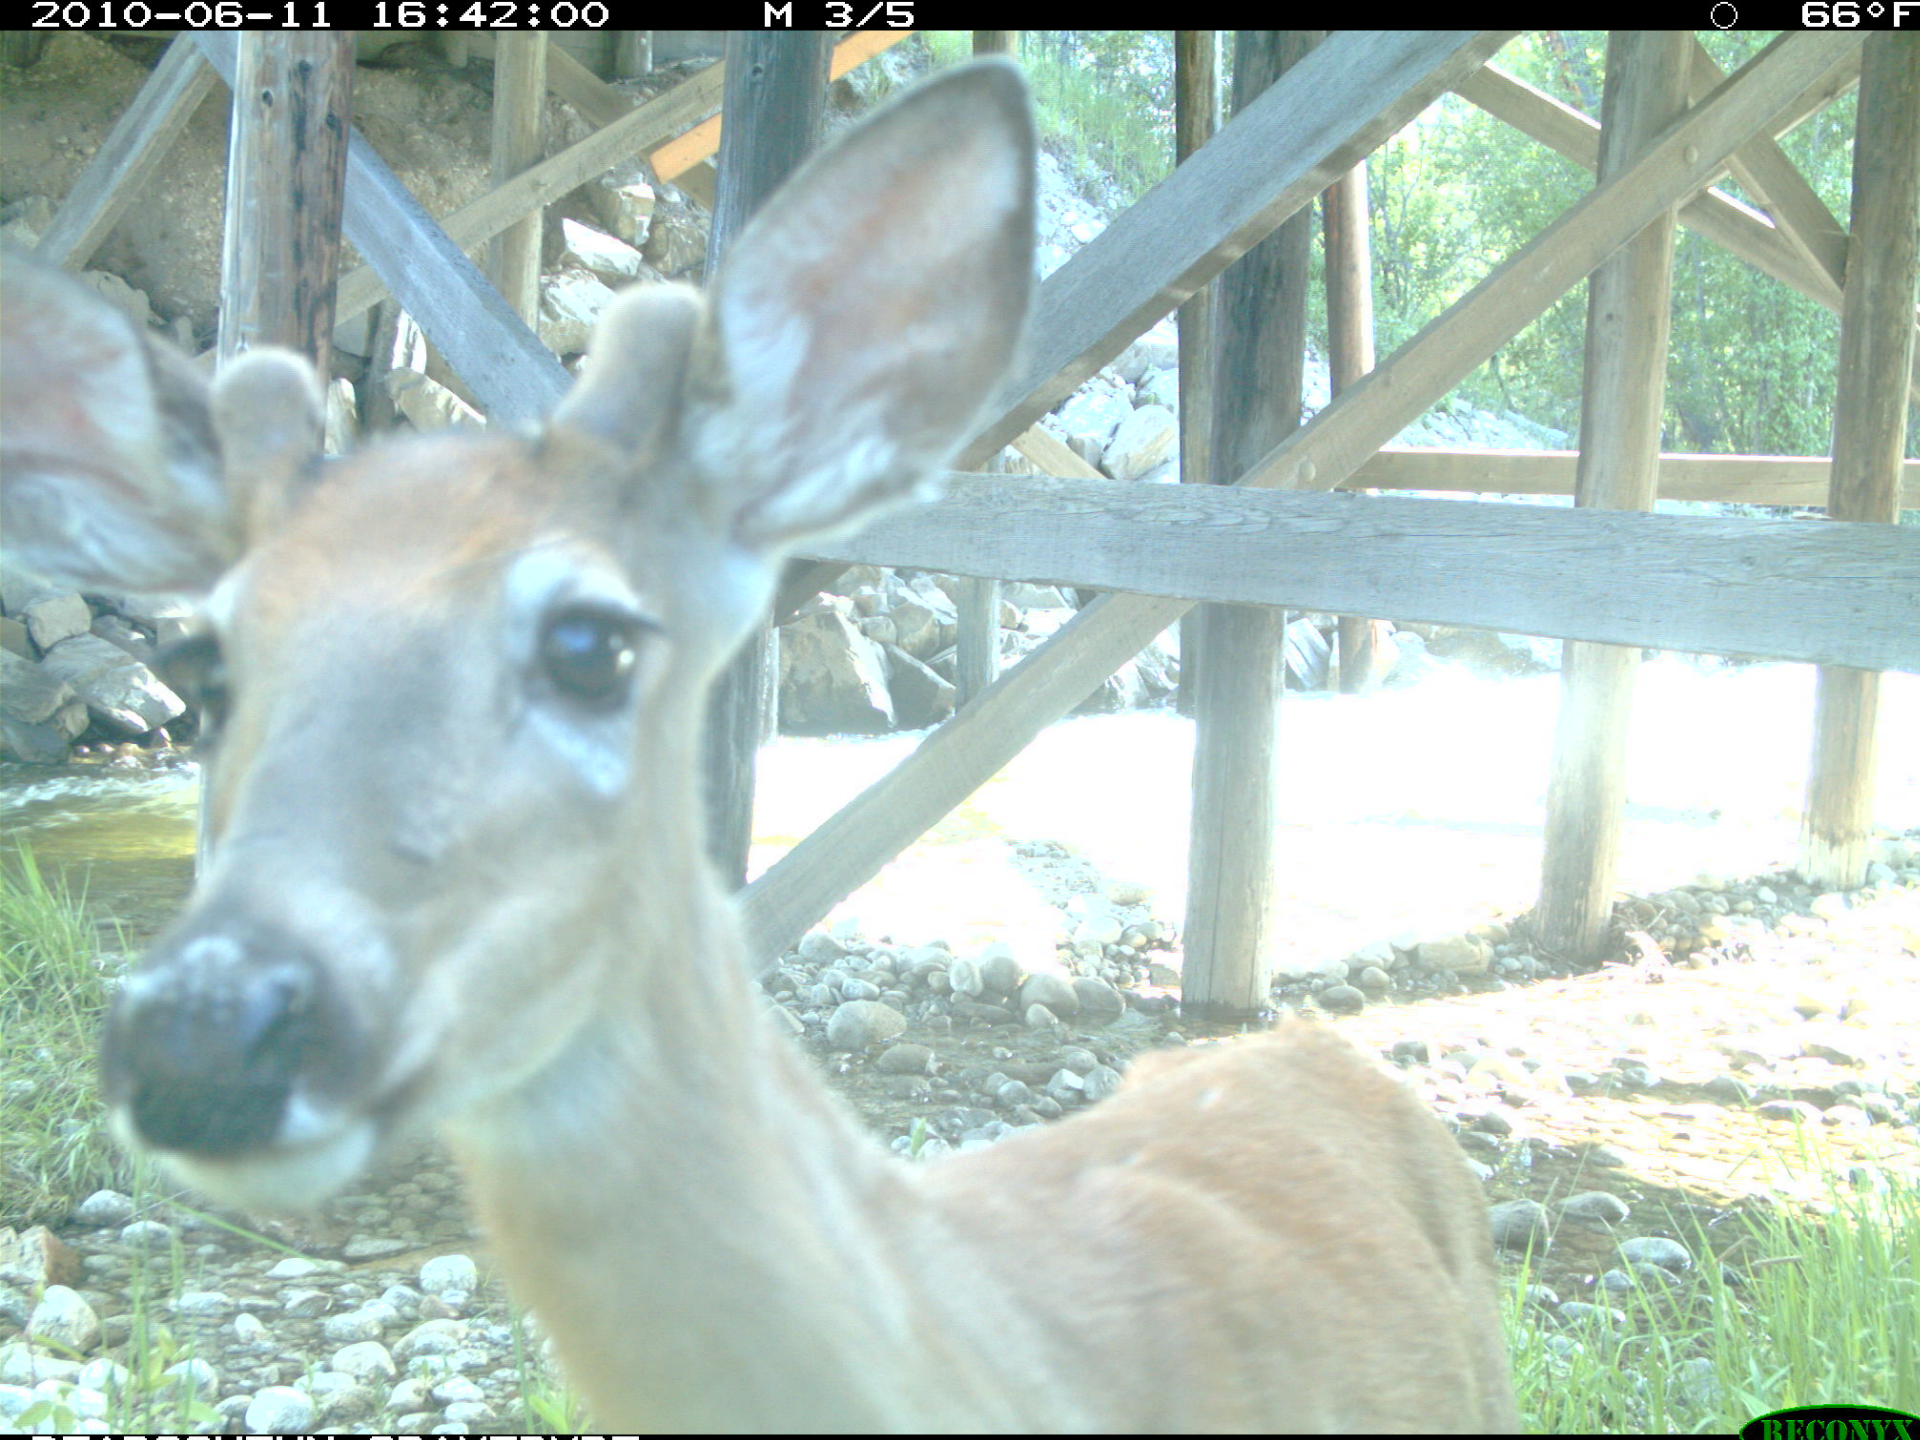
Pre-construction monitoring showed that an existing bridge, Bear Creek South, was working well for white-tailed and mule deer, even though it was not designed as a wildlife crossing structure. Again, height, width, cover, and location are important.

The Bear Creek South bridge camera recorded over 1600 successes by white-tailed deer and 700 successes by turkeys in just 600 days. Black bear also moved under the bridge.

2.6 success per day

| Structure Camera Location | MP | Cam Days | Deer Per Day | Succes Cross | Succ Rate (%) | Repel Rate (%) | Paral Rate (%) |
|---|---|---|---|---|---|---|---|
| Bear Creek South | 57 | 629 | 2.6 | 1662 | 98 | 1 | 1 |

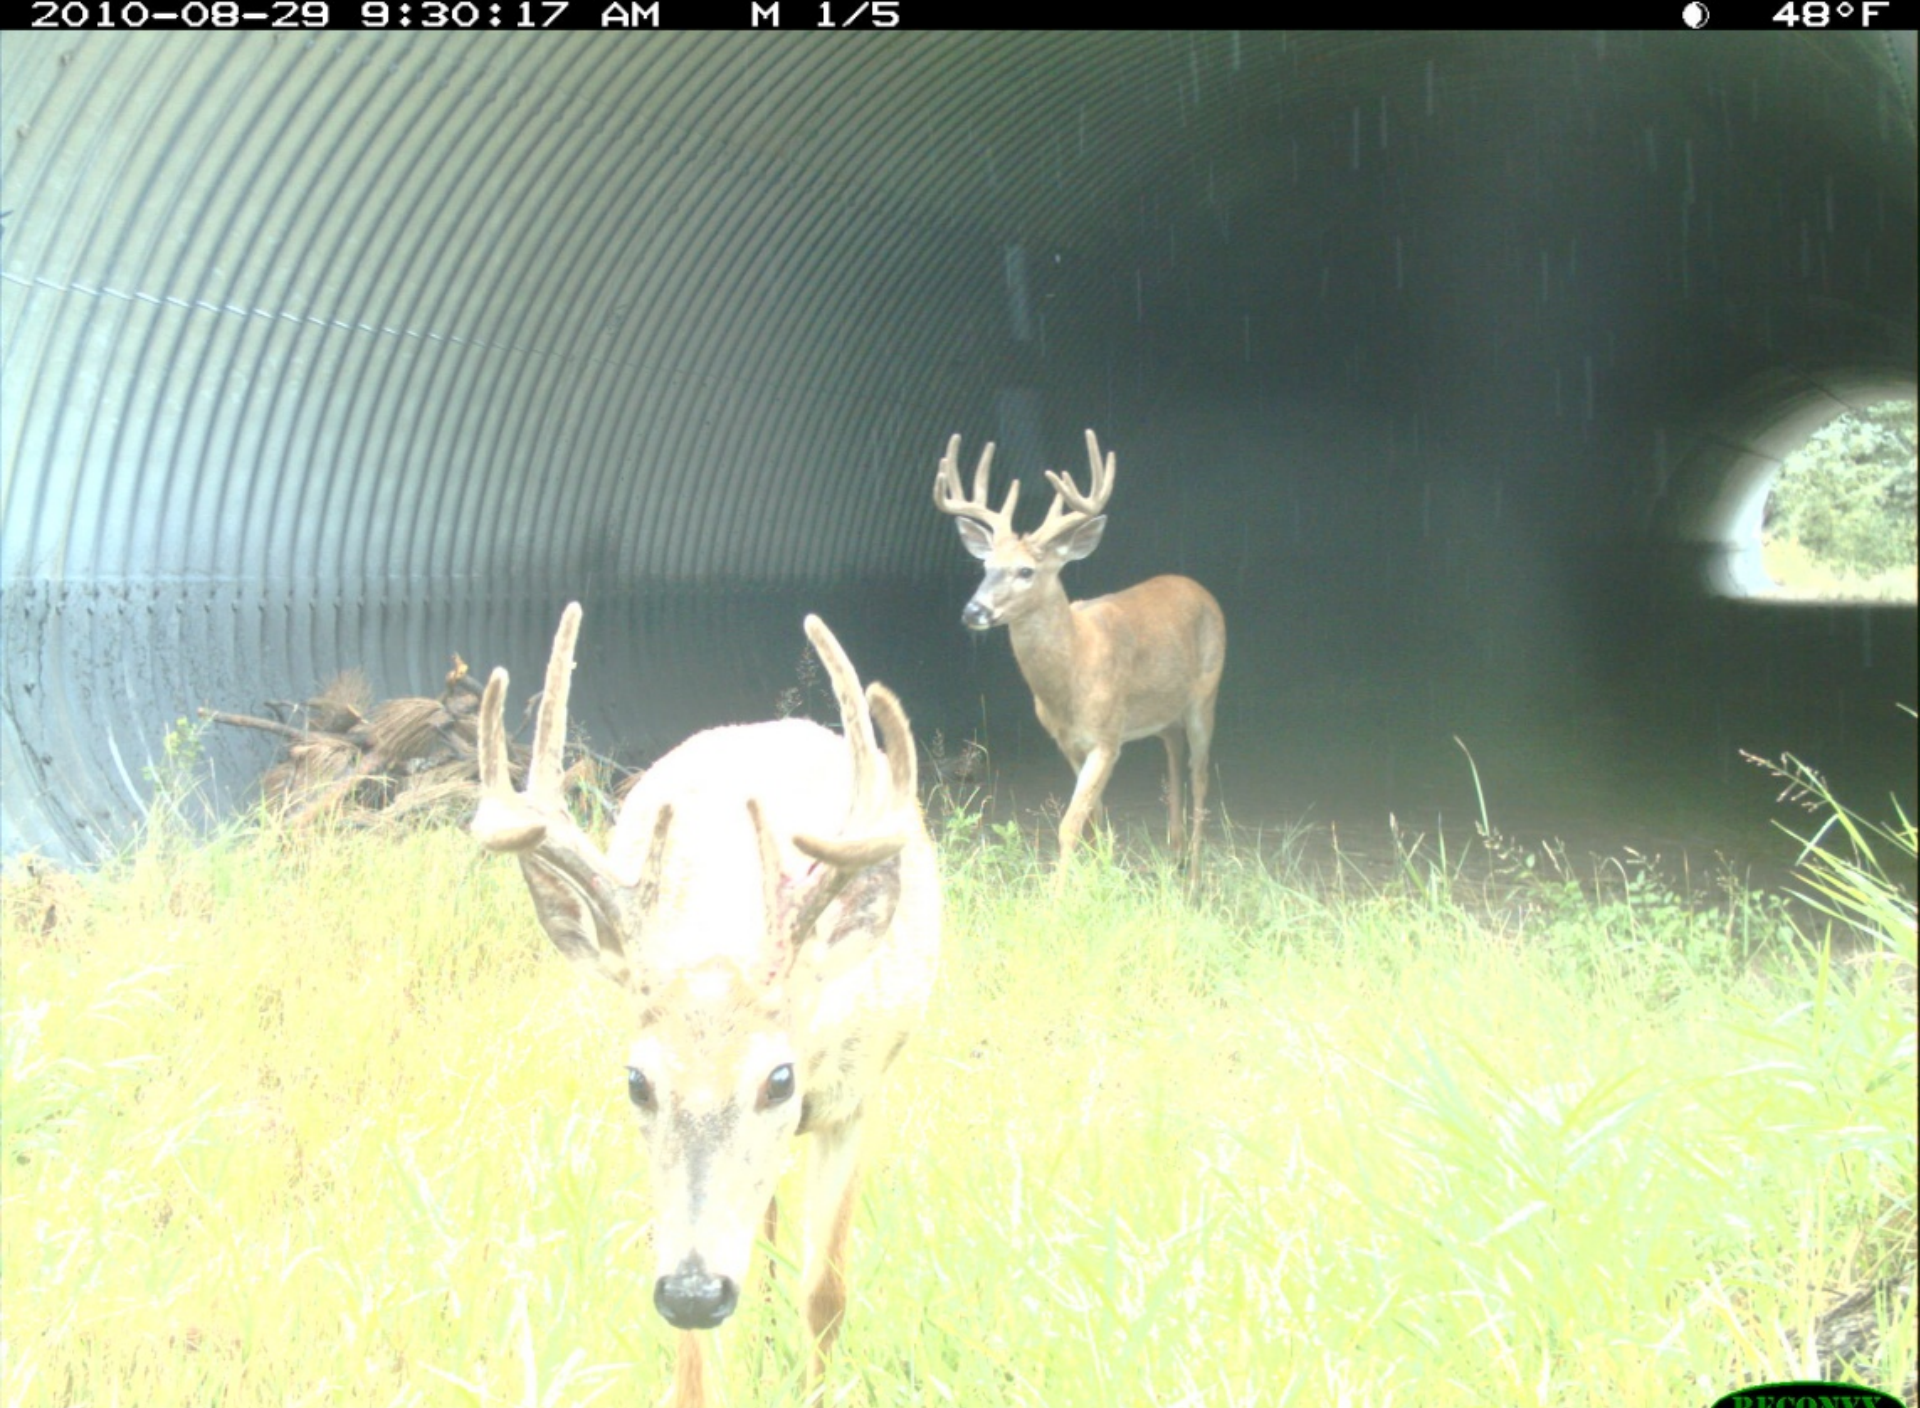
A large, round, corrugated-steel culvert (18 feet high and wide) worked well for white-tailed deer.

The Bass Fishing Access culvert recorded 2247 successes by white-tailed deer, 150 by fox, 15 by coyote, 2 by puma, and 9 by black bear in 1498 days.

| Camera Location | MP | Succ<br>Per<br>Day | Success<br>Cross | Succ<br>Rate<br>(%) | Repel<br>Rate (%) | Paral<br>Rate<br>(%) |
|---|---|---|---|---|---|---|
| Bass Creek Fishing Access (StCu) | 70 | 1.5 | 2247 | 96 | 3 | 1 |

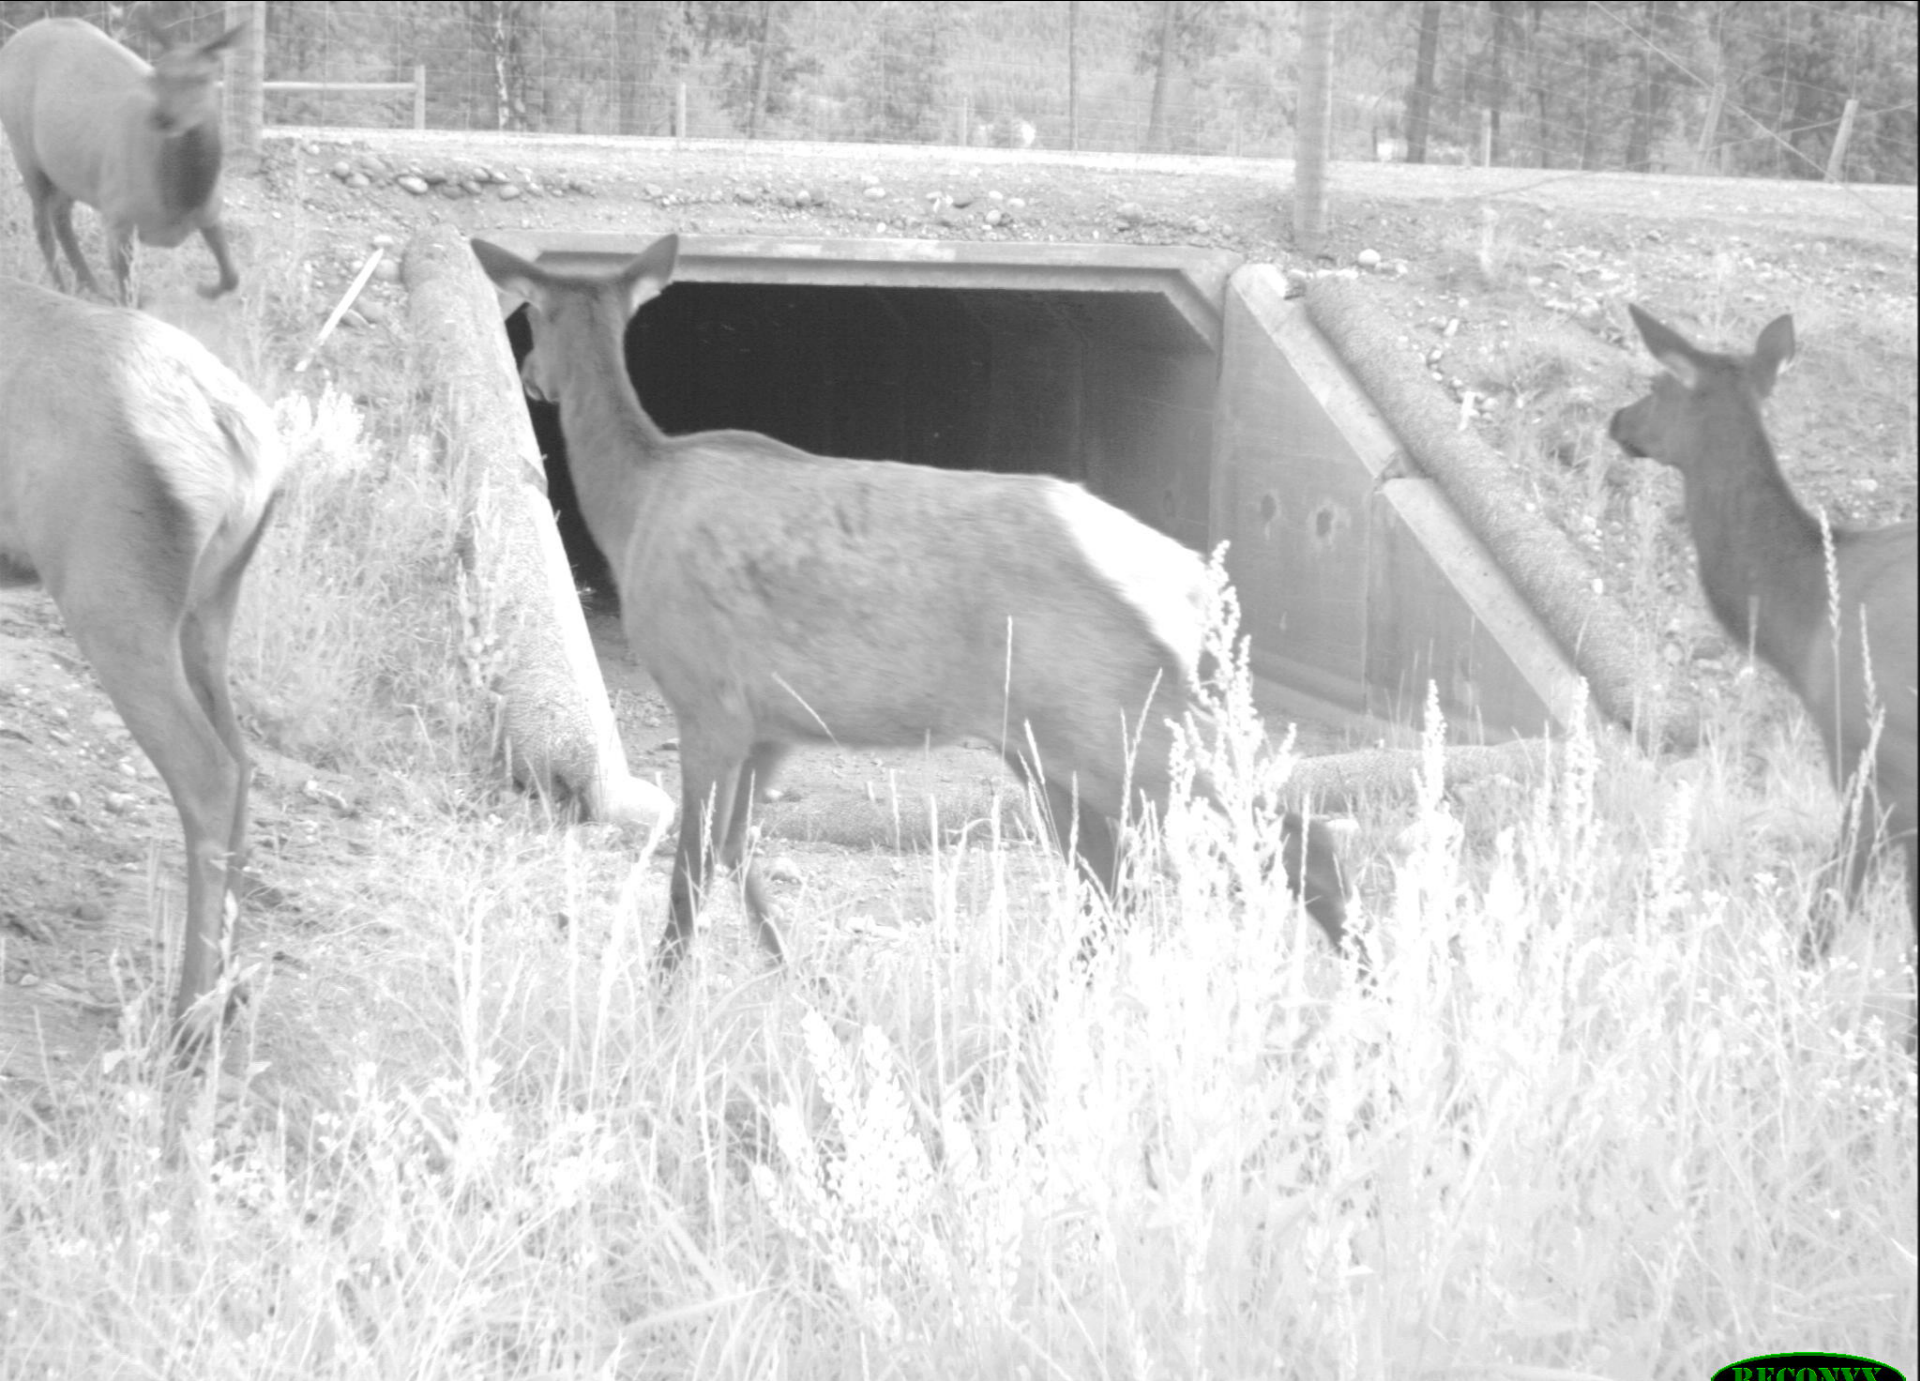
Not all the animals out there are using crossing structures.
