Montana US Highway 93 South Wildlife Crossings Research

MDT # HWY – 308445-RP

2012 Third Quarter Progress Report

Prepared for the Montana Department of Transportation

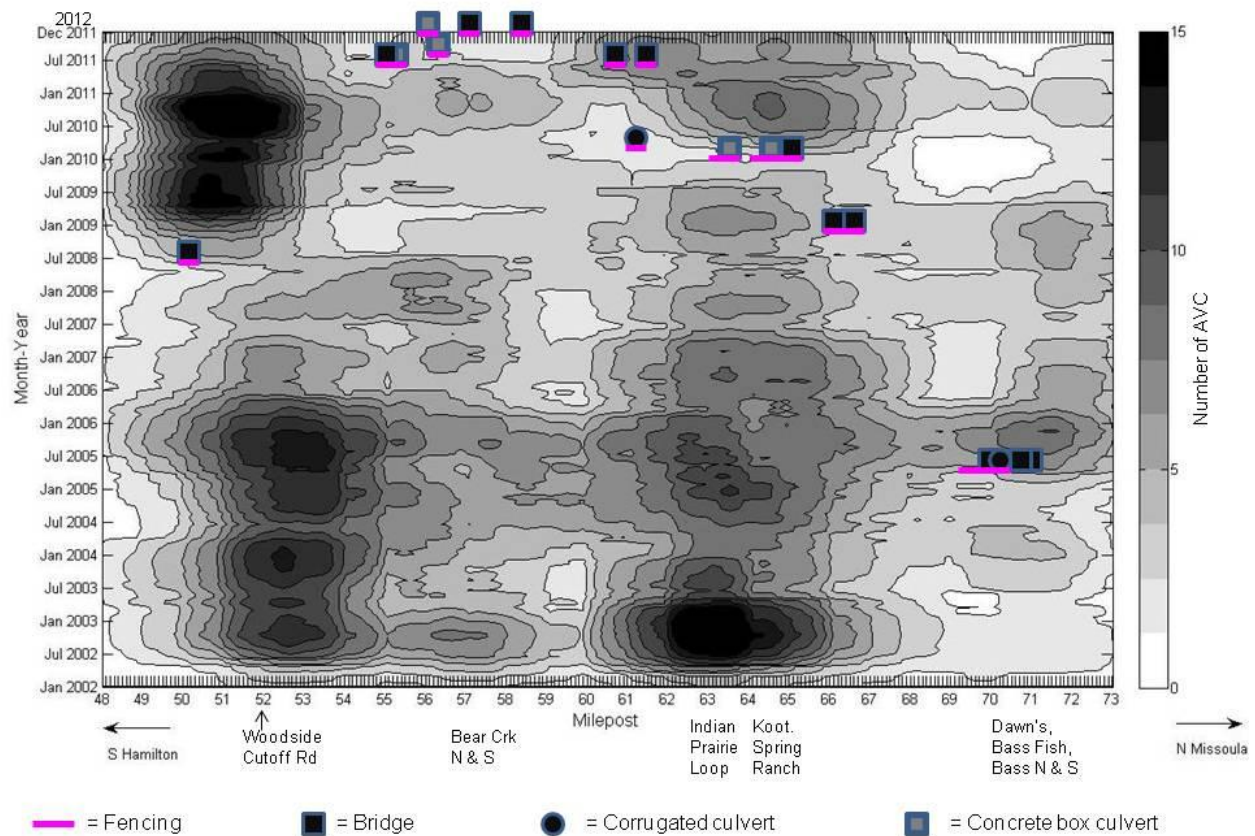
Figure 5. Kernel Density Analysis of AVC carcass data along US 93 South, mp 48 through 73. Darker spots reflect higher carcass counts at specific mile posts at six month intervals. Wildlife crossing structure type, location, date installed, and wildlife fencing are indicated.

Ms. Gunson conducted an updated Kernel Density Analysis that indicates AVC numbers over time and space (Figure 5). Locations of the 19 wildlife crossing structures and the names of key areas with high AVC concentrations are included. This analysis will continue and will include the locations of wildlife exclusion fencing.

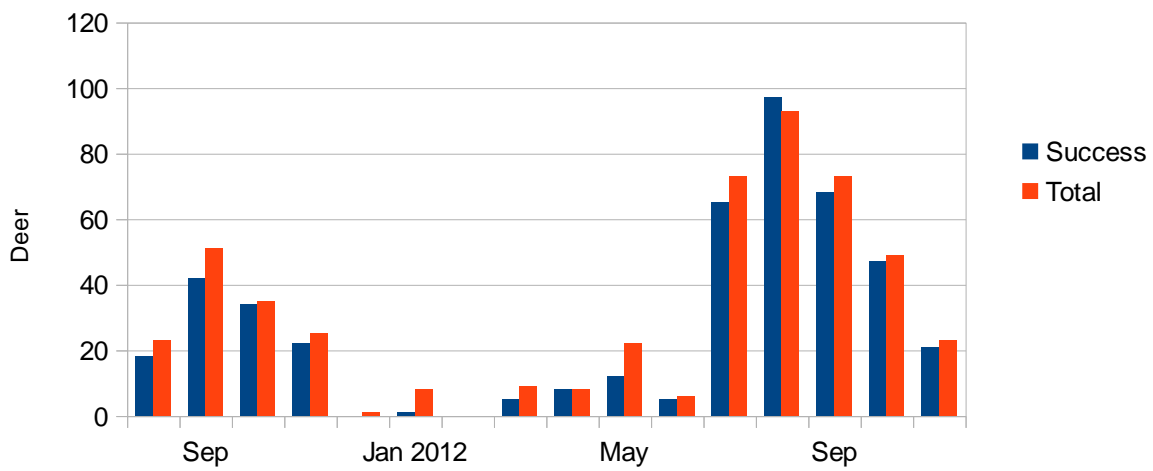
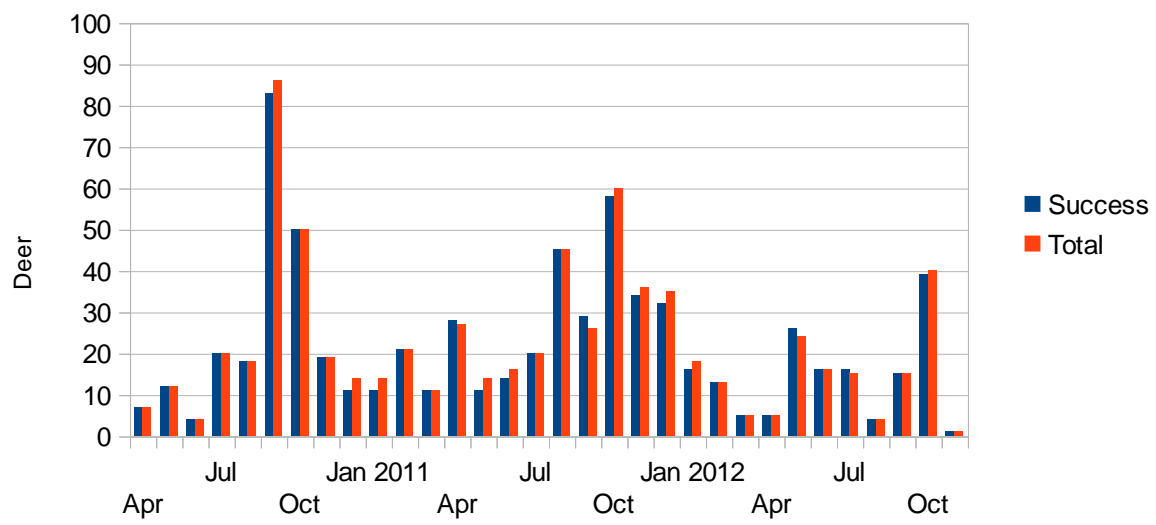
Appendix A contains trend charts for camera locations at each of the 19 wildlife crossing structures. These charts indicate successful use and total number of deer on a monthly basis over the duration of the study at individual camera locations. Success is defined as the number of occasions that white-tailed deer successfully moved through a wildlife crossing structure. There are exceptions where success is greater than total. This can occur when individual deer move back and forth through the structure during individual events (the individual deer are counted once while successes are counted multiple times). These charts are preliminary. Seven structures have less than one year of monitoring.
