## US 191 Corridor Study

*Four Corners to Beaver Creek*

## Existing and Projected Conditions

Technical Memorandum

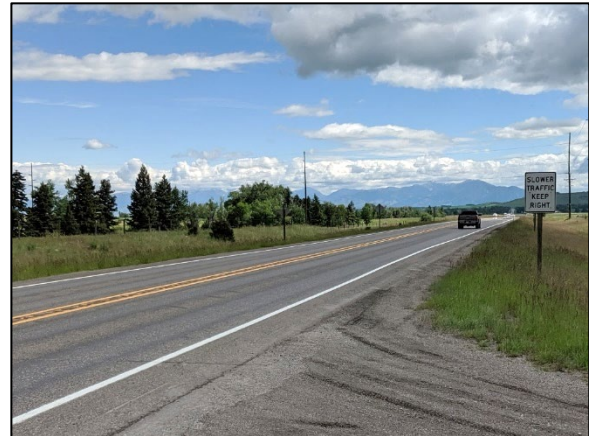
*There is a 0.9 mile-long passing lane for northbound vehicles just outside of the canyon.*

Just south of Wilson Creek Road (RP 73.5), US 191 transitions back to a two-lane highway with a width of 32 feet. Before approaching the Gallatin Canyon, there is a northbound passing lane which begins just north of Gateway South Road and continues north past Kleinschmidt Road (RP 70.6 to 71.5). The roadway through this section is 44 feet in width.

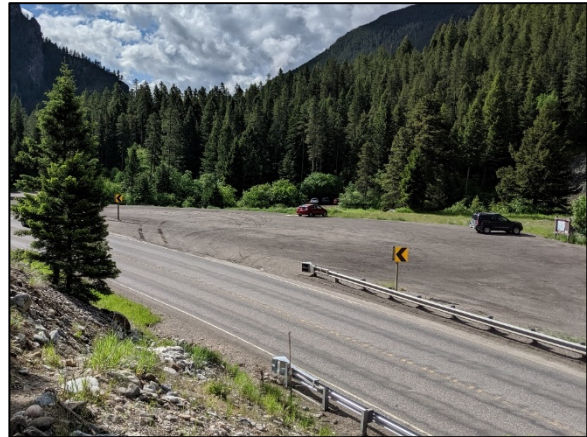
*There are many designated turnouts along the corridor which facilitate access to popular recreation areas.*

There are 22 designated turnouts along the study corridor, all of which occur within the Gallatin Canyon (RP 48 to 70). The turnouts vary in length, width, and spacing but are provided where feasible in order to facilitate free flow traffic conditions. Per *Montana Code Annotated 61-8-311*, the operator of a slow-moving vehicle with four or more vehicles behind it should utilize turnouts to allow following vehicles to pass. Several turnouts within the corridor are also used by recreationists for parking and river access. At times turnouts are not available for slower vehicles who want to pull over and let traffic pass because of parked vehicles using the sites for recreation purposes.

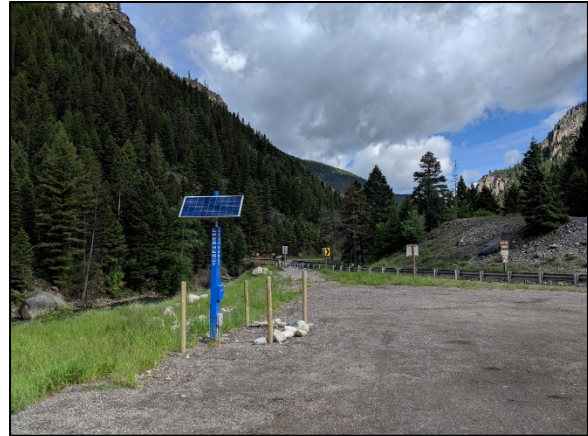
*There are three emergency call boxes along US 191 within the study area.*

There is little to no cell coverage within the Gallatin Canyon. To aid in emergency situations and dispatch emergency services, there are currently five emergency call boxes along US 191, three of which are in the study area. Those call boxes are located at Lava Lake (RP 61), Moose Creek (RP 56), and Karst's Camp (RP 55). All call boxes are installed and maintained by the Big Sky Rotary Club.

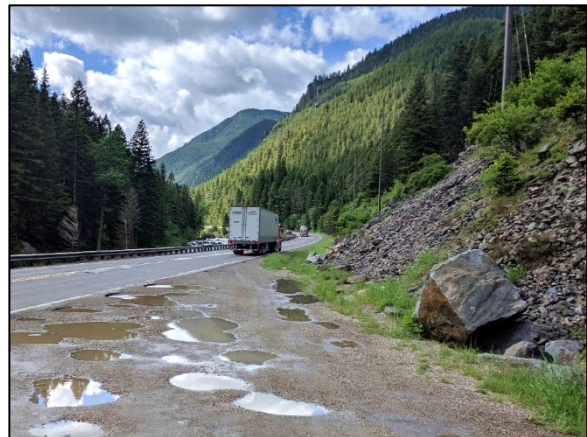
*Multiple rockfall hazard locations have been identified along the corridor.*

In these areas, there is potential for rockfall events, possible emergency road closures, and significant disruption of normal traffic operations. Specific areas include approximate RPs 49.5 to 50.5, 52 to 53.5, 56.5 to 58, and 59 to 63. When working in these areas with rockfall hazards, the types of mitigation measures that can be expected for future projects include blasting, scaling, rock bolting, netting and drapery, rockfall retention structures/fences, and improved or reconfigured roadside ditch configurations. There are currently no physical rockfall protection barriers present in the canyon.

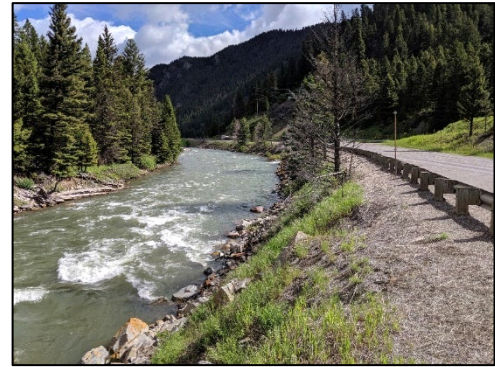
*The US 191 study corridor generally parallels the Gallatin River. The corridor crosses the river at three locations while also crossing several other streams and tributaries within the study area.*

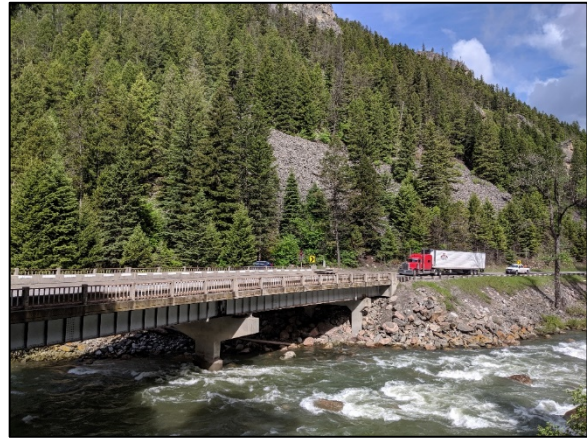
*There are nine bridges in the study corridor, all of which meet current design standards to remain in place. Some of the bridges are currently in need of repair and/or maintenance.*

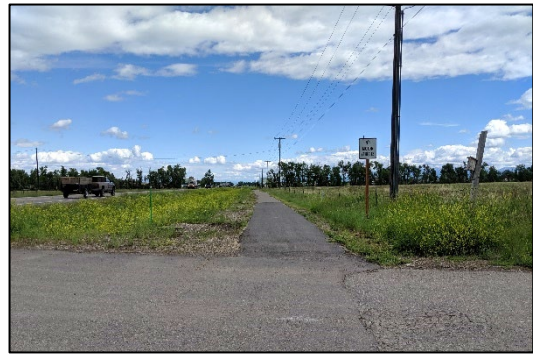
*Two shared use paths existing in the study area, one in Gallatin Gateway and one between Big Sky Canyon Village and Ophir School.*

There are two shared use paths along the study corridor and several trails starting near US 191 but diverging east or west of the corridor. The Gateway shared use path is a 9-ft wide asphalt path along the east side of US 191 beginning at the intersection of Zachariah Lane (RP 77.8) ending at Rabel Lane/Mill Street (RP 76.3). The path crosses under US 191 to Mill Street (RP 76.3). Approximately four miles remain to complete the trail connection into Four Corners at Lower Rainbow Road (RP 81.0). Sustained public use has created an informal trail adjacent to the shoulder on the west side of US 191. The Big Sky Trail shared use path is a 10-ft wide asphalt path along the west side of US 191 beginning just before the junction of MT 64 (RP 48) and ending at Beaver Creek Road (RP 45.3).

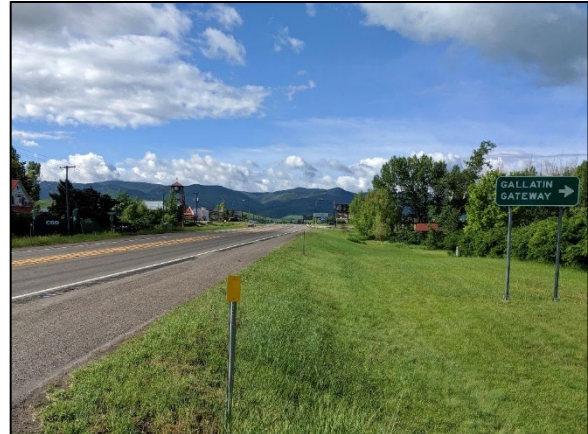
*The study corridor is generally 28 feet wide through the canyon. Between Four Corners and Gallatin Gateway the roadway is wider areas to accommodate turn lanes and a two-way left-turn lane at various locations.*

South of the Four Corners intersection, US 191 transitions into a two-lane highway with a center TWLTL or dedicated left-turn bays for most of the length between Four Corners and Gallatin Gateway. Through this section, US 191 is typically 32 feet in width with some wider locations to accommodate turn lanes. At Lower Rainbow Road (RP 81.1), there is a dedicated southbound right turn lane in addition to the TWLTL resulting in a pavement width of 64 feet. At Mill Street (RP 76.3), there are dedicated southbound right-, through, and left-turn lanes as well as a dedicated northbound left-turn lane and shared through/right-turn lane. The pavement width is also 64 feet at this location.

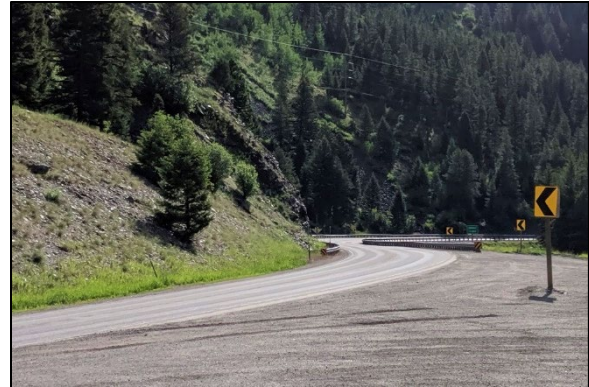
*There are several curves along the study corridor with limited sight distance due to steep side slopes.*

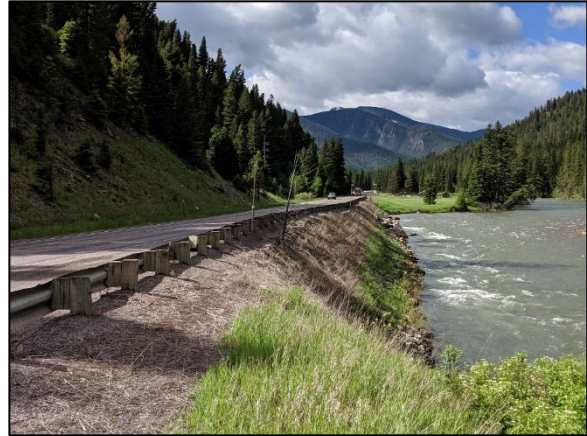
*The study corridor has areas with narrow clear zones and limited sight distances particularly within Gallatin Canyon.*

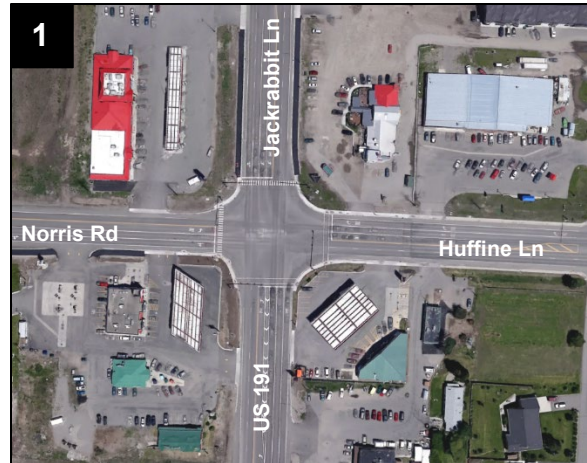
The intersection of US 191/Norris Road/Jackrabbit Lane/Huffine Lane is currently signalized. The northbound approach (US 191) has dedicated right-turn and left-turn lanes and two through lanes. The eastbound approach (Norris Road) consists of a dedicated left-turn lane, through lane, and shared through/right-turn lane. The southbound approach (Jackrabbit Lane) has two dedicated left-turn lanes, a through lane, and a shared through/right-turn lane. The westbound approach (Huffine Lane) consists of dedicated left-turn, through, and right-turn lanes.

There are gas stations on three of the four quadrants of the intersection while a bar/restaurant is located in the fourth. The driveways for these businesses are setback less than 100 feet from the stop bar on all approach legs except along Jackrabbit Lane. There are crosswalks on all approaches.

Under existing traffic conditions, this intersection operated at a LOS C during all peak hours except the August PM peak hour. The intersection experiences about 13 percent fewer vehicles during December than in August but generally operates at the same LOS during the peak travel periods. The eastbound approach (from Ennis) generates the highest delay during all peak hours. The northbound approach (from Big Sky) generates the second highest delay during all peak hours.

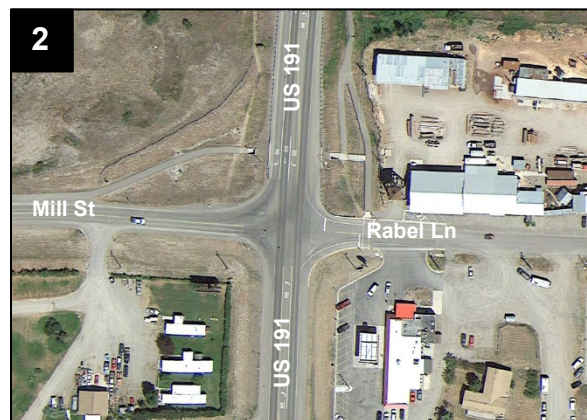
The intersection of US 191/Mill Street/Rabel Lane is currently two-way stop controlled on the minor approaches (east/west). The northbound approach (US 191) has a dedicated left-turn lane and a shared through/right-turn lane. The southbound approach (US 191) consists of dedicated left-turn, through, and right-turn lanes. Both the east and westbound approaches (Mill Street and Rabel Lane, respectively) have one shared left-turn/through/right-turn lane. There is a crosswalk on Rabel lane approximately 50 feet east of the intersection where the shared use path terminates.

Under existing traffic conditions, this intersection operates at a LOS of D, C, and F during the AM, Noon, and PM peak hours, respectively, in the summer peak season. In the winter peak season, the intersection operates at LOS E, C, and E during the AM, Noon, and PM peak hours, respectively. The added delay at the intersection during the winter can be attributed to school traffic (Gallatin Gateway School) as the eastbound traffic volumes are nearly double when school is in session. The north and southbound approaches experience little delay, as these approaches are given the priority movement. The eastbound approach generates the highest delay during all peak hours. When there are high

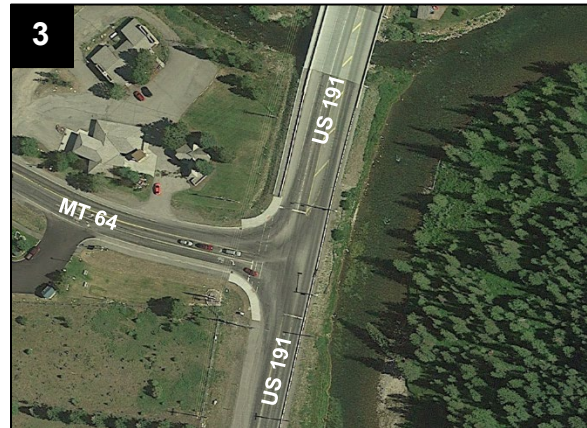
The intersection of US 191/MT 64 is a three-legged intersection which is currently signalized. The northbound approach (US 191) consists of dedicated left-turn and through lanes. The westbound approach (MT 64) has dedicated right-turn and left-turn lanes. The southbound approach (US 191) consists of dedicated right-turn and through lanes. There is a crosswalk on the eastbound approach. The Big Sky Chamber of Commerce and a gas station sit near the intersection, their approaches are located within 250 feet of the intersection.

Under existing traffic conditions, this intersection operates at a LOS of B during the AM and Noon peak hours in both the summer and winter peak seasons. During the PM peak hour, the intersection operates at LOS C in August, but operates at LOS D in December. Although the intersection experiences about 13 percent less traffic in the winter than the summer, the delay on individual approaches can be worse during the winter. The southbound right generates more delay during the AM peak hour, and the eastbound approach generates more delay during the PM peak hour in the winter. This increase in delay can likely be attributed to ski traffic at the resorts in Big Sky. During all peak hours, the eastbound approach (MT 64) generates the highest delay. The delay is primarily attributed to the eastbound right turning movement during the AM and Noon peak hours and the eastbound left turning movement during the PM peak hour.

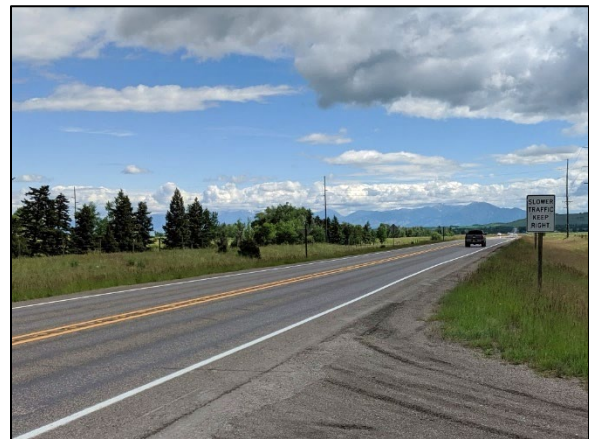
*There are few passing opportunities, high traffic volumes, and a mixture of vehicle types which results in poor levels of service along the corridor.*

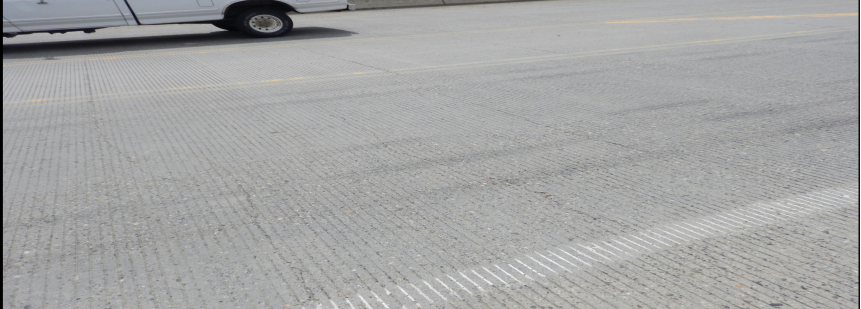
Element #	Parent Element	Name	Unit	Quantity	%CS 1	%CS 2	%CS 3	%CS 4
Photo #:abrasions in wheel path  Location:  Comments:  Element:12 - Reinforced Concrete Deck (SF)

Photo #:cs2 cracking and effloresence on soffit  Location:  Comments:  Element:12 - Reinforced Concrete Deck (SF)			 					
---	--	--	---	--	--	--	--	--

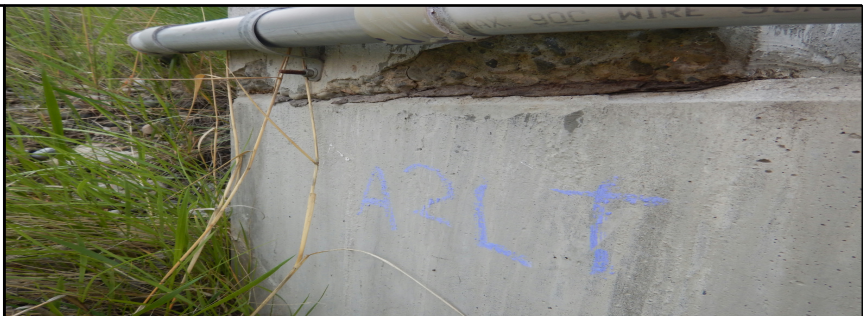
Photo #:Abut 2 RT corner CS3 spall

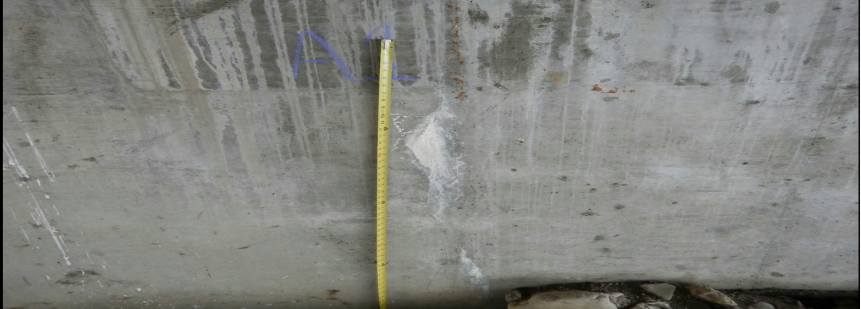
Element #	Parent Element	Name	Unit	Quantity	%CS 1	%CS 2	%CS 3	%CS 4
Photo #:CS3 Efflorescence - Abut 1  Location:  Comments:  Element:215 - Reinforced Concrete Abutment (LF)

Photo #:Abut 1 RT CS3 spall  Location:  Comments:  Element:215 - Reinforced Concrete Abutment (LF)			 					
--	--	--	--	--	--	--	--	--

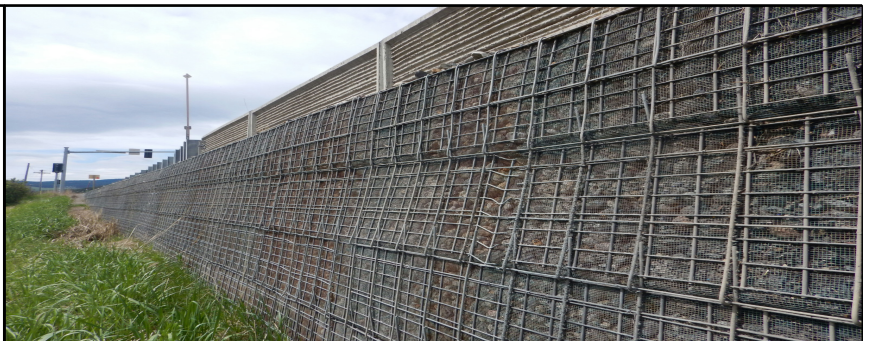
Element:915 - Other Non-Structural Retaining Wall

Comments: good condition with small defects noted

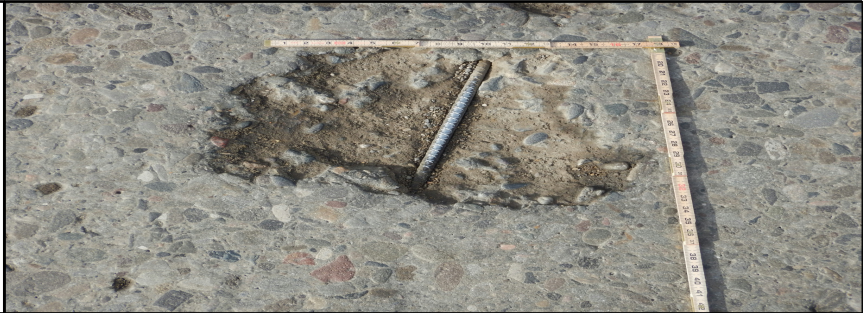
Photo #:Typical CS3 Spall with Exposed Rebar

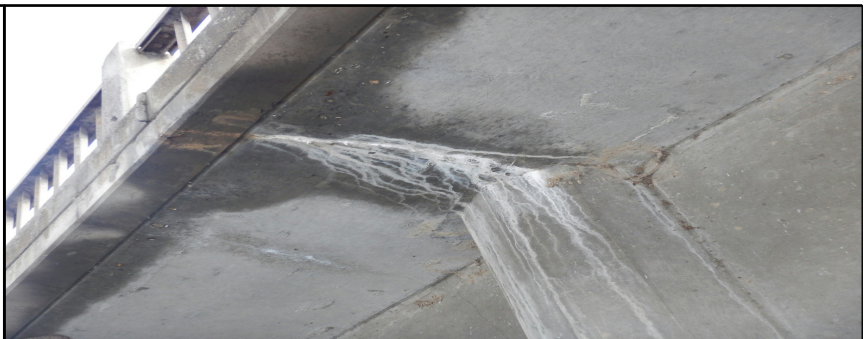
Photo #:Efflorescence Build up Over Pier 2 LT

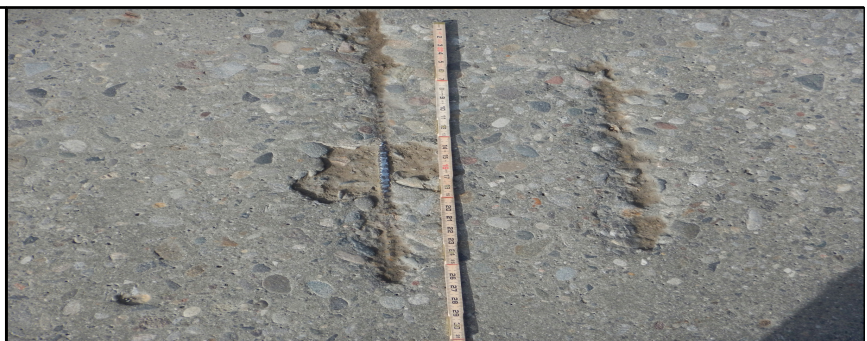
Photo #:Rebar Exposed by Insufficient Concrete Cover

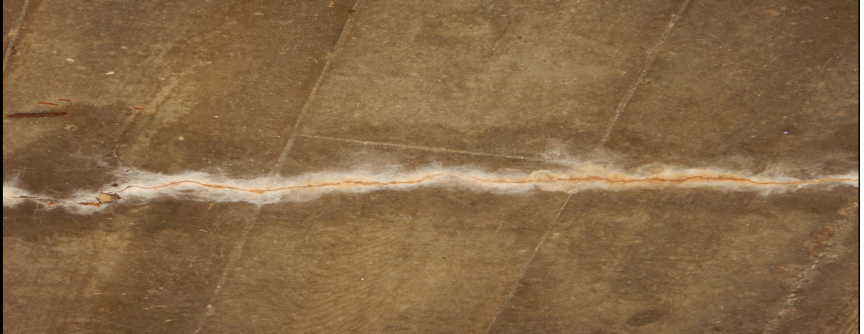
Element #	Parent Element	Name	Unit	Quantity	%CS 1	%CS 2	%CS 3	%CS 4
<p>Photo #: Typical Rust Staining in Soffit Crack</p> <p>Location:</p> <p>Comments:</p> <p>Element: 12 - Reinforced Concrete Deck (SF)</p>

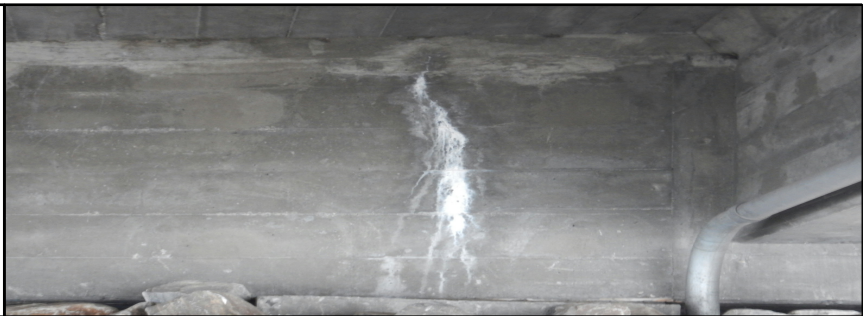
Photo #:Abut 1 LT Crack and Efflorescence

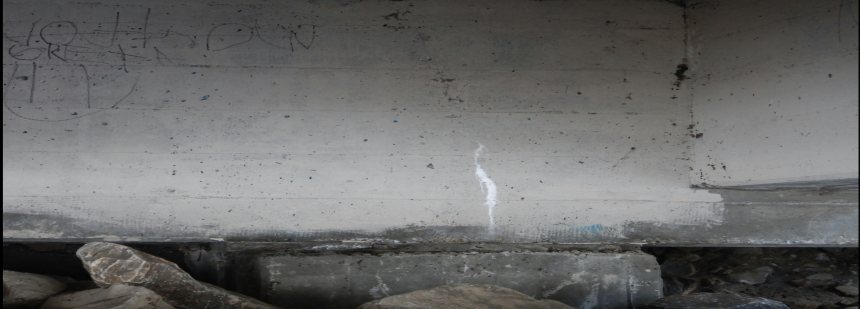
Element #	Parent Element	Name	Unit	Quantity	%CS 1	%CS 2	%CS 3	%CS 4
Photo #: Abut 1 Crack and Efflorescence  Location:  Comments:  Element: 215 - Reinforced Concrete Abutment (LF)

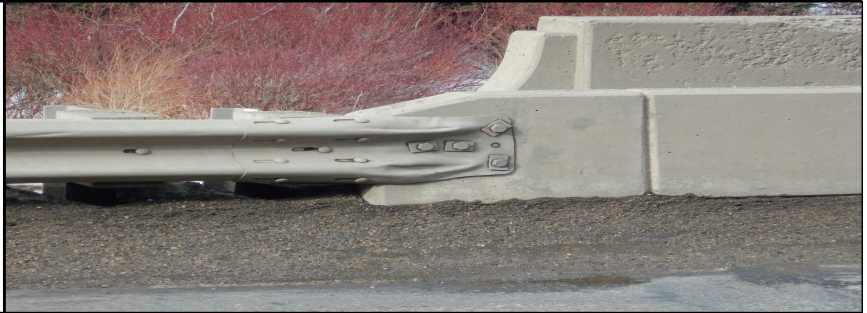
Photo #: Rail Damage Near Abut 4 LT

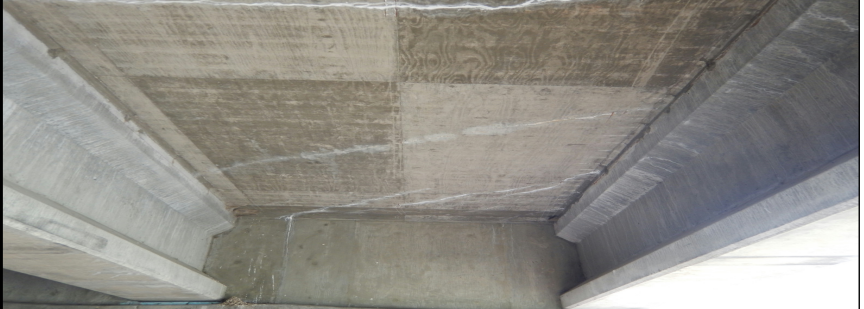
Element #	Parent Element	Name	Unit	Quantity	%CS 1	%CS 2	%CS 3	%CS 4
<p>Photo #:Efflorescence in soffit cracks</p> <p>Location:</p> <p>Comments:</p> <p>Element:12 - Reinforced Concrete Deck (SF)</p>

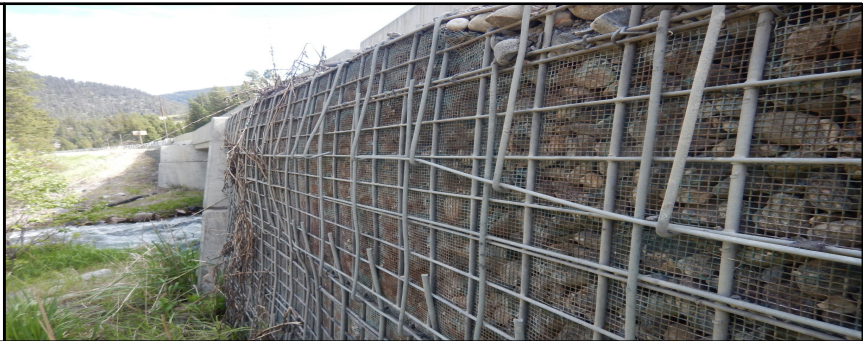
Element: 915 - Other Non-Structural Retaining Wall

Comments: top of basket is bulging outwards

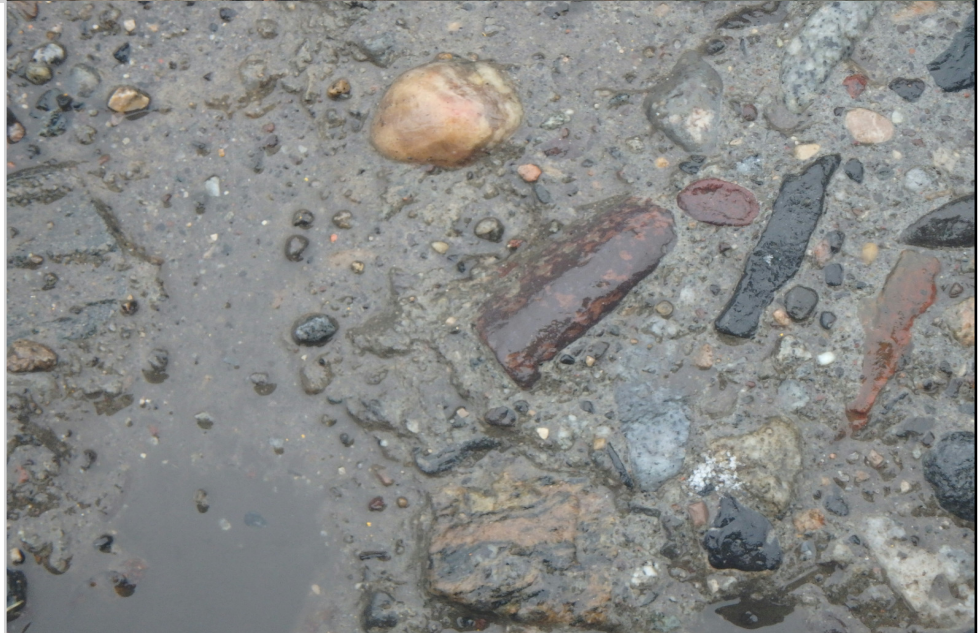
**Photo #:**exposed rebar in deck  
spall Location: , Comments:

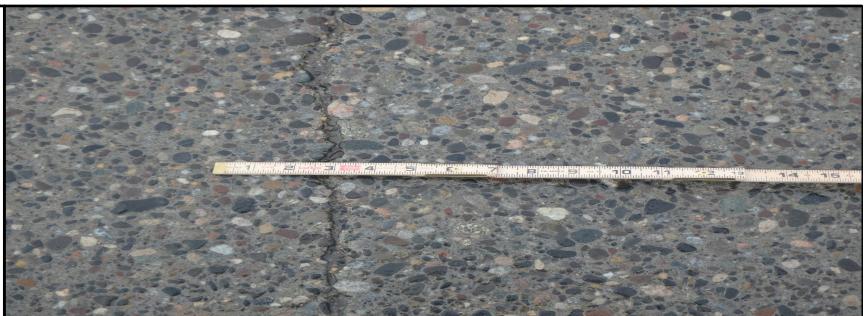
Photo #:st3 deck crack

1 ft 2 of CS3 spall on deck edge. See photo. Condition State 3 : .01  
 4 full width CS3 cracks. See photo. Condition State 3 : 1.7  
 3978 ft 2 of CS2 abrasion. Condition State 2 : 50  
 3977 ft of repaired areas.  
 400 ft 2 of CS2 delamination. Condition State 2 : 50  
 20 full width CS2 efflorescence cracking on soffit. Condition State 2 : 8.5

st2 efflorescence along soffit matching deck cracking  
 exposed rebar without measurable section loss in st3 spalls  
 st3 deck spalling throughout, Approx 16 sqft  
 deck abrasion not associated with patched areas  
 sound patched areas with delamination around patches and adjacent to joints and bridge ends  
 st3 transverse cracking approximately 480 ft , 12 full width or 8%  
 st2 cracking throughout deck

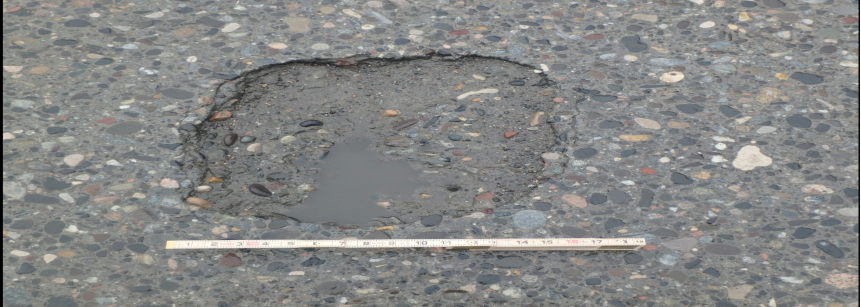
Element #	Parent Element	Name	Unit	Quantity	%CS 1	%CS 2	%CS 3	%CS 4
<p>Photo #:st3 deck spall</p> <p>Location:</p> <p>Comments:</p> <p>Element:12 - Reinforced Concrete Deck (SF)</p>

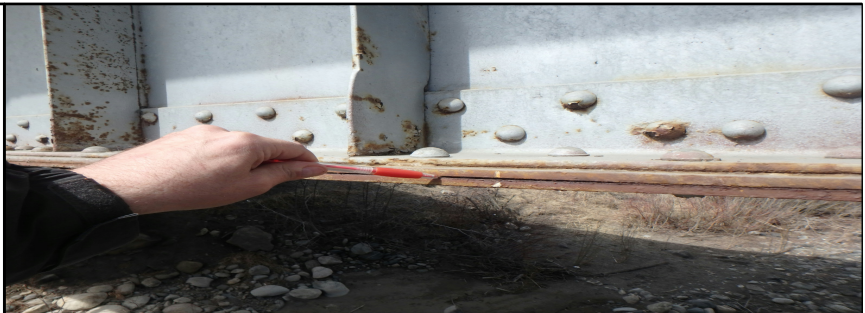
Photo #:PACK RUST

Areas of interior girders without Condition State 1 : 35  
 Surface corrosion full length of exteriors on both flange edges and random areas on webs  
 Interior girders have areas of surface rust adjacent to leaking deck joints and at random areas on the webs.  
 Condition State 2 : 53.8  
 Pack rust with distortion between lower flange plates- Approx 30 ft. Photo Condition State 3 : 3.2  
 No change in crack at web stiffener Condition State 2 : .1  
 Corrosion scaling and pack rust on girder ends under leaking deck joints at Pin and Hanger connections - Approx 5 ft at each connection. Photos  
 Random areas of corrosion scaling on top flanges under deck cracks Condition State 3 : 8

CS3 corrosion scaling on girder ends under leaking deck joints at Pin and Hanger connections - Approx See photos  
 No change in crack at web stiffener.  
 Some CS3 packrust along girders and under leaking joints at pin and hangers. See photo  
 Surface corrosion full length of exteriors on both flange edges and random areas on webs.  
 Interior girders have areas of surface rust adjacent to leaking deck joints and at random areas on the webs.  
 No change at the minor cracking at the web stiffeners,

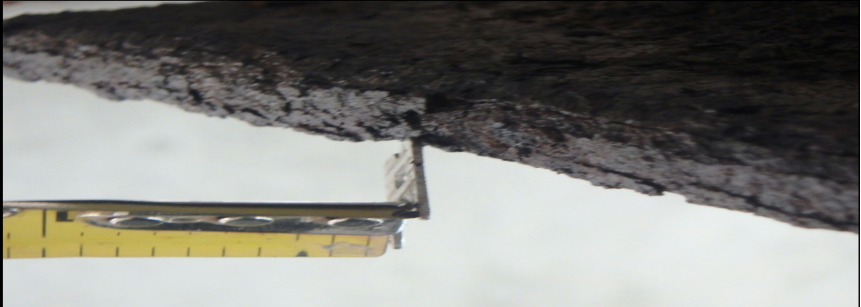
Photo #:CONDITION 3 CORROSION.  Location:  Comments:  Element:107 - Steel Girder Beam (LF)

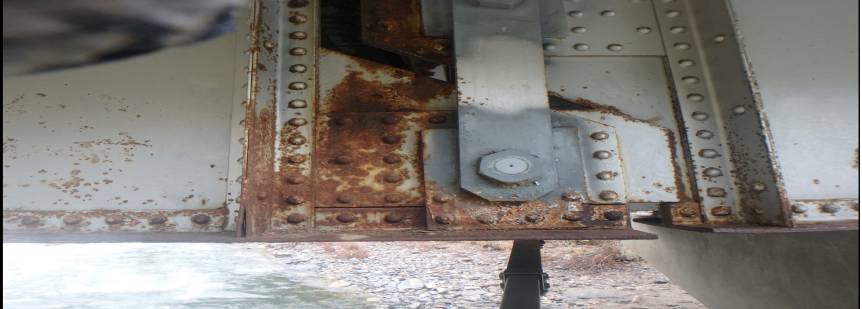
Element #	Parent Element	Name	Unit	Quantity	%CS 1	%CS 2	%CS 3	%CS 4
<p>Photo #:CONDITION 3 CORROSION.</p> <p>Location:</p> <p>Comments:</p> <p>Element:107 - Steel Girder Beam (LF)</p>

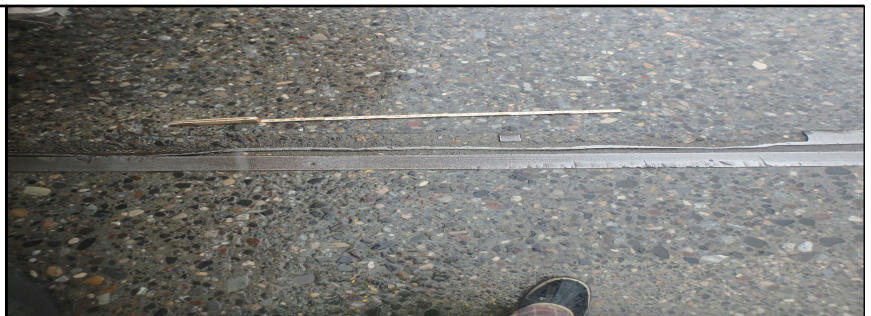
Photo #: bent2 joint damage

10 ft of missing joint on bent 2. See photo. Condition State 4 : 14.5  
Full of debris. Condition State 2 : 100  
52 FT of CS2 leakage. Condition State 2 : 75  
52 FT of CS2 LEAKAGE. Condition State 3 :  
3 ft of adjacent repair. Condition State 2 : 4.4  
17 FT of CS3 leakage. Condition State 3 : 25

joints full of debris still allowing free movement  
delamination along joint edges  
approximately 20ft of joint damage 10ft missing of bent2 NB lane and 10 ft of impacts along bent3 joint-photos  
10ft st3 joint damage over bent 2 NB lane  
st2 leakage dripping through both joints contributing to rusted girders and bearings

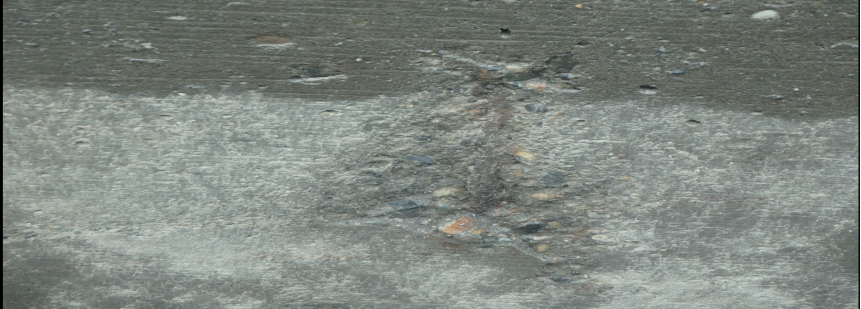
Element #	Parent Element	Name	Unit	Quantity	%CS 1	%CS 2	%CS 3	%CS 4
<p>Photo #:exposed rebar</p> <p>Location:</p> <p>Comments:</p> <p>Element:331 - Reinforced Concrete Bridge Rail (LF)</p>

exposed rebar found in some rail spalls  
 5 st3 spalls along south bridge rail  
 st3 diagonal crack from impact nw corner  
 st2 vertical cracking throughout both rail edges

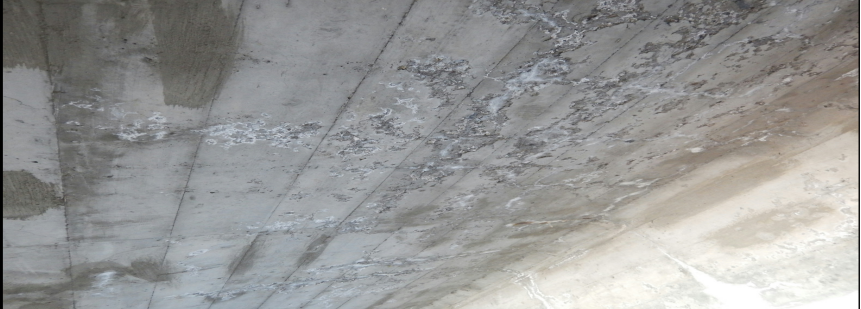
Element #	Parent Element	Name	Unit	Quantity	%CS 1	%CS 2	%CS 3	%CS 4
Photo #:Span 2 Bay 1 soffit efflorescence  Location:  Comments:  Element:16 - Reinforced Concrete Top Flange (SF)

Photo #:CS3 efflorescence and rust staining  Location:  Comments:  Element:16 - Reinforced Concrete Top Flange (SF)			 					
---	--	--	---	--	--	--	--	--

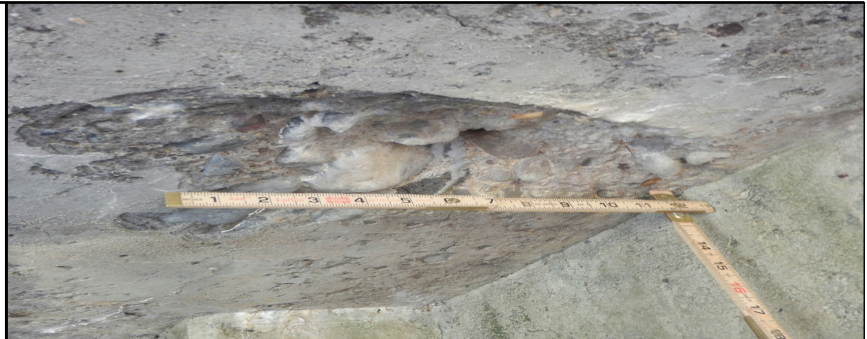
Photo #:LT deck edge CS3 spalling and delamination

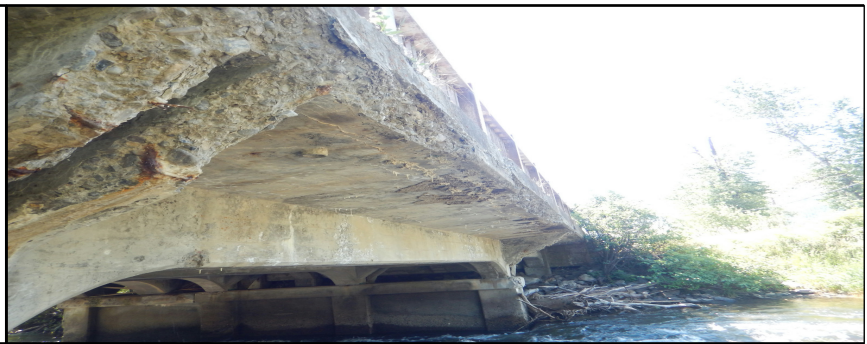
Photo #:LT deck edge CS3 spalling

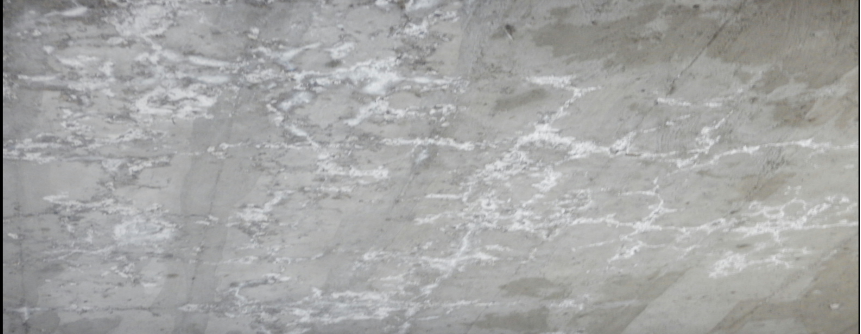
Element #	Parent Element	Name	Unit	Quantity	%CS 1	%CS 2	%CS 3	%CS 4
Photo #:Soffit efflorescence and map cracking  Location:  Comments:  Element:16 - Reinforced Concrete Top Flange (SF)

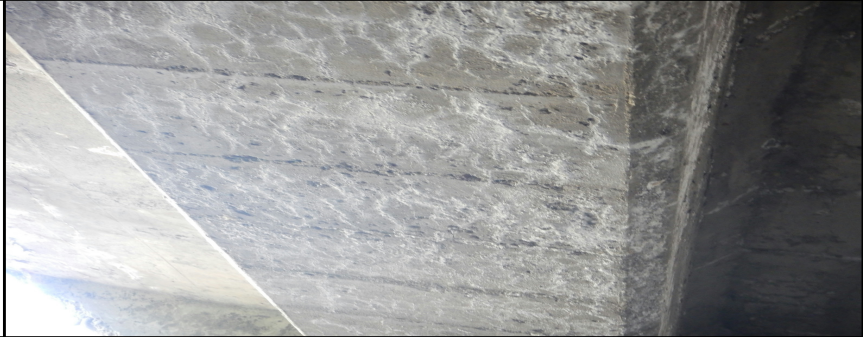
Photo #:G5 Span 2 CS3 spall and exposed rebar

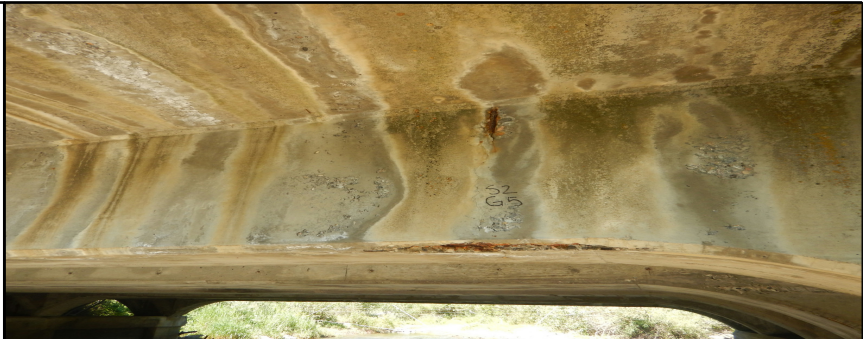
Photo #:Deep delamination adjacent to G5 Span 2 spall

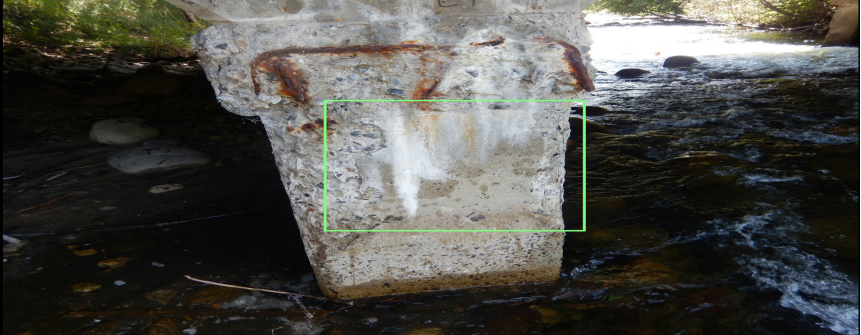
Element #	Parent Element	Name	Unit	Quantity	%CS 1	%CS 2	%CS 3	%CS 4
<p>Photo #:CS3 efflorescence Pier 3 LT column</p> <p>Location:</p> <p>Comments:</p> <p>Element:205 - Reinforced Concrete Column (EA)</p>

<p>Photo #:CS3 delamination o Pier 3 RT exterior</p> <p>Location:</p> <p>Comments:</p> <p>Element:205 - Reinforced Concrete Column (EA)</p>			 					
---	--	--	---	--	--	--	--	--

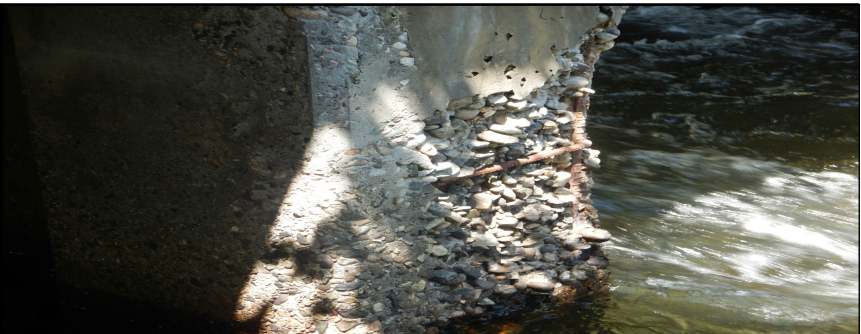
<p>Photo #:Pier 2 RT Column spalls with exposed rebar</p> <p>Location:</p> <p>Comments:</p> <p>Element:205 - Reinforced Concrete Column (EA)</p>

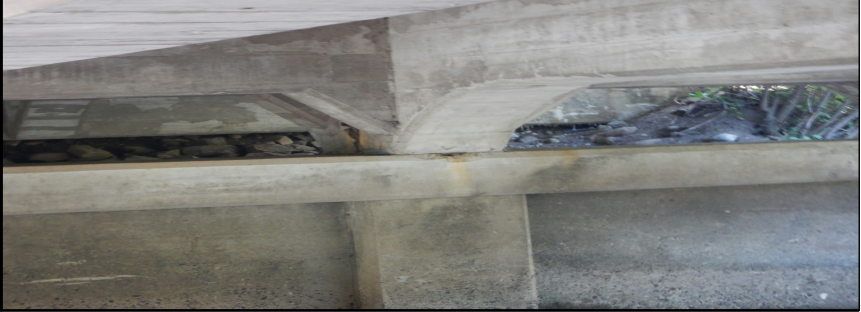
Element #	Parent Element	Name	Unit	Quantity	%CS 1	%CS 2	%CS 3	%CS 4
<p>Photo #: Pier 2 - Spall under G2</p> <p>Location:</p> <p>Comments:</p> <p>Element: 234 - Reinforced Concrete Cap (LF)</p>

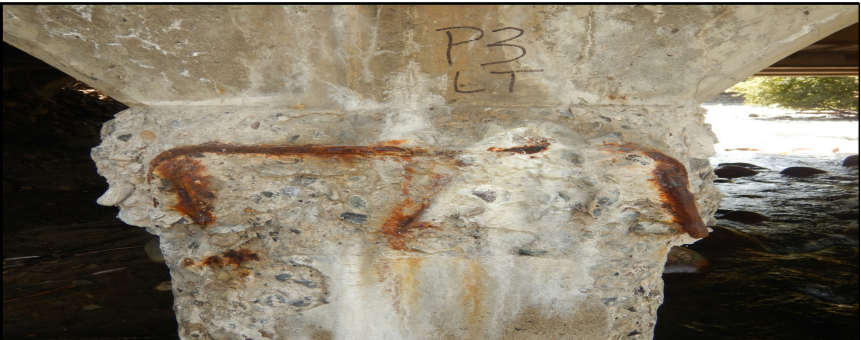
<p>Photo #: CS3 spall with exposed rebar Pier 3 LT cap end</p> <p>Location:</p> <p>Comments:</p> <p>Element: 234 - Reinforced Concrete Cap (LF)</p>

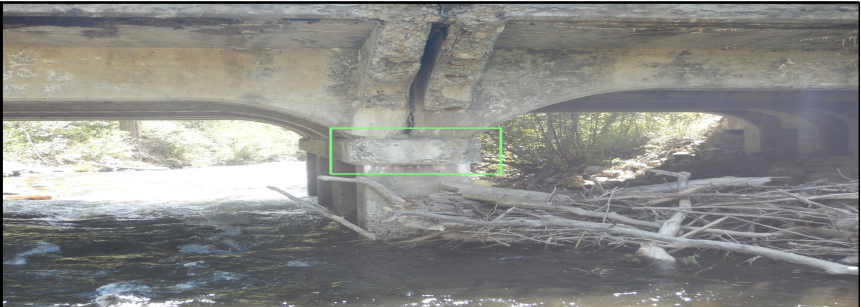
<p>Photo #: CS3 spall Pier 2 LT cap end</p> <p>Location:</p> <p>Comments:</p> <p>Element: 234 - Reinforced Concrete Cap (LF)</p>

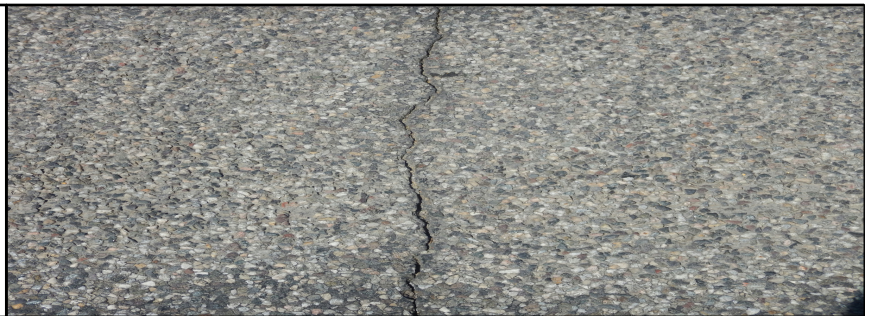
Photo #:Wearing Surface crack over pier

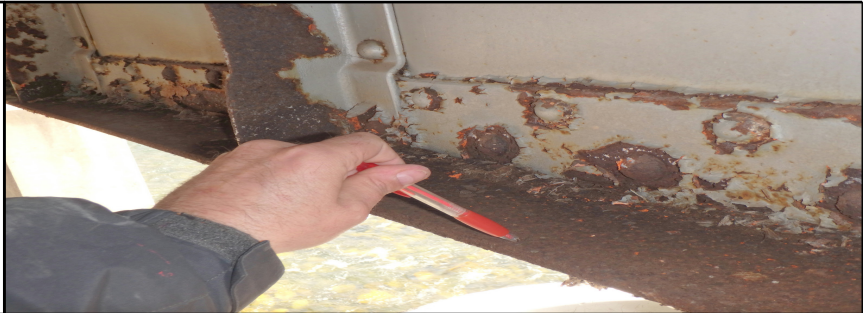
Photo #:PACK RUST.

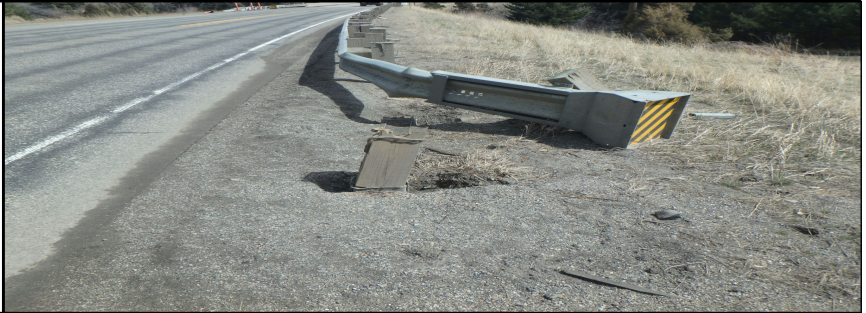
Photo #:damaged guardrail end 2

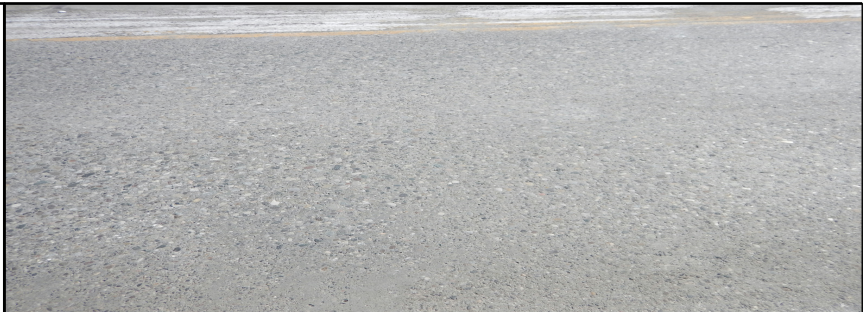
Photo #:Spall on slab haunch - Abut 1 LT

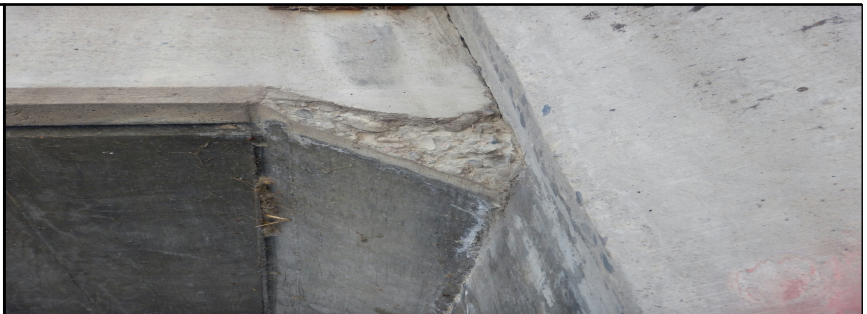
Damage to guard angle with shallow spalling of slab edge in south bound lane at Abut 1  
Abrasion with exposed coarse aggregate full width of both lanes  
CS3 spall on slab haunch at Abut 1 LT  
Full length longitudinal CS2 cracks on CL and in each lane  
Efflorescence in soffit cracks - approx 40 ft  
Shoulders covered with snow and ice.  
Total in previous inspection did not account for defect overlap.

Element:38 - Reinforced Concrete Slab (SF)

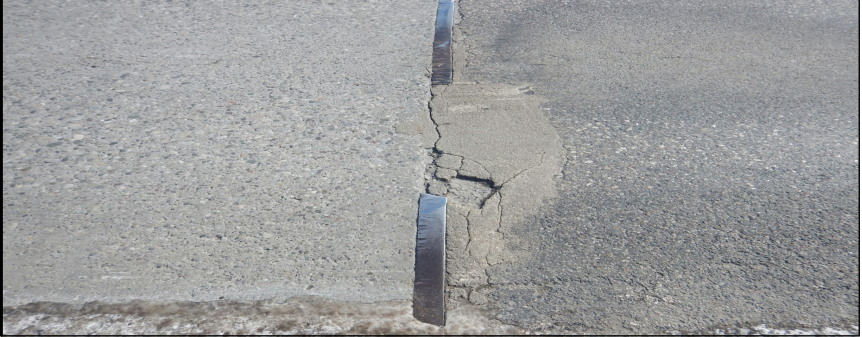
Element #	Parent Element	Name	Unit	Quantity	%CS 1	%CS 2	%CS 3	%CS 4
<p>Photo #:Damage to guard angle and spalling of slab edge</p> <p>Location:</p> <p>Comments:</p> <p>Element:38 - Reinforced Concrete Slab (SF)</p>

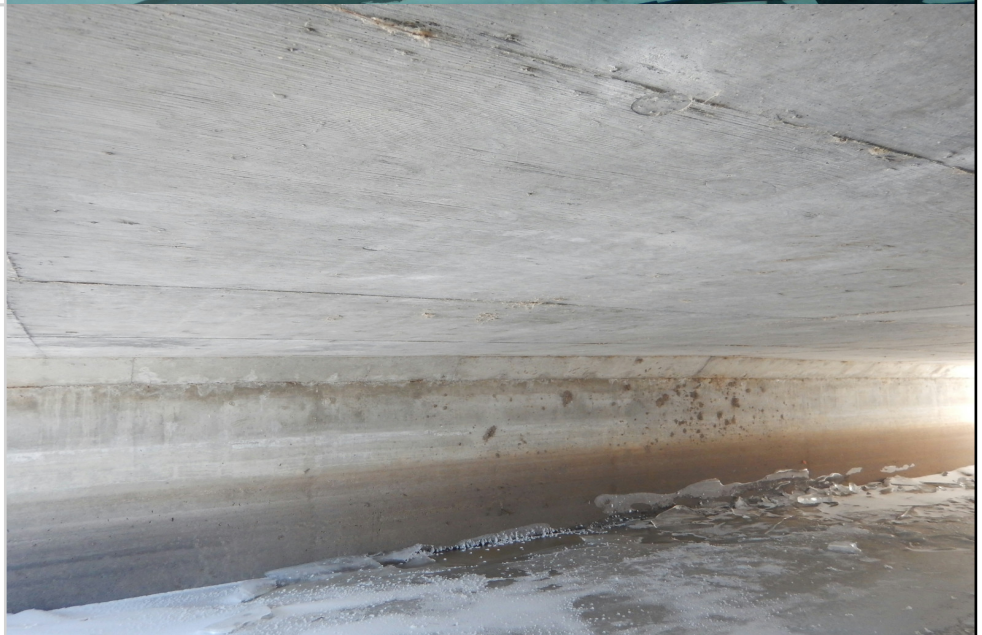
**Photo #:**Underside of slab and  
Abut 2 Location: , Comments:

Abrasion with exposed coarse aggregate full width of both lanes Condition State 2 : 61  
Longitudinal cracks on CL and in each lane Condition State 2 : 7.6  
Efflorescence in soffit along CL Condition State 2 : 2.5

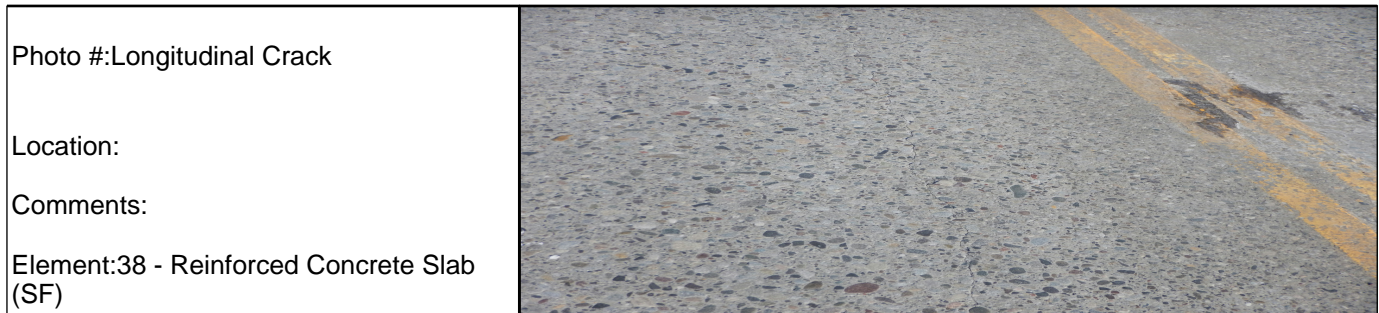
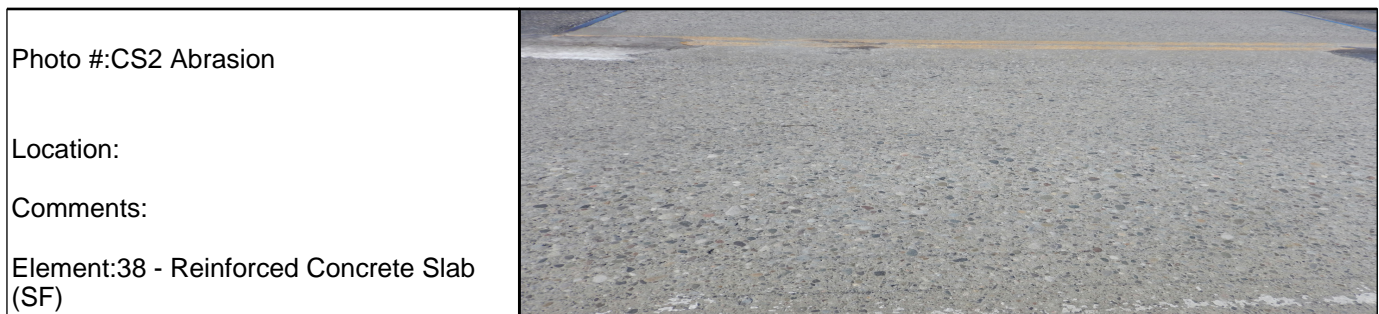
CS2 abrasion full width of both lanes  
Efflorescence in soffit along CL crack  
Small spalls associated with damage to guard angle on Abut 2 slab edge  
Two sqft of sound patches at beidge ends  
CS2 longitudinal cracks on CL and in each lane

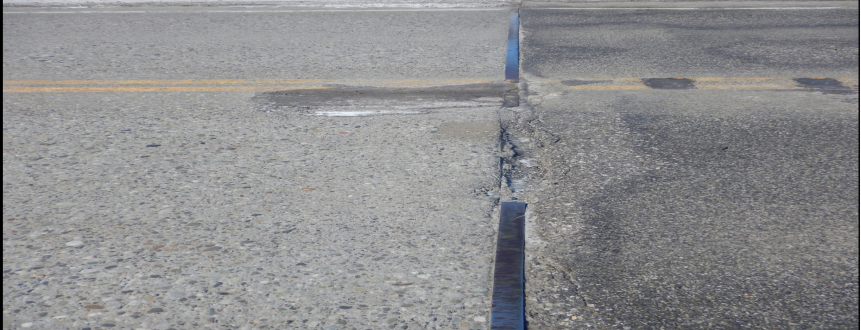
Element #	Parent Element	Name	Unit	Quantity	%CS 1	%CS 2	%CS 3	%CS 4
<p>Photo #: Typical patch and spalling at slab edge</p> <p>Location:</p> <p>Comments:</p> <p>Element: 38 - Reinforced Concrete Slab (SF)</p>

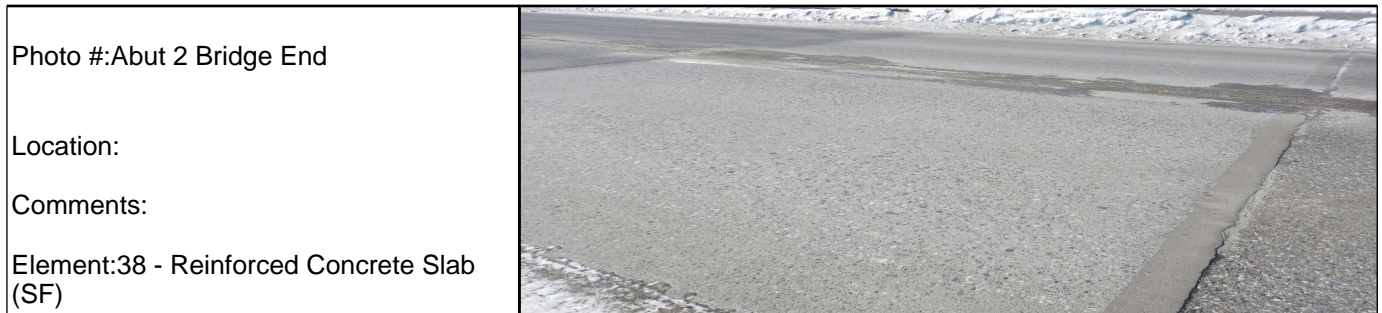
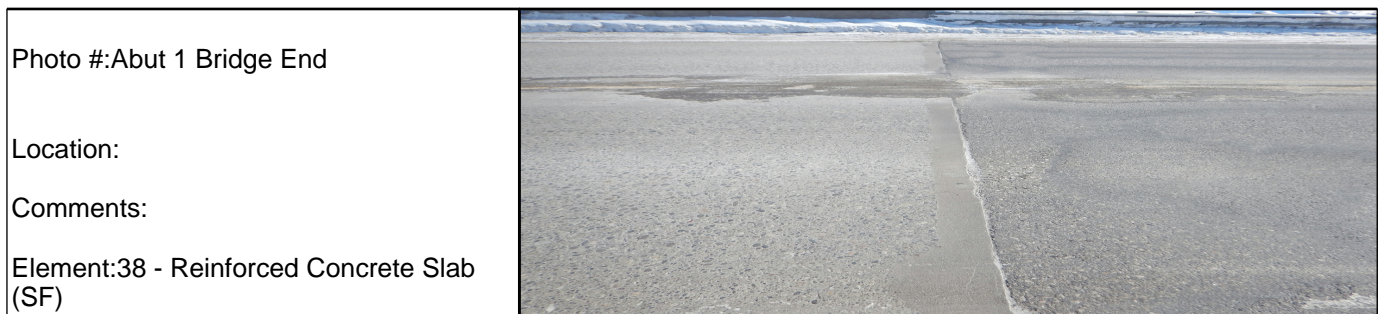
CS2 abrasion full width of both driving lanes  
Efflorescence in soffit cracks matching surface cracks  
Full width repairs at each bridge end where guard angle was removed.  
Some minor cracking  
Longitudinal CS2 cracks each side of CL
