Appendix 4:

Existing and Projected Conditions Report

EXISTING AND PROJECTED CONDITIONS

prepared for:
Montana Department of Transportation

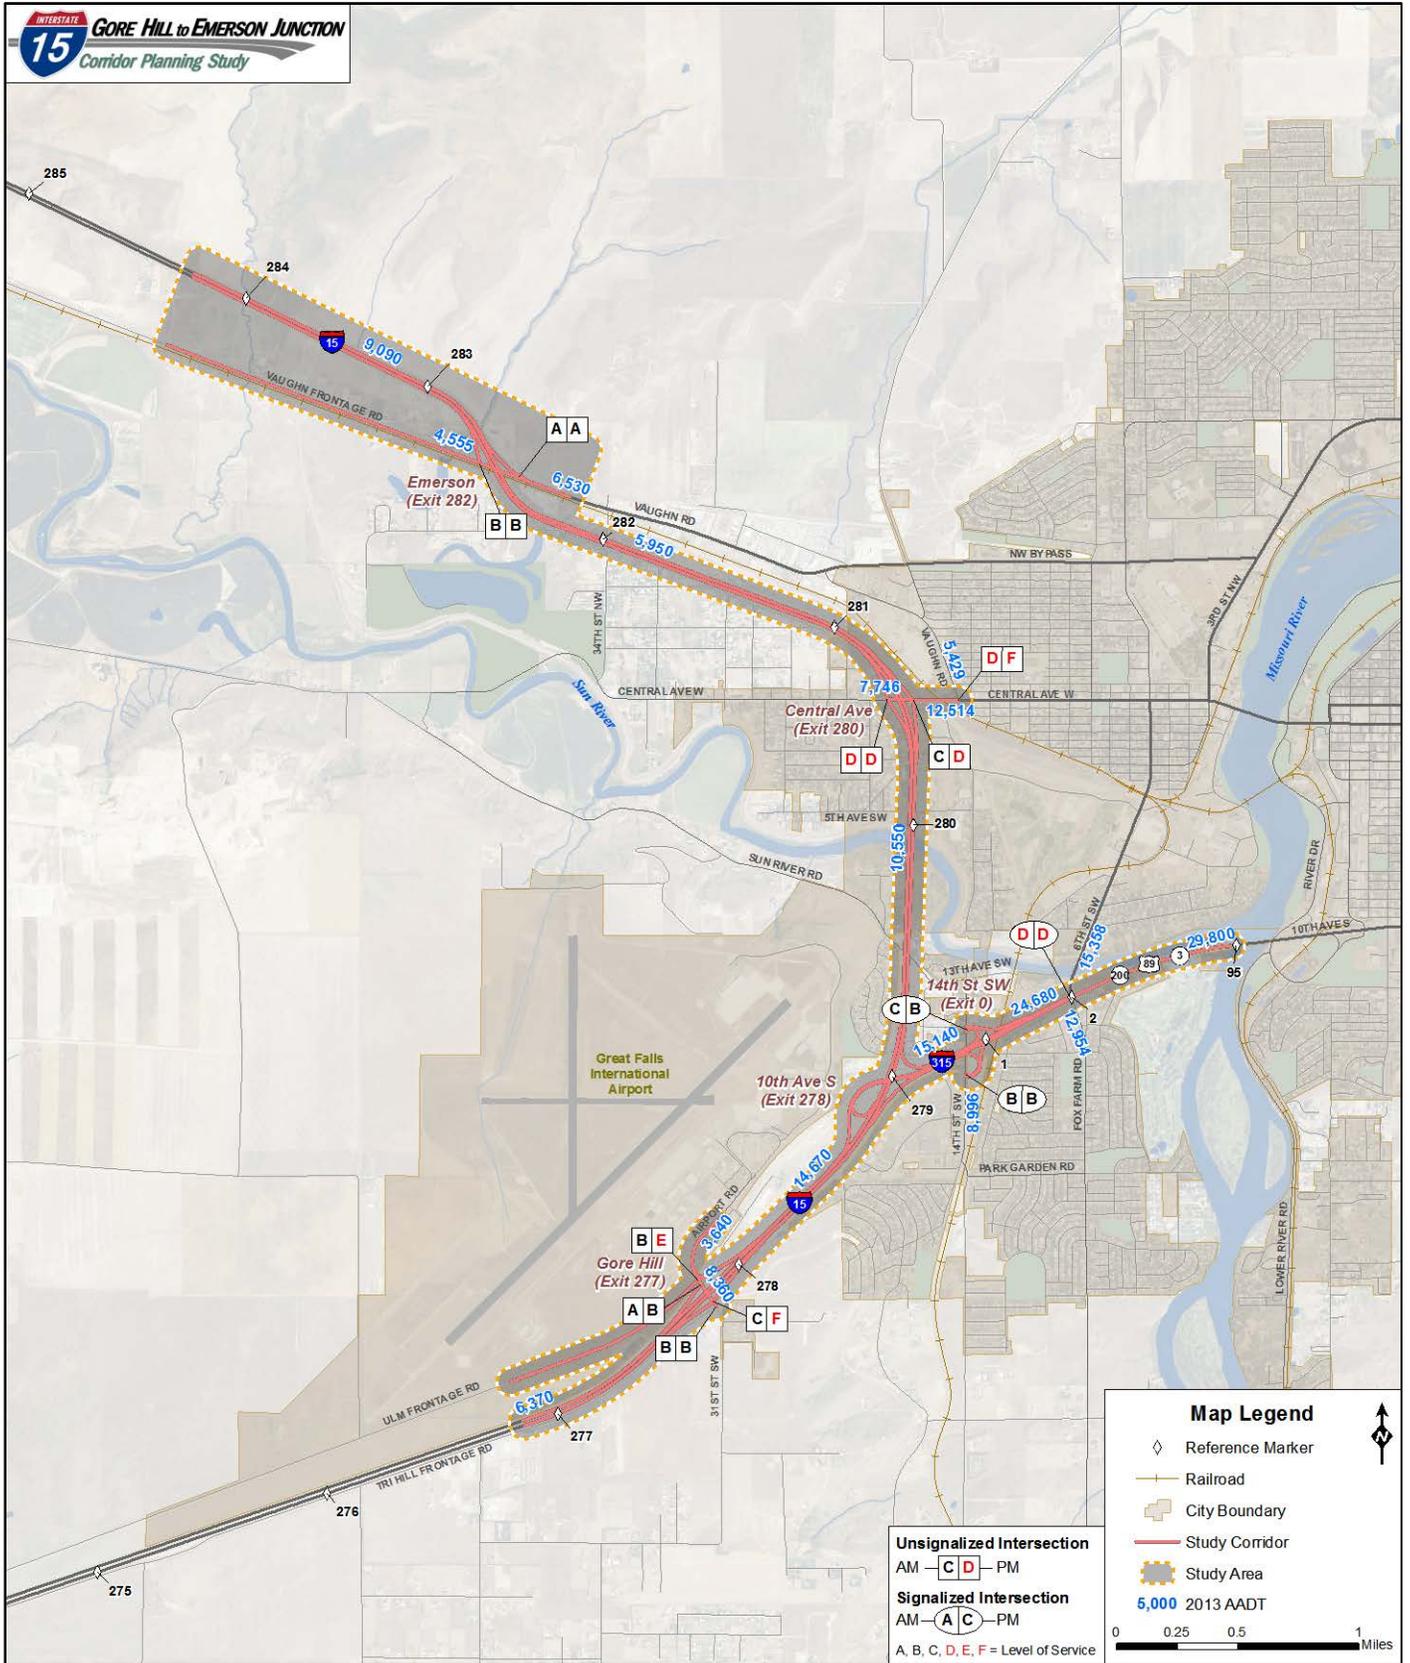
Figure 3.1: Existing Traffic Conditions

The MDT *Traffic Engineering Manual* states that a LOS of B or better is recommended for both urban and rural freeways. I-15 is shown to operate at LOS A during the existing peak hours within the study area. I-315 also operates at LOS A, with the exception of the westbound lane east of 14th Street Southwest, which operates at LOS B during the PM peak hour.

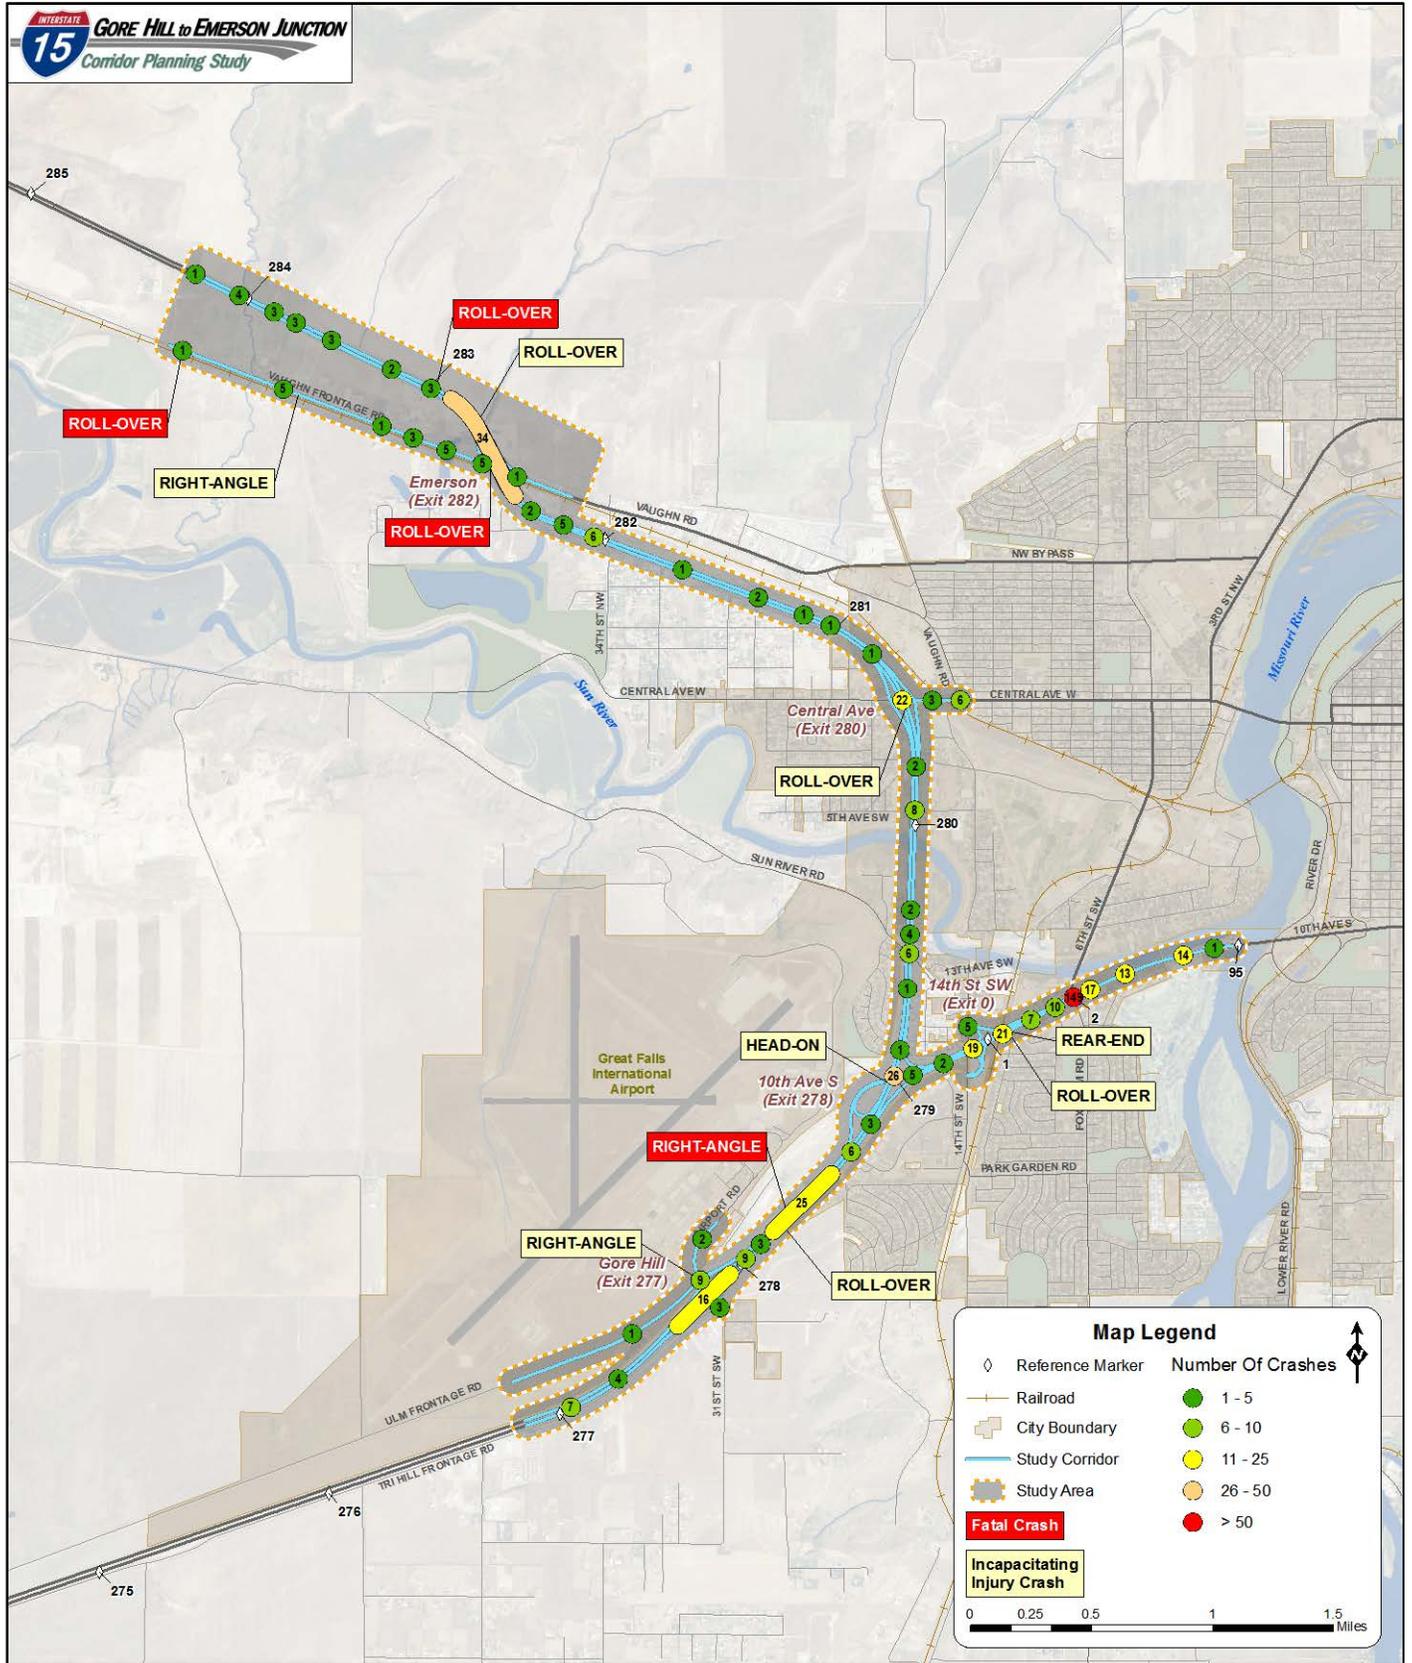
Figure 3.2: Crash Locations

Segment	Begin RP	End RP	# Fatal	# Incap	Total Crashes	AADT 3-year Average	Crash Rate	Severity Index	Severity Rate
I-15	Southwest of Gore Hill	270.4	277.8	0	0	18	6,360	1.55	1.00	1.55
	Northeast of Gore Hill	277.8	278.9	1	2	70	13,474	2.85	1.16	3.29
	10th Ave South to Central Ave	279.9	280.5	0	1	32	9,786	1.79	1.06	1.90
	Central Ave to Emerson Junction	280.5	282.5	0	0	48	6,486	4.06	1.00	4.06
	North of Emerson Junction	282.5	286.5	2	1	43	9,470	2.49	1.37	3.41
I-315	10 th Ave South to 14 th St Southwest	0	0.3	0	0	13	15,890	0.45	1.00	0.45
	14 th St Southwest to Fox Farm	0.3	1.4	0	2	114	25,870	2.41	1.04	2.50
	East of Fox Farm	94.4	95.7	0	0	137	30,890	2.43	1.00	2.43

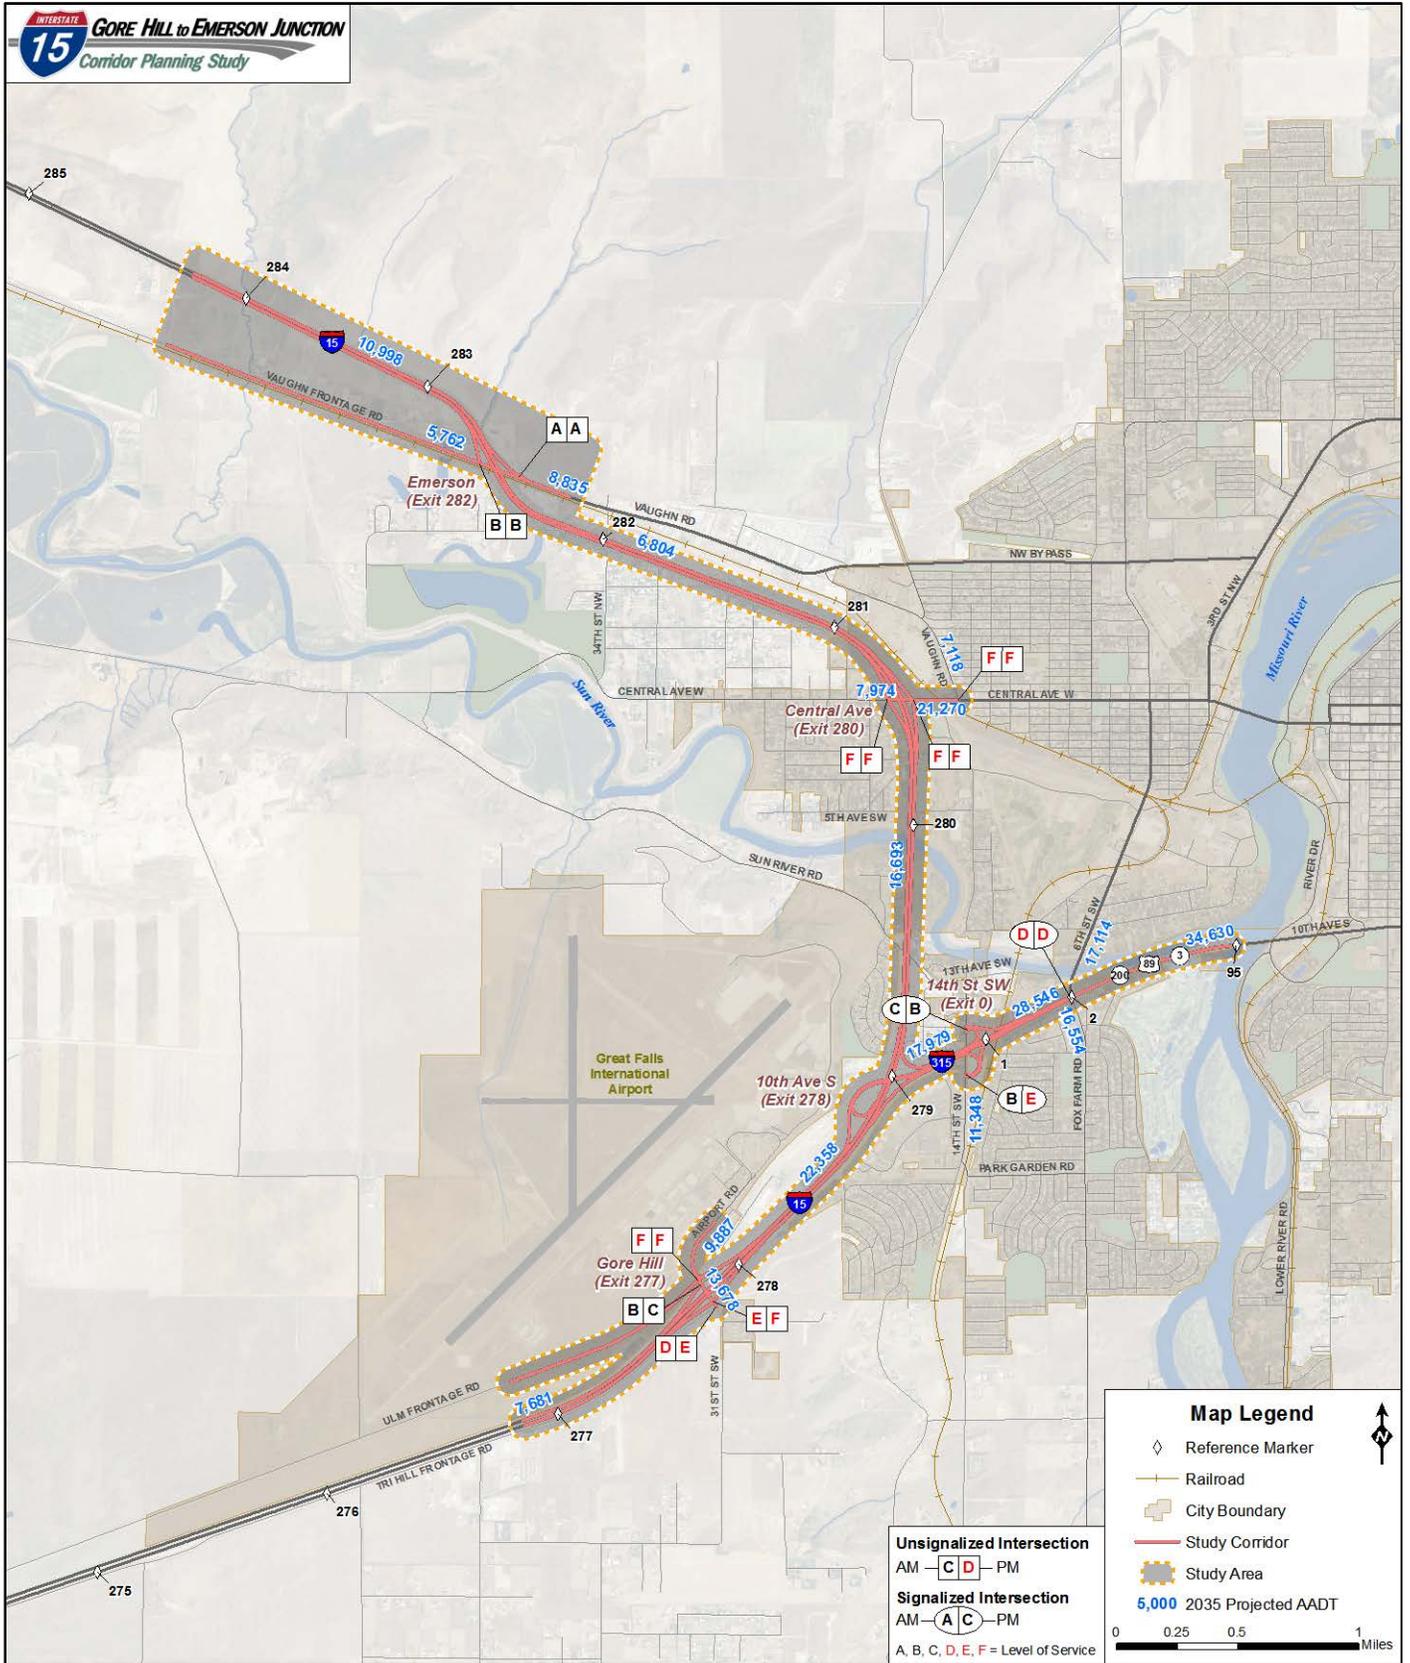
Figure 4.1: Projected Traffic Conditions

Intersection Name	Control Type	AM Peak Hour		PM Peak Hour	
		Delay (s/veh)	LOS	Delay (s/veh)	LOS
Tri Hill and Frontage Airport Rd	Two-way stop	27.3	D	43.7	E
I-15 NB and Airport Rd	Two-way stop	44.2	E	(a)	F
I-15 SB On and Airport Rd	Two-way stop	10.4	B	23.5	C
I-15 SB Off and Airport Rd	Two-way stop	121.8	F	3138.9	F
14 th St SW and I-315 EB	Signalized	13.3	B	12.4	B
14 th St SW and I-315 WB	Signalized	22.2	C	19.6	B
Fox Farm and I-315	Signalized	39.0	D	35.6	D
Central Ave and I-15 SB	Two-way Stop	178.9	F	314.9	F
Central Ave and I-15 NB	Two-way Stop	113.1	F	445.2	F
Central Ave and Vaughn Rd	Two-way Stop	406.0	F	1422.7	F
Vaughn Rd and I-15 SB	Two-way Stop	11.0	B	11.0	B
Vaughn Rd and I-15 NB	Two-way Stop	7.3	A	7.4	A

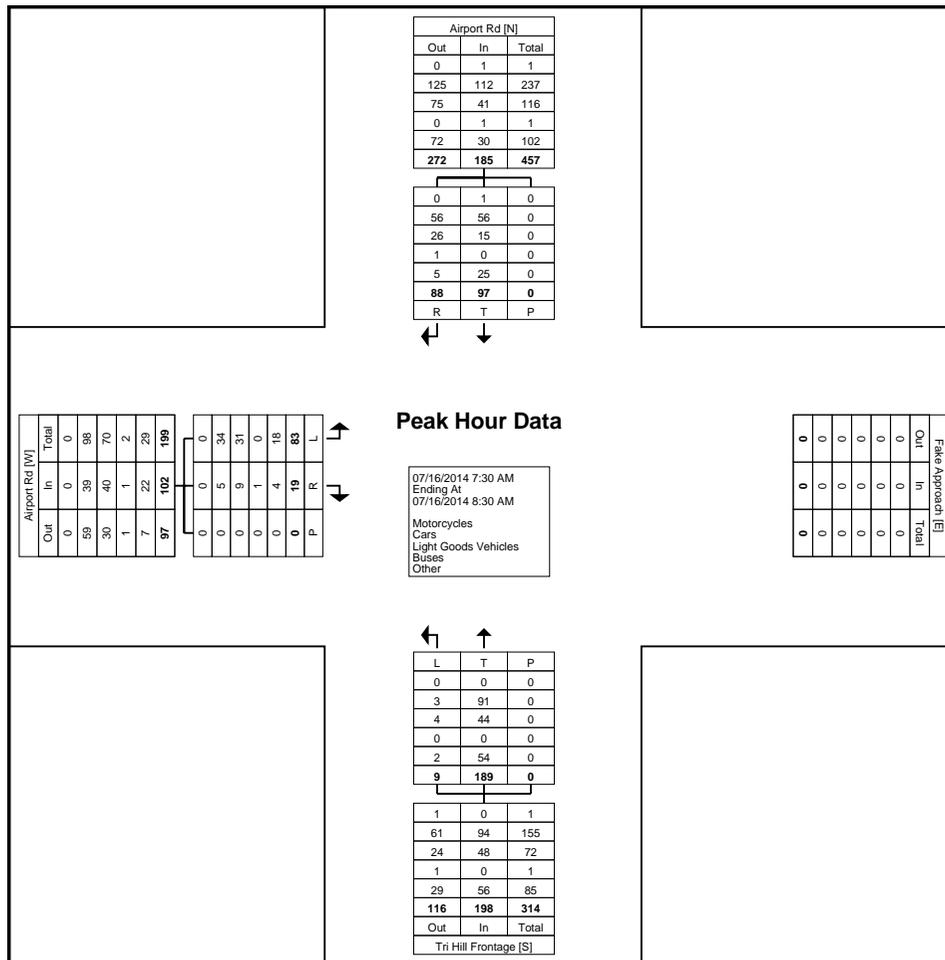
Turning Movement Peak Hour Data Plot (7:30 AM)

Count Name: 01-TriHillFrontage_AirportRd TMC
Site Code: TMC-01
Start Date: 07/16/2014
Page No: 5

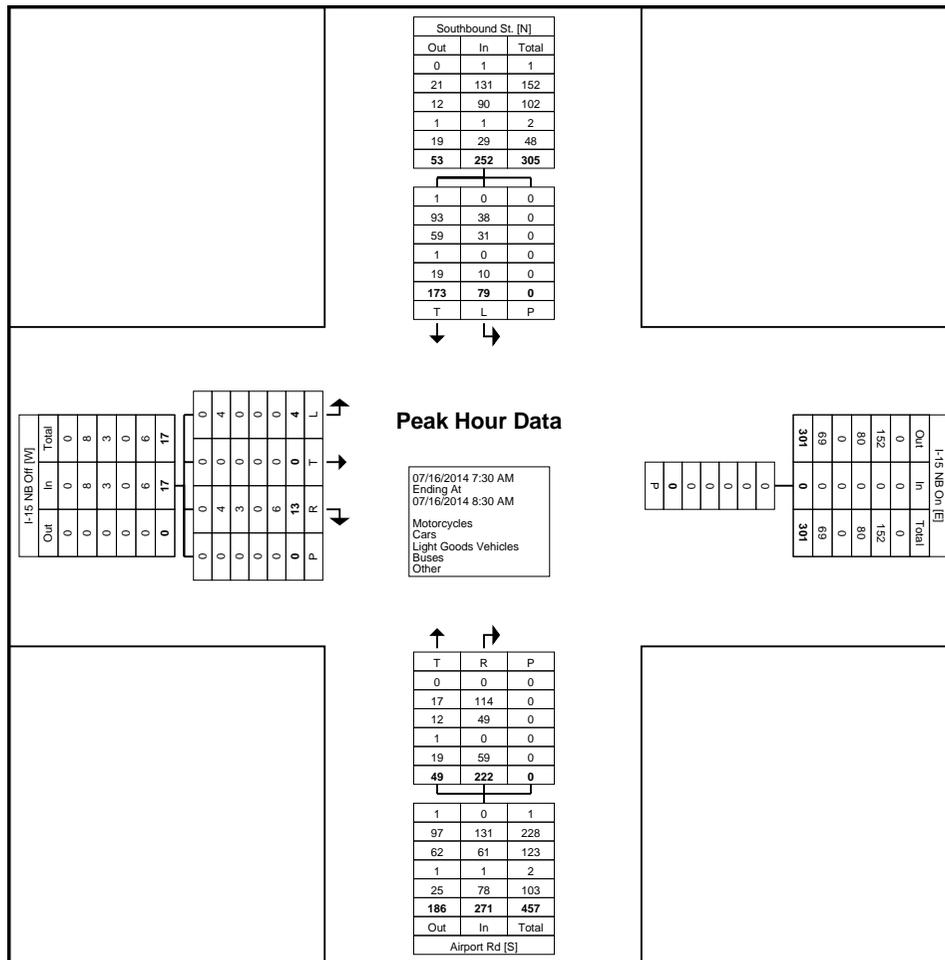
Turning Movement Peak Hour Data Plot (7:30 AM)

Count Name: 02-I15NB_AirportRd TMC
Site Code: TMC-02
Start Date: 07/16/2014
Page No: 5

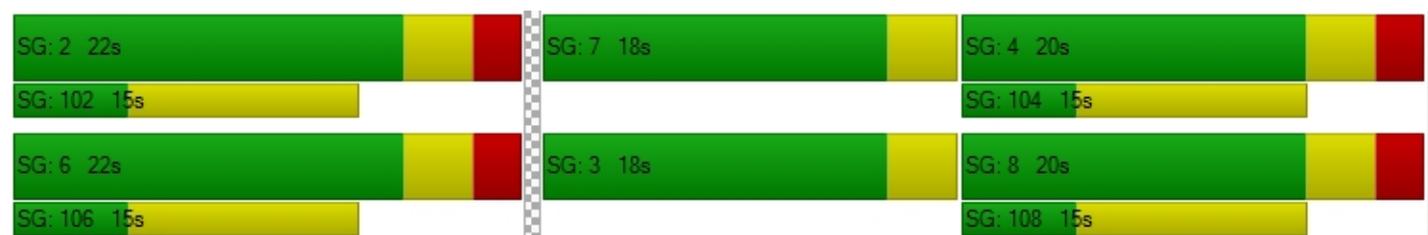
Sequence

Ring 1	2	7	4	-	-	-	-	-	-	-	-	-	-	-	-	-
Ring 2	6	3	8	-	-	-	-	-	-	-	-	-	-	-	-	-
Ring 3	-	-	-	-	-	-	-	-	-	-	-	-	-	-	-	-
Ring 4	-	-	-	-	-	-	-	-	-	-	-	-	-	-	-	-

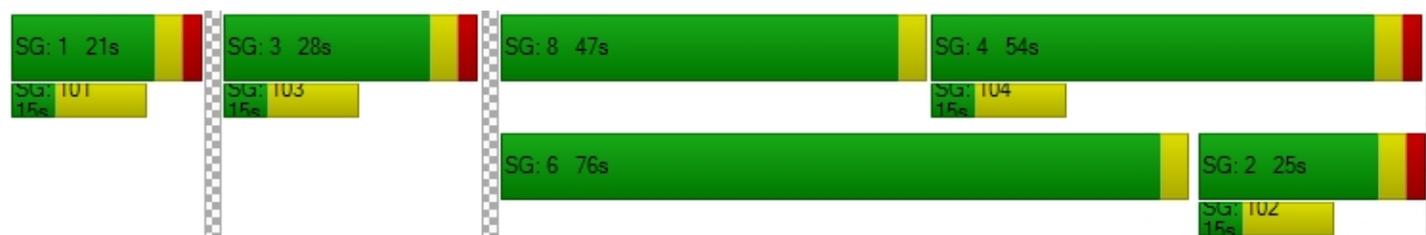
Sequence

Ring 1	1	3	8	4	-	-	-	-	-	-	-	-	-	-	-	-
Ring 2	-	-	6	2	-	-	-	-	-	-	-	-	-	-	-	-
Ring 3	-	-	-	-	-	-	-	-	-	-	-	-	-	-	-	-
Ring 4	-	-	-	-	-	-	-	-	-	-	-	-	-	-	-	-

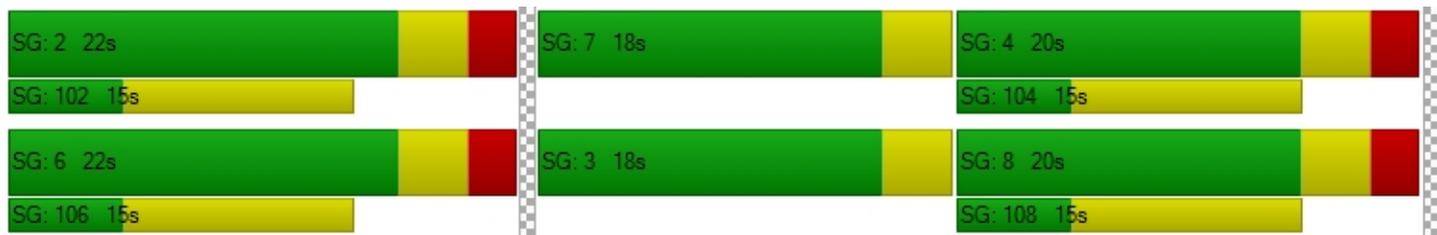
Sequence

Ring 1	2	7	4	-	-	-	-	-	-	-	-	-	-	-	-	-
Ring 2	6	3	8	-	-	-	-	-	-	-	-	-	-	-	-	-
Ring 3	-	-	-	-	-	-	-	-	-	-	-	-	-	-	-	-
Ring 4	-	-	-	-	-	-	-	-	-	-	-	-	-	-	-	-

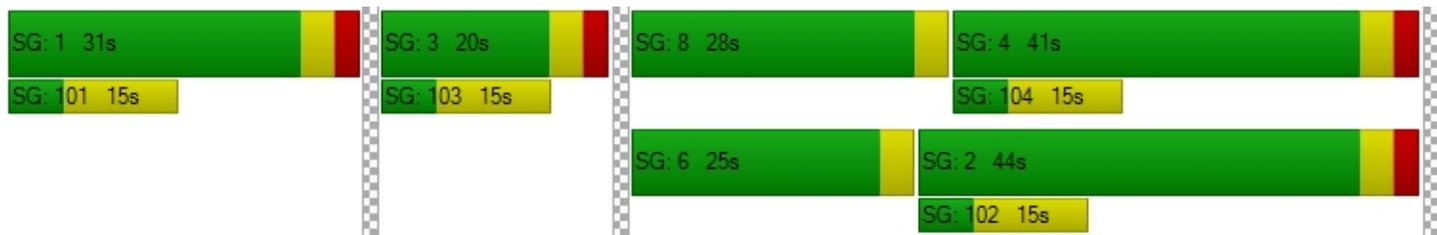
Sequence

Ring 1	1	3	8	4	-	-	-	-	-	-	-	-	-	-	-	-
Ring 2	-	-	6	2	-	-	-	-	-	-	-	-	-	-	-	-
Ring 3	-	-	-	-	-	-	-	-	-	-	-	-	-	-	-	-
Ring 4	-	-	-	-	-	-	-	-	-	-	-	-	-	-	-	-

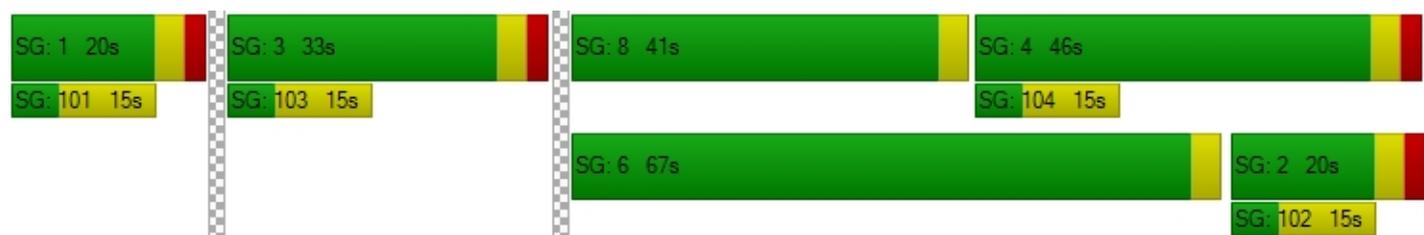
Sequence

Ring 1	1	3	8	4	-	-	-	-	-	-	-	-	-	-	-	-
Ring 2	-	-	6	2	-	-	-	-	-	-	-	-	-	-	-	-
Ring 3	-	-	-	-	-	-	-	-	-	-	-	-	-	-	-	-
Ring 4	-	-	-	-	-	-	-	-	-	-	-	-	-	-	-	-

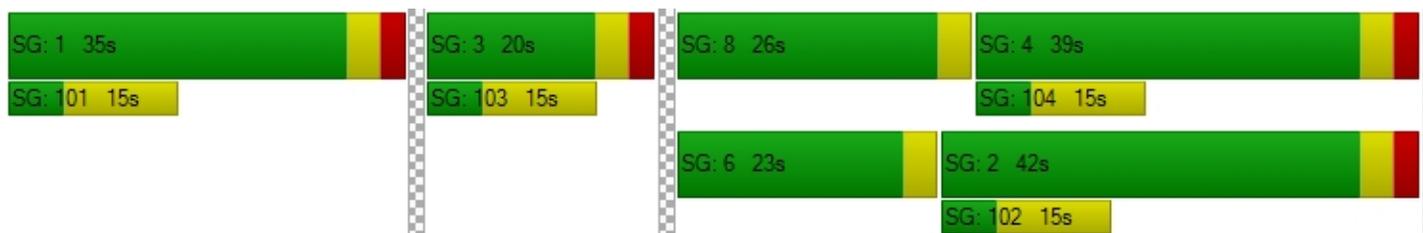
Sequence

Ring 1	1	3	8	4	-	-	-	-	-	-	-	-	-	-	-	-
Ring 2	-	-	6	2	-	-	-	-	-	-	-	-	-	-	-	-
Ring 3	-	-	-	-	-	-	-	-	-	-	-	-	-	-	-	-
Ring 4	-	-	-	-	-	-	-	-	-	-	-	-	-	-	-	-
