Jefferson City
Safety Rest Area Study

SUMMARY REPORT

December 2019

MONTANA DEPARTMENT
OF TRANSPORTATION

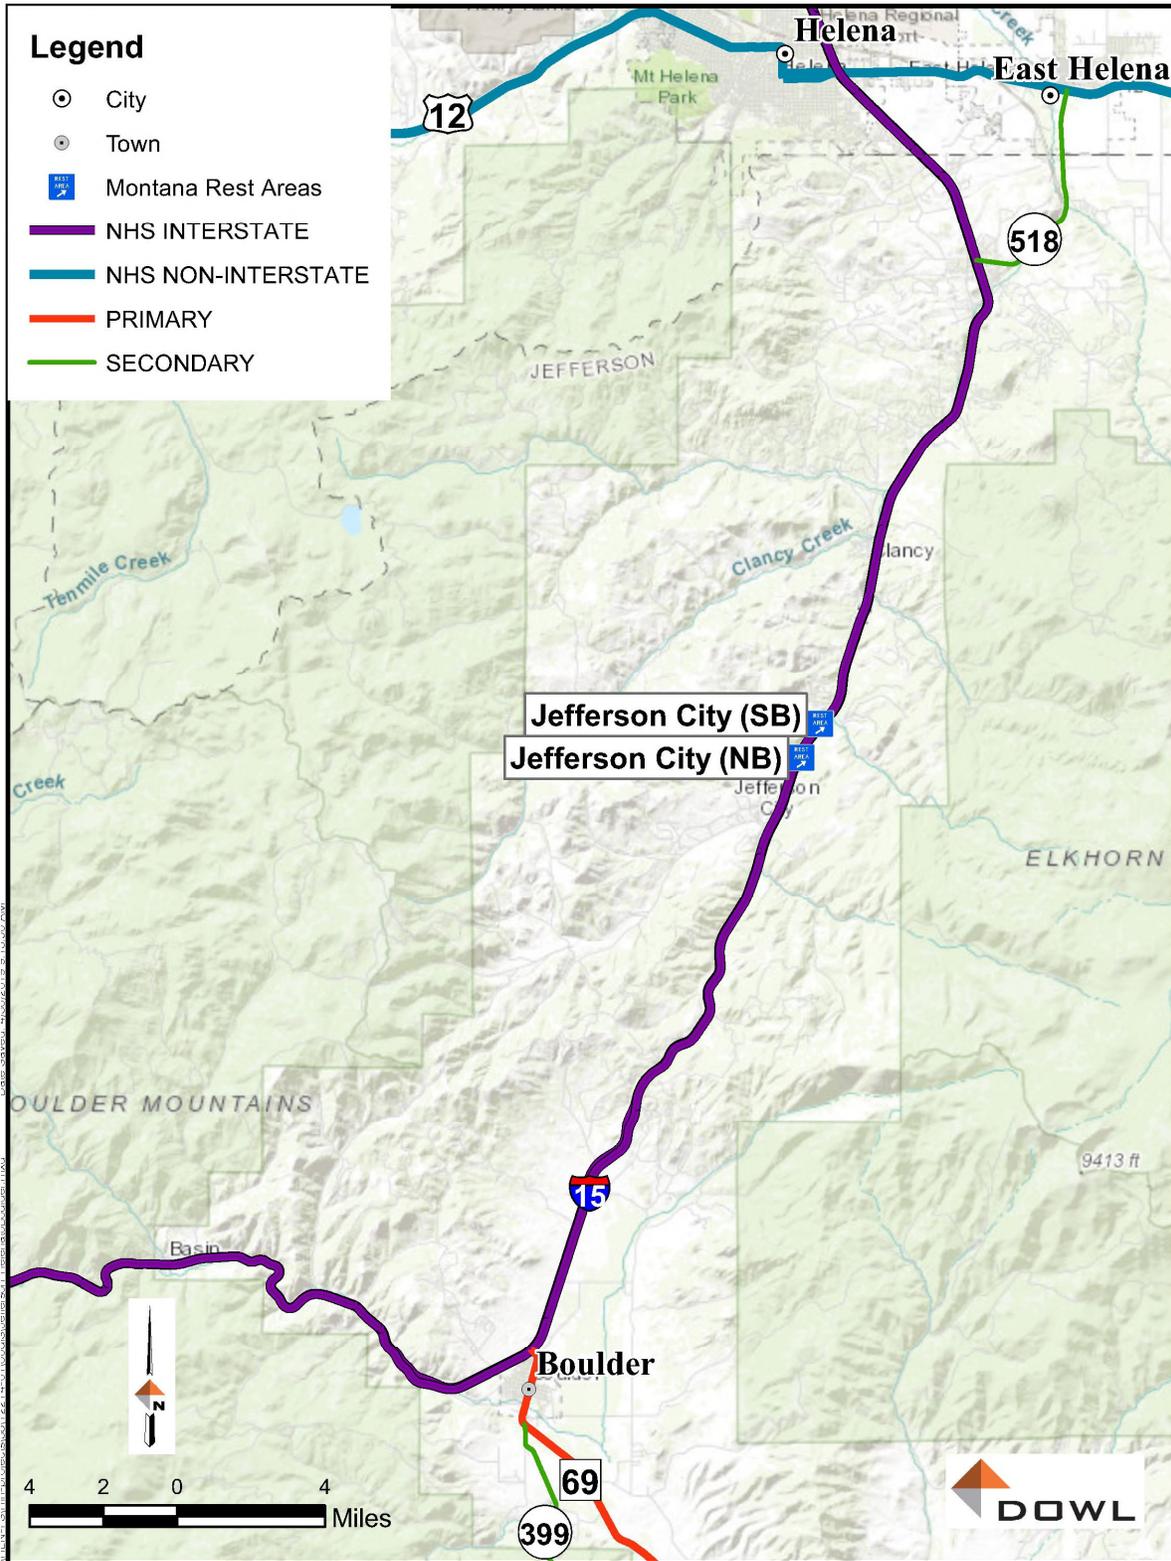
Figure 1: Study Area

Figure 1 illustrates the Jefferson City Safety Rest Area location in reference to the communities of Boulder, Butte, and Helena along Interstate 15 (I-15). Network spacing criteria from the Montana Rest Area Plan characterized the Jefferson City Safety Rest Area as potentially redundant due to its proximity to Helena (approximately 15 miles to the north), Boulder (approximately 13 miles to the south), and Butte (approximately 50 miles to the south).

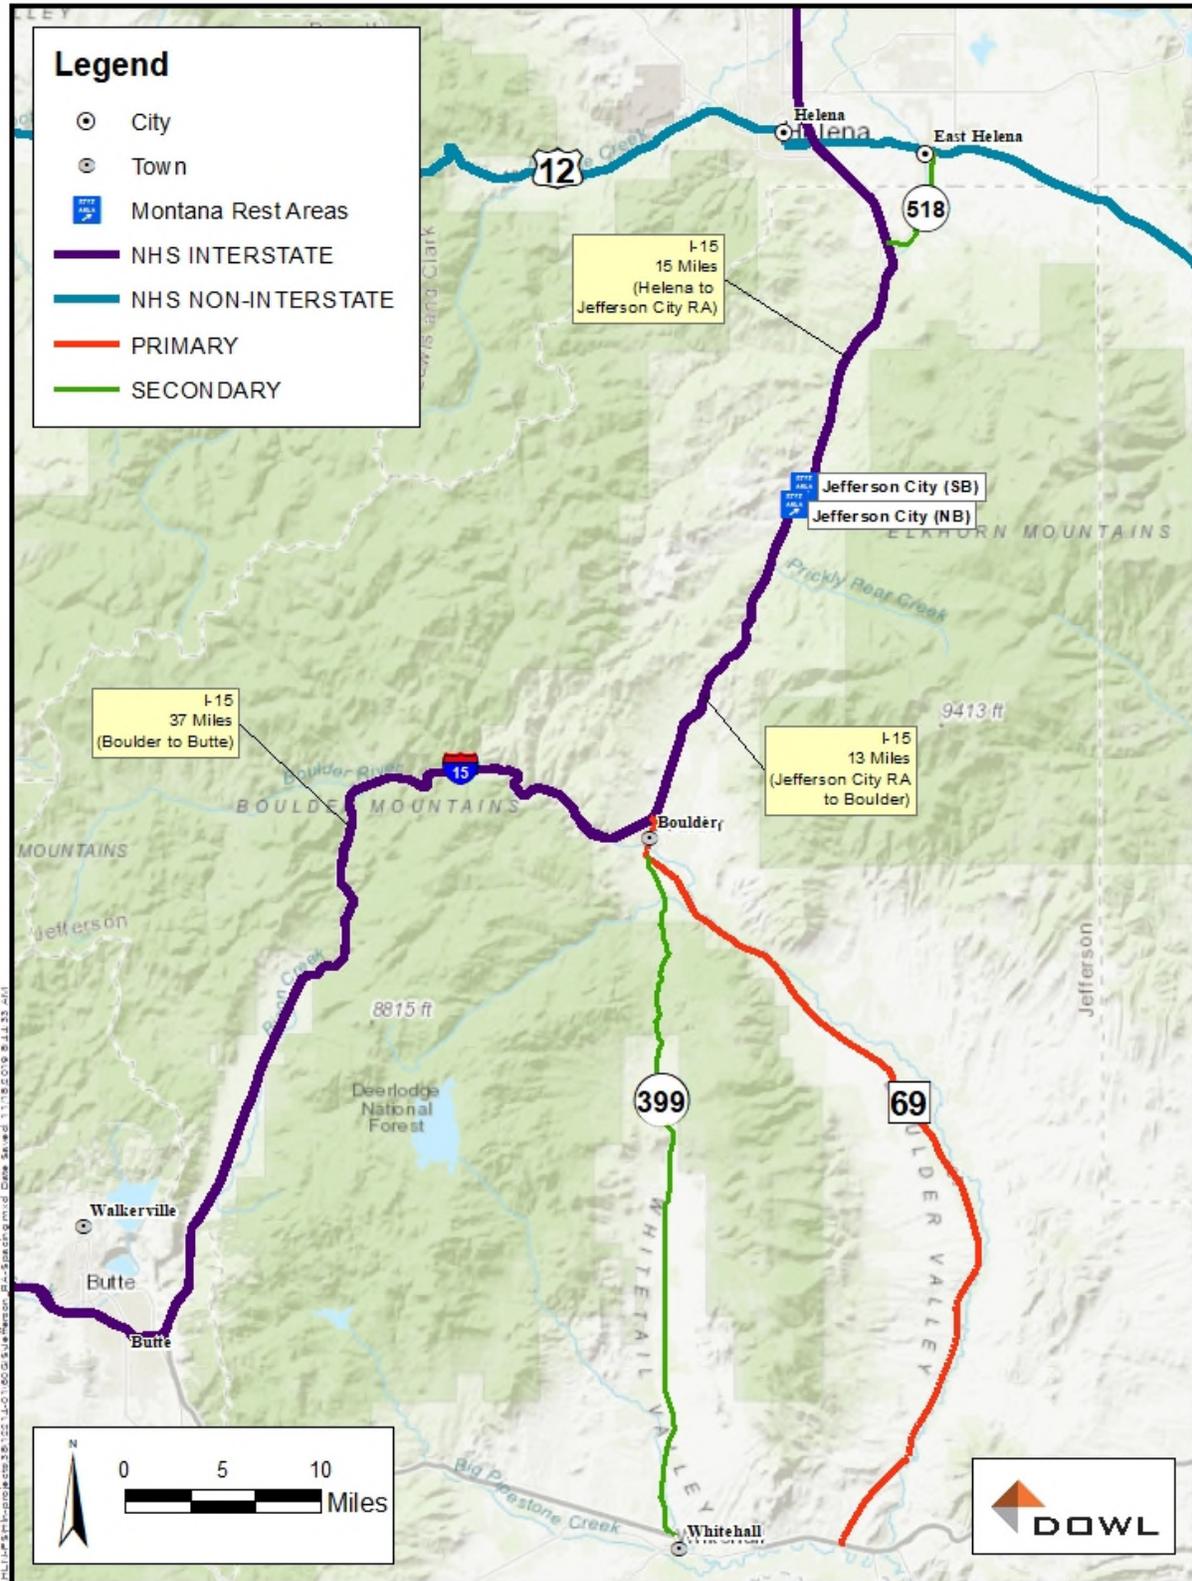
Figure 2: Jefferson City Safety Rest Area Spacing Analysis

The Montana Rest Area Plan recommends approximately one hour of travel time between safety rest areas. This generally equates to a distance of approximately 70 miles on Interstate facilities. Table 1 and Figure 2 provide a summary of spacing distances between safety rest areas, truck parking areas, urban areas, and other key locations in the vicinity of the Jefferson City Safety Rest Area. The analysis considers spacing only along the Interstate 15 corridor from the Helena to Butte urban areas. Boulder is not a designated urban area; however, is included in the analysis as a key stopping location along this portion of the I-15 corridor with at least one commercial establishment with 24-hour services. Currently, the Jefferson City Safety Rest Area operates as a seasonal facility.

Beginning Location	Ending Location		
	Helena (Urban Area)	Jefferson City Rest Area	Boulder (Other)
Jefferson City Rest Area	15 miles		
Boulder (Other)	28 miles	13 miles	
Butte (Urban Area)	65 miles	50 miles	37 miles

Key findings regarding spacing between stopping opportunities are summarized below.

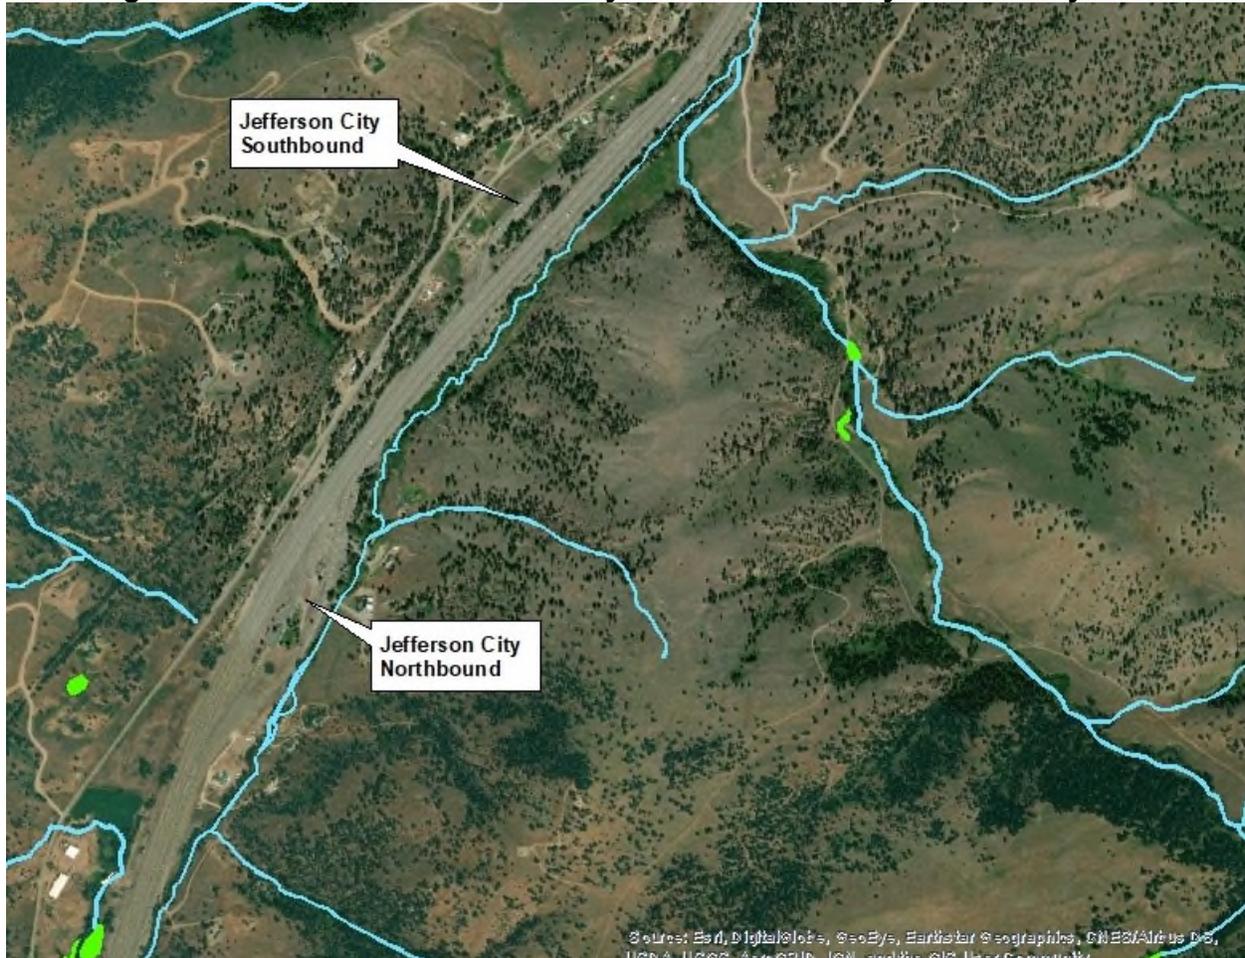
Figure 3: Wetlands and Waterways Within the Vicinity of The Study Area

One surface water, Prickly Pear Creek, occurs in the proximity of the northbound site (Figure 3). Prickly Pear Creek is a small, perennial riverine flowing northeast/southwest. Prickly Pear Creek eventually conveys to Lake Helena and the Missouri River, and is therefore, considered a jurisdictional water under the Clean Water Act (i.e., within the U.S. Army Corps of Engineers regulatory jurisdiction). Additionally, a small spring fed pond is located at the southbound site.

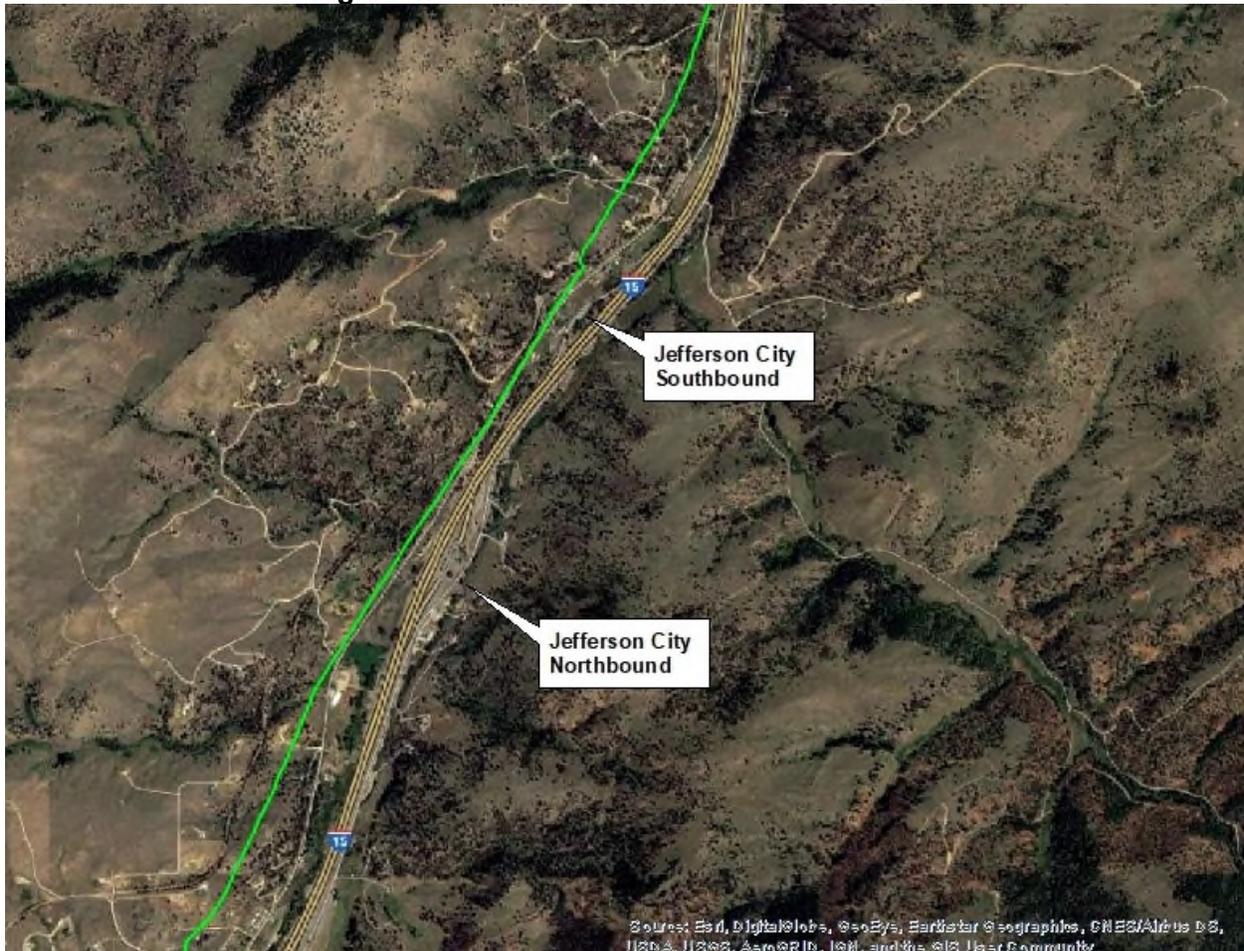
Figure 4: East Helena – Boulder Gas Line

Based on available MDEQ information, there are no underground storage tank (UST) sites, petroleum release fund claims, hazardous waste handler sites, abandoned or inactive mine sites, or open cut permits within or directly adjacent to the two sites. The National Pipeline Mapping System shows one pipeline designated as a gas transmission pipeline approximately 427 feet west of the southbound site. The pipeline travels north/south adjacent to I-15. The pipeline is designated as part of the East Helena-Boulder Line in the Northwestern Energy GT&S system and is owned by Northwestern Corporation (Figure 4).
