Standards Review – Nonstandard Conditions & Notes

Baker Airport

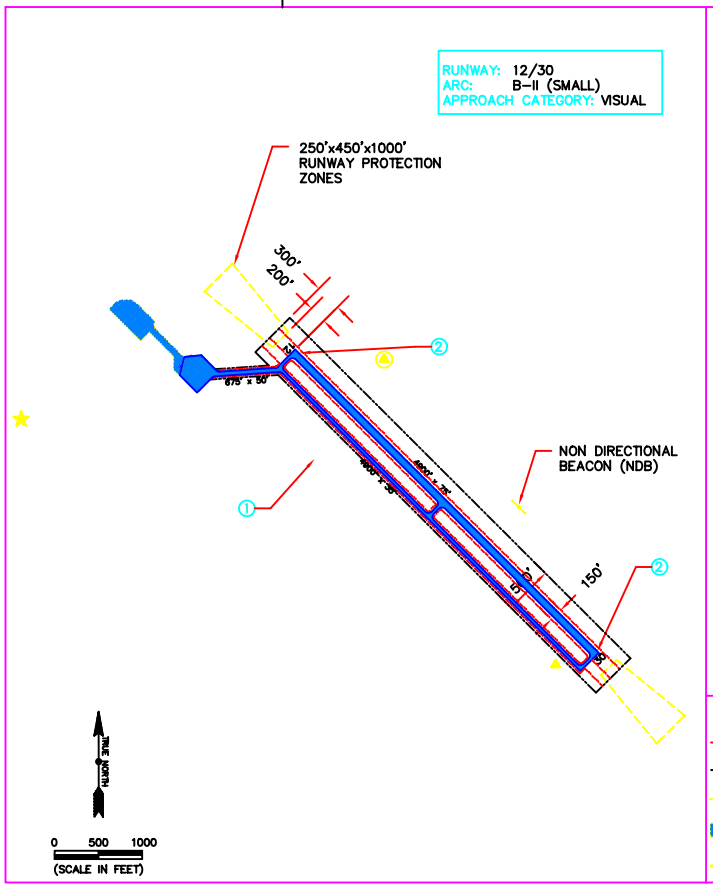
Runway 12/30

① TREES PENETRATE TRANSITIONAL SURFACE.

② RUNWAY HAS VISUAL APPROACHES BUT IS MARKED NPI ON BOTH ENDS.
