Colstrip Airport

Standards Review
Nonstandard Conditions & Notes

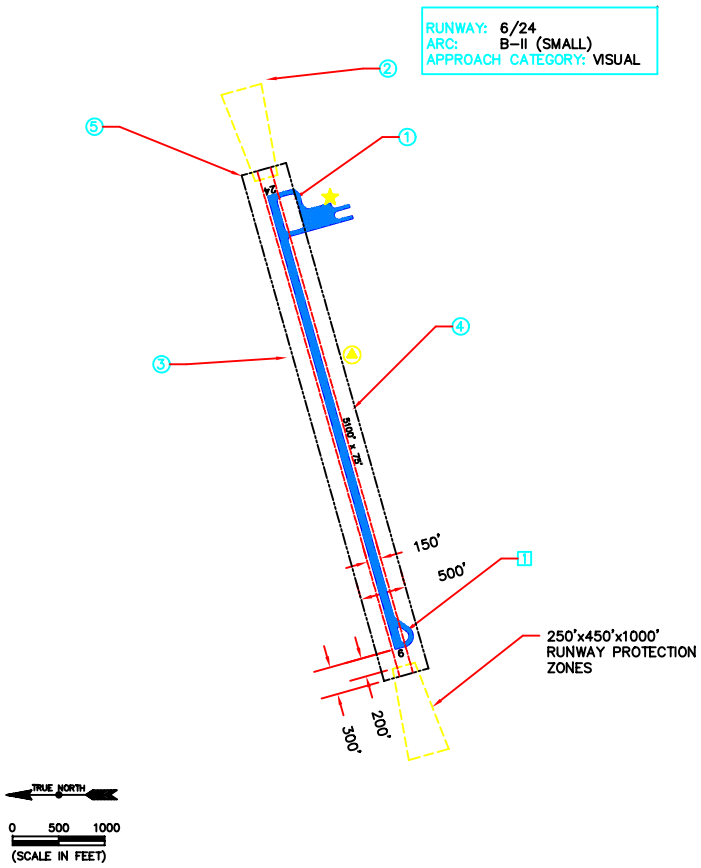
Runway 6 / 24

① NONFRANGIBLE INFORMATION SIGN IN OFA & PRIMARY SURFACE.

② TERRAIN PENETRATES ULTIMATE TRANSITIONAL SURFACE, MAY NOT PENETRATE UNDER CURRENT CONDITIONS.

③ TERRAIN PENETRATES TRANSITIONAL SURFACE.

④ BRUSH IN OFA.

⑤ TREES IN OFA & PENETRATE TRANSITIONAL SURFACE.

1 ONLY ONE HOLD LINE ON JUG HANDLE.
