Forsyth Airport

Standards Review
Nonstandard Conditions & Notes

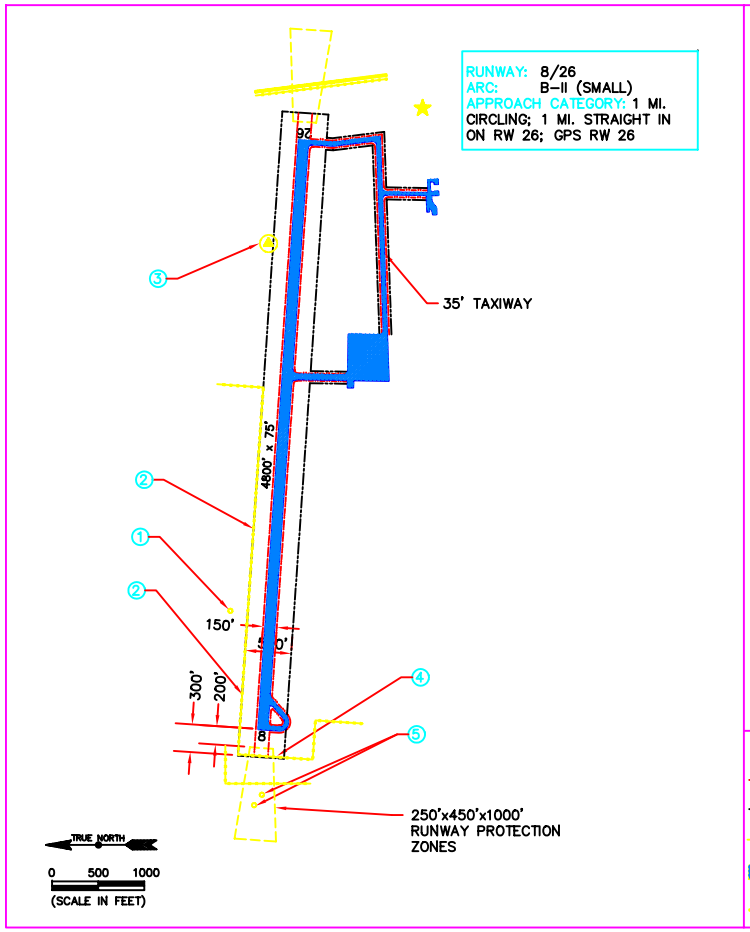
Runway 8 / 26

1. TREE PENETRATES TRANSITIONAL SURFACE.
2. FENCE PENETRATES PRIMARY SURFACE OR TRANSITIONAL SURFACE IN AT LEAST TWO PLACES.
3. WIND CONE PENETRATES TRANSITIONAL SURFACE.
4. FENCE IN OFA.
5. TWO PINE TREES BRUSH BOTTOM OF APPROACH SLOPE.
