Montana Department of Transportation
Research Programs
November 2011

EVALUATION OF AN AUTOMATED FIXED ANTI-ICING DEVICE FOR USE ON BILLINGS DISTRICT BRIDGE DECK

EVALUATION REPORT

Update – November 2011: Discontinuing Project Due to System Failures

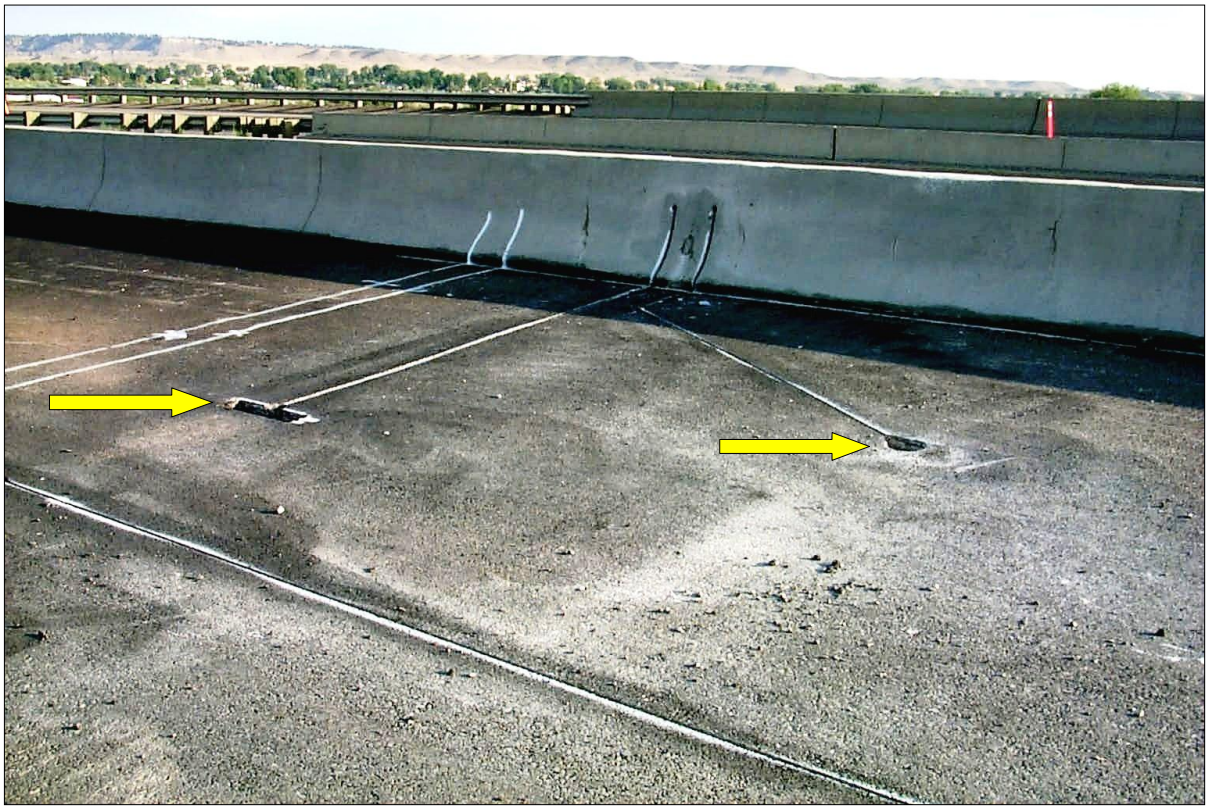
August 2006-February 2007

↑ Here is a closer view of the sensor locations prior to installation (yellow arrows).

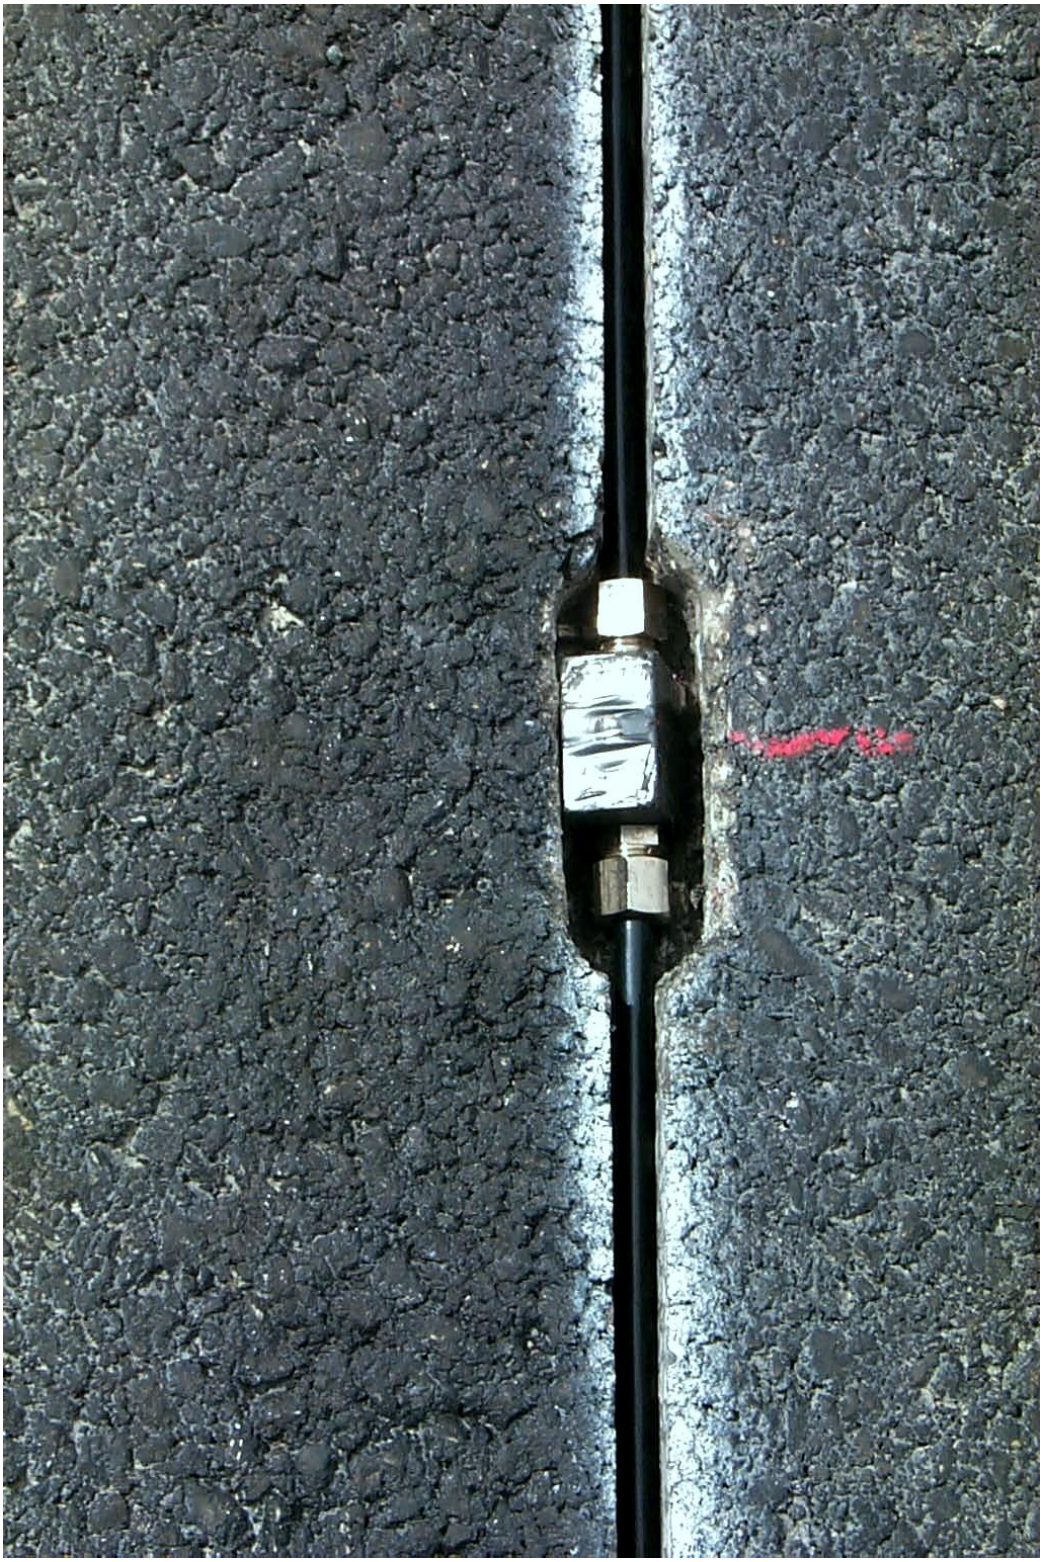
← Control boxes are installed on the exterior of the bridge rail. The yellow arrow shows the control for the product supply lines, the red arrow for the sensor conduits.

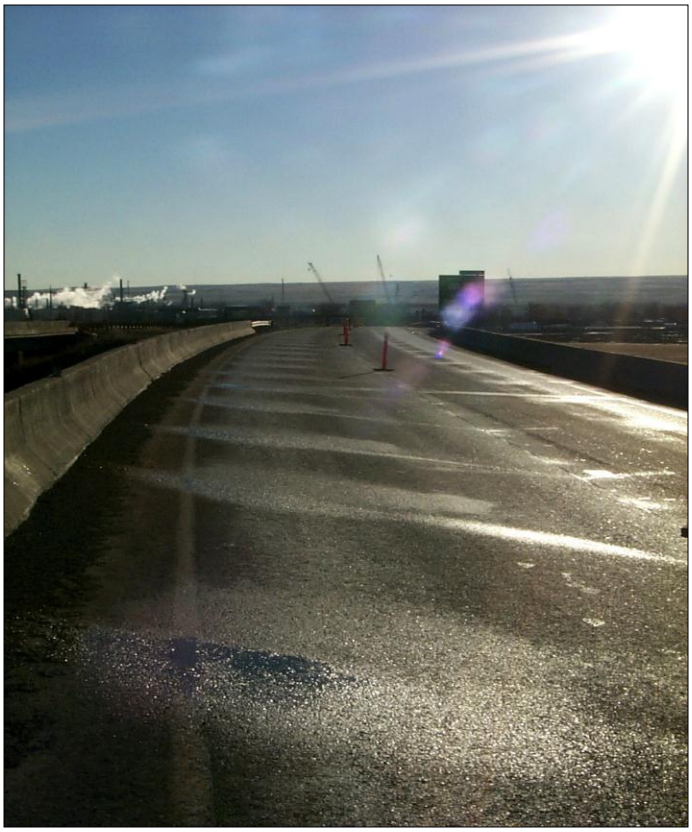
← This image is the east view over the span during the FAST system spray test. As stated earlier, a limited amount of chloride is applied. Where other anti-icing systems depend on larger quantities of product to cover the road surface to mitigate the formation of ice, the FAST system relies on the pick-up action of vehicle tires to assist in transmission of the anti-icing chlorides.

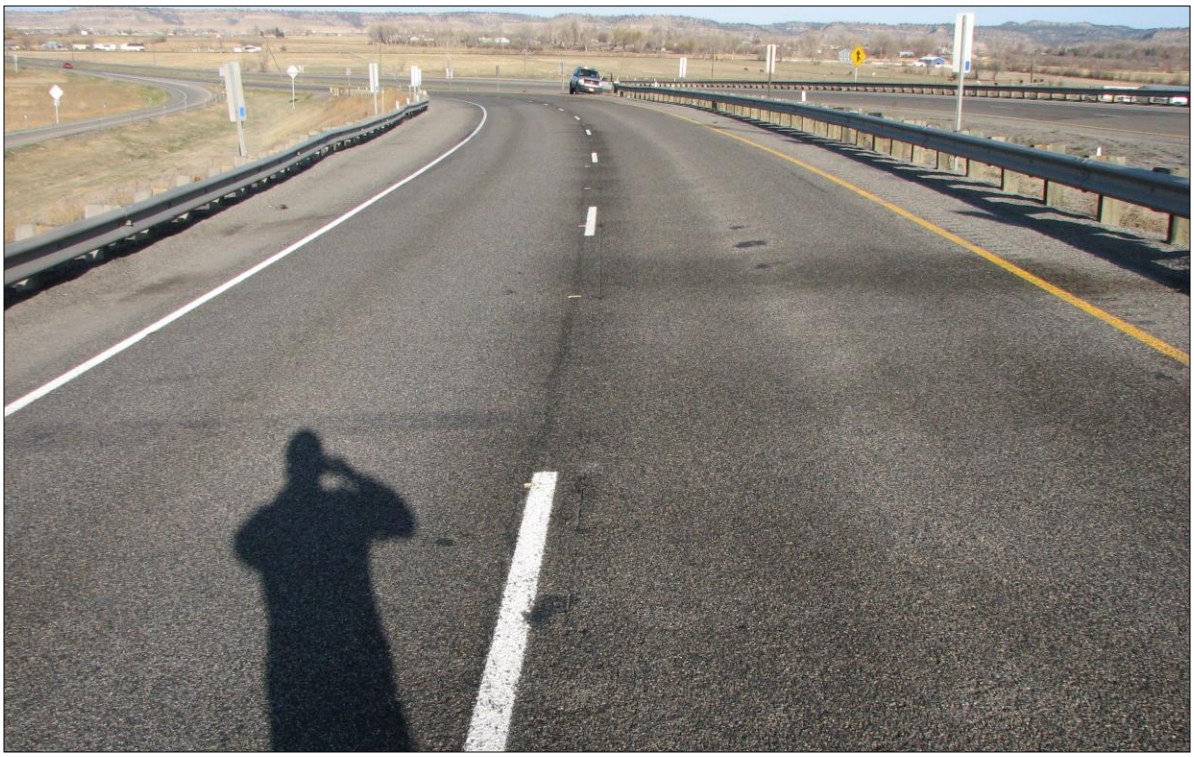
↑ Condition of approach August 2008 – view west.

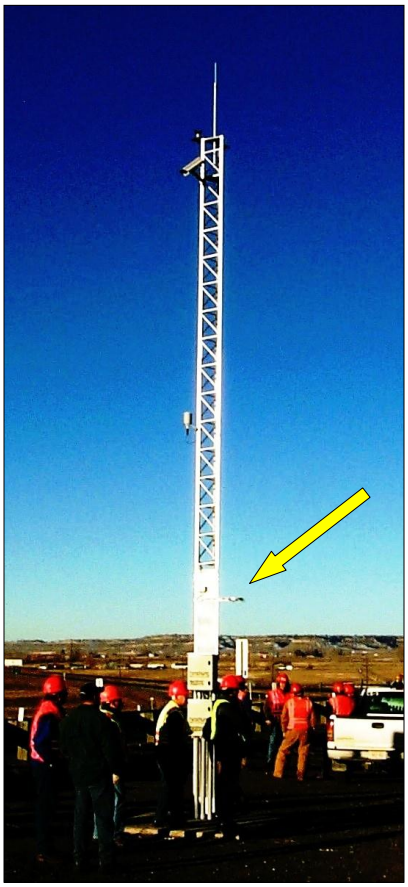
← Representative image of the RWIS: Note the yellow arrow shows the original location of the precipitation sensor. It was found at this height that overspray from passing snow plows would coat the sensor with debris and diminish its effectiveness. The sensor was relocated higher up the RWIS and since has not been an issue. The image below is the close-up of that sensor.
