# MONTANA DEPARTMENT OF TRANSPORTATION STREAM MITIGATION MONITORING REPORT

*Bowser Creek  
Flathead County, Montana*

*Project Completed: 2010  
Monitoring Report #2: December, 2014*

MDT Project Number: NH 15(93)  
Control Number: 2038-011

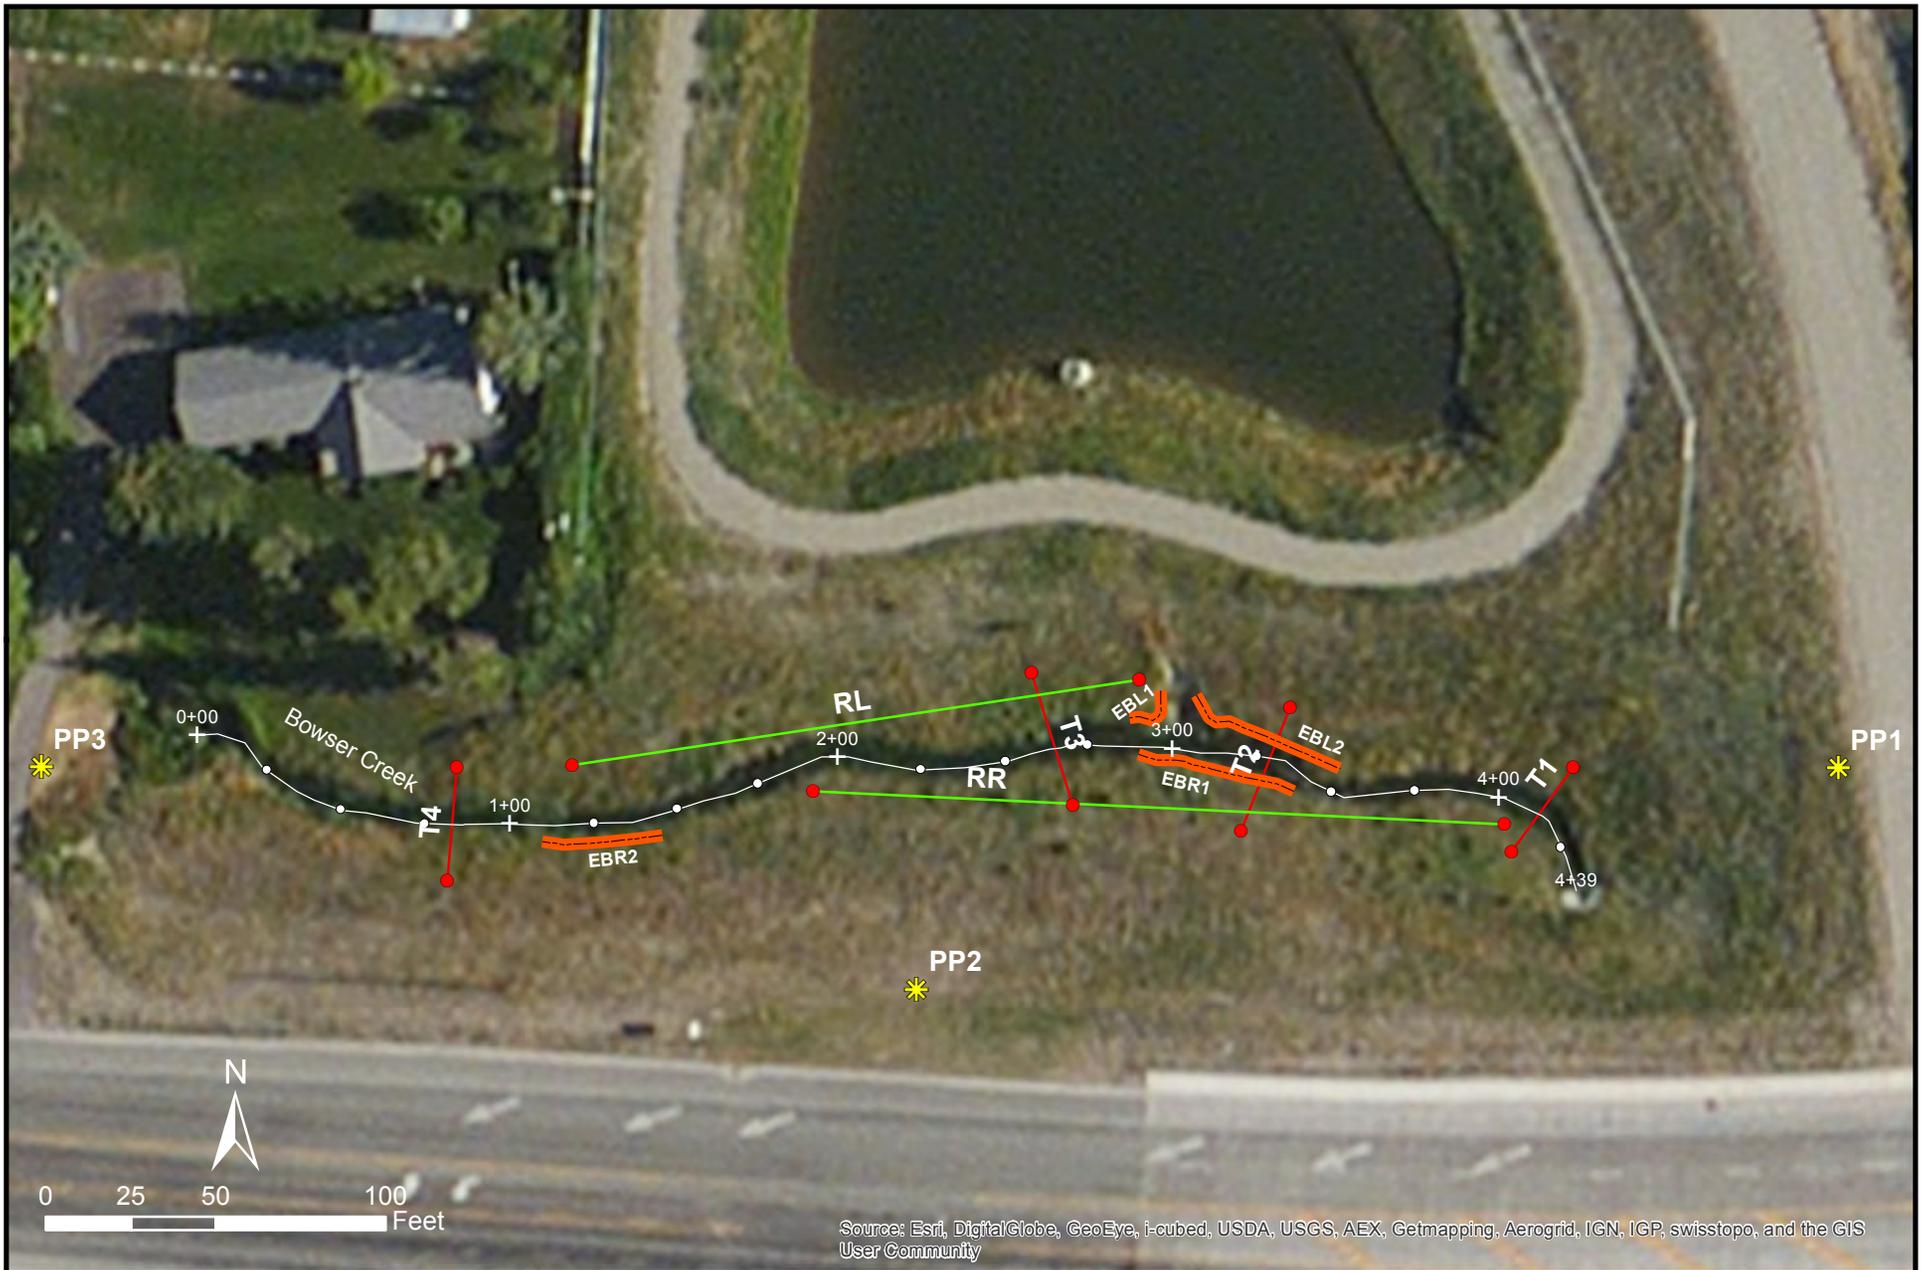
Total eroding stream bank length was 149 feet, or 17% of the overall project bank length of 878 feet. Photos of each eroding bank are included in Appendix C of this report. Figure 3 in Appendix A shows the GIS mapped location of eroding stream banks.

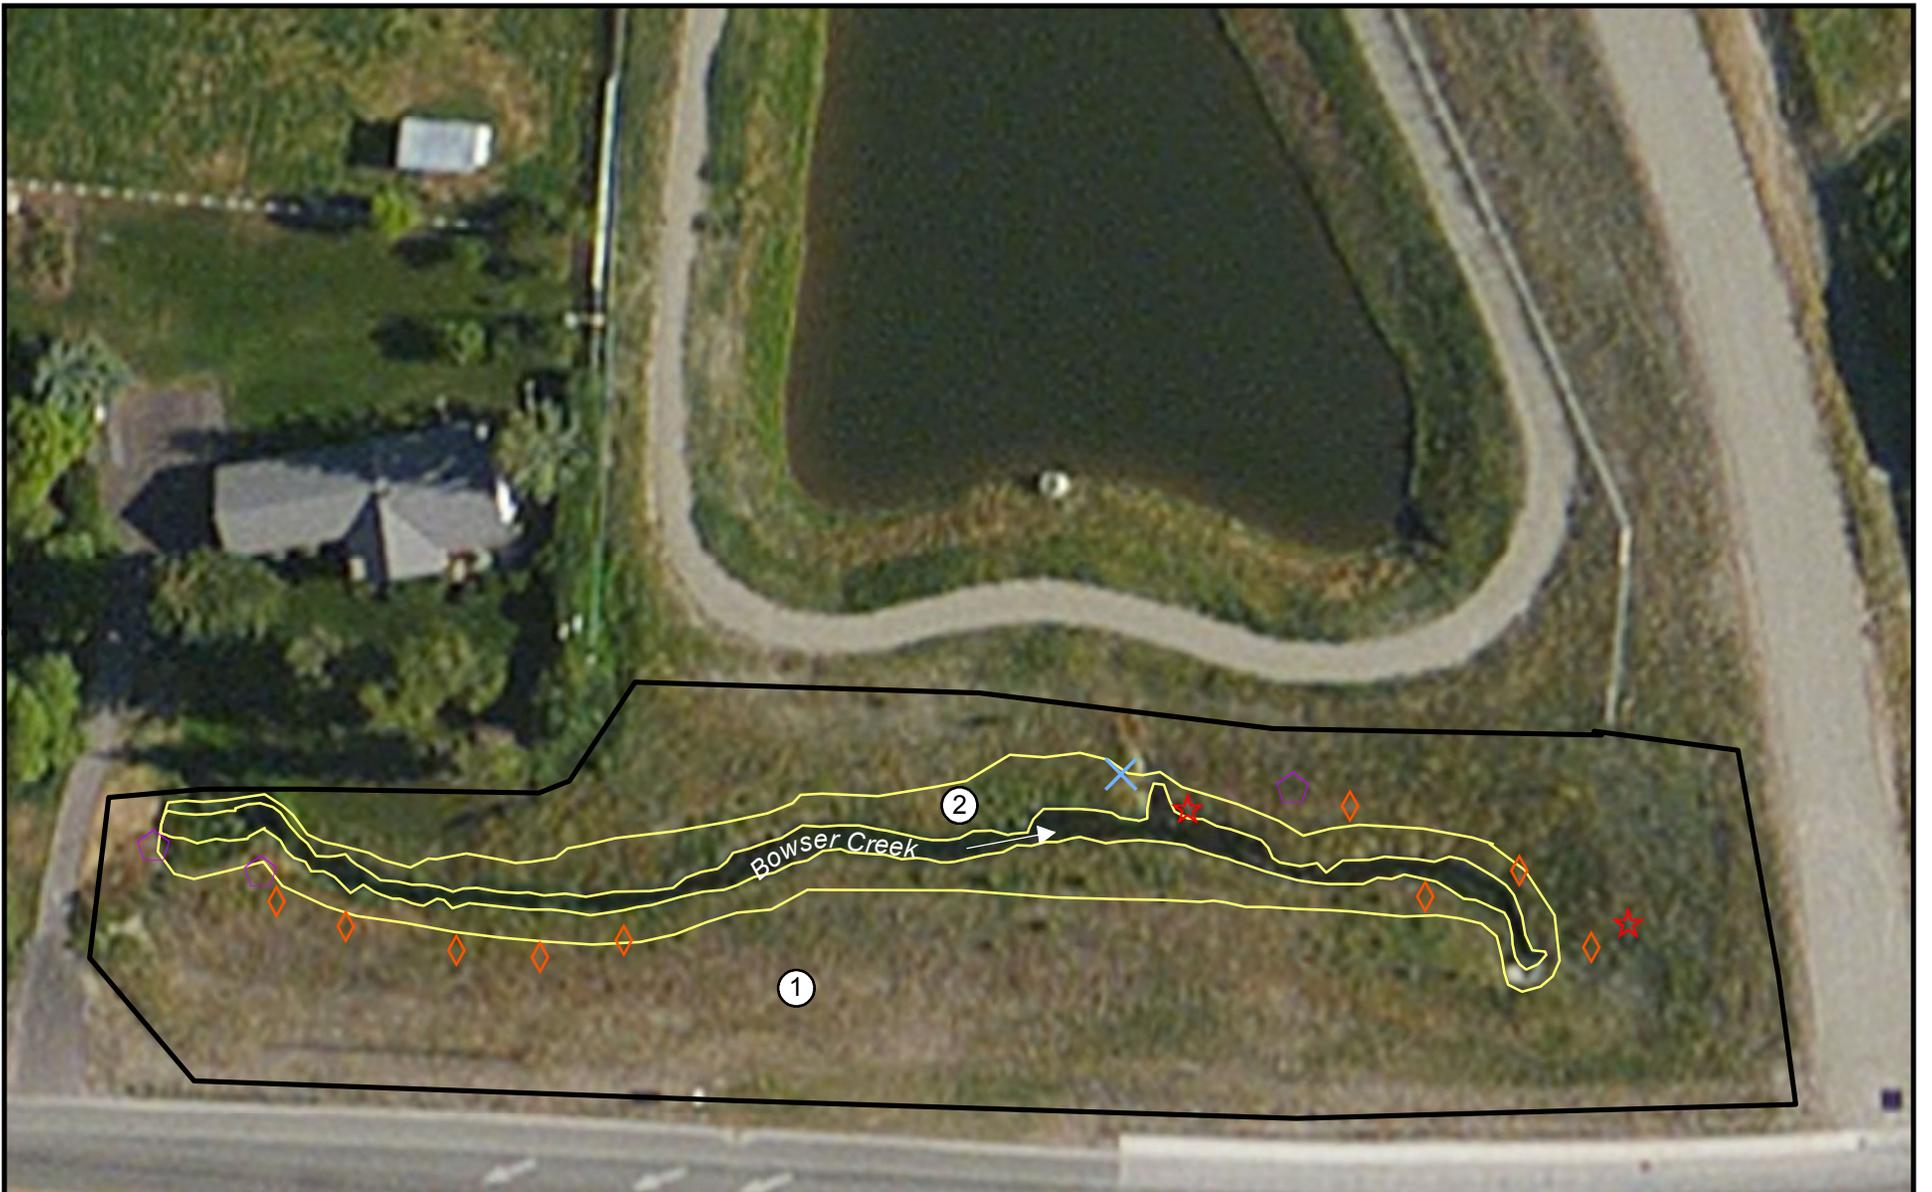
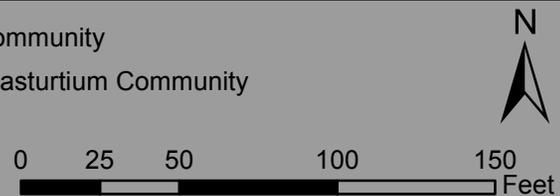
The Bowser Creek field assessment identified the presence of six Montana State-listed noxious weeds (Table 4). All noxious weed species observed are shown on Figure 4 in Appendix A with the exception of those observed in trace amounts, which were not mapped. The combined cover of all six noxious weeds identified in 2014 was 7%, an increase of 4% from the 2013 monitoring event. Infestations of *Cirsium arvense*, the most prevalent weed, were primarily located on the northeast and southwest ends of the project area (Figure 4).

Noxious weeds were observed in approximately 7% of the Bowser Creek project area. Weeds are dispersed sporadically on both banks within the project area and are illustrated on Figure 4 in Appendix A. The documentation of noxious weeds provided in this monitoring report allow for MDT to develop management plans for controlling noxious weeds along the reconstructed segment of Bowser Creek.

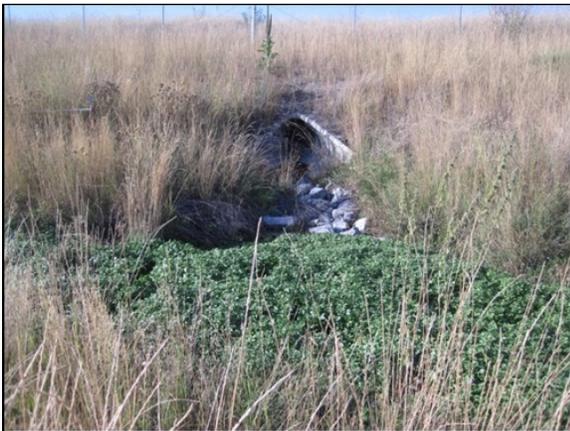
**Photo 2—2013**  
**Description:** View across Bowser Creek of culvert on north side of channel. **Compass:** 0 (North)

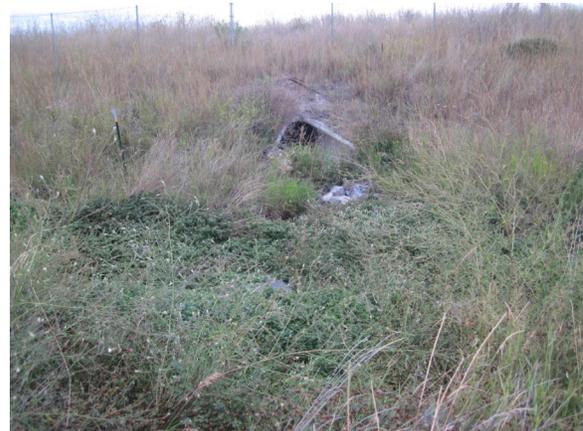
**Photo 2—2014**  
**Description:** View across Bowser Creek of culvert on north side of channel. **Compass:** 0 (North)

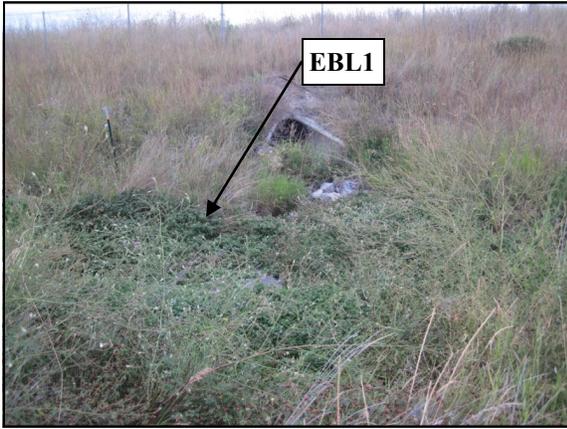
**Photo 3**  
**EBL1**– Upstream of culvert, stream bank eroding for approximately 17 feet.
