MONTANA DEPARTMENT OF TRANSPORTATION STREAM MITIGATION MONITORING REPORT

STREAM MITIGATION MONITORING REPORT #3

*Spring Creek
Flathead County, Montana*

MDT Project Number: NH-MT 5-3(59) 109
Control Number: 2038

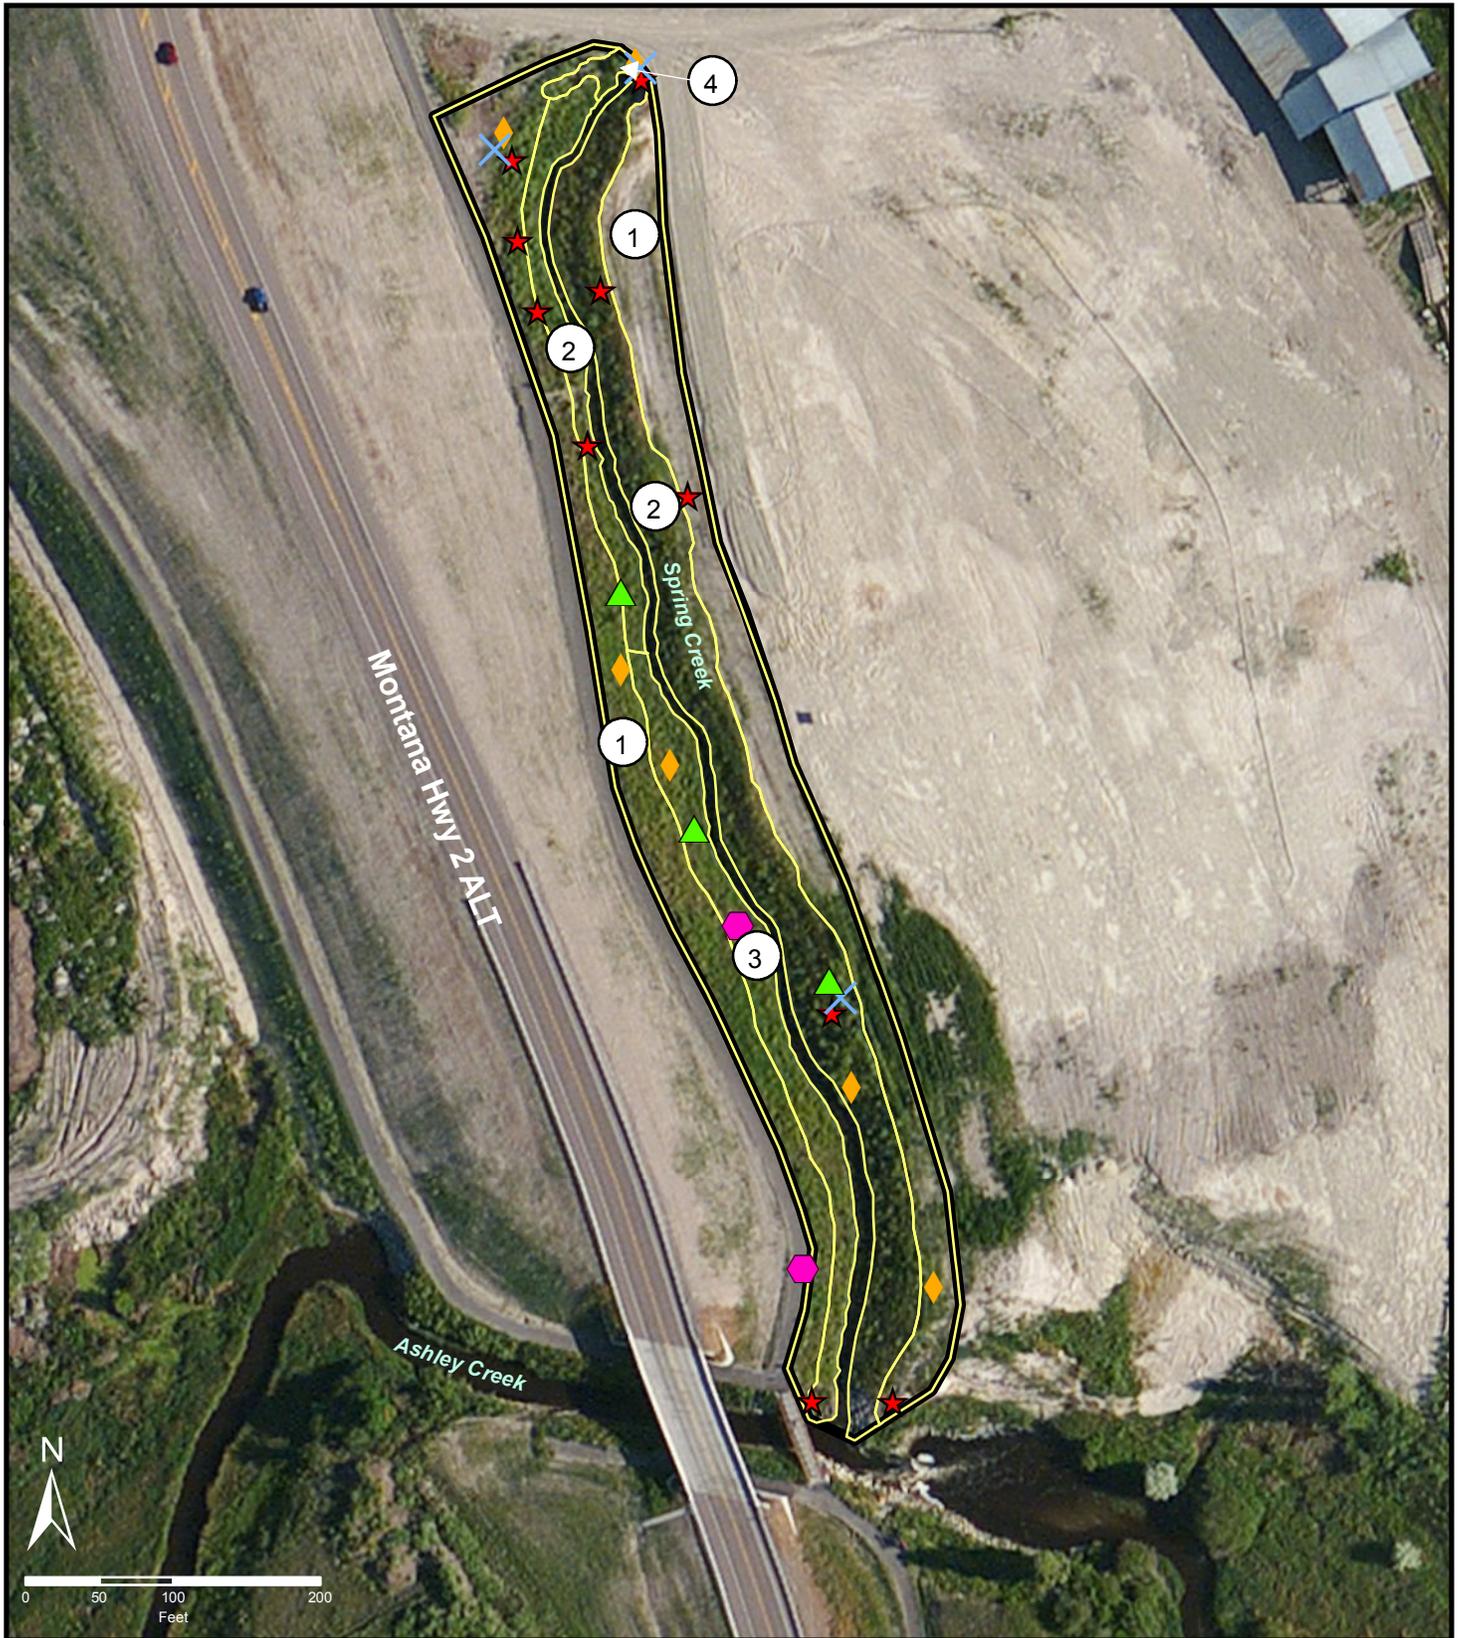
Spring Creek - 2015 Monitoring Features
Figure 3
Date: 10/12/2015
<i>Spring_features2015.mxd</i>

Bank erosion was observed along one 30-foot long segment of the constructed channel (Figure 3, Appendix A). The bank has retreated approximately 1-2 feet since it was constructed. Wooden stakes used to pin coir logs remain in the channel, indicating the original extent of the bank at this location. The channel along this bank segment remains relatively densely vegetated with reed canary grass (*Phalaris arundinacea*), with lesser cover provided by Maximilian sunflower (*Helianthus maximiliani*) and Canadian thistle (*Cirsium arvense*). No floodplain exists to the west of the channel, and the adjacent area is a sloped embankment that extends upward to the bike path to the west of the creek. The erosion occurred approximately 30 feet downstream from one of the two beaver dams; however, the dam did not appear to be the primary cause of erosion. The bio-degradation of coir logs installed along the banks appears to have left a void in the bank at this location.
