EVALUATION OF A CONVENTIONAL CHIP SEAL UNDER AN OVERLAY TO MITIGATE REFLECTIVE CRACKING (INFORMAL)

Annual Report

Project name: St. Xavier N & S

Project Number: SFCS 313-1(18)22

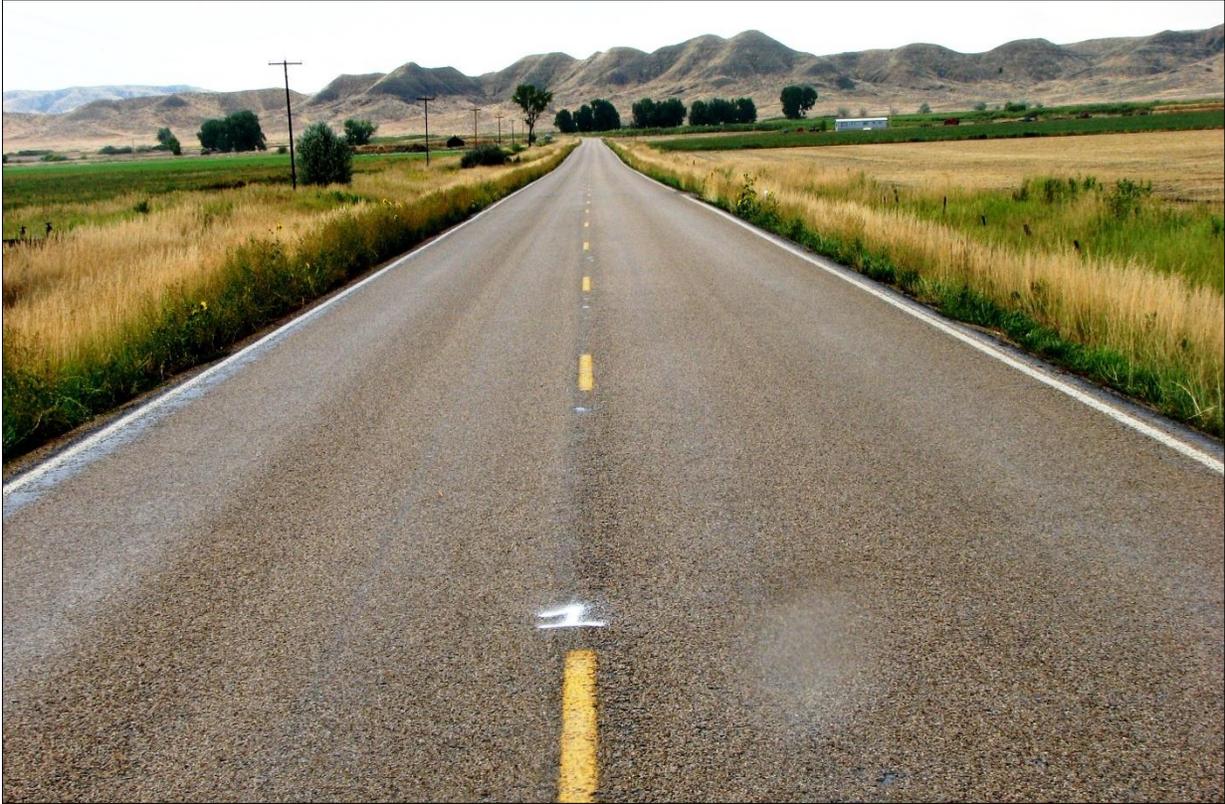
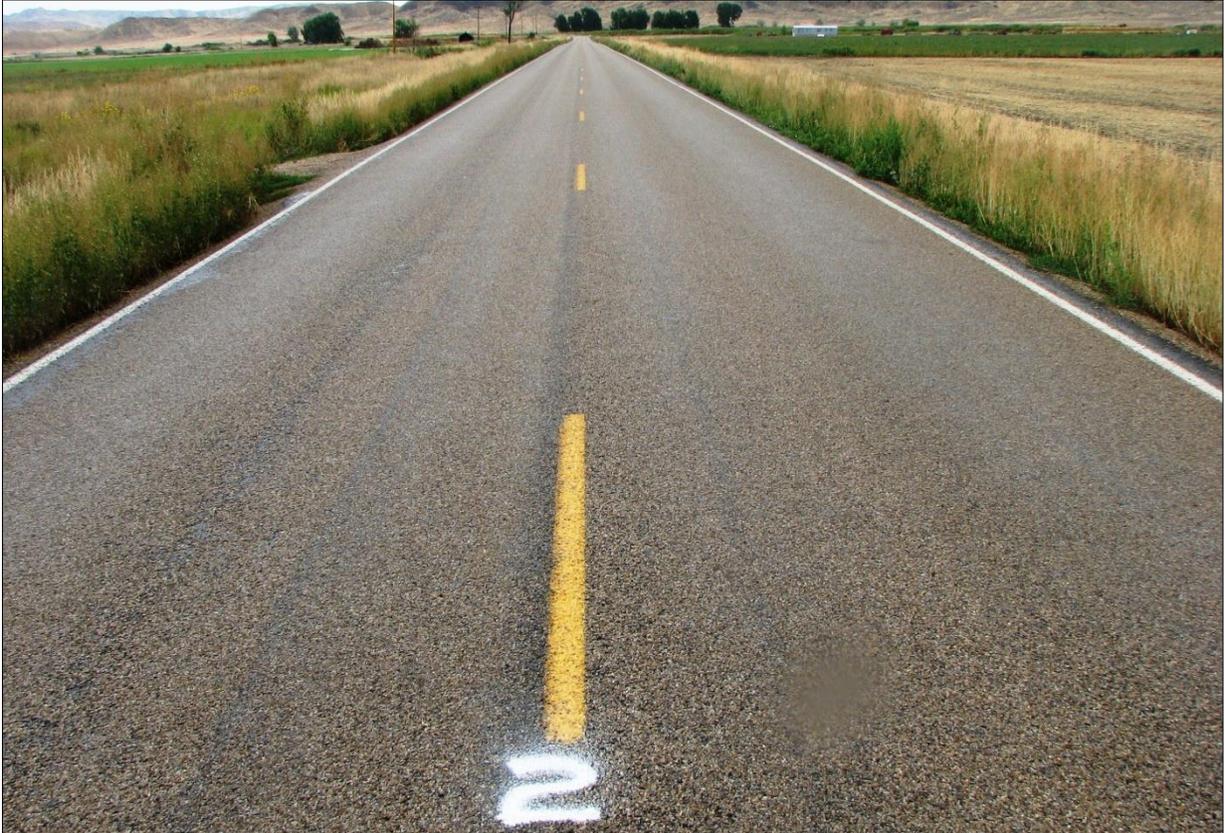
July 2009 Sections 1 & 2 (views east)

Since construction in 2008, the site visits conducted in 2009-2014 to date has displayed no distress data to report.

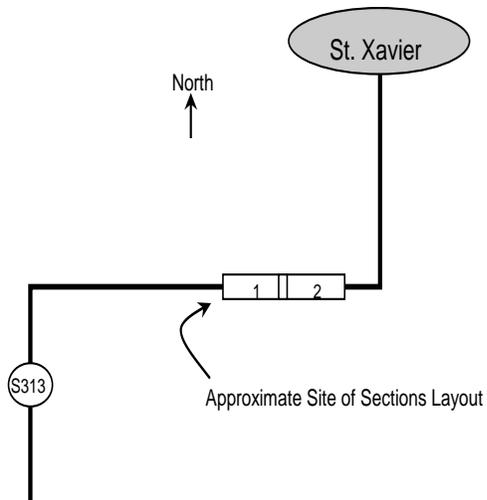
Section Crack Map

During the March 2015 inspection it was found the control section 1 had formed two (2) transverse cracks rated as moderate severity ($>1/2"$ - $<3/4"$). No cracks were visible on test section 2.
