EXPERIMENTAL EVALUATION REPORT

Thin-Whitetopping Bonded Composite

Location: Glendive, Montana – Dawson County

Project No.: STPP 20-1(6)0 P-20, Highway 16, Milepost 0-0.6

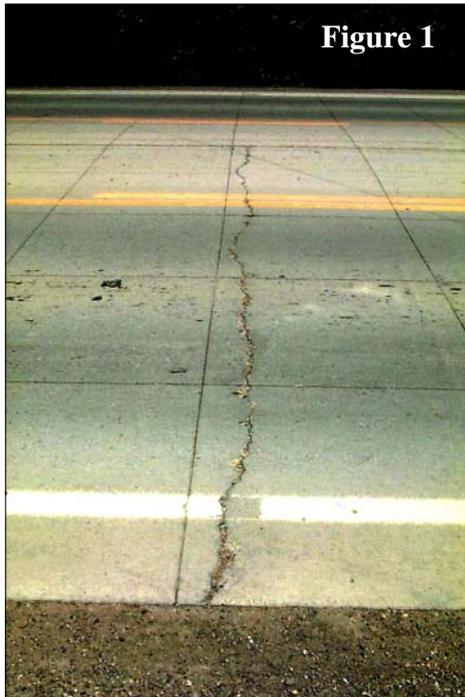
Figure 1

A visual inspection of the entire project was performed to document all types of surface cracking and distress. Photographic documentation of some of the cracks as well as a representative crack map is included in this report. Note that the crack map is strictly an interpretation of progressive cracking during the analysis phase of the project, it is not to scale. Currently three transverse cracks are present on this project, all in the southbound lane. Location as follows (footage counted from the south end of the project going north), #1 at 1244' (541m), #2 at 1380' (420m), and #3 at 1480' (451m), see crack map at end of report. Note that these cracks developed soon after placement during construction. These cracks have widened since construction and are rated as severe in nature (example of crack in figure 1). Incompressible debris (rocks, friables etc.) is entering the cracks and will accelerate the deterioration of the fracture with freeze thaw events. No additional transverse cracking has occurred
