## **EXPERIMENTAL PROJECTS INSTALLATION REPORT**

### **TAPCO (BLINKERBEAM/BLINKSYNC) BLINKERCHEVRON TRAFFIC CONTROL SIGNAGE**

**Project Name:** Curve Near Beaverhead Rock

**Project Number:** HSIP 49-2(10)14

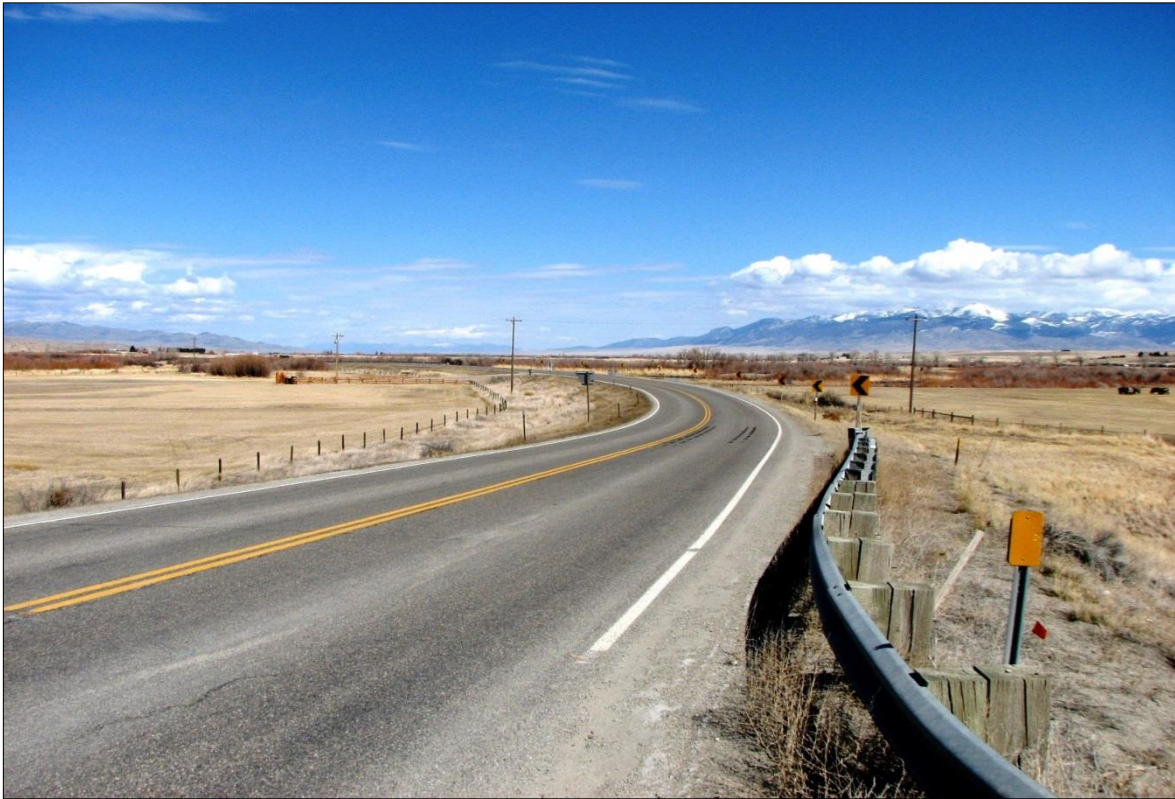
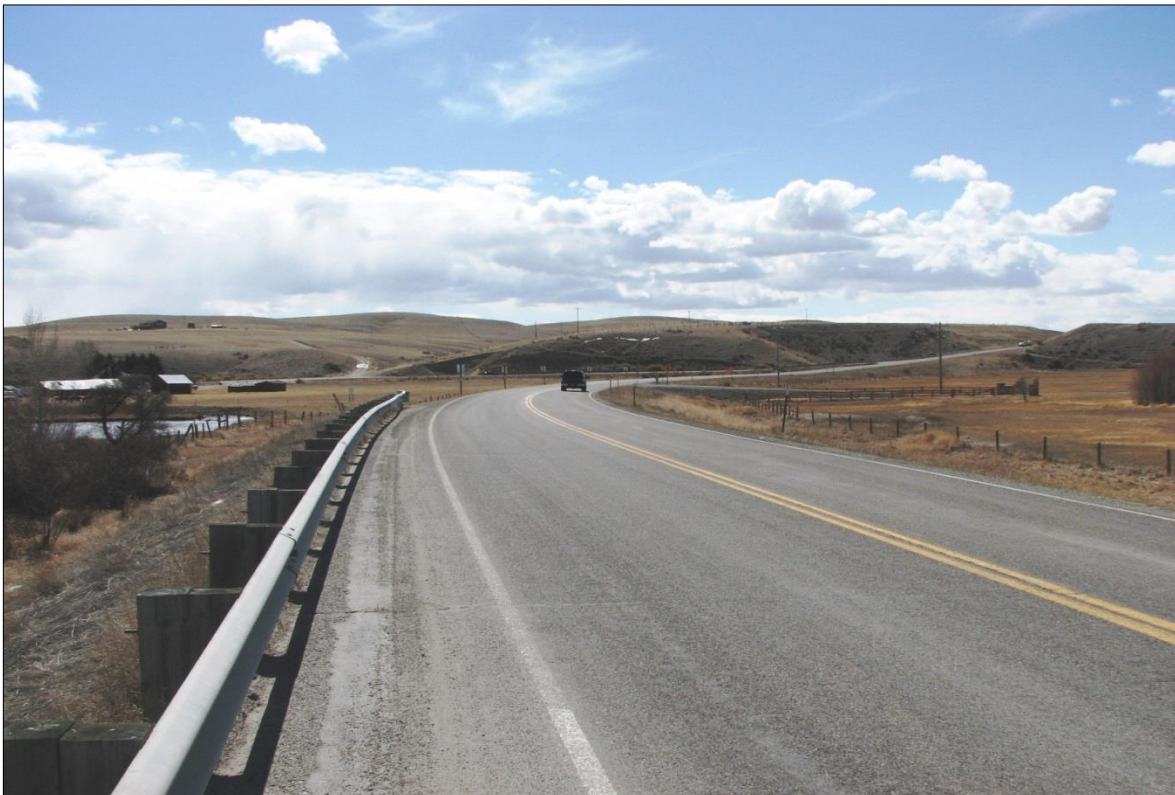
**March 2013**

Project site pre-installation images of the curve at Beaverhead Rock: ↑ Upper image is the northbound view; ↓ lower image is southbound.

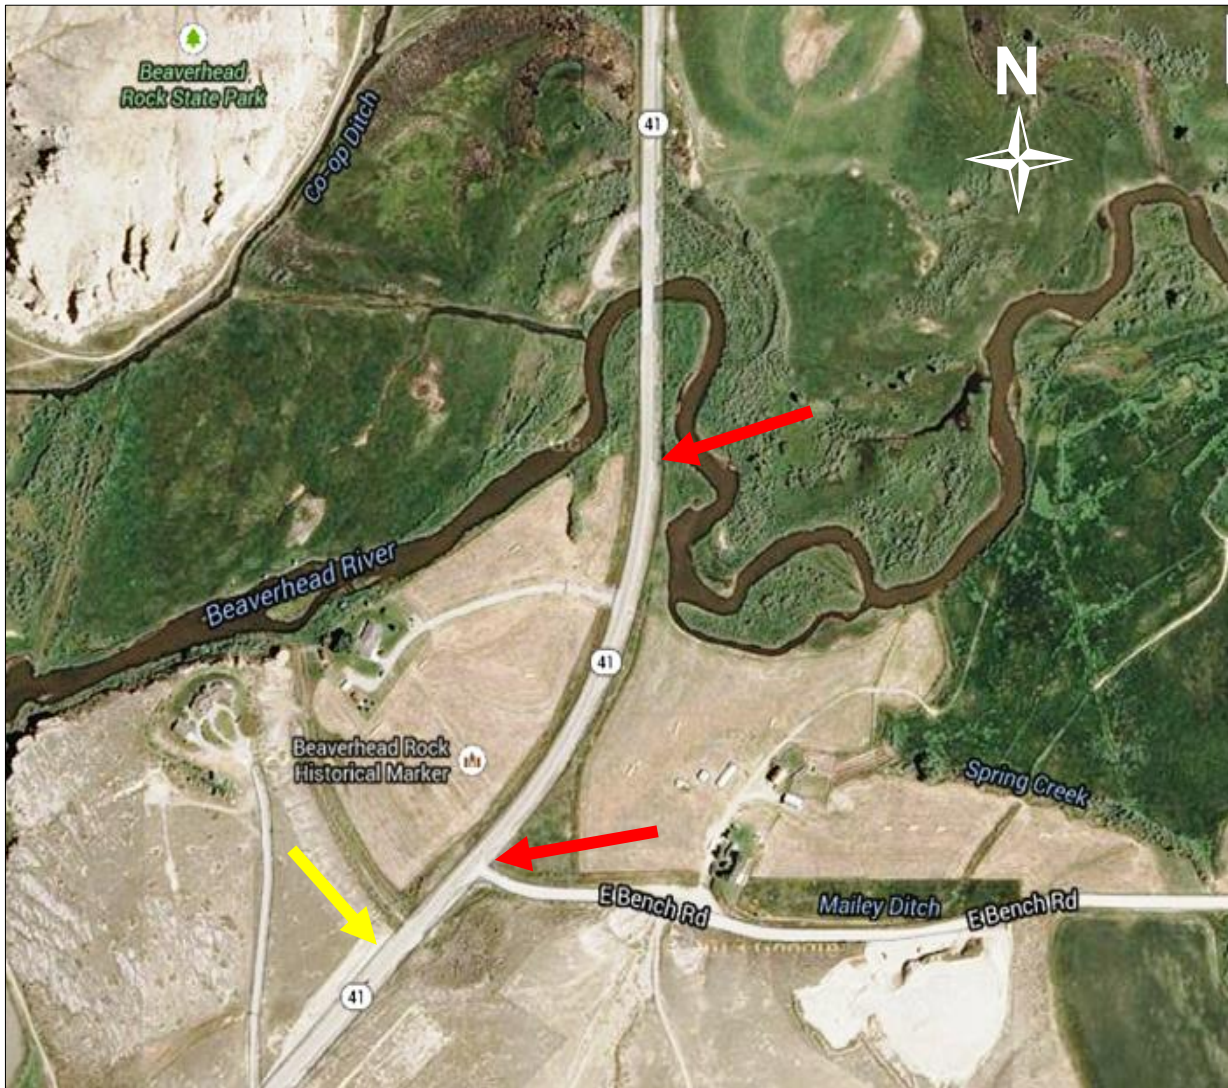
↑ Aerial view of the TAPCO installation project location. Red arrows show the approximate placement of the chevron system.

The yellow arrow denotes the approximate point of the crest of the vertical curve in relationship to the northbound traffic. From this point the road slopes downward with minimum sight distance and reaction time to drivers approaching the curve.

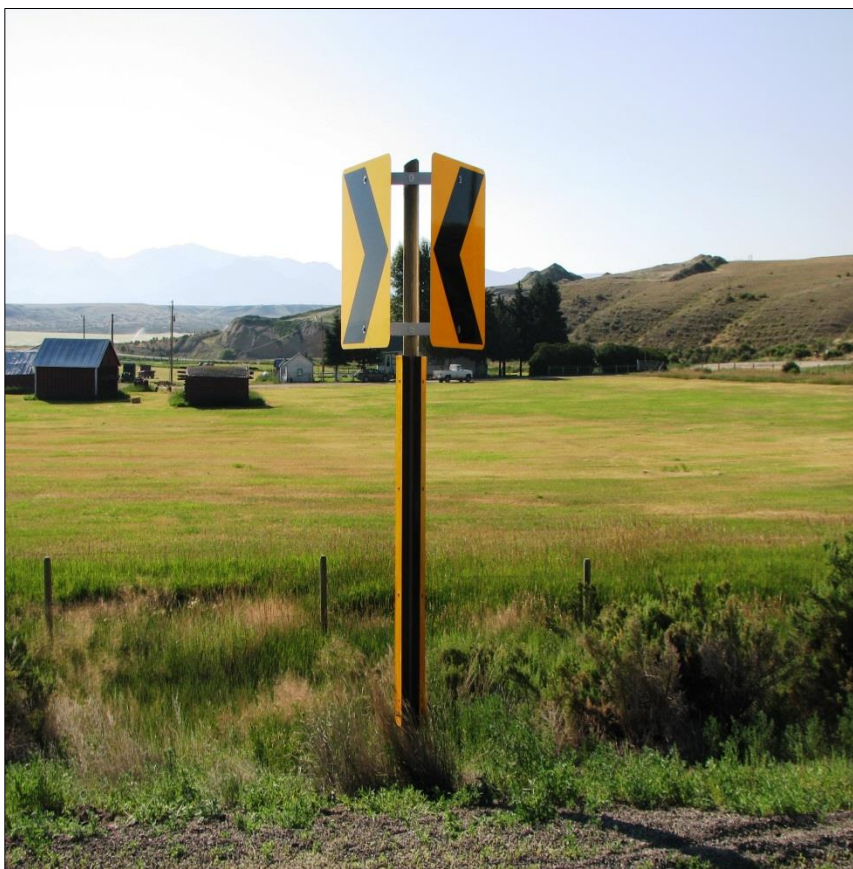
◀ Five (5) conventional chevron signage alternating with each of the six (6) radar-activated units.
