# Bridge No. L15672000+02001

Big Fork Bridge

Condition Evaluation Report

Inspection Date: September 11, 2015

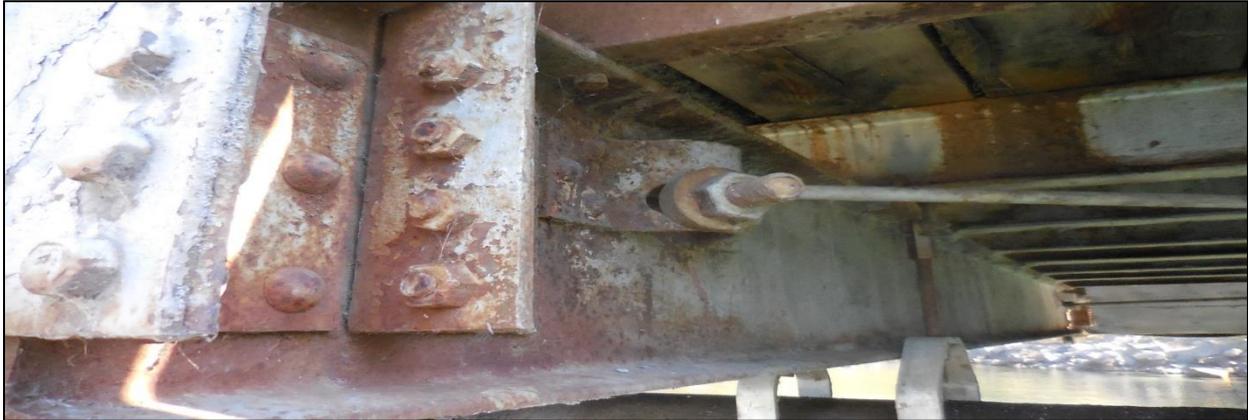
The floor beams were rolled beams attached to the lower chord by a riveted/bolted connection. Approximately 25 percent of the surface area of the floor beams had a sound painted coating. Approximately 50 percent of the floor beam surface area had paint deterioration with freckle corrosion. The floor beams had a loss of painted coating on approximately 15 percent of the surface area with minor surface corrosion and negligible section loss. The remainder of the floor beam had areas of 1/16 in. deep pitting. Areas of heavier section loss were noted at the following locations:

The floor beams were found to be in fair to poor condition. The areas of heavier corrosion along the bottom edge of the floor beam webs and the hole noted in the web of Floor Beam 3' should be monitored during future fracture critical inspections. There were no signs of deflection or crushing of the floor beam webs in the areas of heavier corrosion. Since the bridge is currently posted at 3 tons, it is recommended the floor beams be monitored during future fracture critical inspections.

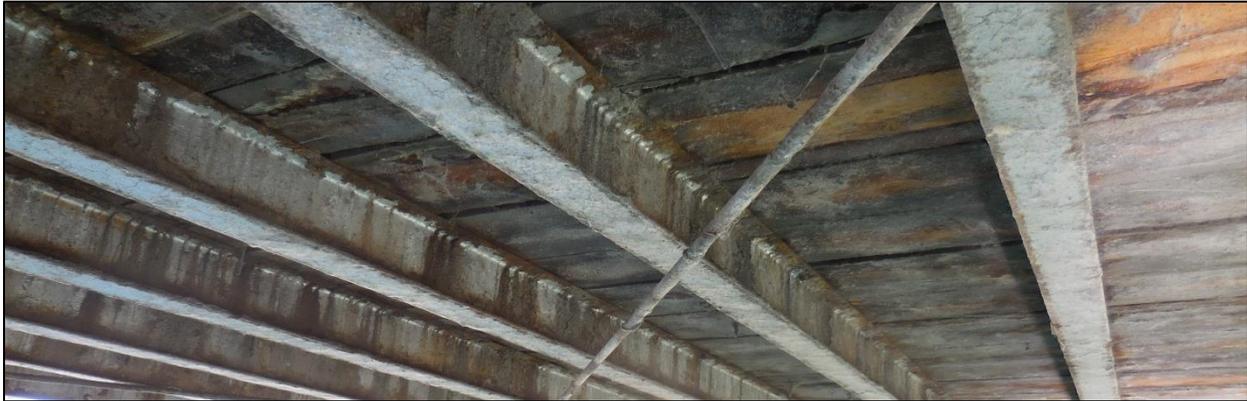
During the inspection of the floor beams, a cursory inspection of the steel stringers, and underside of the timber deck was performed. The steel stringers were rolled beams connected to the floor beams by a bolted connection. The steel stringers had a sound painted coating on approximately 50 percent of the surface area. Approximately 25 percent of the stringer surface area had areas of paint deterioration with freckle corrosion. Approximately 15 percent of the surface area had failed/peeling paint with minor surface corrosion with negligible loss of section. The remainder of the stringers had areas of pitting and section loss, primarily at the abutments. Areas of heavier section loss are noted below:

The underside of the timber deck had no coating noted. The underside of the deck had random areas of checking, splitting and signs of mold due to moisture.

The steel stringers were in fair to poor condition. It is recommended that the paint deterioration and corrosion be monitored during future inspections. Stringers 1 and 8 at each abutment had heavy corrosion and holes in the webs at the bearing areas. The excessive corrosion in these areas is attributed to the debris accumulation that has occurred in the past. It is recommended that these areas be cleaned during future inspections to prevent accelerated corrosion due to trapped moisture.

The underside of the timber deck was in fair condition. It is recommended that the deck be monitored for decay and rot.

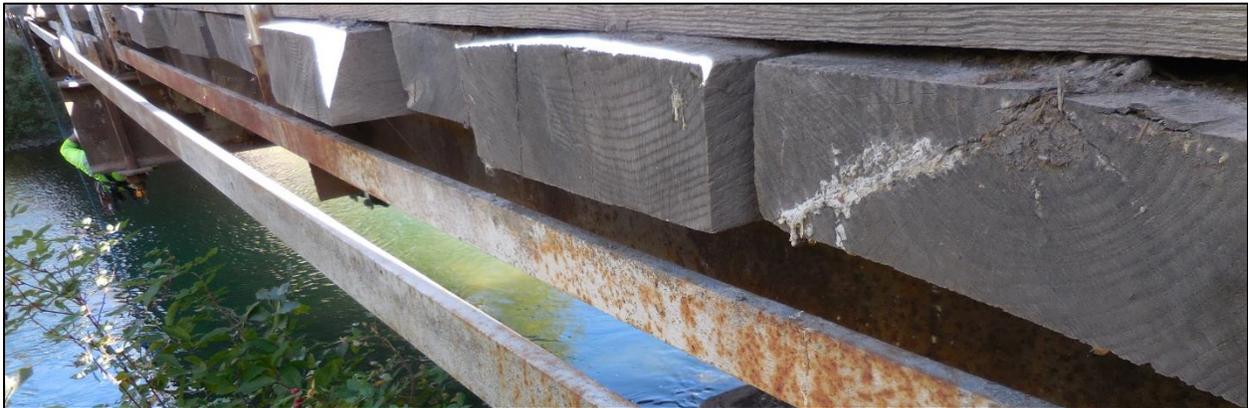
The lower chords were comprised of two eyebars linked together at the truss panel points. The lower chords had a sound painted coating on approximately 35 percent of the surface area. Approximately 30 percent of the lower chord surface area had areas of paint deterioration with freckle corrosion. Approximately 20 percent of the surface area had a failed painted coating with moderate surface corrosion and negligible section loss. The remaining areas of the lower chord had pitting up to 1/16 in. deep at the truss connection points and up to 1/18 in. deep at the bearing connections. The eyebars at the bearing connections had rust scale up to 1/4 in. thick. The bearings and lower chord ends were buried by debris that had fallen from the deck and through the sidewalk.

The lower chord was found to be in fair to poor condition. It is recommended that the paint deterioration and areas of corrosion be monitored during future inspections. The areas of heavier corrosion that was noted on the lower chord connections at the bearing can be attributed to the debris accumulation that has occurred in the past. It is recommended that the bearing areas and the ends of the lower chord be cleaned during future inspections to prevent accelerated corrosion due to trapped moisture.

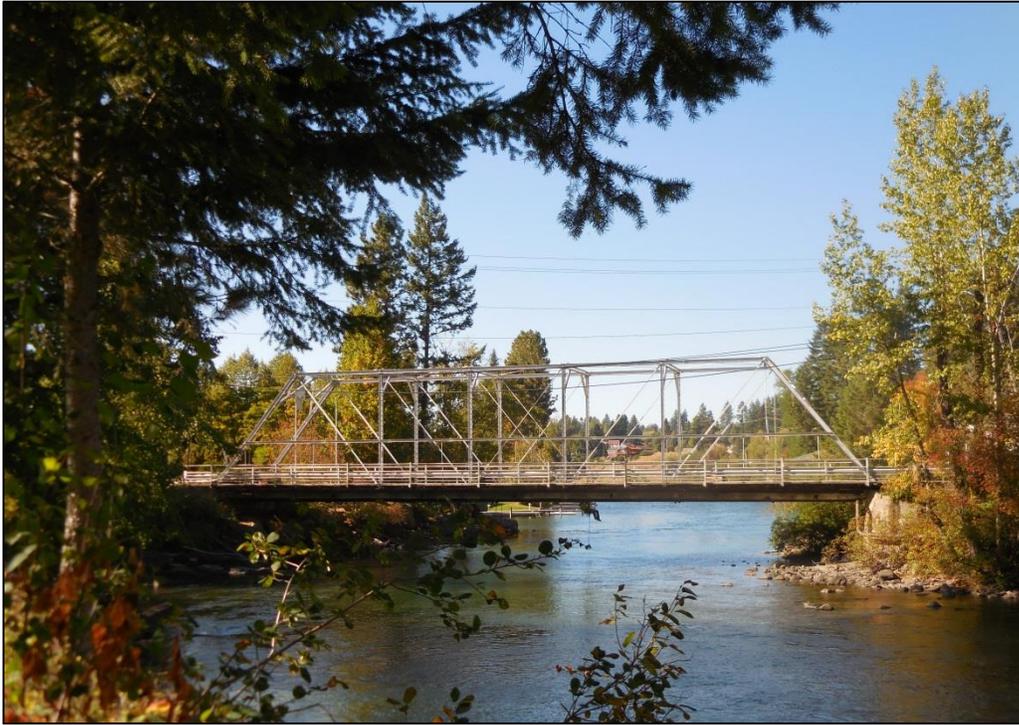
**Photo 1** : South Elevation looking north at bridge

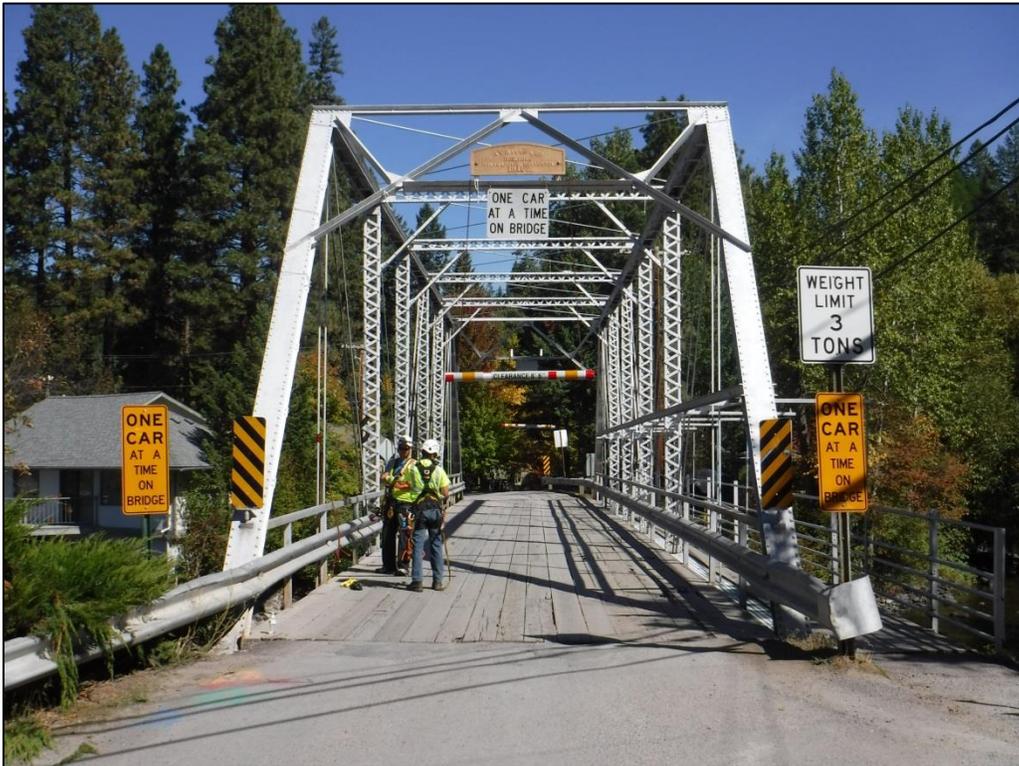
**Photo 2**: West Portal

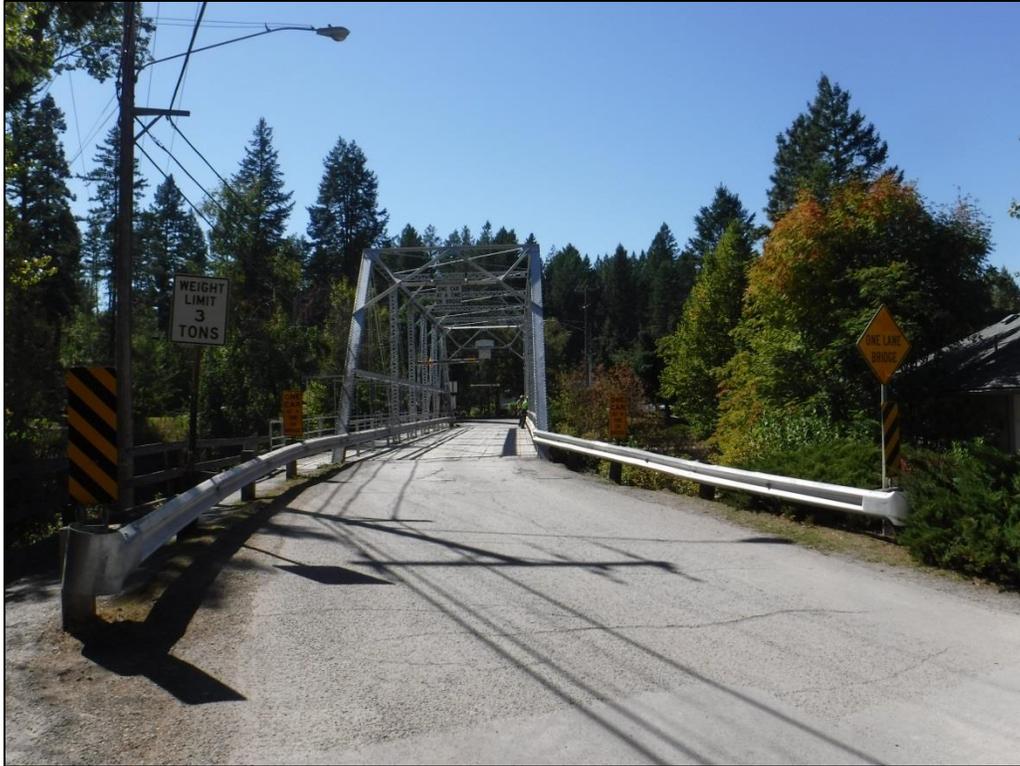
**Photo 3:** East Portal

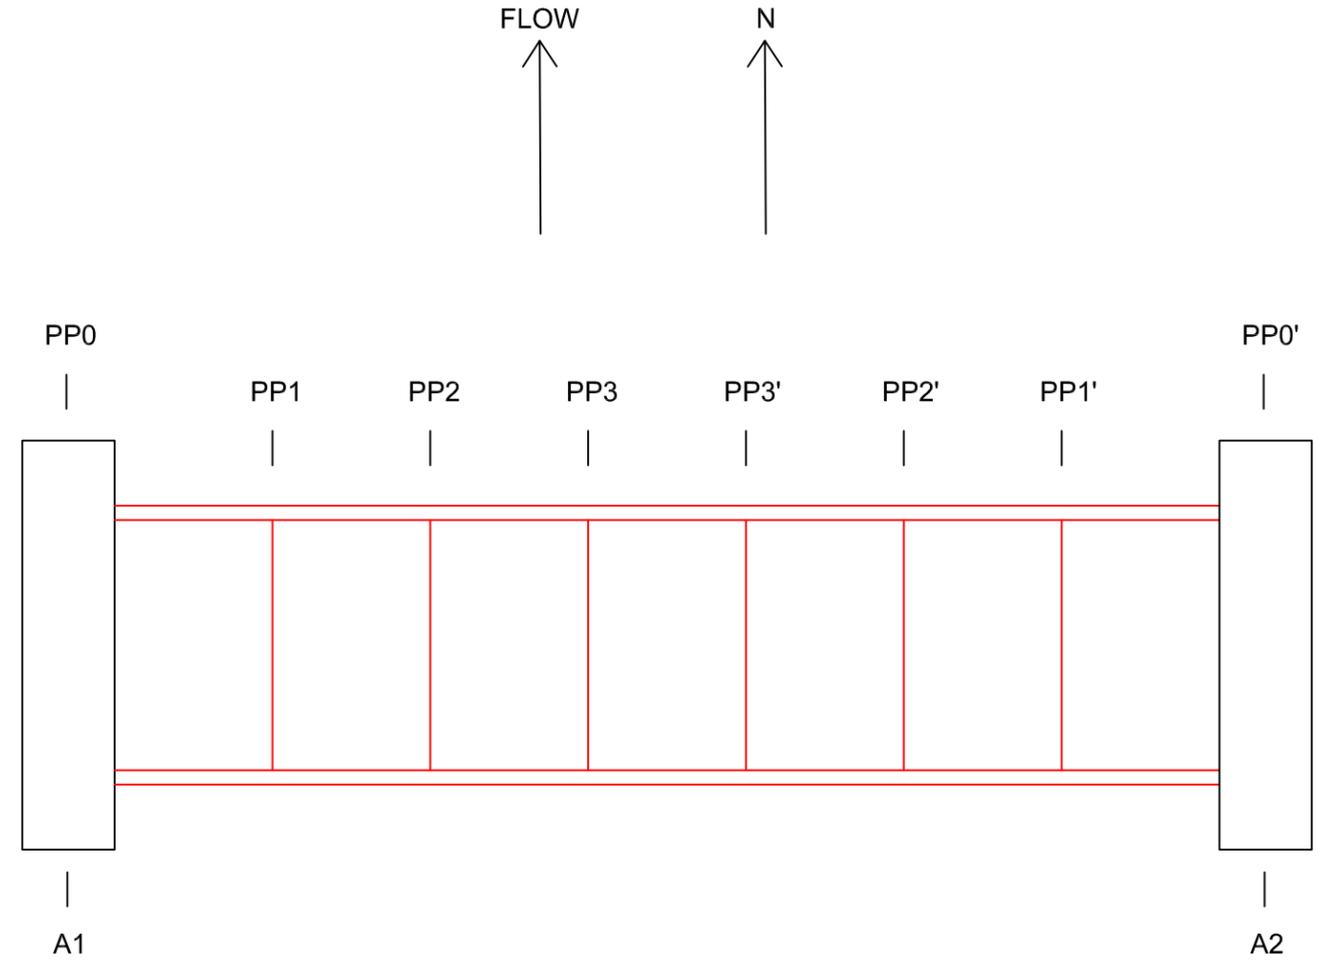
FLOOR PLAN VIEW

The following drawing shows the members that were considered fracture critical during inspection. Fracture critical inspection requires visual inspection from no further away than arm's length, which was achieved via rope access methods. During this inspection, only the floor beams were inspected no further than arm's length.

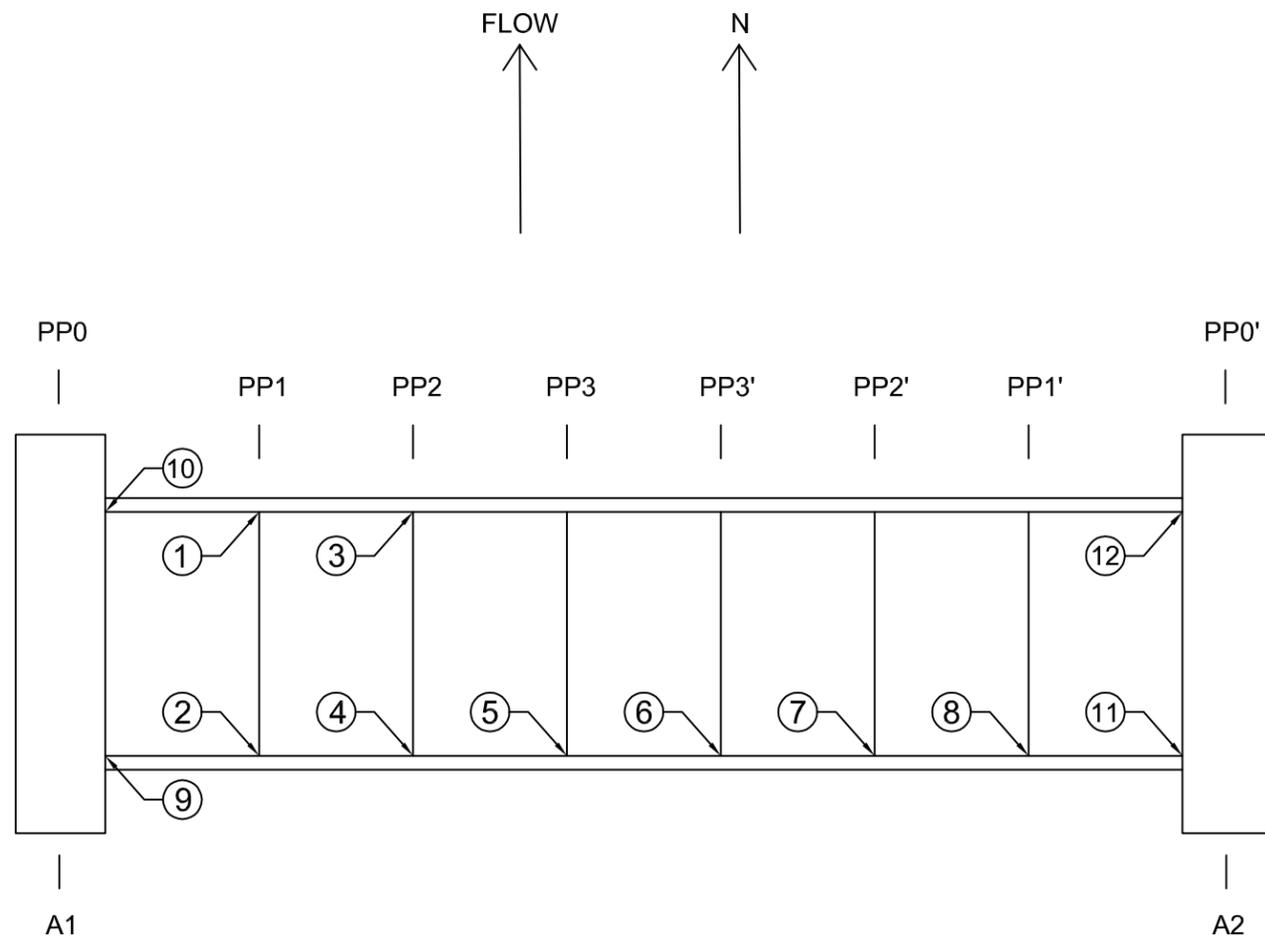
FLOOR PLAN VIEW

6. FLOOR BEAM 3': 1/8 IN. DEEP SECTION LOSS ON END 3 FT. OF THE BEAM. SECTION LOSS WAS 1 IN. HIGH AT THE WEB TO BOTTOM FLANGE INTERFACE ON BOTH FACES. A 1/2 IN. DIAMETER HOLE WAS NOTED IN THE WEB OF THE FLOOR BEAM 1 IN. ABOVE THE BOTTOM FLANGE AND APPROXIMATELY 3 FT. FROM THE END OF THE FLOOR BEAM.

11. STRINGER 1 AT ABUTMENT 2: END OF THE STRINGER HAD A 14 IN. LONG BY 3 IN. HIGH HOLE IN THE STRINGER WEB ADJACENT TO THE BOTTOM FLANGE LOCATED AT THE END OF THE STRINGER.

12. STRINGER 8 AT ABUTMENT 2: END OF THE STRINGER HAD A 6 IN. LONG BY 3 IN. HIGH HOLE IN THE STRINGER WEB ADJACENT TO THE BOTTOM FLANGE LOCATED AT THE END OF THE STRINGER.
