# Appendix 1

## Field Review Memorandum and Photo Log

**Subject: Summary of Field Review Conducted on January 31, 2012  
MT 16 / MT 200 Glendive to Fairview Corridor Planning Study**

**MT 16 / MT 200 GLENDIVE TO FAIRVIEW  
CORRIDOR PLANNING STUDY  
PHOTO LOG**

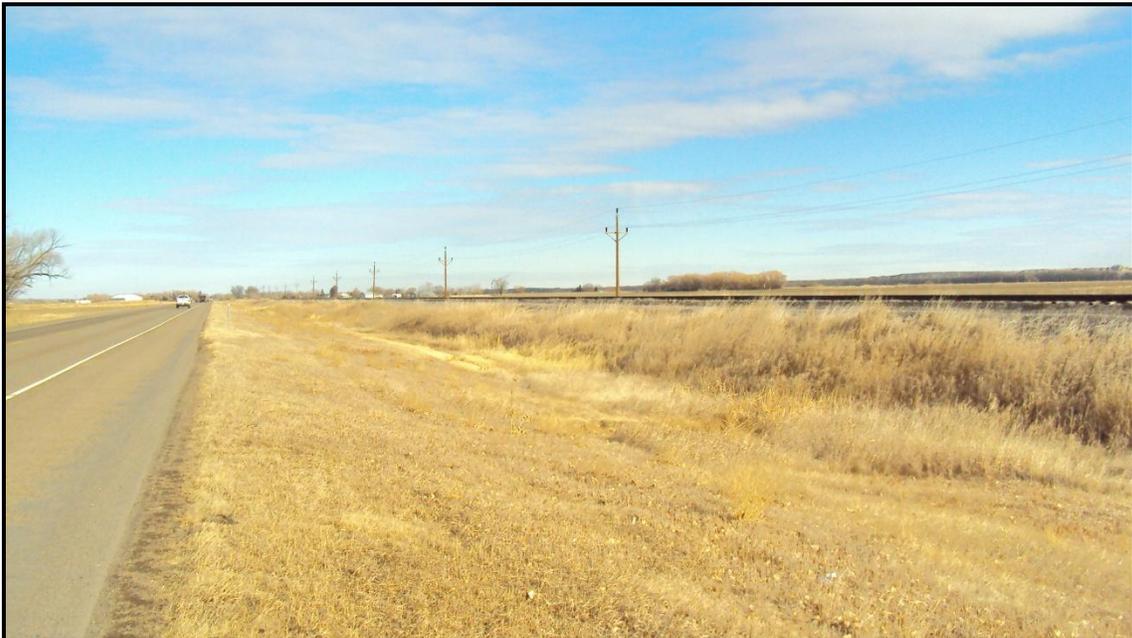
- Railway paralleling MT 16 at RP 45.0. Photo 58.
- Damaged guardrail at RP 46.7. Photo 60.

**Photo 58.** Looking north at railway paralleling MT 16. RP 45.0.

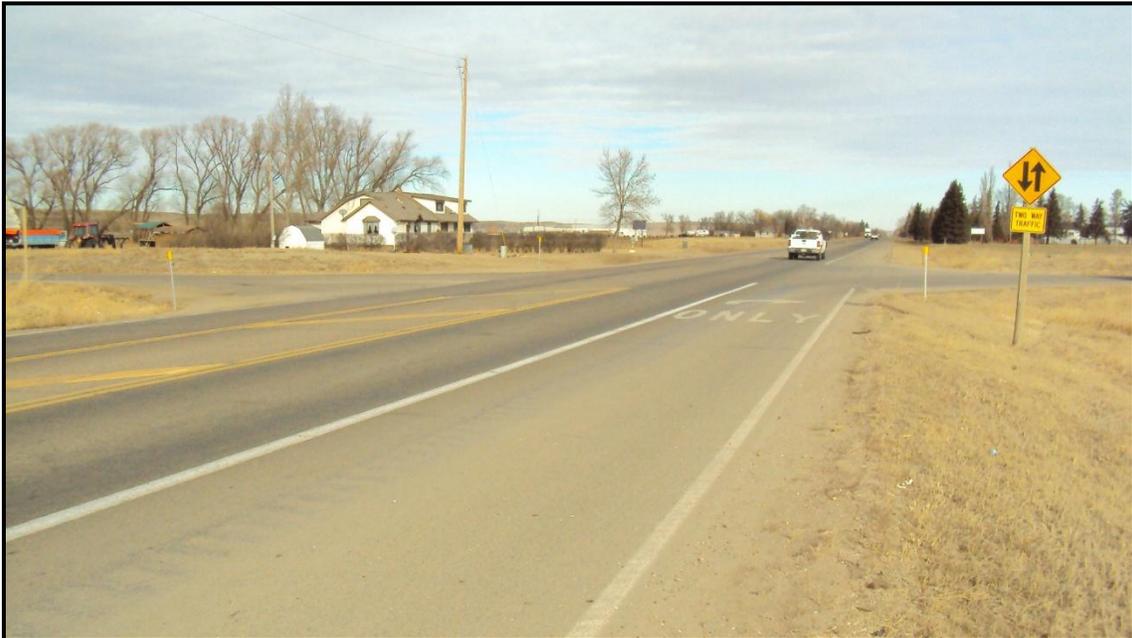
- Return to two-lane configuration and northbound right-turn lane at RP 53.6. Photo 64.

**Photo 64.** Looking north on MT 200 (north of Sidney) at return of two-lane section. RP 53.6.
