# STRUCTURE INSPECTION REPORT

Structure # 03719  
BITTERROOT RIVER 010 - W MISSOULA

## Bridge Inspection Date: 08/08/2017

Bridge No. L32101000+01001  
Missoula, Montana  
Condition Evaluation Report:  
Routine and Fracture Critical Inspection  
Inspection Date: August 8 and 10, 2017

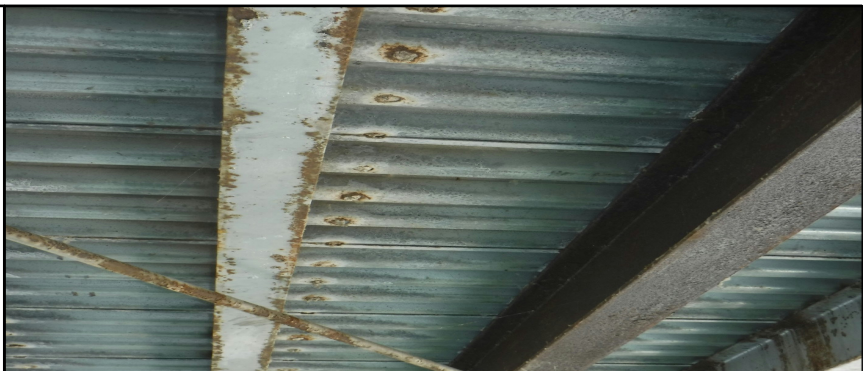
Photo #: Stay-in-Place Form Corrosion

Approximately 1 percent of the corrugated stay-in-place forms had welding burn through with minor surface corrosion and negligible section loss.  
Approximately 5 percent of the corrugated stay-in-place forms had welding burn through allowing debris to fall through the formwork.

Comments: Typical corrugated stay-in-place forms with weld burn through and minor surface corrosion.

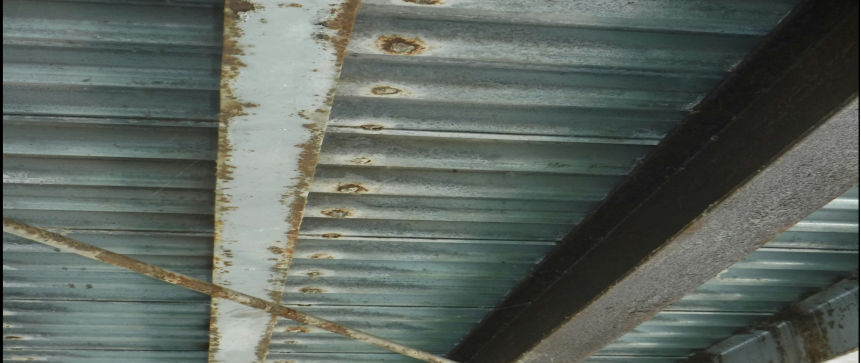
Element #	Parent Element	Name	Unit	Quantity	%CS 1	%CS 2	%CS 3	%CS 4
<p>Photo #: Stay-in-Place Form Corrosion</p> <p>Location:</p> <p>Comments: Typical corrugated stay-in-place forms with weld burn through and minor surface corrosion.</p> <p>Element: 30 - Steel Corrugated or Orthotropic Deck (SF) Pony Truss</p>

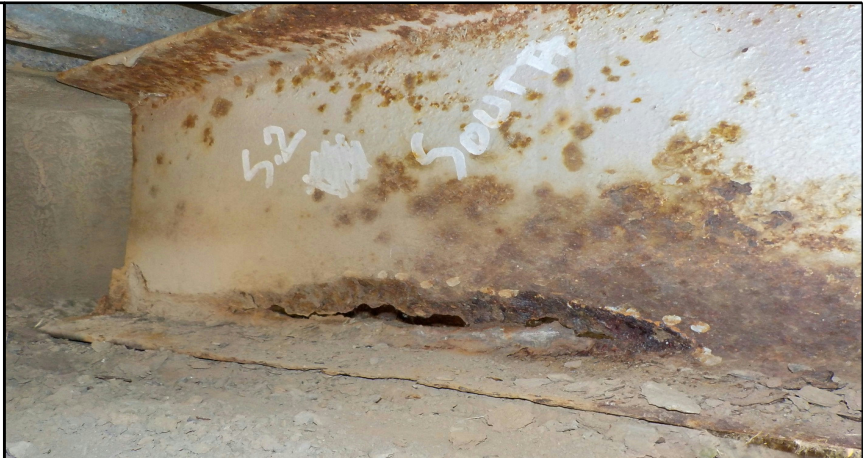
Photo #:Stringer 2 over Abutment 1  
Corrosion

Stringers 2, 5, and 7 over Abutment 1 heavy corrosion over the end 2 ft. with areas of through corrosion. See 2017 FC Inspection Report for table of defects.

Comments: The stringer web had heavy corrosion and section loss over a 17 in. long by 2 in. high area with a 1 in. diameter hole center 10 in. from the stringer end.

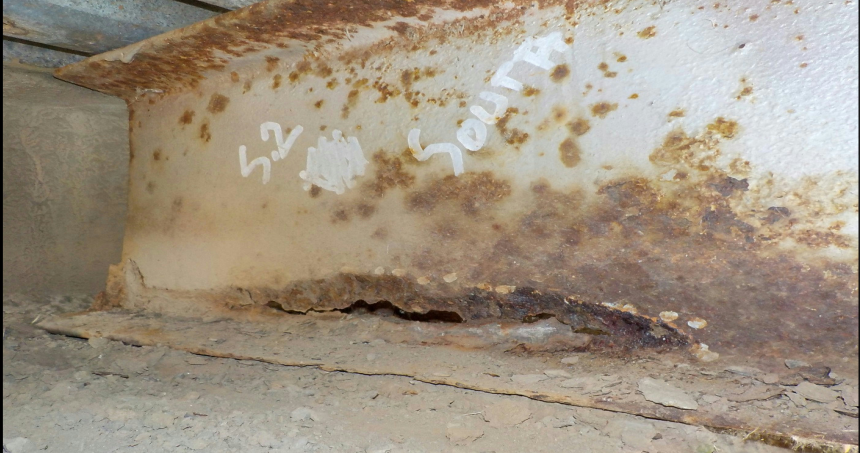
Element #	Parent Element	Name	Unit	Quantity	%CS 1	%CS 2	%CS 3	%CS 4
<p>Photo #:Stringer 2 over Abutment 1 Corrosion</p> <p>Location: Stringer 2 over Abutment 1</p> <p>Comments: The stringer web had heavy corrosion and section loss over a 17 in. long by 2 in. high area with a 1 in. diameter hole center 10 in. from the stringer end.</p> <p>Element:113 - Steel Stringer (LF) Pony Truss</p>

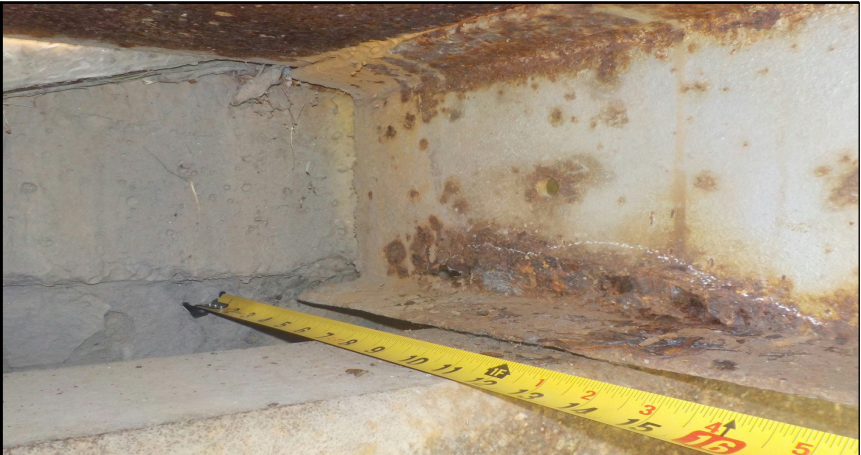
<p>Photo #:Stringer 7 over Bent 3 Corrosion</p> <p>Location: Stringer 7 over Bent 3</p> <p>Comments: The stringer web had heavy corrosion with up to 50 percent section loss over a 6 in. long by 2 in. high adjacent to the stringer end that had a 1/2 in. diameter hole 6 in. from the stringer end at the web to lower flange interface.</p> <p>Element:113 - Steel Stringer (LF) Pony Truss</p>

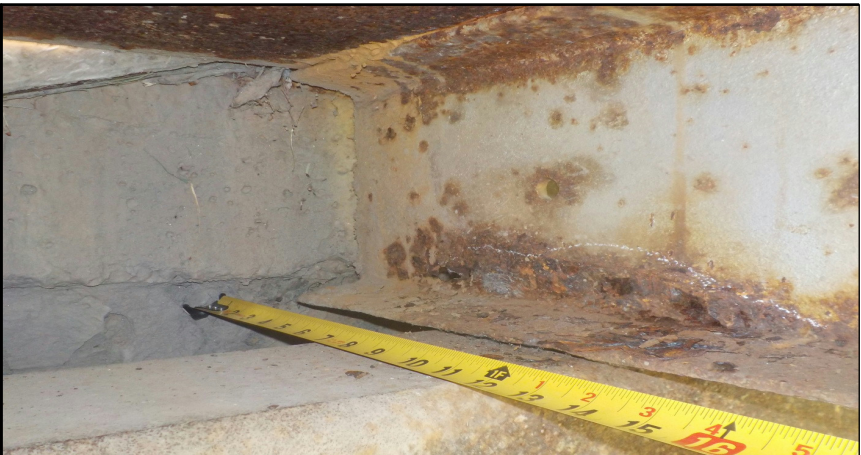
<p>Photo #:Stringer 7 over Bent 3 Corrosion</p> <p>Location: Stringer 7 over Bent 3</p> <p>Comments: The stringer web had heavy corrosion with up to 50 percent section loss over a 6 in. long by 2 in. high adjacent to the stringer end that had a 1/2 in. diameter hole 6 in. from the stringer end at the web to lower flange interface.</p> <p>Element:113 - Steel Stringer (LF) Thru-Truss</p>

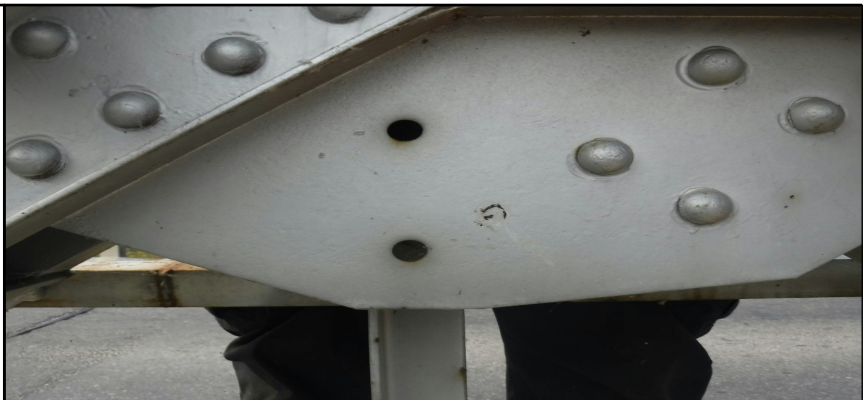
Photo #:Span 2, North Truss, Gusset Plate U1' Missing Rivet

The north truss had three members with minor impact damage on L2'-U2', L2'-U1', L0'-U1'.  
The truss members had minor to moderate surface corrosion throughout.  
Span 2, North Truss, Gusset Plate U1': the exterior gusset plate had two misdrilled 3/4 in. diameter holes.

Comments: The exterior gusset plate had two misdrilled 3/4 in. diameter holes.

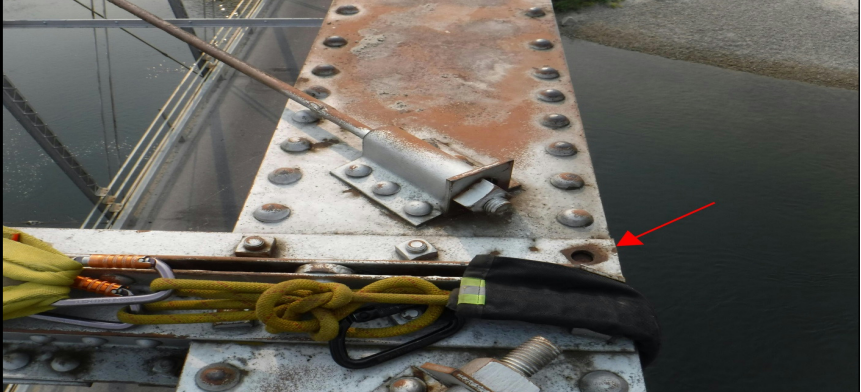
Element #	Parent Element	Name	Unit	Quantity	%CS 1	%CS 2	%CS 3	%CS 4
<p>Photo #:Span 1, South Truss, Top Chord at U4 Sheared Bolt</p> <p>Location: Span 1, South Truss, Top Chord at U4.</p> <p>Comments: One bolt was sheared off on the horizontal brace to top chord connection plate.</p> <p>Element:120 - Steel Truss (LF) Thru-Truss</p>

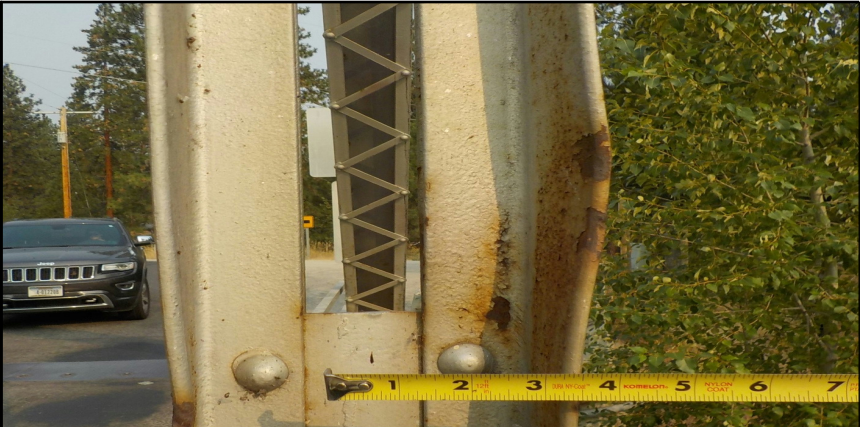
Span 1, North Truss, Vertical L1-U1: the exterior flange of the vertical was bent 1 in. to the north due to impact damage approximately 5 ft. above the bridge deck.  
The truss members had minor to moderate surface corrosion throughout.  
Span 1, South Truss, Top Chord at U4: one bolt was sheared off on the horizontal brace to top chord connection plate.

<p>Photo #:Span 1, North Truss, Vertical L1-U1 Impact</p> <p>Location: Span 1, North Truss, Vertical L1-U1.</p> <p>Comments: The exterior flange of the vertical was bent 1 in. to the north due to impact damage approximately 5 ft. above the bridge deck.</p> <p>Element:120 - Steel Truss (LF) Thru-Truss</p>

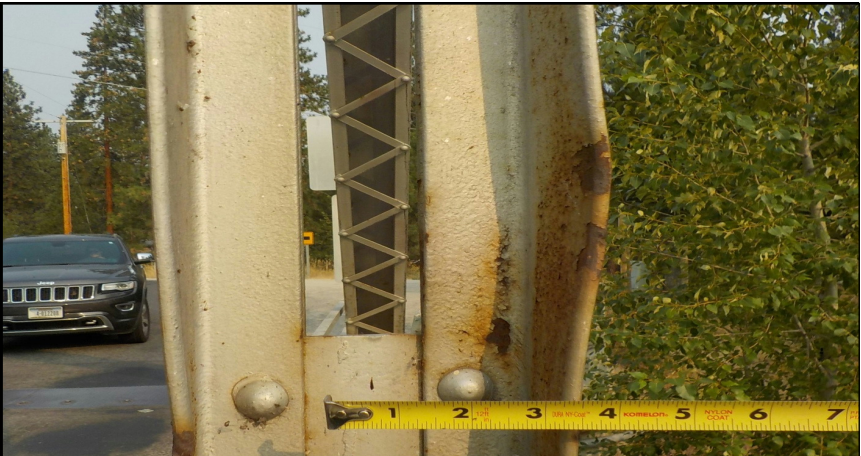
<p>Photo #:Span 1, North Truss, Vertical L1-U1 Impact</p> <p>Location: Span 1, North Truss, Vertical L1-U1.</p> <p>Comments: The exterior flange of the vertical was bent 1 in. to the north due to impact damage approximately 5 ft. above the bridge deck.</p> <p>Element:120 - Steel Truss (LF) Pony Truss</p>

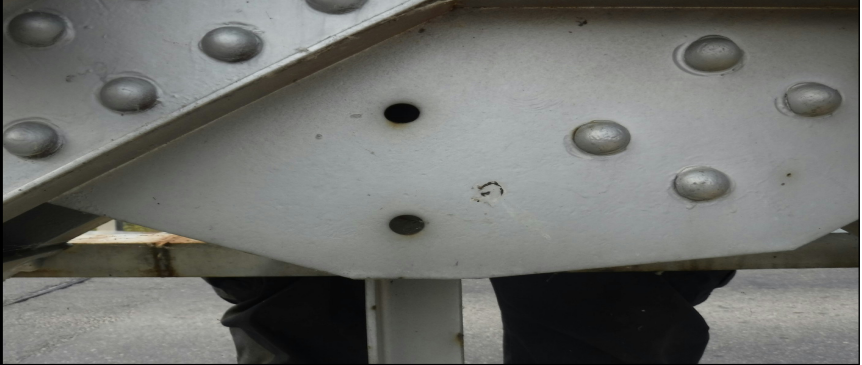
Element #	Parent Element	Name	Unit	Quantity	%CS 1	%CS 2	%CS 3	%CS 4
<p>Photo #:Span 2, North Truss, Gusset Plate U1' Missing Rivet</p> <p>Location: Span 2, North Truss, Gusset Plate U1'.</p> <p>Comments: The exterior gusset plate had two misdrilled 3/4 in. diameter holes.</p> <p>Element:120 - Steel Truss (LF) Thru-Truss</p>

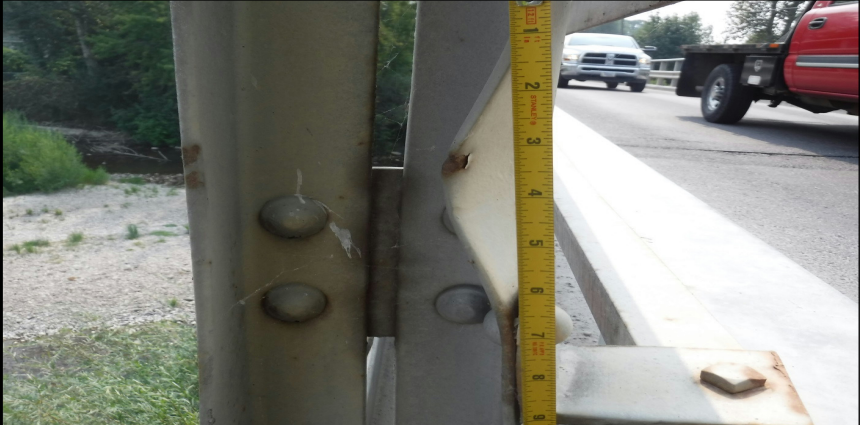
<p>Photo #:Span 2, North Truss, Vertical L2'-U2' Impact</p> <p>Location: Span 2, North Truss, Vertical L2'-U2'.</p> <p>Comments: The interior flange of the vertical was bent 1 in. over a 6 in. length due to impact damage.</p> <p>Element:120 - Steel Truss (LF) Pony Truss</p>

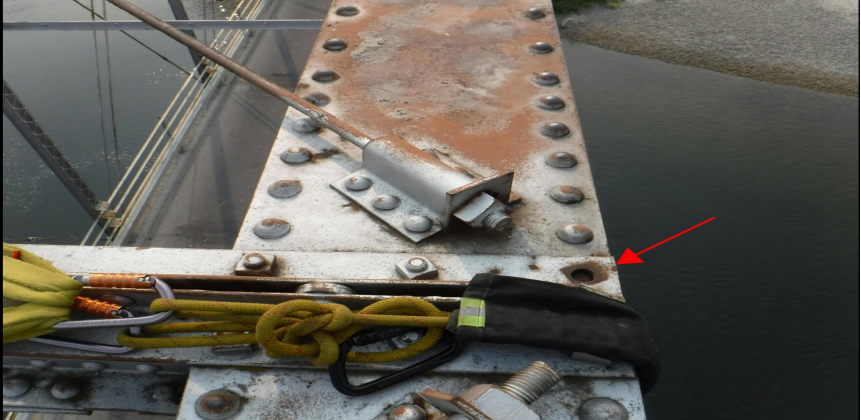
Element #	Parent Element	Name	Unit	Quantity	%CS 1	%CS 2	%CS 3	%CS 4
<p>Photo #:Span 1, South Truss, Top Chord at U4 Sheared Bolt</p> <p>Location: Span 1, South Truss, Top Chord at U4.</p> <p>Comments: One bolt was sheared off on the horizontal brace to top chord connection plate.</p> <p>Element:120 - Steel Truss (LF) Pony Truss</p>

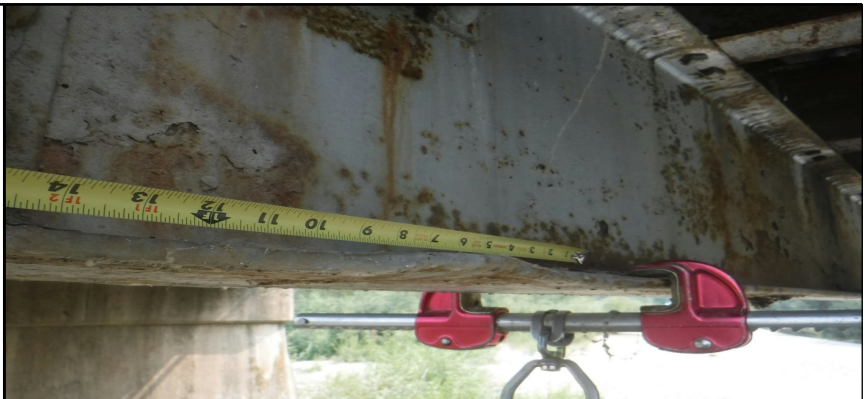
Comments: The flange had bent upwards 1/2 in. over a 6 in. length approximately 16 in. from the north end.

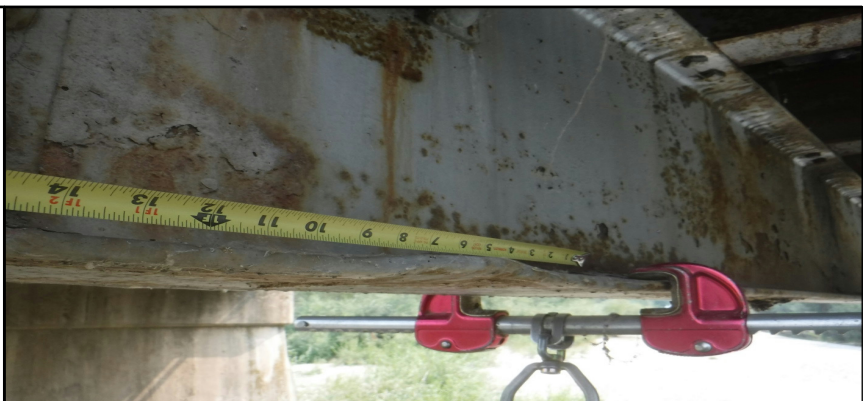
Photo #:Floor Beam 1' on Span 1 Impact

Location: The bottom west flange of Floor Beam 1' on Span 1.

Comments: The flange had bent upwards 1/2 in. over a 6 in. length approximately 16 in. from the north end.

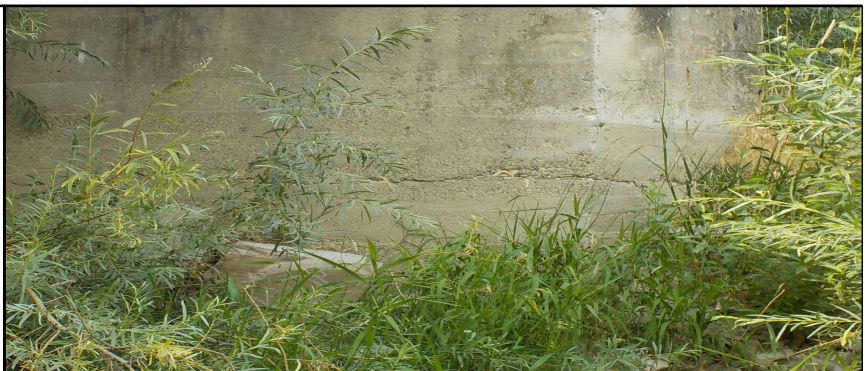
Photo #: Bent 3 Cracking

A 5 ft. long horizontal crack up to 1/16 in. wide was located near the bottom, northeast corner.

Comments: A 5 ft. long horizontal crack up to 1/16 in. wide was located near the bottom, northeast corner.

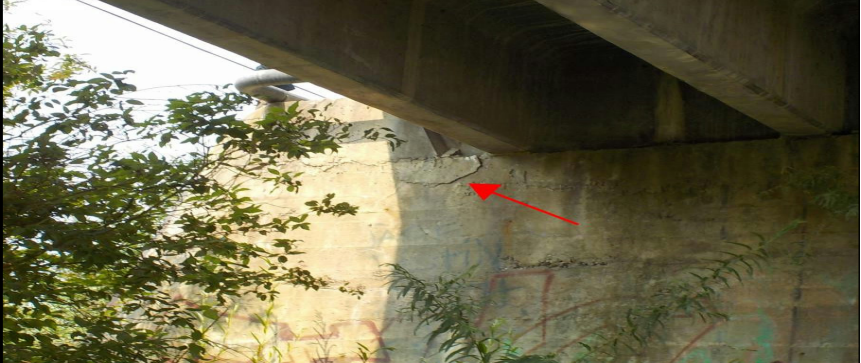
Element #	Parent Element	Name	Unit	Quantity	%CS 1	%CS 2	%CS 3	%CS 4
<p>Photo #:Bent 3 Delamination</p> <p>Location:</p> <p>Comments: Bent 3 had a 12 in. wide by 10 in. high area of delamination on the top, southeast corner of the bent.</p> <p>Element:210 - Reinforced Concrete Pier Wall (LF) Bent 3</p>

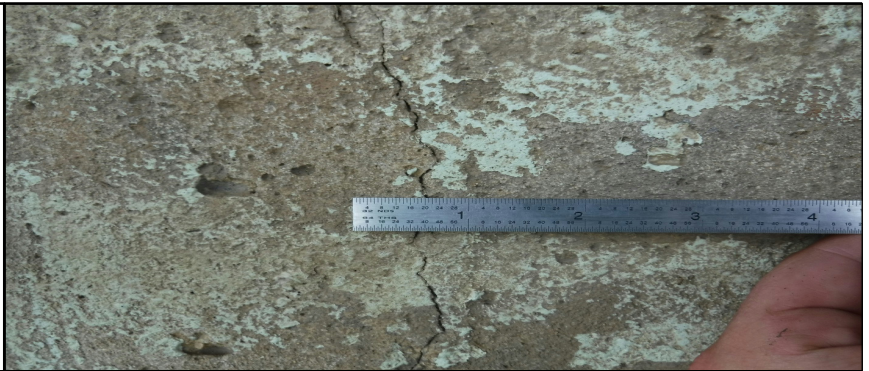
Photo #: Abutment 1 Cracking

Abutment 1 had one full height, vertical crack up to 1/8 in. wide in the middle of the abutment.

Comments: Abutment 1 had one full height, vertical crack up to 1/8 in. wide in the middle of the abutment.

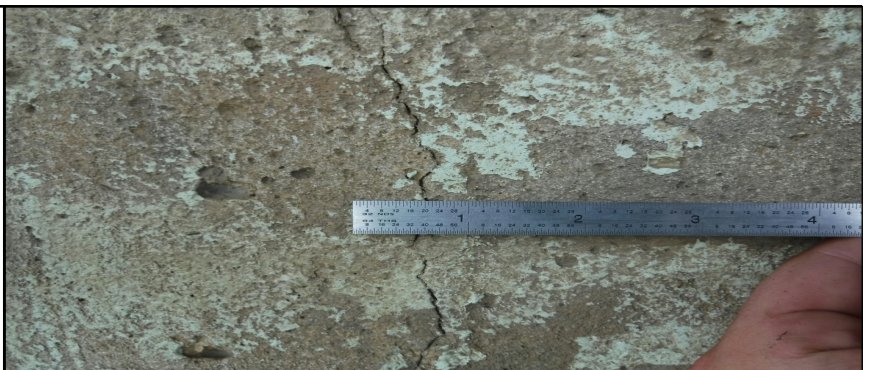
Photo #: Abutment 1 Cracking

Comments: Abutment 1 had one full height, vertical crack up to 1/8 in. wide in the middle of the abutment.

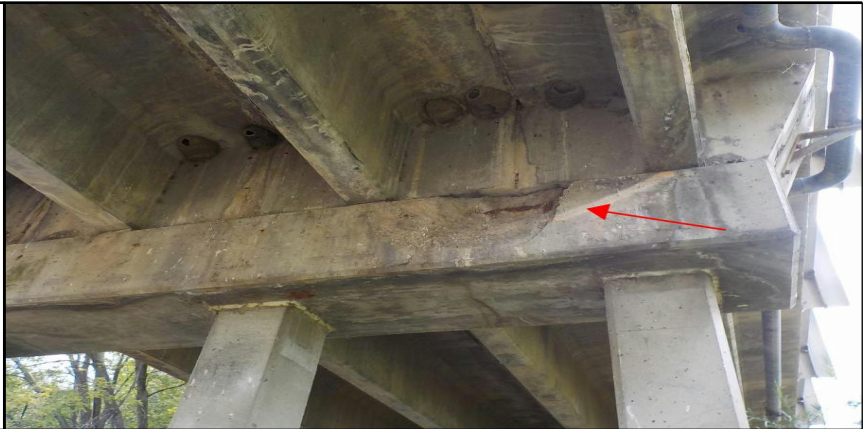
Photo #:Bent 3 Spall

The exposed reinforcing steel in the spall had moderate corrosion with negligible section loss. Bent 4 had a 3 ft. wide by 2 ft. high spall with exposed reinforcing steel on the west face of the bent cap.

Comments: Bent 4 had a 3 ft. wide by 2 ft. high spall with exposed reinforcing steel on the west face of the bent cap. The exposed reinforcing steel had moderate corrosion with negligible section loss.

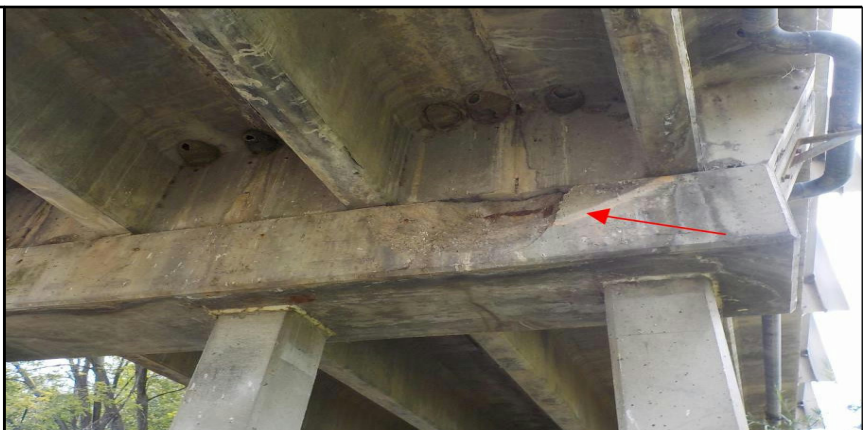
Photo #:Bent 3 Spall

Comments: Bent 4 had a 3 ft. wide by 2 ft. high spall with exposed reinforcing steel on the west face of the bent cap. The exposed reinforcing steel had moderate corrosion with negligible section loss.

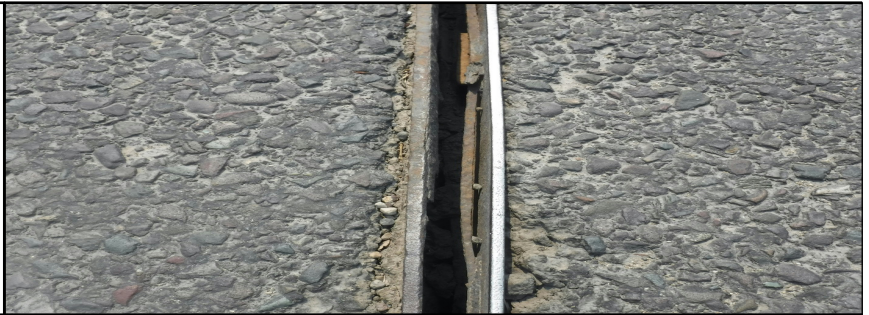
Photo #:Joint 3 over Bent 3 Failed Seal

The joint had separated from the Span 2 deck up to 3/4 in. over a 4 ft. length.  
The joint had a 1/2 in. bend over a 6 in. length in the south wheel path.  
The rubber seal had failed over 90 percent of its length.

Comments: The rubber seal had failed over 90 percent of its length.

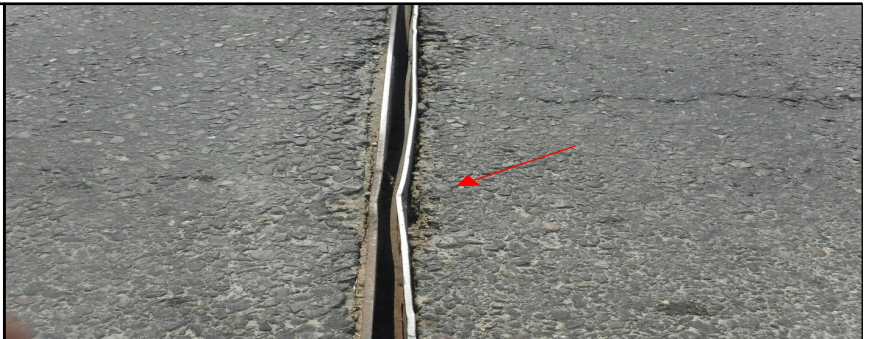
Photo #:Joint over Bent 3

Location: Joint 3 over Bent 3

Comments: The joint had separated from the Span 2 deck up to 3/4 in. over a 4 ft. length.

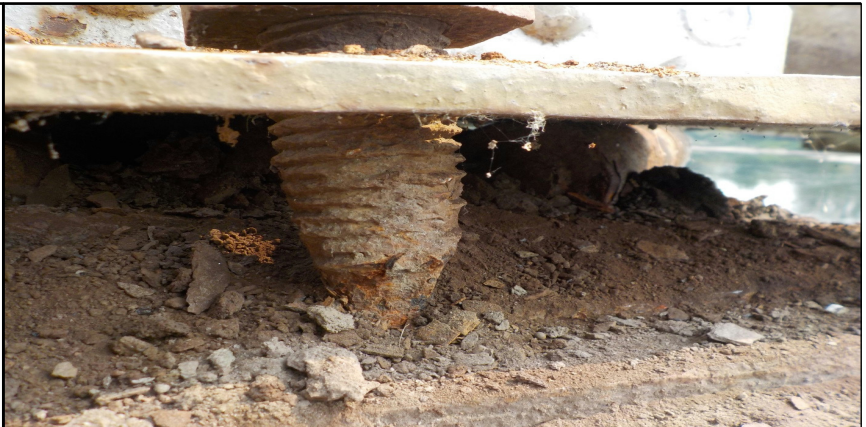
Comments: Heavy corrosion with up to 25 percent section loss to the anchor rods on the North Truss, Abutment 1 movable bearing.

Repair Suggestions:					
Repair ID	Date Requested	Type	Status	Priority	Comments
#Error	10-17-2017	Repair suggestion	Open	High	Both movable bearings on Abutment 1 need to be replaced.
#Error	11-09-2017	Repair suggestion	Open	Low	Patch potholes in asphalt wearing surface.
#Error	11-09-2017	Repair suggestion	Open	Low	Replace joint seal above Bent 3
#Error	11-09-2017	Repair suggestion	Open	Low	Repair spalls with exposed steel reinforcement on curbs and bents.
#Error	11-09-2017	Repair suggestion	Open	High	Shim stringer ends on Span 2 Bent 3 to prevent vertical movement.

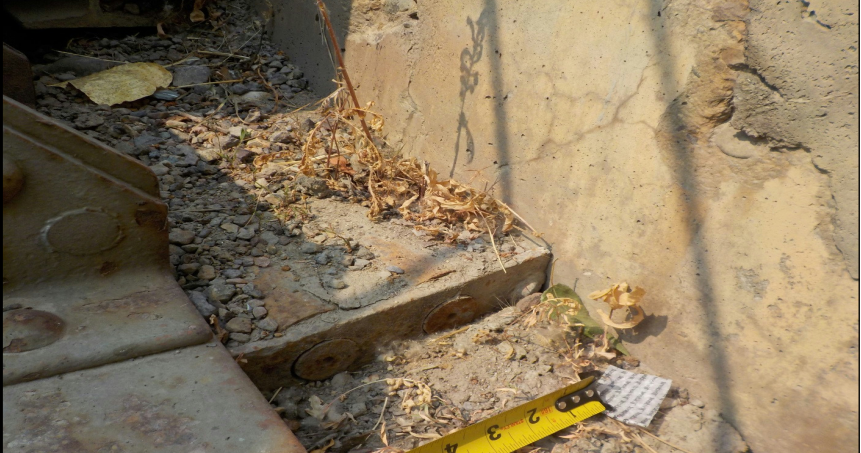
Element #	Parent Element	Name	Unit	Quantity	%CS 1	%CS 2	%CS 3	%CS 4
<p>Photo #: Abutment 1, South Truss Roller Bearing</p> <p>Location: Abutment 1, South Truss</p> <p>Comments: Three rollers on the South Truss, Abutment 1 bearing which had been displaced from underneath the bearing due to the roller keeper being severed.</p> <p>Element: 311 - Movable Bearing (roller, sliding, etc.) (EA)</p>

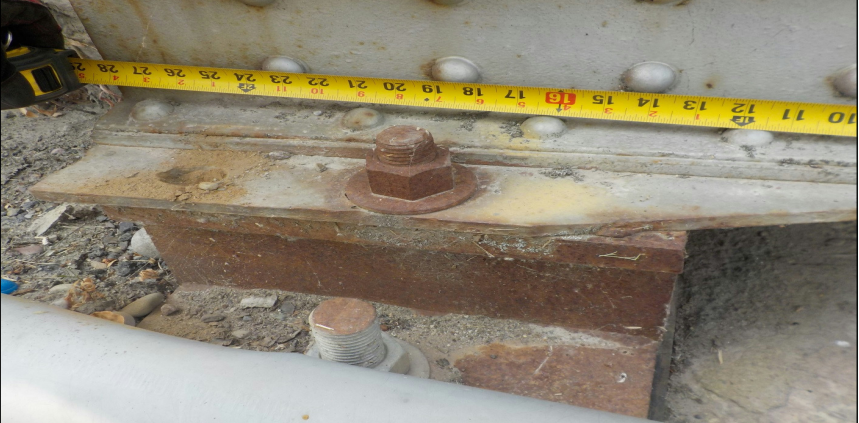
The Bent 3, Span 2 slider bearings were left unpainted and had moderate corrosion with pitting up to 1/16 in. deep.

Element #	Parent Element	Name	Unit	Quantity	%CS 1	%CS 2	%CS 3	%CS 4
<p>Photo #: Bent 3, North Truss, Span 2 slider bearing</p> <p>Location: Bent 3, North Truss, Span 2 slider bearing.</p> <p>Comments: Bent 3, North Truss, Span 2 slider bearing left unpainted with moderate corrosion and pitting up to 1/16 in. deep.</p> <p>Element: 311 - Movable Bearing (roller, sliding, etc.) (EA)</p>

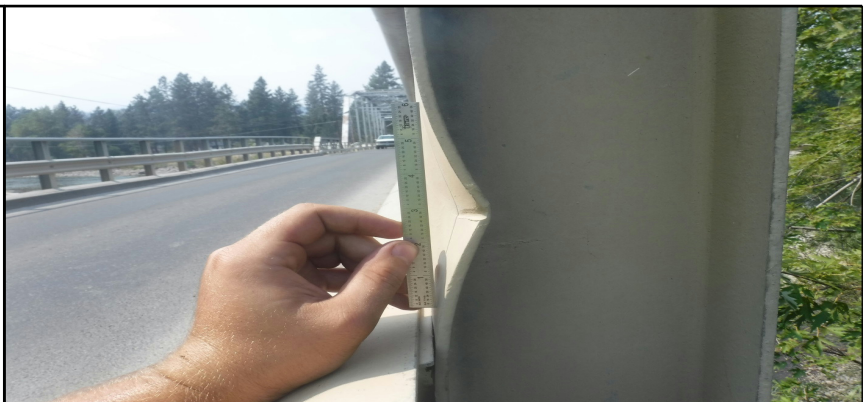
Photo #: Bridge Rail Impact - Photo 2

Comments: Three vertical members had impact damage that bent the interior flange 3/4 in. over a 6 in. length with gouging on the North Rail near the East Approach in Span 4.

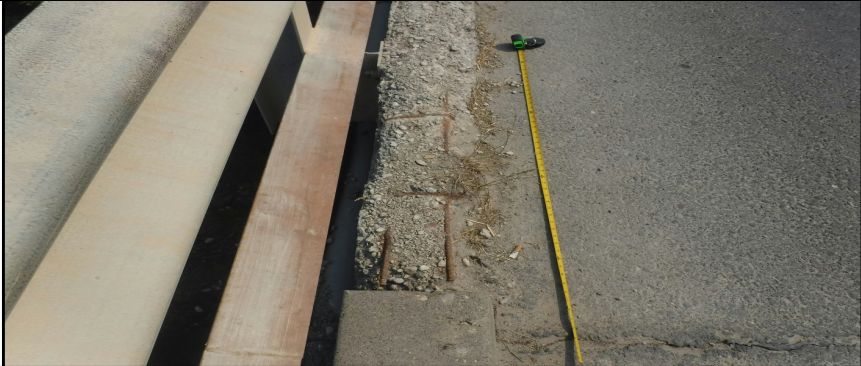
Element #	Parent Element	Name	Unit	Quantity	%CS 1	%CS 2	%CS 3	%CS 4
Photo #:Curb Spalling - Photo 2

Location:								
Comments: The North Curb had section loss up to 5 in. with exposed longitudinal and stirrup reinforcing steel for 4 ft. over Bent 4.								
Element:330 - Steel Bridge Rail (LF)

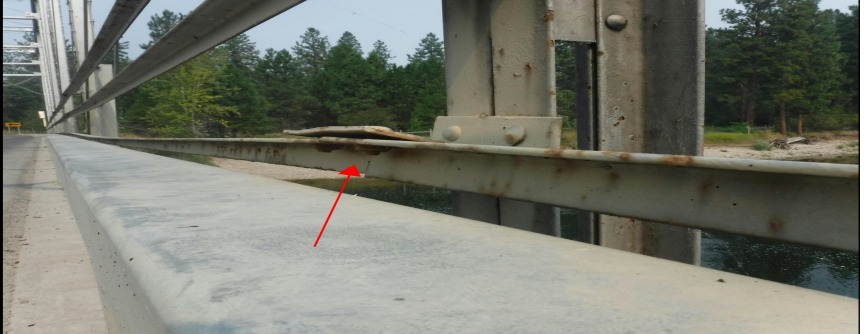
Element #	Parent Element	Name	Unit	Quantity	%CS 1	%CS 2	%CS 3	%CS 4
<p>Photo #:Bridge Rail Impact - Photo 3</p> <p>Location:</p> <p>Comments: The bottom angle on the North Rail at Panel Point 1' was bent 3/4 in. upwards on Span 2.</p> <p>Element:330 - Steel Bridge Rail (LF)</p>

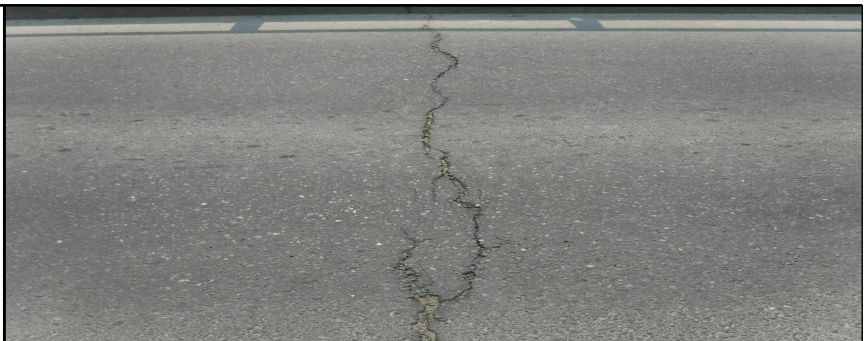
Photo #:Wearing Surface Cracking - Photo 2

Comments: Transverse crack up to 1/2 in. wide over Bent 4.

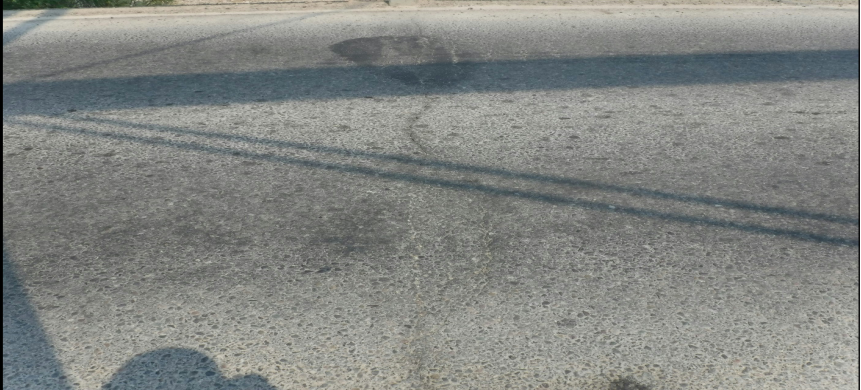
Element #	Parent Element	Name	Unit	Quantity	%CS 1	%CS 2	%CS 3	%CS 4
<p>Photo #:Wearing Surface Cracking - Photo 1</p> <p>Location:</p> <p>Comments: Typical transverse and map cracking up to 1/8 in. wide on Span 1 wearing surface. Note cold patch repair of pothole.</p> <p>Element:510 - Wearing Surfaces (SF)</p>

- The approaches should be monitored during future inspections for additional cracking and cold patch deterioration
- The bituminous overlay should be monitored during future inspections for additional wear, cracking, and potholes; it is recommended the potholes be patched throughout the bridge deck

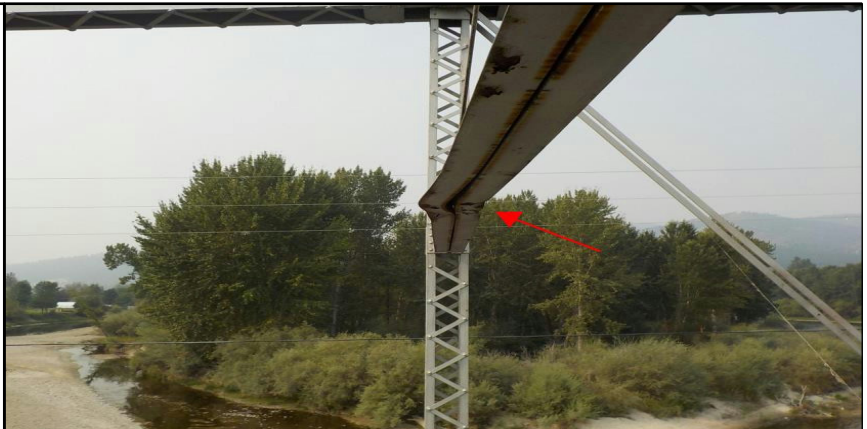
Panel Point 3': the lower, horizontal bracing member was bent 2 in. to the east and upward and downward 1 in. due to impact damage.

Comments: The lower, horizontal bracing member was bent 2 in. to the east and upward and downward 1 in. due to impact damage.

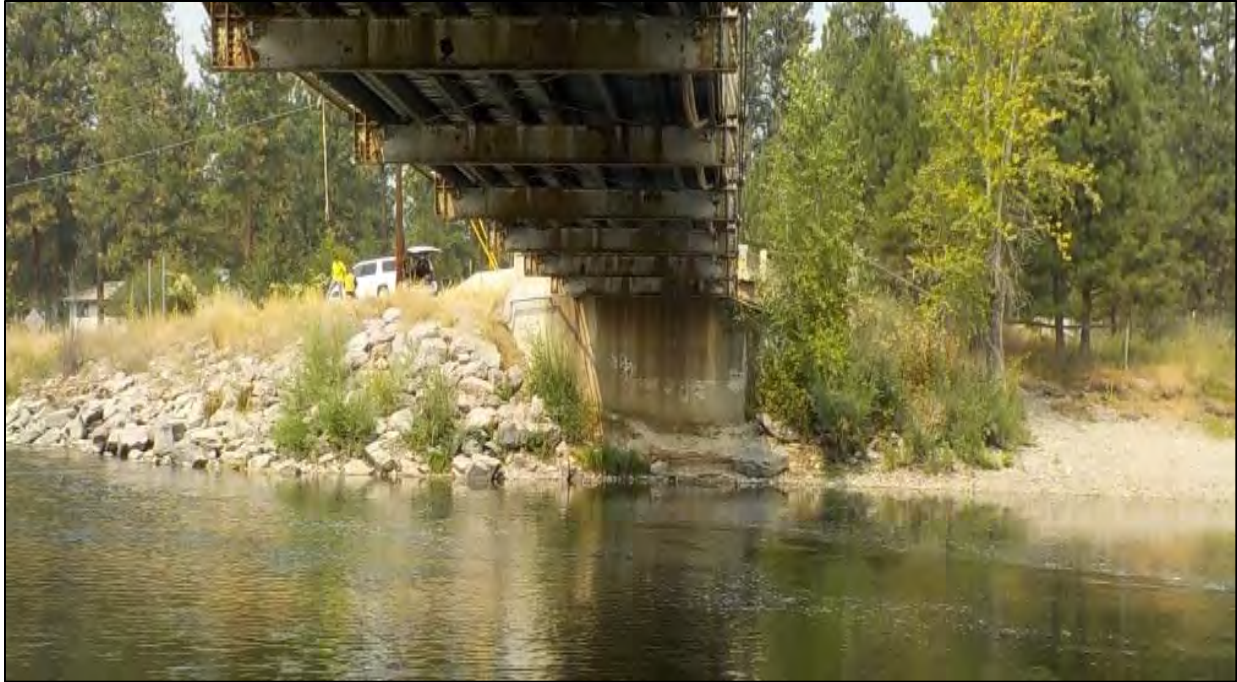
**Photo 13:** Abutment 1 East Elevation looking west

Abutment 1 (**Photo 13**) was constructed of reinforced concrete. The abutment had one full height, vertical crack up to 1/8 in. wide in the middle of the abutment (**Photo 55**). The abutment had rust staining under the truss due to corrosion from the steel members above the abutment.

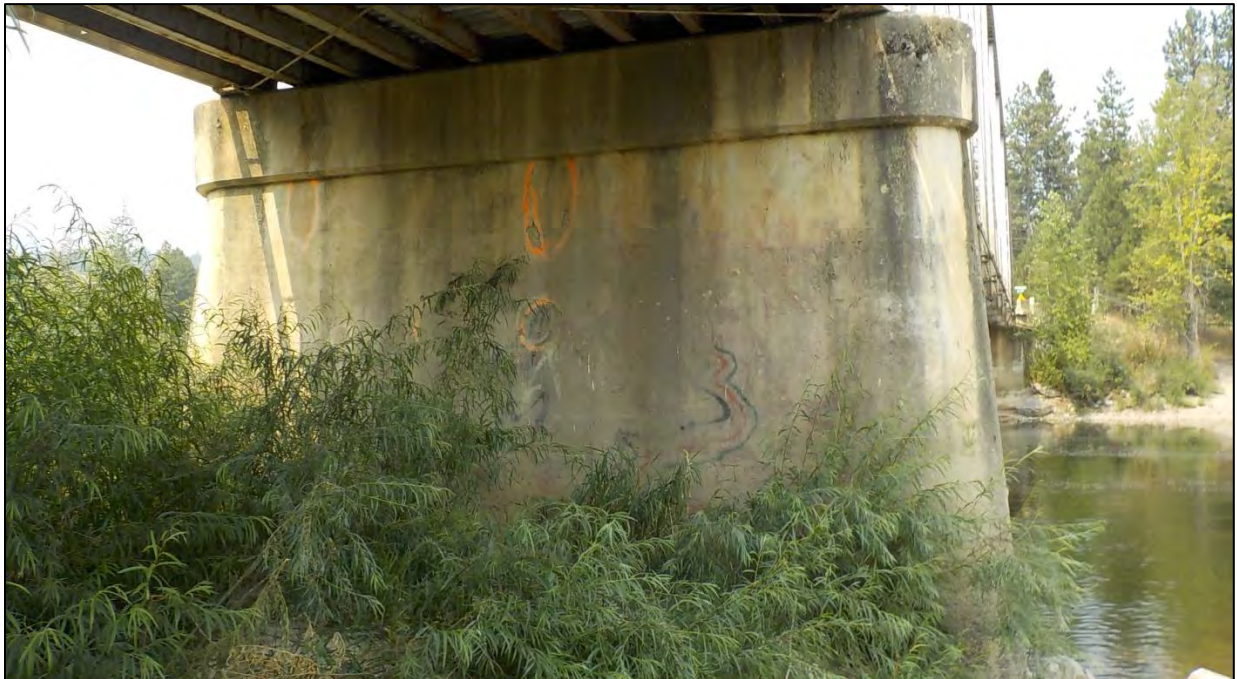
**Photo 14:** Bent 2 East Elevation looking west

Bent 2 (**Photo 14**) had random hairline temperature and shrinkage cracking over its entire surface area. The west elevation had seven areas of delaminations up to 60 in. wide by 12 in. high. The east elevation had five areas of delaminations up to 15 in. wide by 30 in. wide. The edges of the delaminations were spalling with up to 1 in. of penetration and no exposed reinforcing steel (**Photo 56**).

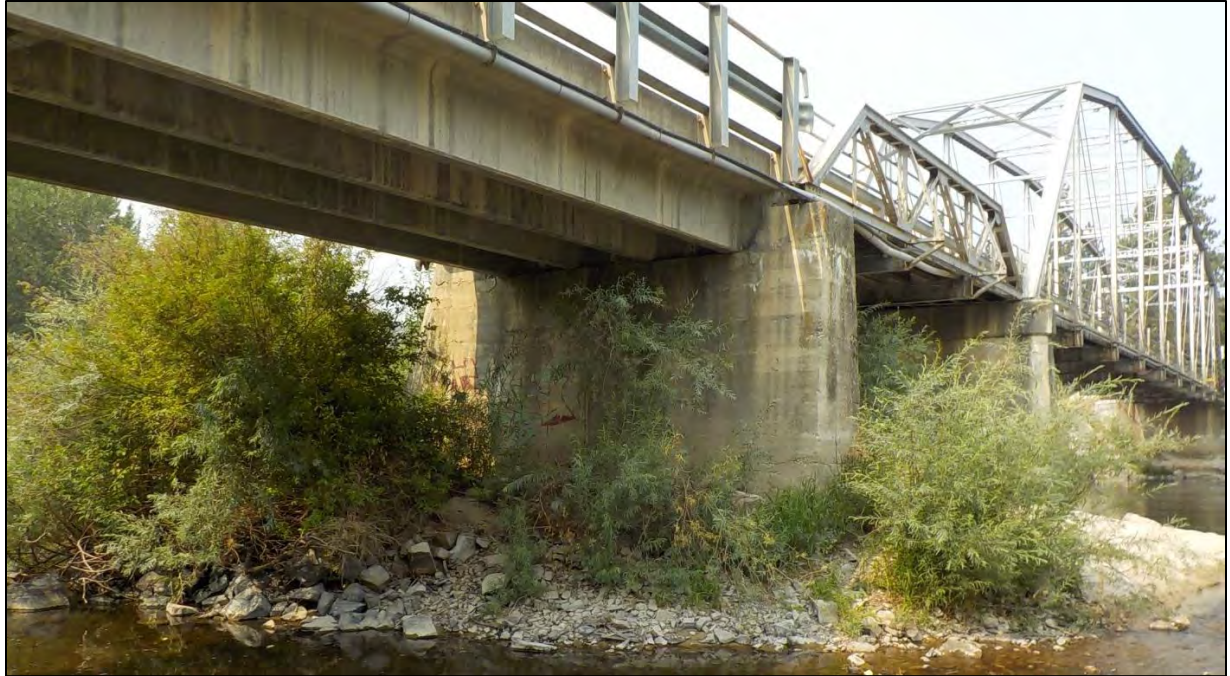
**Photo 15:** Bent 3 East Elevation looking west

Bent 3 (**Photo 15**) had random hairline map cracking throughout its surface area with minor efflorescence build-up in random, isolated areas. The top, southeast corner of the bent had a 12 in. wide by 10 in. high area of delamination (**Photo 57**). A 5 ft. long horizontal crack up to 1/16 in. wide was located near the bottom, northeast corner of the bent (**Photo 58**).

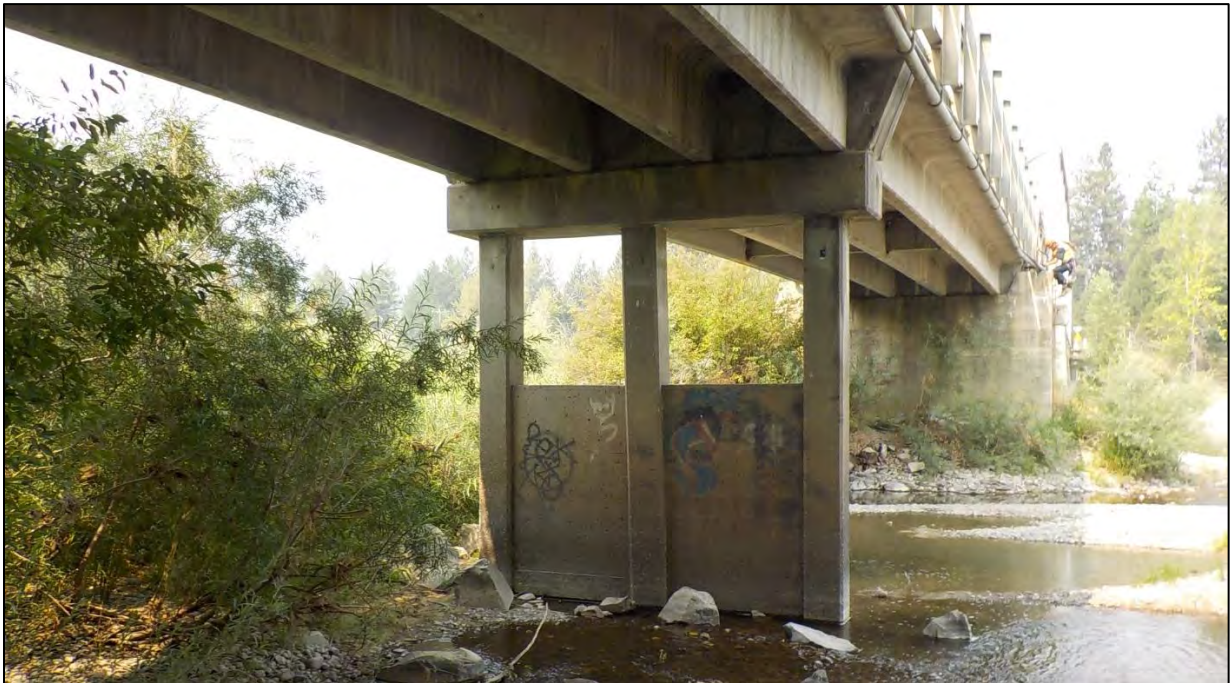
**Photo 16:** Bent 4 East Elevation looking west

Bent 4 (**Photo 16**) had a 3 ft. wide by 2 ft. high spall with exposed reinforcing steel on the west face of the bent cap. The exposed reinforcing steel had moderate corrosion with negligible section loss (**Photo 59**).

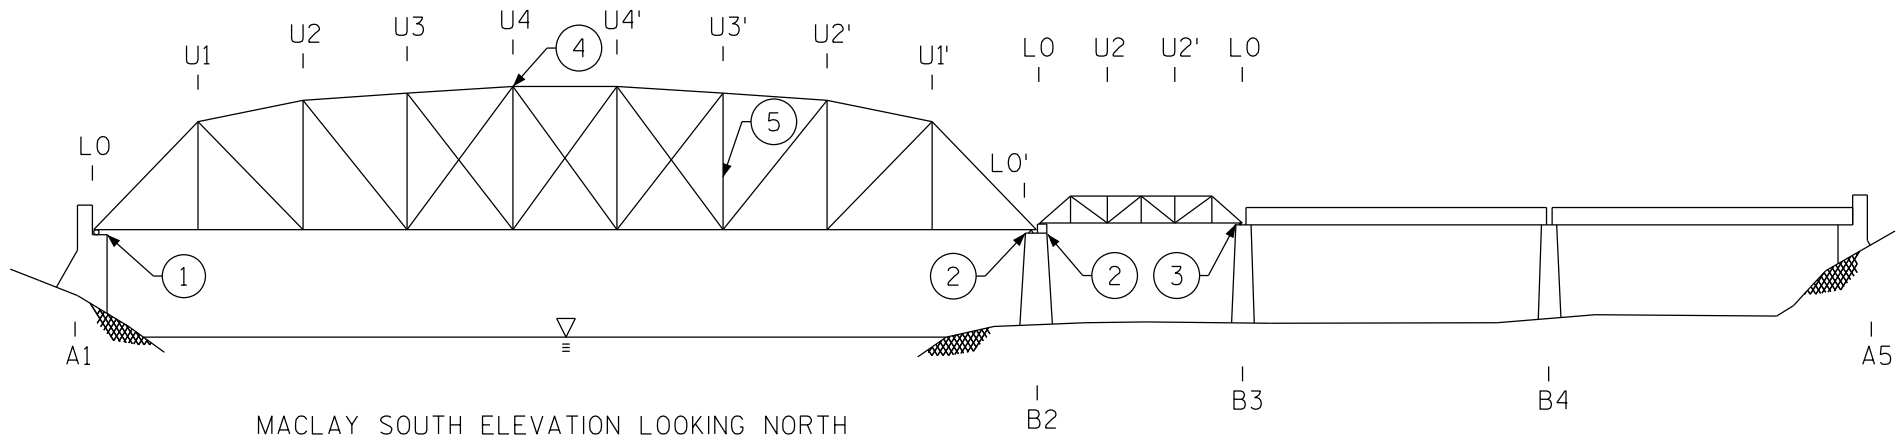
MACLAY NORTH ELEVATION VIEW

- 4. ONE BOLT WAS SHEARED OFF OF THE HORIZONTAL BRACE TO TOP CHORD CONNECTION PLATE.
- 5. THE LOWER, HORIZONTAL BRACING MEMBER WAS BENT 2 IN. TO THE EAST, AND UPWARD AND DOWNWARD 1 IN. DUE TO IMPACT DAMAGE.

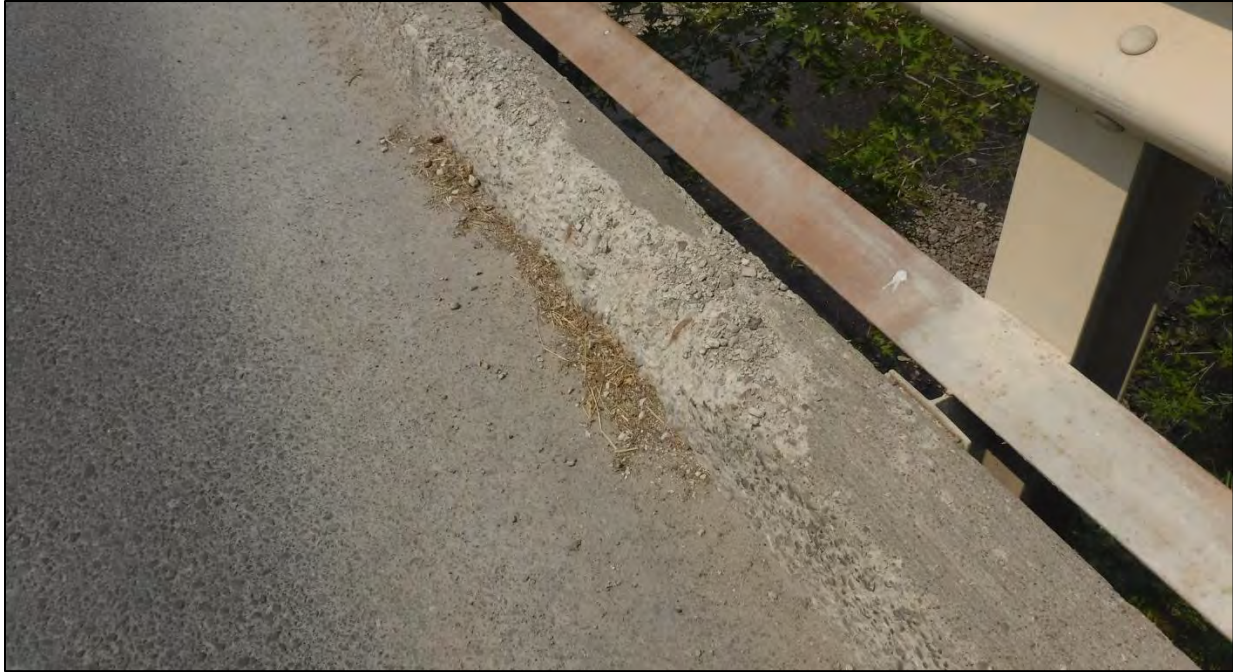
A 5-1/2 in. high by 8 in. wide concrete curb spanned both edges of Spans 3 and 4. The North Curb on Span 4 had section loss up to 1-1/2 in. on the top and interior faces with no exposed reinforcing steel (**Photo 30**). The North Curb had section loss up to 5 in. with exposed longitudinal and stirrup reinforcing steel for 4 ft. over Bent 4 (**Photo 31**).

**Photo 30:** The North Curb on Span 4 had section loss up to 1-1/2 in. on the top and interior faces with no exposed reinforcing steel

- The rail should be monitored during future inspections for corrosion and impact damage
- The areas of spalling with exposed reinforcing steel on the concrete curb should be repaired, and the remainder of the curb should be monitored during future inspections for cracking, spalling, and delaminations

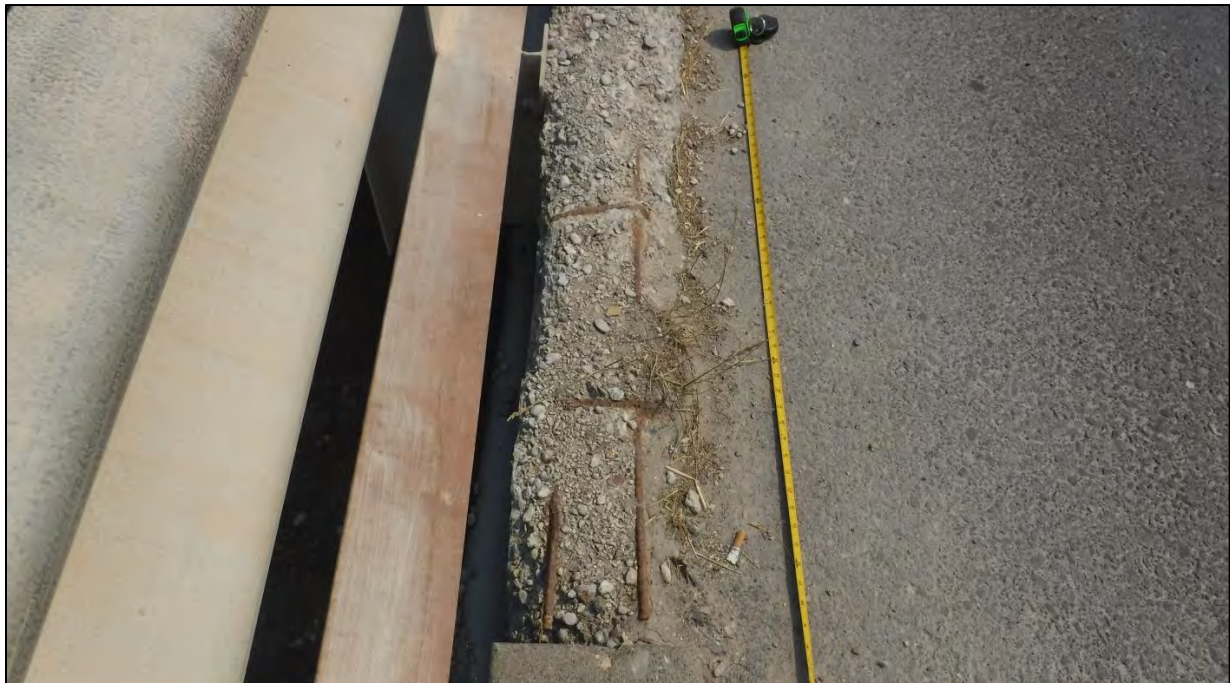
**Photo 31:** The North Curb had section loss up to 5 in. with exposed longitudinal and stirrup reinforcing steel for 4 ft. over Bent 4

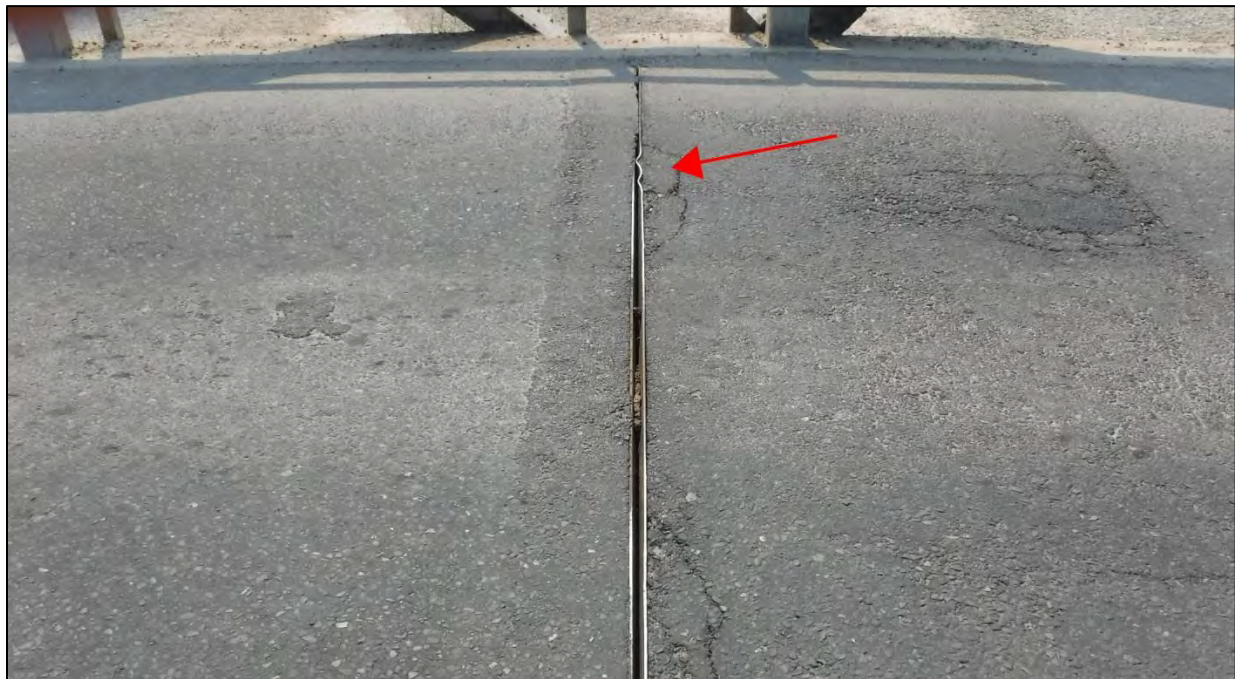
Joint 2 over Bent 2 was an open joint. The joint edge had two 3/4 in. bends over a 1 ft. section in the south wheel path (**Photo 39**). The joint opening measured at 1/2 in. on the South Rail on a 90 degree day.

**Photo 39:** Joint 2 over Bent 2 with area of 3/4 in. bends in the steel plates

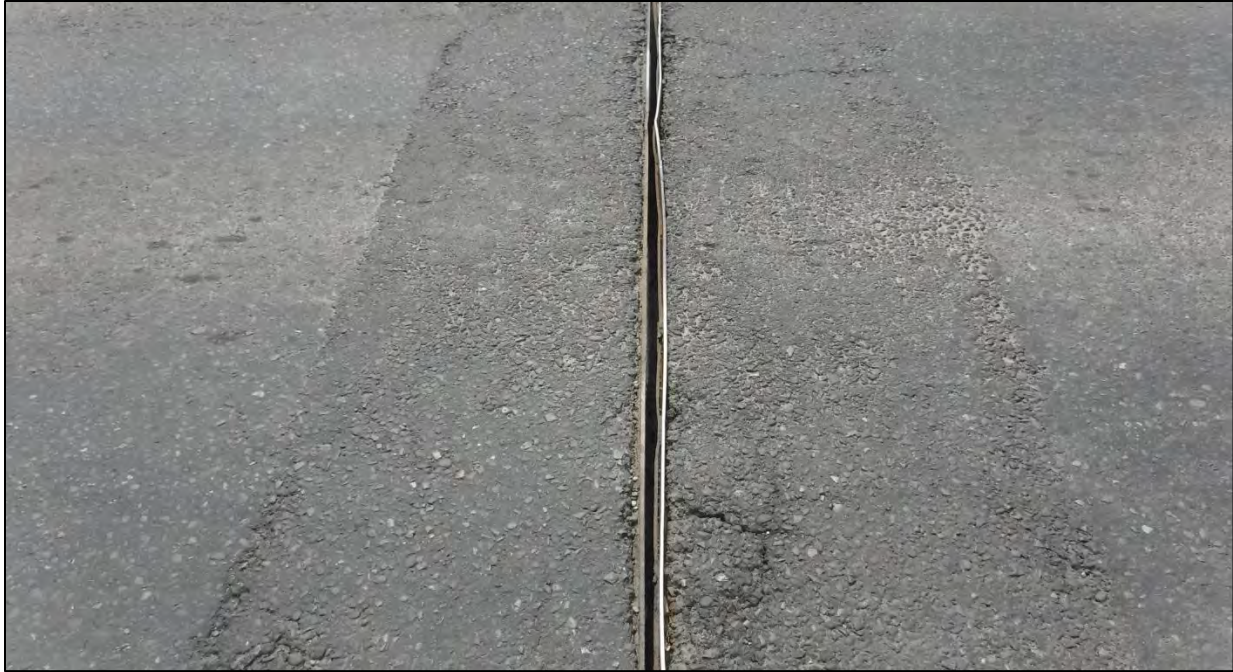
**Photo 40:** Joint 3 over Bent 3

Joint 3 over Bent 3 was a compression joint that was fully compressed on the South Rail on a 90 degree day (**Photo 40**). The rubber seal had failed on 90 percent of its length (**Photo 41**). The joint had separated from the Span 2 header over a 4 ft. length (**Photo 42**). The joint edge had a 1/2 in. bend over a 6 in. length in the south wheel path.
