# STRUCTURE INSPECTION REPORT

Structure # 03719  
BITTERROOT RIVER 010 - W MISSOULA

## Bridge Inspection Date: 08/08/2017

Bridge No. L32101000+01001  
Missoula, Montana  
Condition Evaluation Report:  
Routine and Fracture Critical Inspection  
Inspection Date: August 8 and 10, 2017

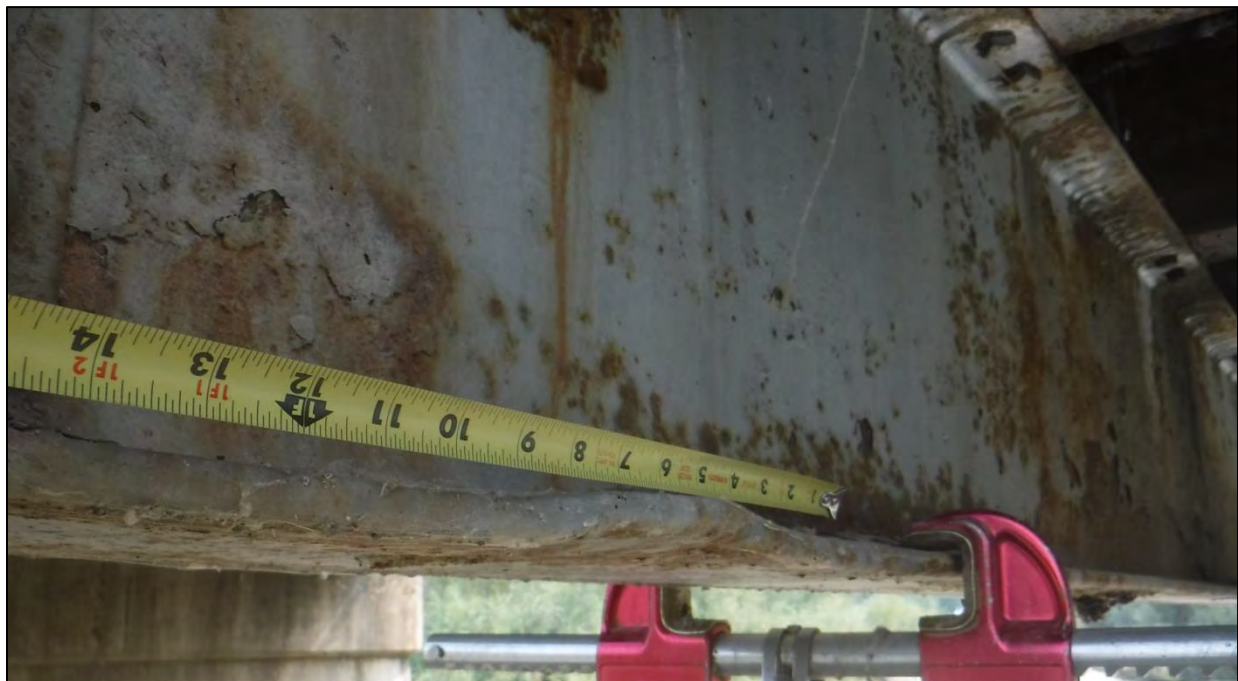
The floor beams were steel rolled beam sections connected to the lower chord by a pinned connection. Approximately 40 percent of the painted coating on the floor beams had failed with minor surface corrosion and negligible section loss, 40 percent had failed with exposed primer underneath, and the remaining painted coating was bubbling and peeling. The bottom west flange of Floor Beam 1' on Span 1 had bent upwards 1/2 in. over a 6 in. length approximately 16 in. from the north end (**Photo 43**).

**Photo 43:** The bottom west flange of Floor Beam 1' on Span 1 had bent upwards 1/2 in. over a 6 in. length approximately 16 in. from the north end

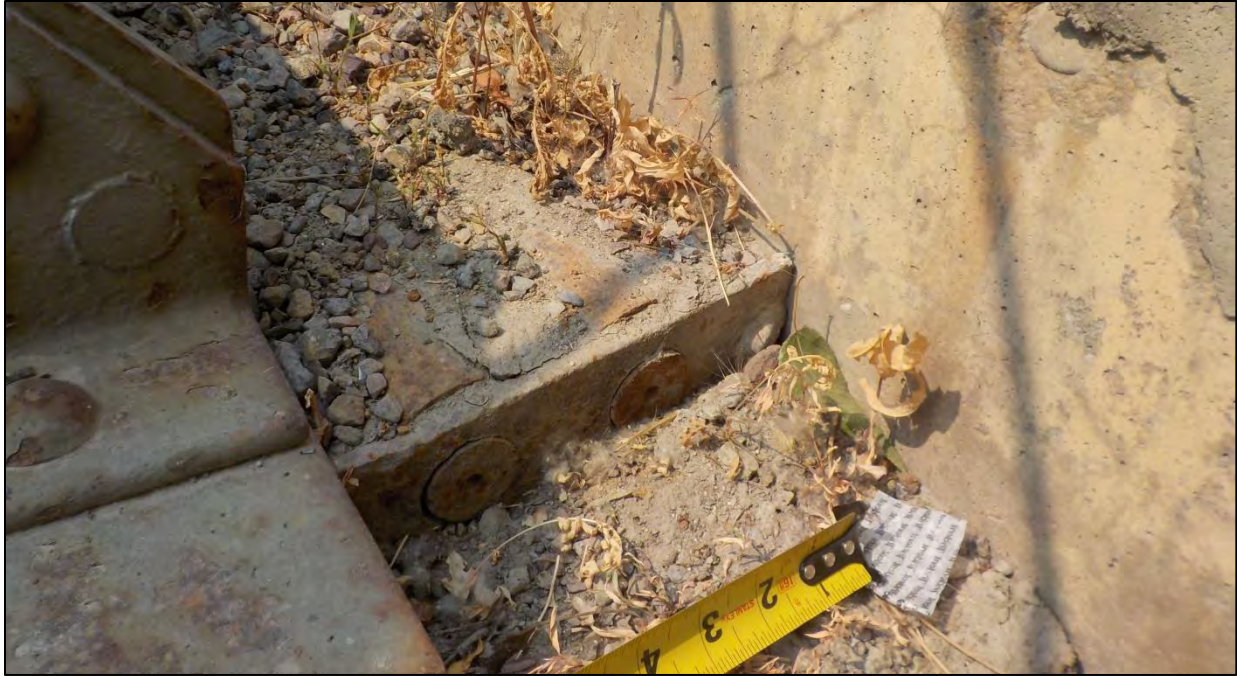
**Photo 64:** Abutment 1, South Truss roller bearing with the rollers and roller keeper protruding out from underneath the bearing and resting against the abutment backwall

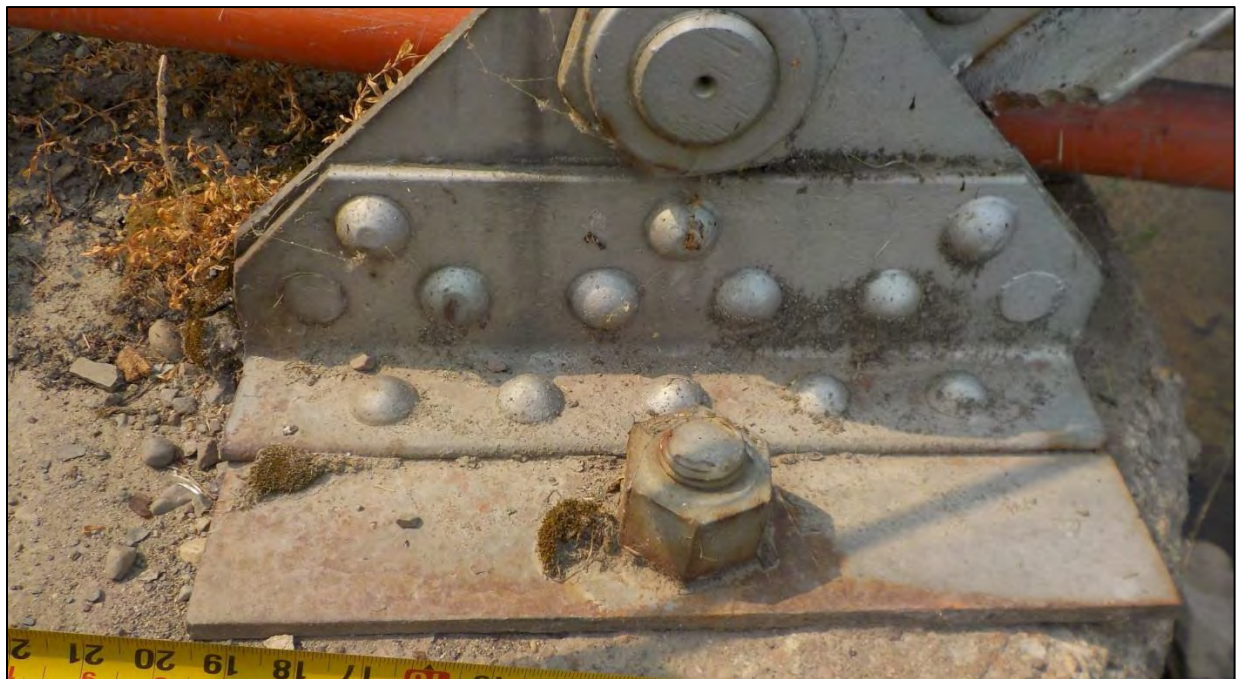
**Photo 65:** Bent 2, North Truss, Span 1 fixed bearing

Bent 2, North Truss, Span 1 fixed bearing (**Photo 65**) and Span 2 fixed bearing (**Photo 67**) had a failed painted coating on approximately 5 percent of the surface area with minor surface

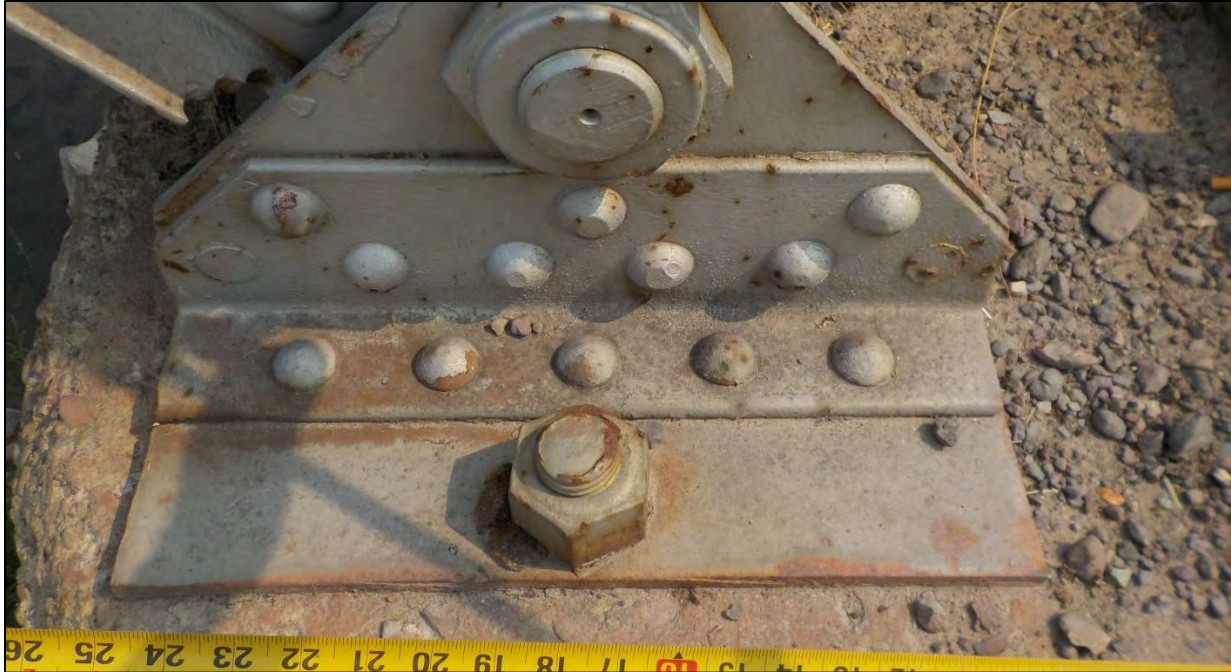
**Photo 66:** Bent 2, South Truss, Span 1 fixed bearing

Bent 2, South Truss, Span 1 fixed bearing (**Photo 66**) and Span 2 fixed bearing (**Photo 68**) had a failed painted coating on approximately 10 percent of the surface area with minor surface corrosion and negligible section loss, 15 percent had failed with exposed primer underneath, and the remaining painted coating was chalking.

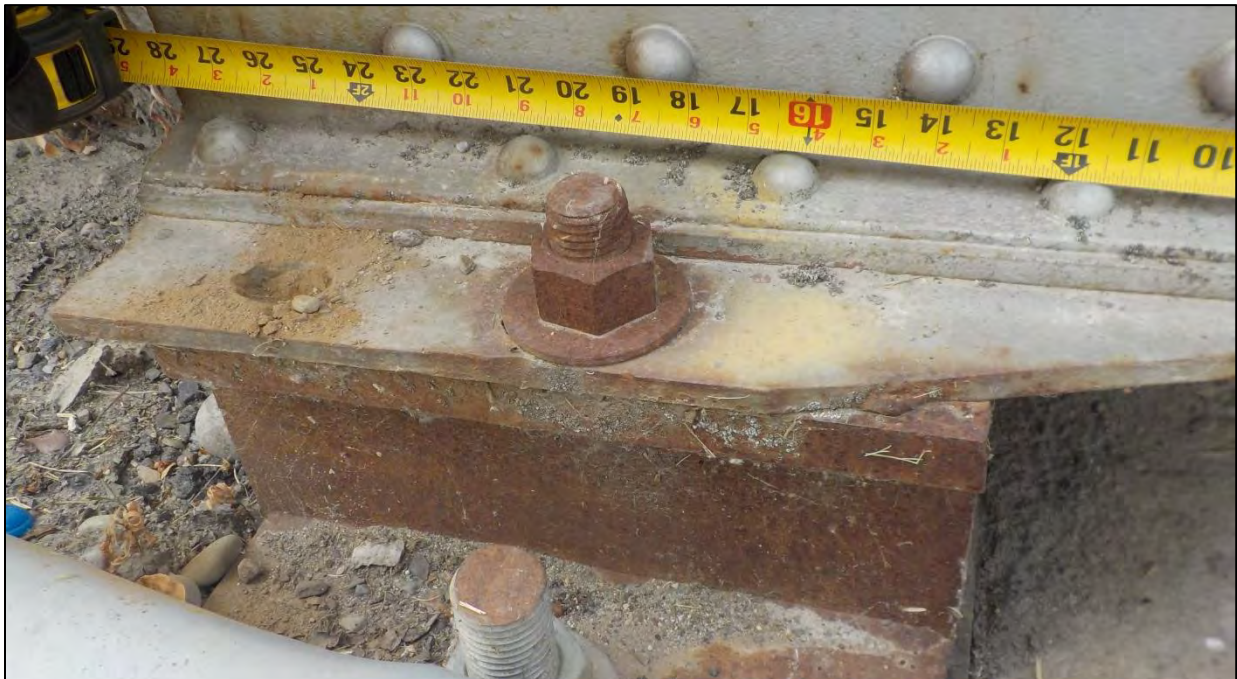
**Photo 69:** Bent 3, North Truss, Span 2 slider bearing

Bent 3, North Truss sliding bearing (**Photo 69**) was unpainted and had moderate corrosion with pitting up to 1/16 in. deep. The top plate was displaced 1-3/8 in. to the east (in expansion) in relation upper flange of the bearing.

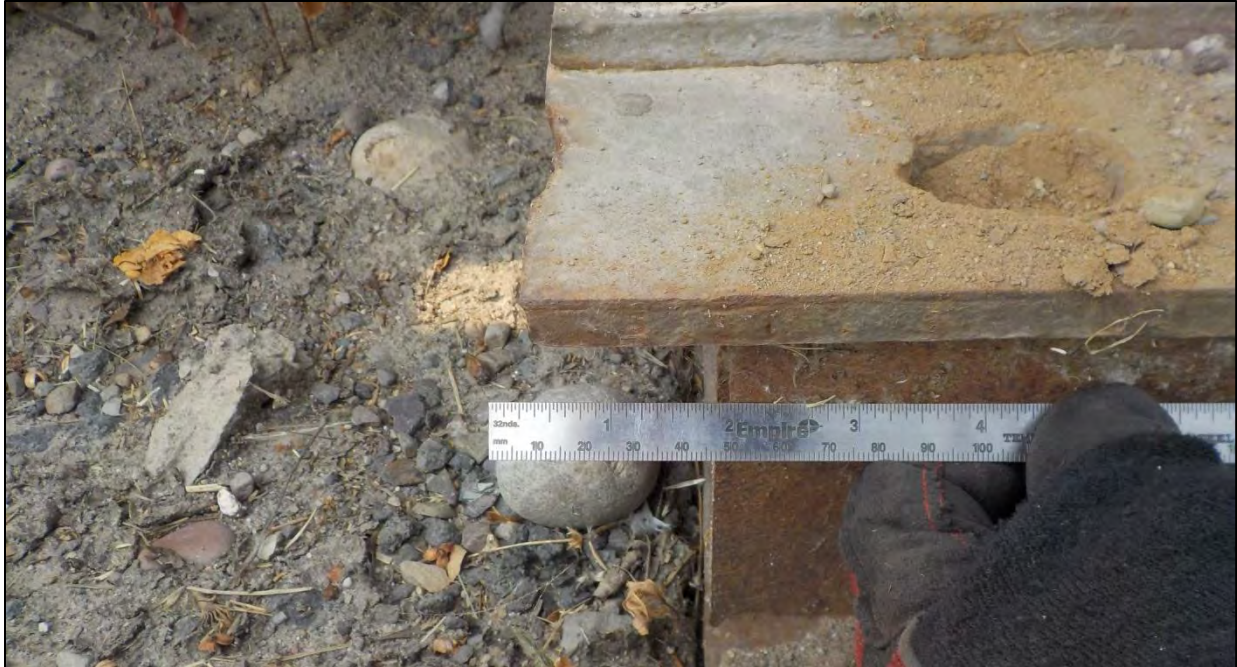
**Photo 70:** Bent 3, South Truss, Span 2 slider bearing

Bent 3, South Truss sliding bearing (**Photo 70**) was unpainted and had moderate corrosion with pitting up to 1/16 in. deep. The top plate was displaced 1-3/4 in. to the east (in expansion) in relation upper flange of the bearing.
