# MONTANA DEPARTMENT OF TRANSPORTATION STREAM MITIGATION MONITORING REPORT

*Ashley Creek  
Flathead County, Montana*

**YEAR 2013**

MDT Project Number: NH-MT 5-3(59) FST  
Control Number: 2038

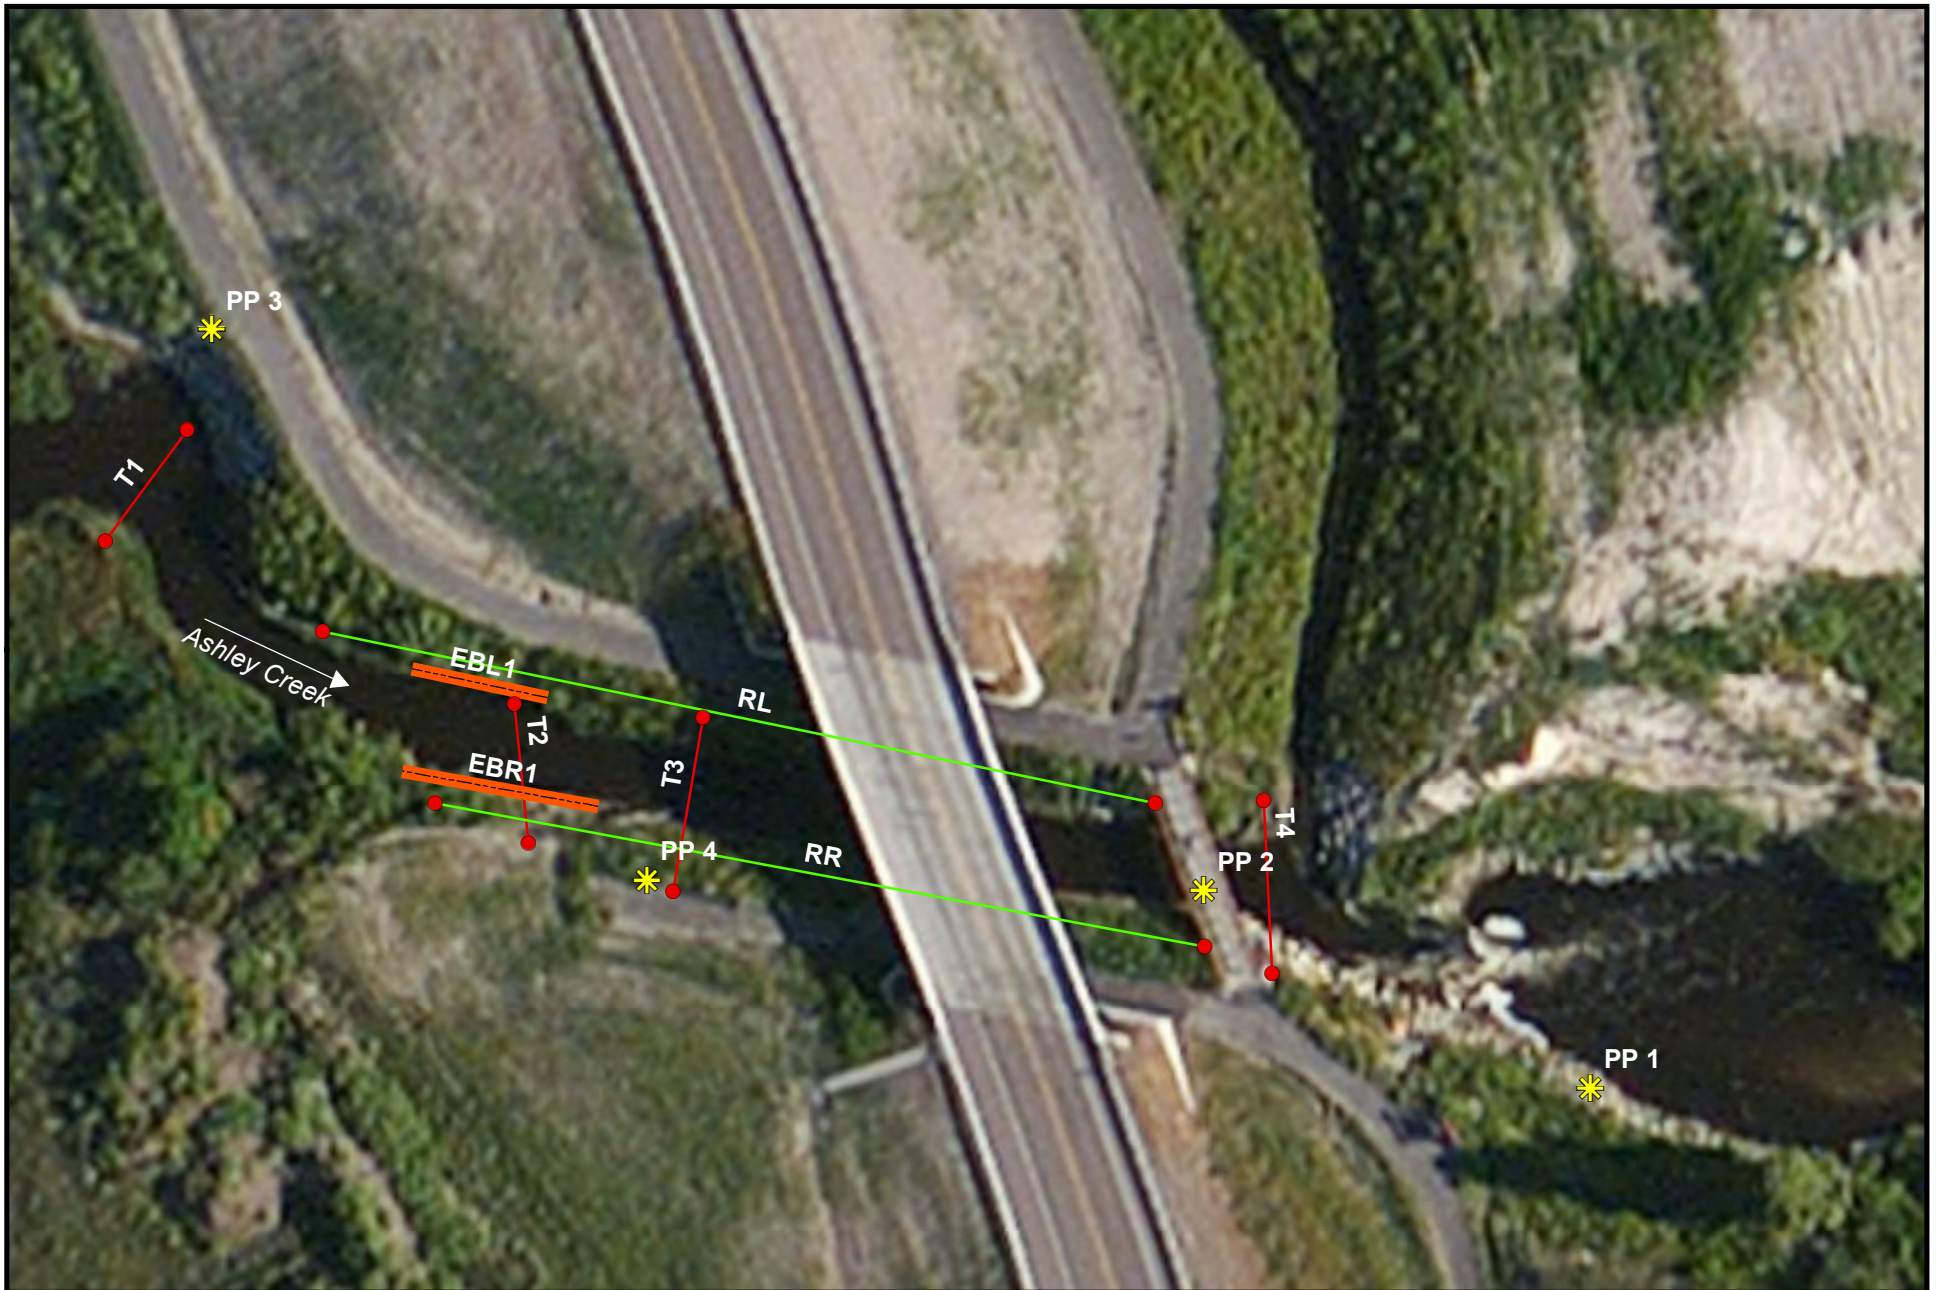
houndstongue, and field bindweed (*Convolvulus arvensis*). Noxious weeds were observed on both banks and distributed relatively evenly across the project site. Total cover of noxious weeds across the site was 11%. Figure 2 in Appendix A indicates locations of two common tansy infestations for use in developing a weed management plan for the site.

Two segments of eroding stream banks were observed along Ashley Creek, with bank erosion observations described in Table 5. Photos of each eroding bank are included in Appendix D of this report. Figure 2, Appendix A shows the GIS mapped location of eroding streambanks. Eroding streambank length totaled 85 feet, or 8% of the total project bank length of 1050 feet.

Vegetation monitoring conducted in 2013 identified six noxious weed species within the project site. Weeds are dispersed sporadically on both banks. Two areas exhibiting dense common tansy are illustrated on Figure 2 in Appendix A. The documentation of noxious weeds provided in Section 4.3 of this monitoring report allow for MDT and the Flathead County Weed District to develop management plans for controlling noxious weeds along the reconstructed segment of Ashley Creek.
