# MONTANA DEPARTMENT OF TRANSPORTATION STREAM MITIGATION MONITORING REPORT

*Sweathouse Creek  
Ravalli County, Montana*

**YEAR 2013**

MDT Project Number: NH 7-1(114)59  
Control Number: CN 201 5004

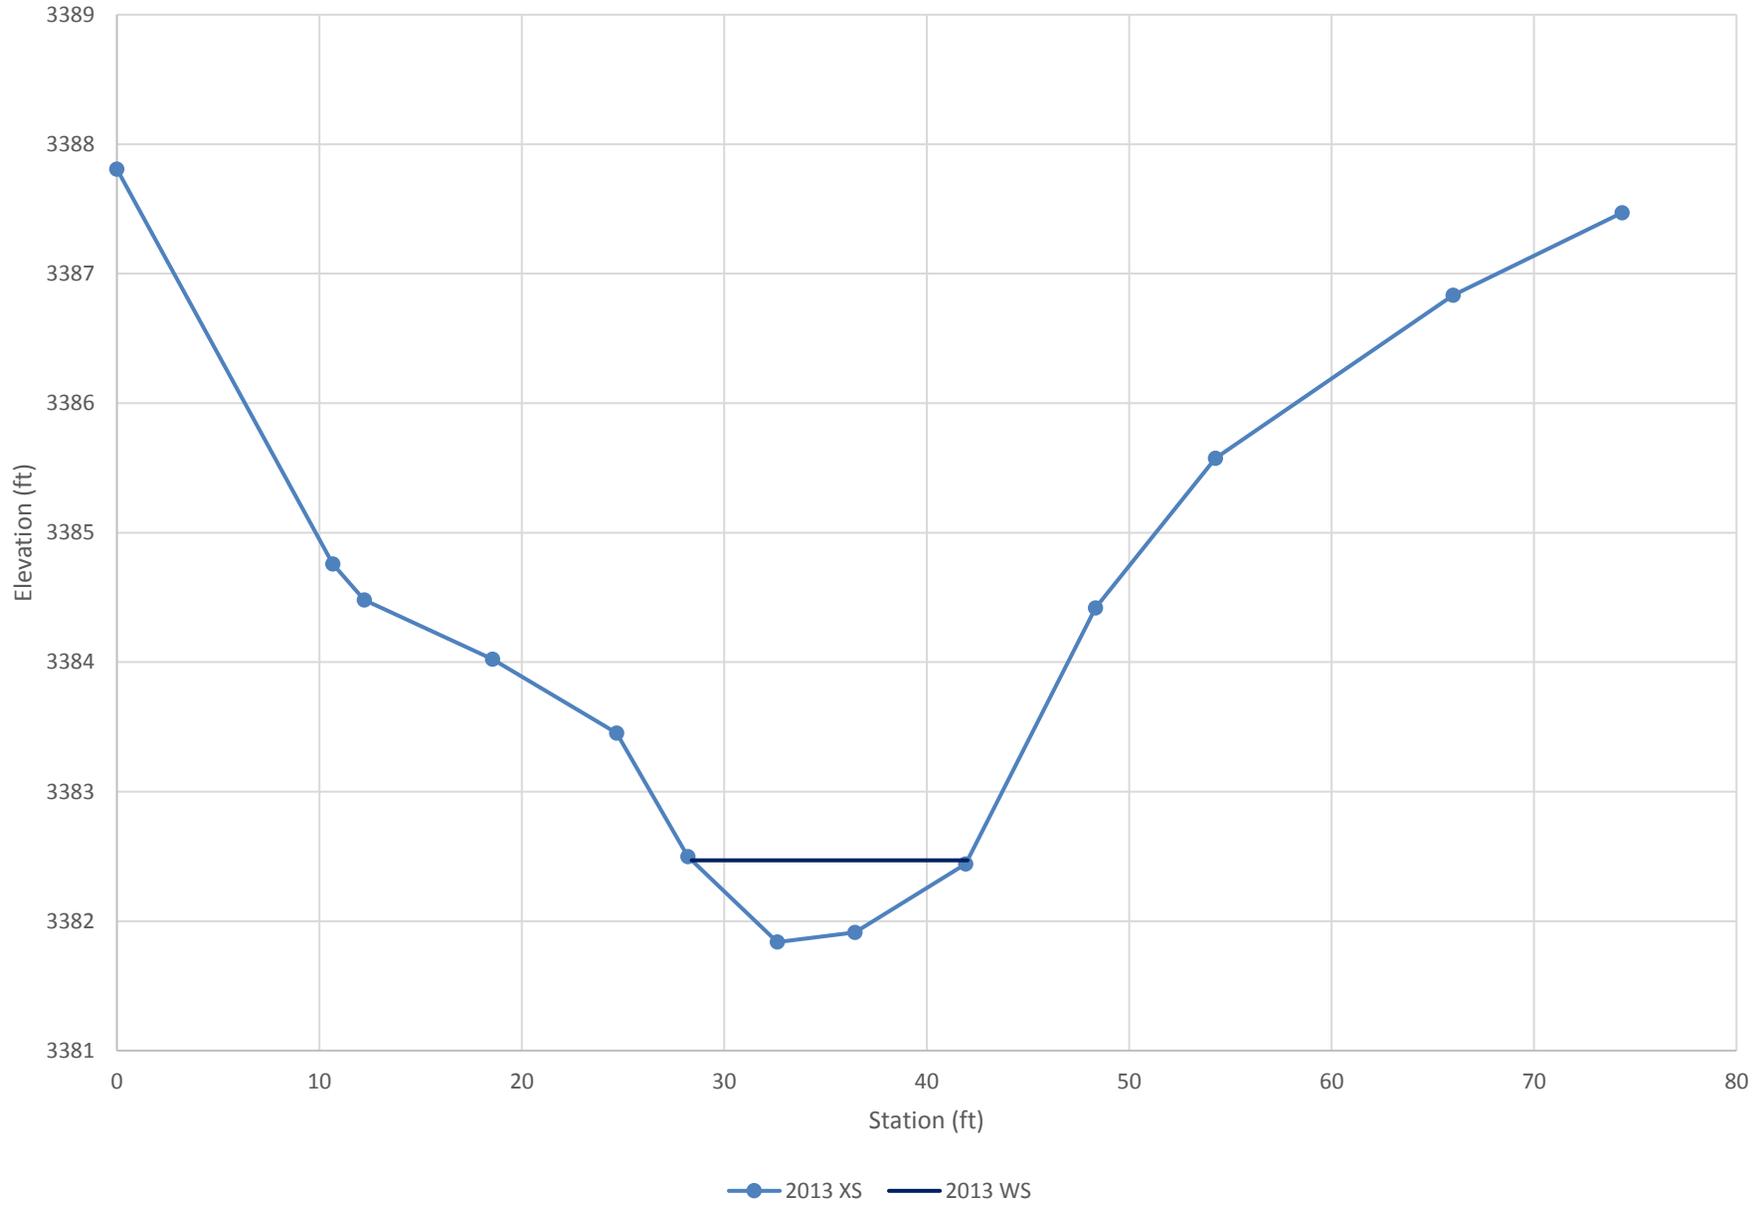
### Sweathouse Creek Transect #1 - Riffle

Four perpendicular transects were surveyed, including two pools and two riffles. Plots for each surveyed transect are included in Appendix B. These transects indicate the development of point bars and deeper scour pools at both pool transects (transects #2 and #3) as compared to the riffles. The lower riffle (transect #4) lies at the downstream end of a pool, and exhibits some bar development on the north bank. No evidence of erosion was noted at any of the surveyed transects. Perpendicular transects will be re-surveyed during subsequent monitoring events to document bar formation, pool depths, or lateral channel movements.

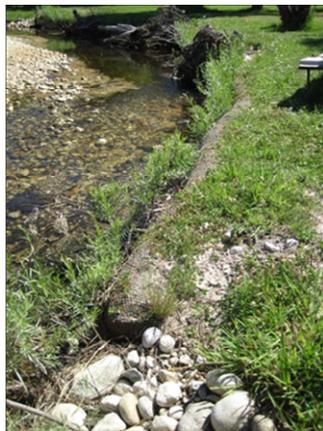
**Photo Point 2.1**  
**Description:** View of un-keyed coir log on south bank  
**Compass:** 90 (East)

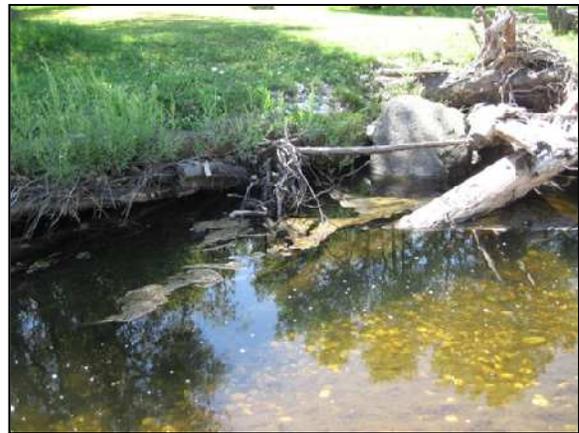
No stream bank erosion was noted within the Sweathouse Creek stream mitigation site. Root wads installed along the south bank appeared secure, with no evidence of undercutting or bank sloughing. The root wads provide structure for the development of pool scour features, as evidenced by results of Transects #2 and #3 in Appendix B. Results of transect surveys and their associated photos indicate gravel point bar development on the inside of the meander bend, and generation of scour pools against the root wads. These banks offer good fish habitat and cover, as evidenced by observations of several trout utilizing the root wad structures. Based on the observations and transect data, the bioengineered banks are successfully providing pool habitat features while maintaining bank integrity throughout the project reach.

**Description:** Log structure along south streambank. **Compass:** 110 (East-Southeast)
