# MONTANA DEPARTMENT OF TRANSPORTATION STREAM MITIGATION MONITORING REPORT

*Foy's Bend Fisheries Conservation Area  
Flathead County, Montana*

*Project Completed: 2013  
Monitoring Report #3: December 2015*

MDT Project Number: NH-MT 5-3(50) 109F  
Control Number: 20380013

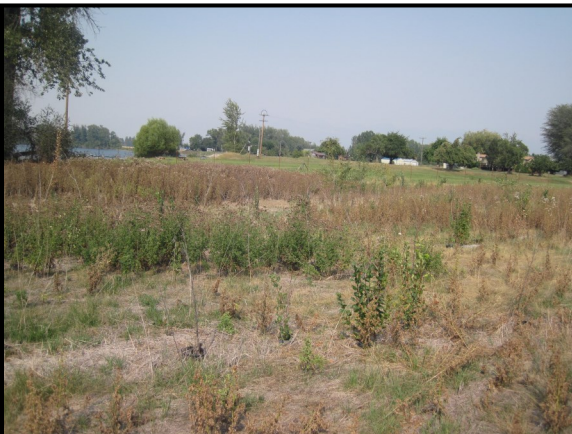
**Additional Photo 1 - 2015**

**Description:** Sprayed weeds in Exclosure #6

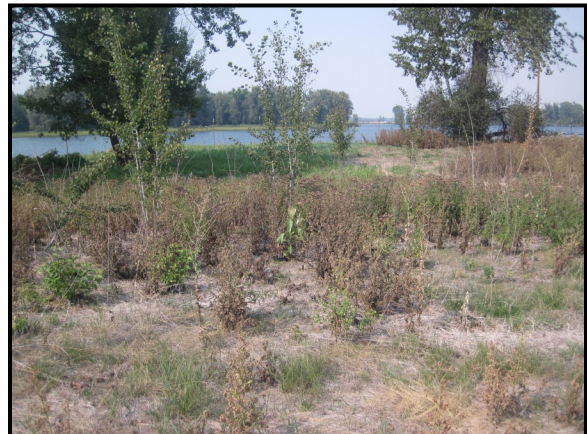
**Additional Photo 2 - 2015**

**Description:** Sprayed weeds in Exclosure #6

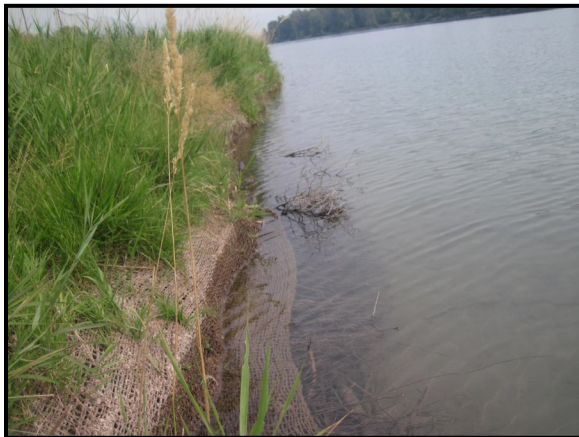
**Additional Photo 3 - 2015**

- Soil placed along the outer (river-side) edge of the coir lift has been stripped from the lift throughout length of Reach 1. Soil loss stopped at the upper limit of a clearly defined debris line formed by wave action. Soil loss was estimated at 6" based on the design thickness of the soil lift (see Additional Photo 3 and 4 on page C-5 in Appendix C).

**Description:** Submerged woody fascine along reconstructed bank. Taken looking downstream near bank transect 6

Fine soils placed within protective coir may be secured if a second, finer layer of coir fabric is placed between the outer coir layer and the soil. This second layer is often used in bioengineered stream banks to prevent fine soil loss when the bank is submerged. The recommended fabric to achieve this goal is North American Green, product #125-BN. This product includes a fine coir mesh and biodegradable reinforcement twine.

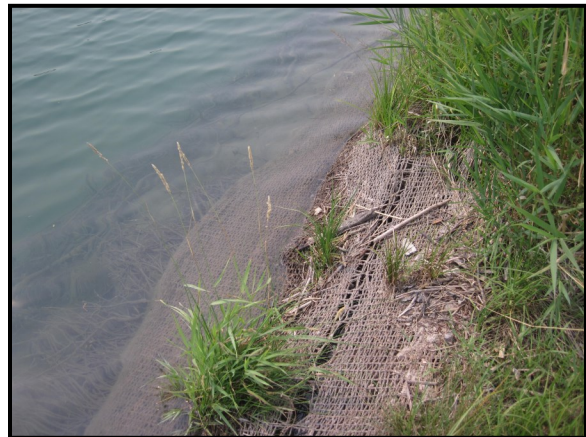
**Additional Photo 4 - 2015**

**Description:** Leading edge of coir bank and submerged woody fascine. Taken looking upstream near bank transect 6

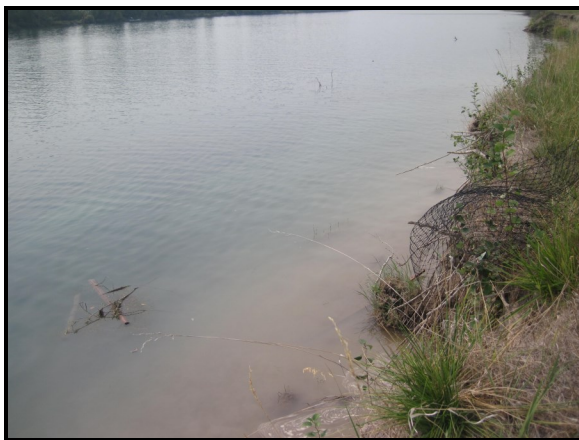
**Additional Photo 5 - 2015**

**Description:** Suspended fine sediment along reconstructed bank following passing motor boat. Taken looking upstream at bank transect 1

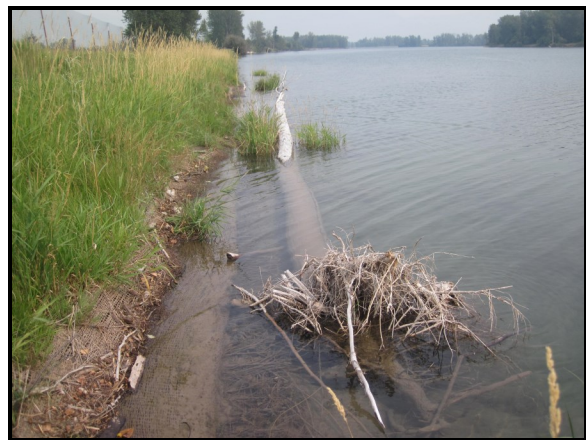
**Additional Photo 6 - 2015**

**Description:** Large wood deposited along reconstructed river bank. Taken looking downstream near bank transect 10

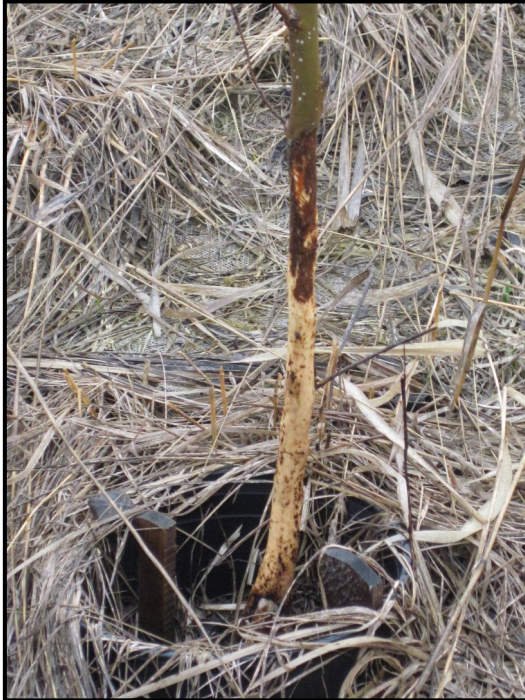
**Additional Photo 7– March, 2015**

Monitoring of the planted woody vegetation within the fenced exclosures indicated a substantial drop in survival between 2014 and 2015. Vole herbivory is likely a leading cause for mortality; however, some of the plants may have been exposed to herbicide treatments in 2015. Monitoring crews noted a much more aggressive application of herbicides in 2015 as compared to 2014, which may have resulted in additional mortality of planted shrubs.

**Description:** Evidence of vole herbivory on planted shrubs within exclosures.

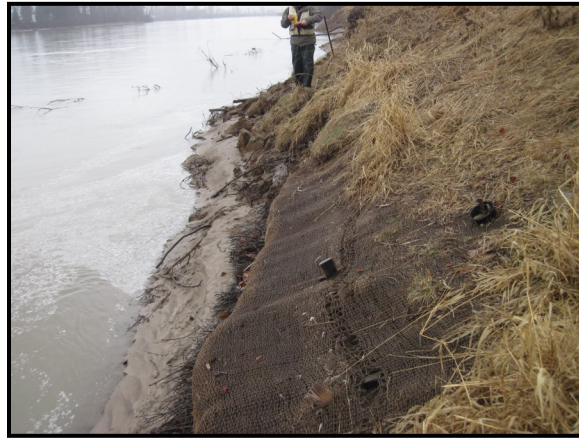
**Additional Photo 8– March, 2015**

**Description:** Upper extent of reconstructed bank at low water. Taken looking upstream near bank transect 1

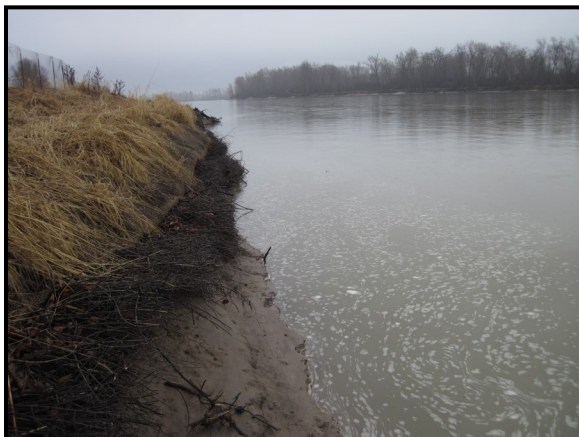
**Additional Photo 9 – March, 2015**

- Visual observations in March 2015 noted additional soil loss from beneath the bioengineered bank treatment as evidenced by the coir fascine and soil lift slumping into the river at low water (see fascine profile in Appendix B and Additional Photos 9 and 10 on page C-6 of Appendix C).

**Description:** Upstream extent of undermined segment of reconstructed bank, looking downstream near bank transect 3

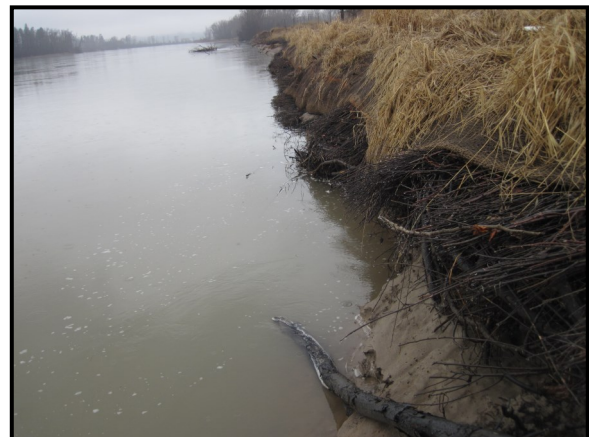
**Additional Photo 10 – March, 2015**

**Description:** Downstream extent of undermined segment of reconstructed bank, looking upstream near transect 4.5

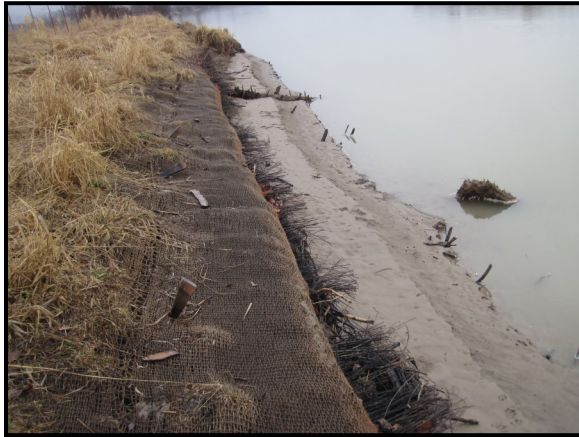
**Additional Photo 11 - March 2015**

**Description:** Downstream extent of reconstructed bank segment during low water; taken near bank transect 12

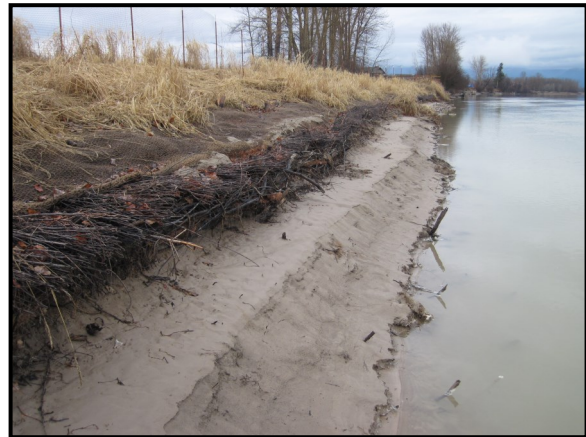
**Additional Photo 12 - March 2015**

**Description:** Downstream extent of reconstructed bank segment during low water; taken near bank transect 13

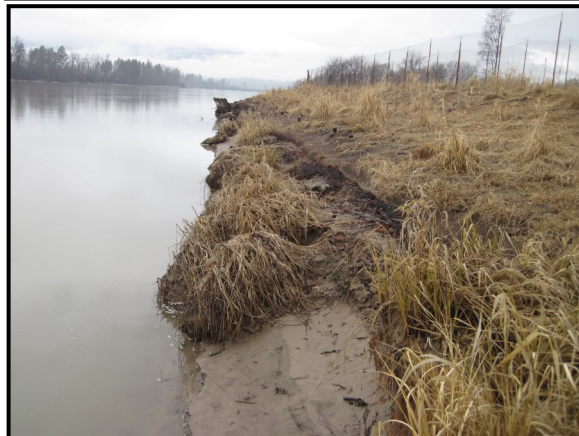
**Additional Photo 13 - March 2015**

**Description:** Phalaris sod mats beneath fascine; taken looking upstream near transect 10

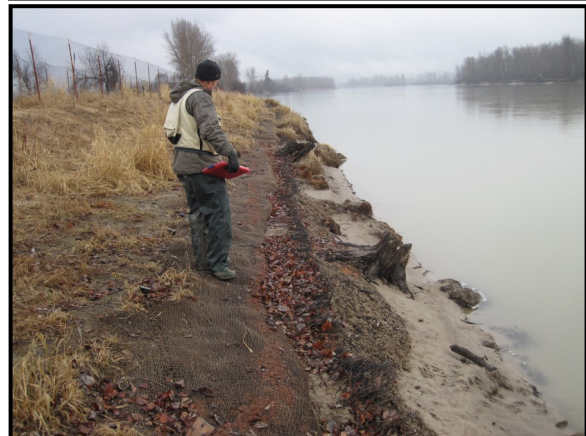
**Additional Photo 14 - March 2015**

**Description:** Remnant stumps along lower reconstructed bank segment; taken near transect 10
