MONTANA DEPARTMENT OF TRANSPORTATION STREAM MITIGATION MONITORING REPORT

*Foy's Bend Fisheries Conservation Area
Flathead County, Montana*

*Project Completed: 2013
Monitoring Report #4: December 2016*

MDT Project Number: NH-MT 5-3(50) 109F
Control Number: 20380013

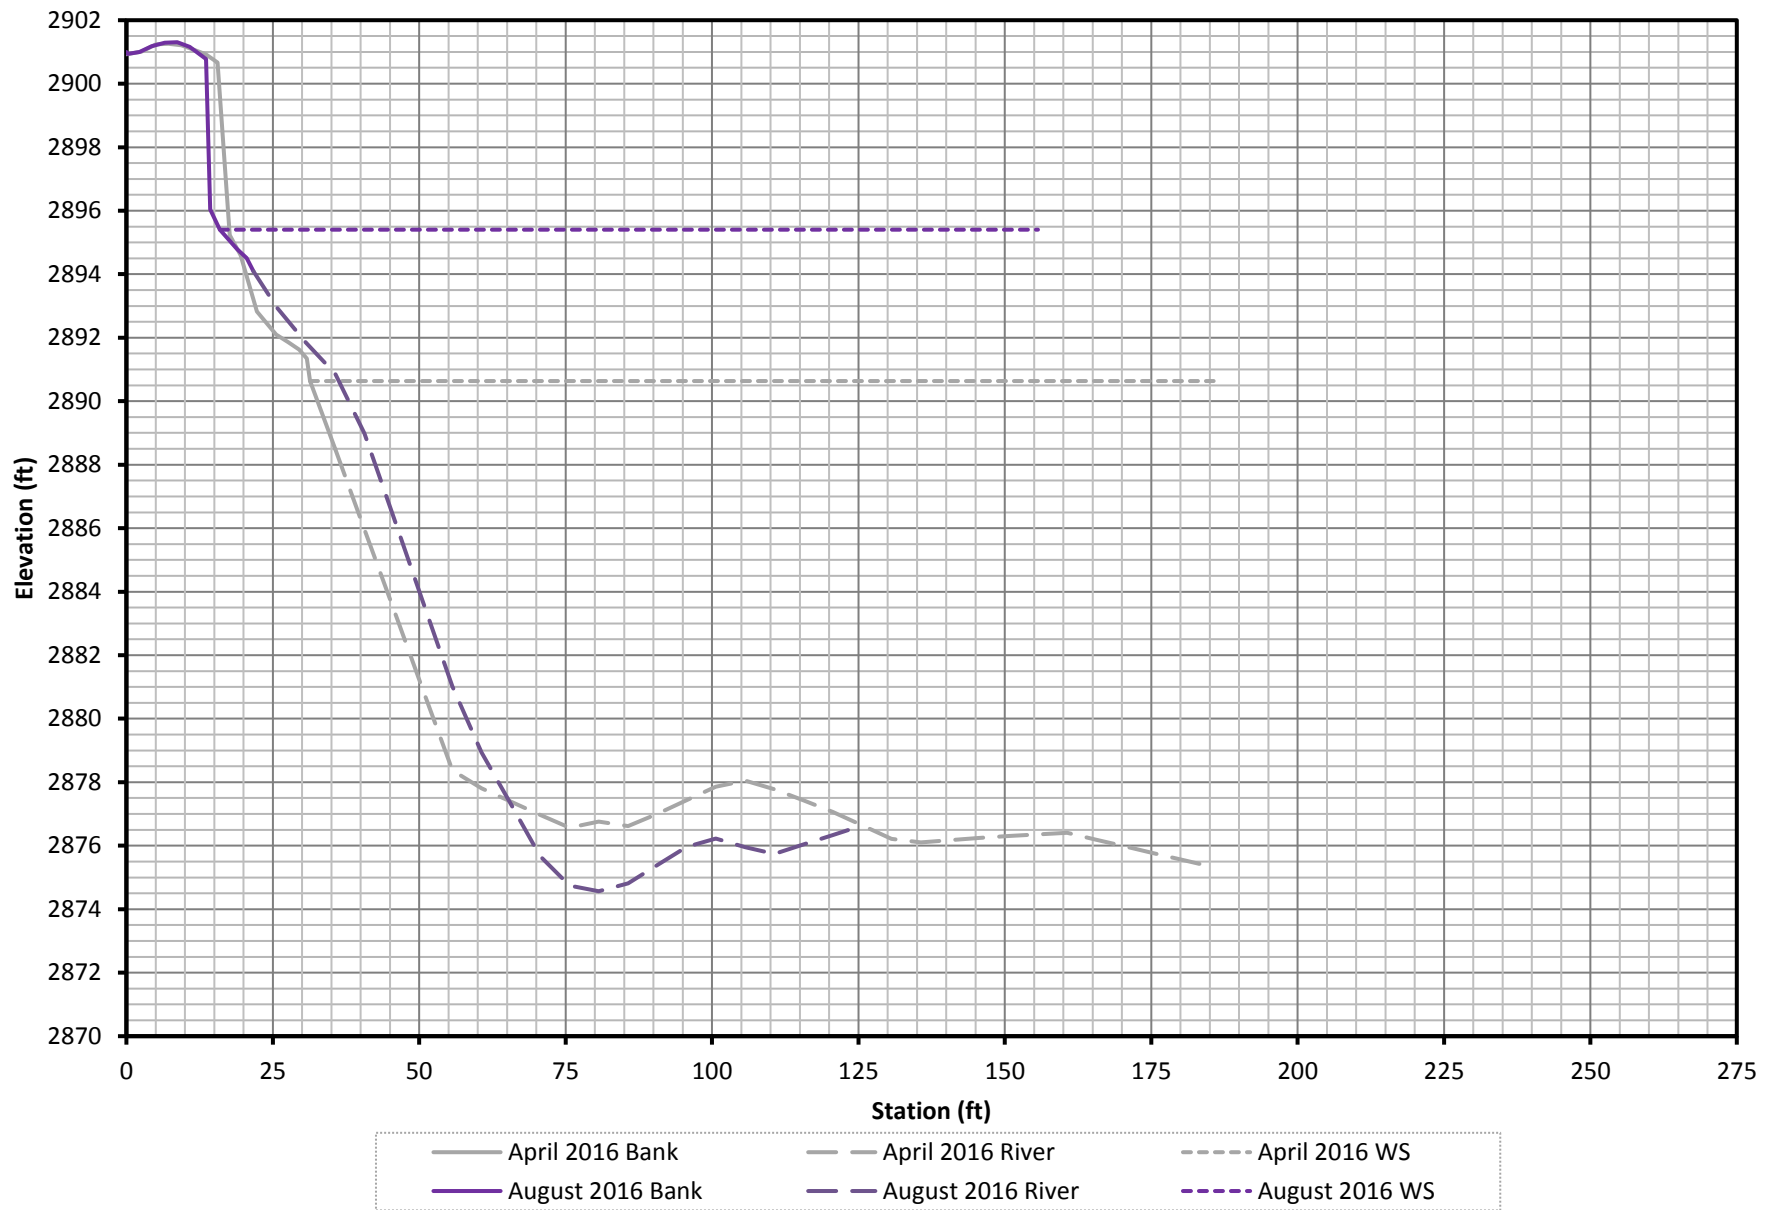
Foy's Bend Bank Transect # -0.5

- Photo Point 5.1 and Additional Photos 1 and 2 in Appendix C reveal the top of the river bank has continued to erode northward. The top of the bank at transect -0.5, located 130 feet upstream of the reconstructed bank, revealed a retreat by two feet between April and August 2016. Survey transect 0.5, located 20 feet upstream of the reconstructed bank, eroded three feet northward near the top of the bank.
- Extended bank survey results at transects -0.5, 0, and 0.5 indicate the bank below the low water surface has not eroded northward; rather, it shows evidence of deposition. The source of this deposition may be material that has calved off the top of the bank and has sloughed down the bank or from natural deposition following the spring 2016 runoff event

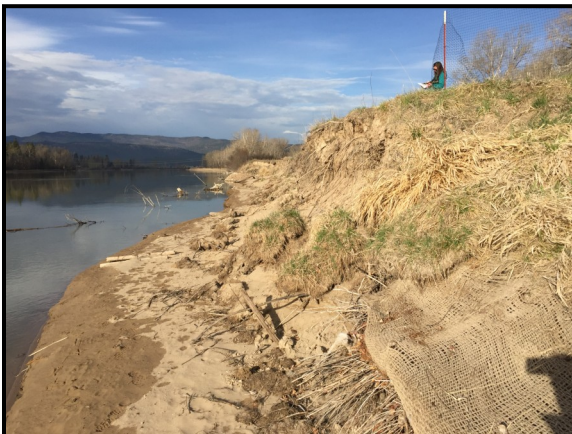
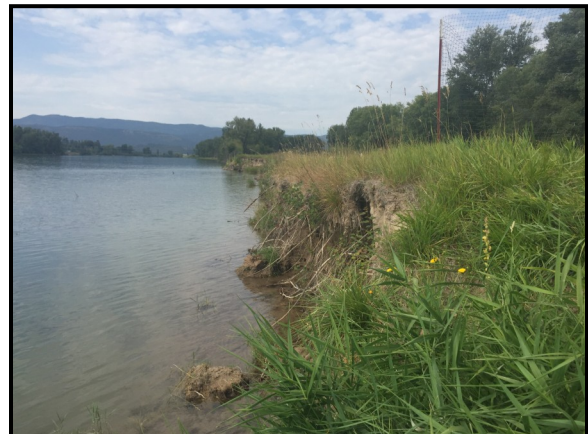
Additional Photo 1: April, 2016

Description: Eroding river bank upstream of reconstructed bank segment during low water.

Description: Eroding river bank upstream of reconstructed bank segment during high water.

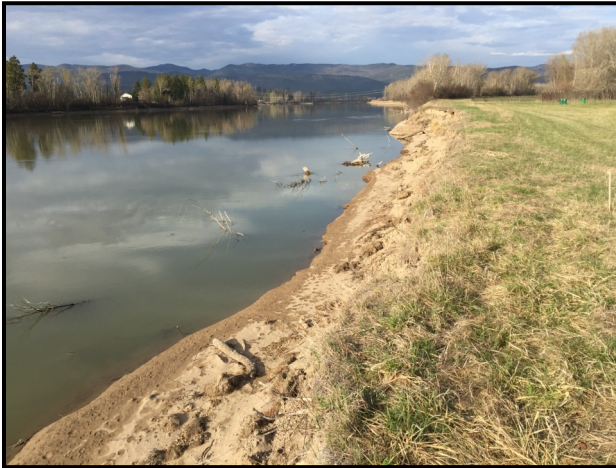
Additional Photo 2: April, 2016

Description: Bank erosion upstream of reconstructed bank segment.

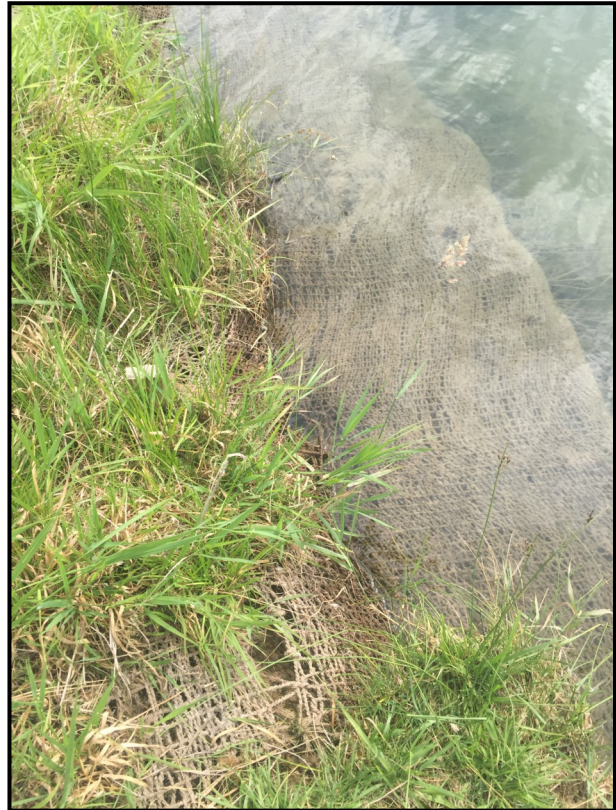
Additional Photo 3: August 2016

- Soil placed along the outer (river-side) edge of the coir lift has been stripped from within the lift throughout length of Reach 1. Soil loss stopped at the upper limit of a clearly defined debris line formed by wave action. Soil loss was estimated at 6” vertically based on the design thickness of the soil lift (see Additional Photos 3, 4, and 5 on page C-5 of Appendix C).

Description: Leading edge of coir bank and submerged woody fascine. Taken looking upstream near bank transect 1.5

Fine soils placed within protective coir may be secured if a second, finer layer of coir fabric is placed between the outer coir layer and the soil. This second layer is often used in bioengineered stream banks to prevent fine soil loss when the bank is submerged. The recommended fabric to achieve this goal is North American Green, product #125-BN. This product includes a fine coir mesh and biodegradable reinforcement twine.

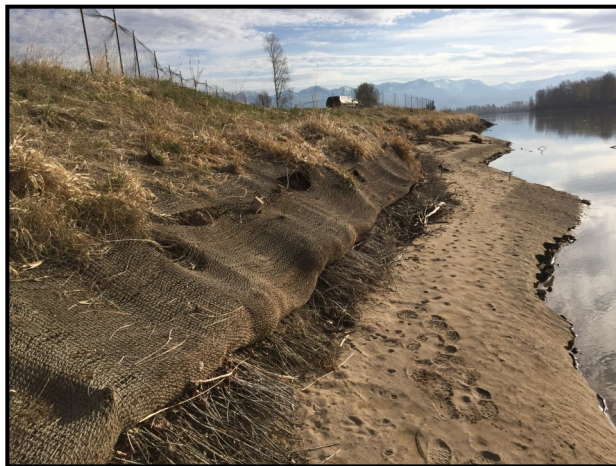
Additional Photo 4: April, 2016

Description: Loss of soil in coir lift due to wave action during high water

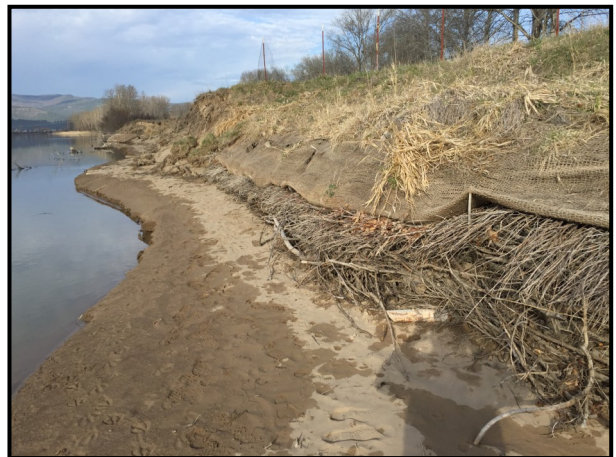
Additional Photo 5 : April, 2016

of Appendix B and Additional photo 5 on page C-5 of Appendix C). Slope failure below the fascines is likely the main contributing factor to the drop in fascine elevation.

Description: Fascine in Reach 1 is beginning to drop due to bank undercutting.

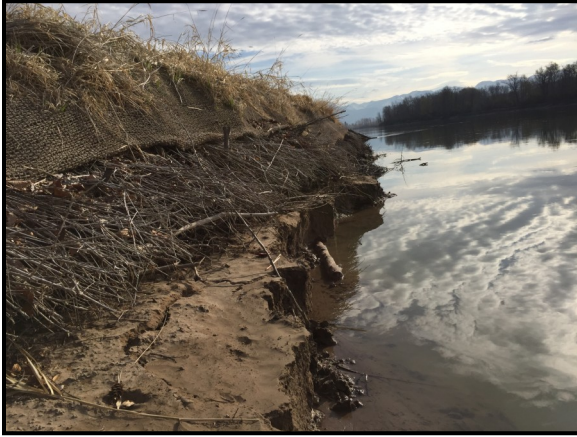
Additional Photo 6: April 2016

- Soil placed along the outer (river-side) edge of the coir lift has been stripped from the lift throughout length of Reach 2. Soil loss stopped at the upper limit of a clearly defined debris line formed by wave action during high water. Soil loss was estimated at 6" based on the design thickness of the soil lift (see Photo Point 6.1 on page C-4 and Additional Photo 6 on Page C-6 in Appendix C).

- Nearly all of the fascines installed remain intact; however, undercutting and erosion of the bank beneath the fascines along Reach 2 of the bank has caused the fascines to slump and drape into the river (see Additional Photos 6 and 7 on page C-6 of Appendix C).

Description: Bank sloughing and soil stripped from coir lift within Reach 2 Photo taken near transect 4.

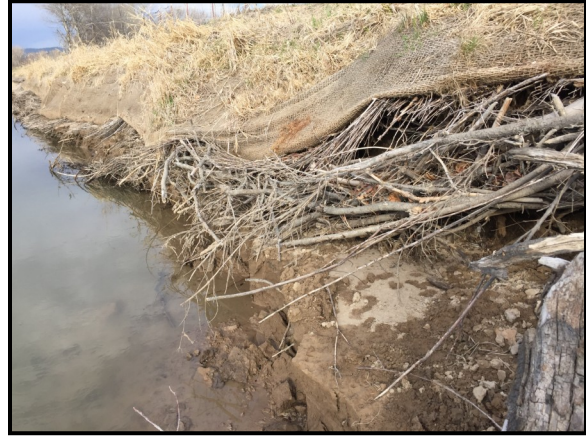
Additional Photo 7: April 2016

- Visual observations in April 2016 noted continued soil loss from beneath the bank treatments and slumping of the woody fascines and coir fabric along the lower bank. These conditions were particularly evident between Transects 3.5 and 4 (see Additional Photo 7 on page C-6 of Appendix C).

Description: Bank undercutting beneath bioengineered bank treatment in Reach 2.

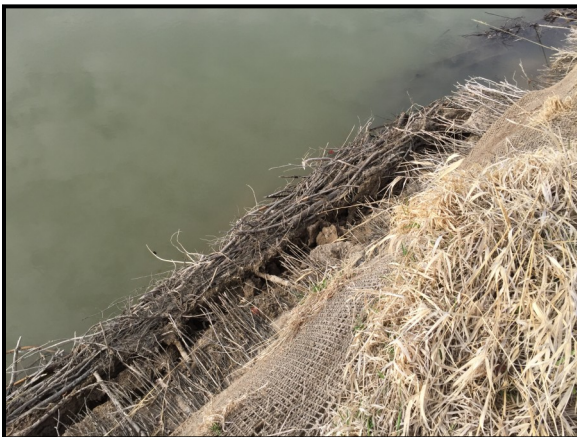
Additional Photo 8: April 2016

- Undercutting of the stabilized bank has caused a 20-foot segment of woody fascine to separate from the bank near transect #4. Additional fracturing of the woody fascine from beneath the bank is expected as the lower bank continues to recede northward (see Additional Photo 8 on page C-6 of Appendix C).

- Erosion beneath the reconstructed bank near transect #4.5 has caused a 20-foot segment of the fascine to separate from the bank (see Additional Photo 8 on page C-6 of Appendix C).

Description: Woody fascine separated from bank treatment in Reach 2.

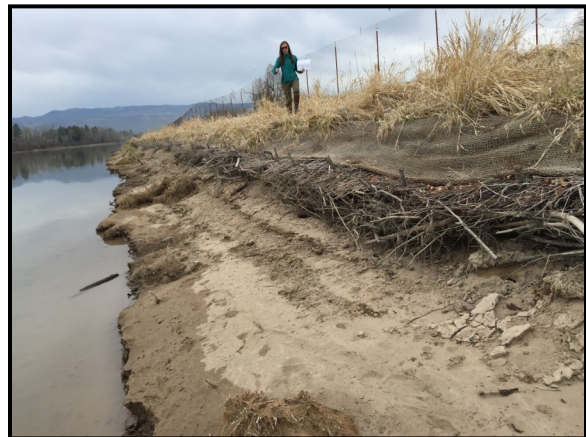
Additional Photo 9: April 2016

- Visual observations in March 2015 noted additional soil loss from beneath the bioengineered bank treatment as evidenced by the coir fascine and soil lift slumping into the river at low water (see fascine profile in Appendix B and Additional Photos 9 and 10 on page C-6 of Appendix C).

- Surveys indicate the bank immediately below the bioengineered treatment has slowly, but consistently steepened and retreated northward at Transects 7, 8, 10, 11, 12, 13, and 14 over the past two to three years. Continual migration of the bank between the high summer and low winter water surface elevations is threatening to undermine the woody fascines and resloped bank segment along Reach 3 (see Additional Photo 9 and 10 on page C-6 of Appendix C).

Description: Bank slope beneath woody fascine in Reach 3 becoming steeper. Photo taken near survey transect 13.

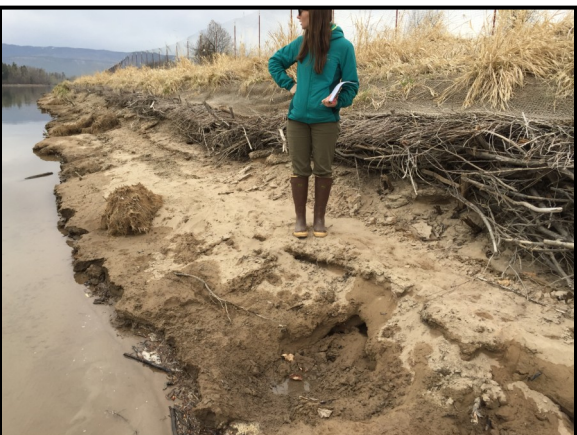
Additional Photo 10: April 2016

Description: Bank slope beneath woody fascine in Reach 3 becoming steeper. Photo taken near survey transect 9.
