MONTANA DEPARTMENT OF TRANSPORTATION STREAM MONITORING REPORT

*Little Rock Creek at Judith Slide Repair
Fergus County, Montana*

*Project Completed: 2013
Monitoring Report #3: December, 2016*

MDT Project Number: STPS 426-2(12) 15
Control Number: 7726000

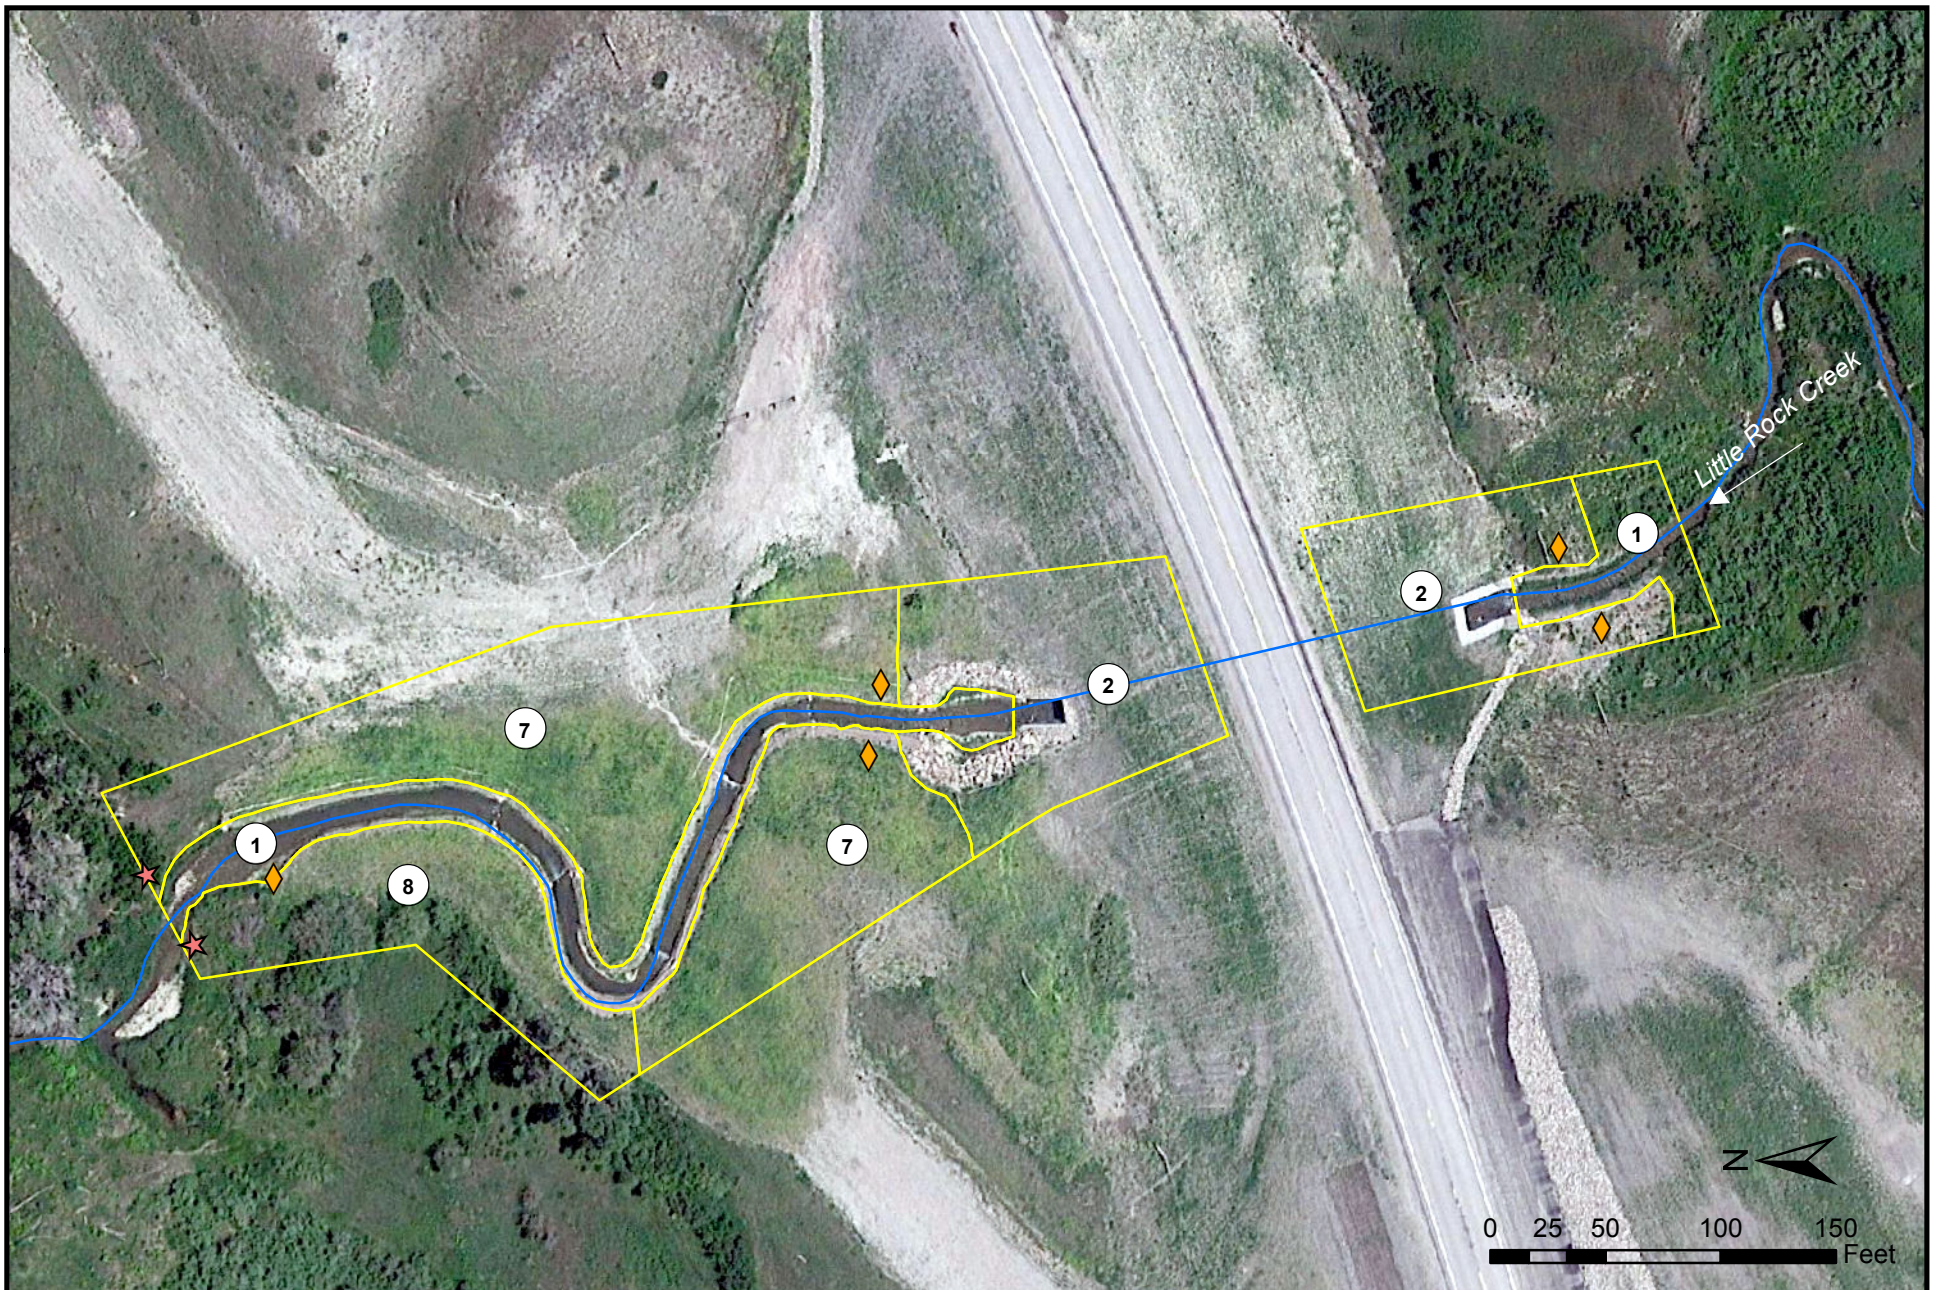
Dominant species recorded along the riparian and stream bank transects were combined with visual observations in other areas to develop a vegetation community map (Figure 3, Appendix A). The dominant plant species observed within the riparian zone were absinthium (*Artemisia absinthium*), nodding wild rye (*Elymus canadensis*), intermediate wheatgrass (*Elymus hispidus*), slender wild rye (*Elymus trachycaulus*), and western-wheat grass (*Pascopyrum smithii*), which primarily occurred above the coir encapsulated soil lifts. The lower banks of the channel were dominated by narrow-leaf willow (*Salix exigua*) and reed canary grass (*Phalaris arundinacea*).

Four vegetation community types were observed in 2016 (Figure 3, Appendix A) and are included in Table 4.

Three Montana State-listed noxious weeds were observed within the reconstructed segment of Little Rock Creek in 2016 (Table 6). *Lepidium latifolium* was misidentified in 2014, and was removed in 2015 from the list of noxious weeds observed at this site. Canada thistle (*Cirsium arvense*) and leafy spurge (*Euphorbia esula*) infestations observed on site are shown on Figure 3 in Appendix A. Gypsy flower (*Cynoglossum officinale*) was observed in isolated trace amounts, and was therefore not mapped on Figure 3. The combined areal cover of all three noxious weed species identified in 2016 was estimated at 4%. The increase in noxious weeds was primarily observed in riparian areas as opposed to the stream banks. Three of the most prolific infestations were observed near the downstream end of the relocated channel segment, along both stream banks where livestock crosses the channel. Infestations of noxious weeds were observed just outside of the project site during the 2013 monitoring event, which offered a seed source for establishment of weeds within the site.

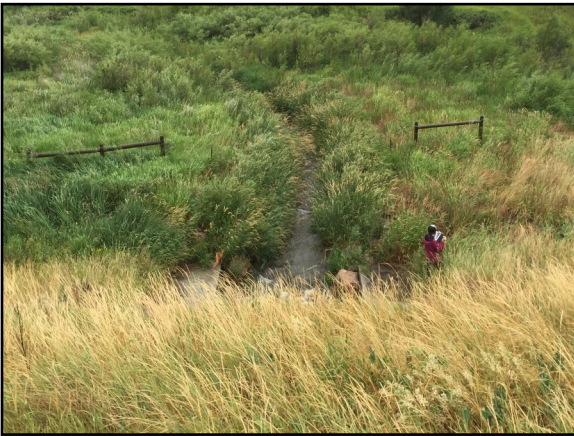
Additional Photo 1

Table 2 summarizes the areal percent cover of total vegetation, woody vegetation, and noxious weeds observed along each riparian and stream bank transect during the 2014 through 2016 monitoring events. Both riparian vegetation transects were located downstream of the box culvert, and are representative of the reconstructed channel and associated riparian zones below the culvert outlet. Total percent cover of vegetation increased from 83% in 2015 to 88% in 2016. Total percent woody cover increased from 14% in 2015 to 17% in 2016. Percent cover of Montana State-listed noxious weeds increased from 3% in 2015 to 4% in 2016 (See Section 4.3). Vegetation upstream and downstream of the culvert is establishing well, with a diversity of stream bank and riparian vegetation developing on both sides of the channel (See Photo Point 1 and Additional Photo #1 in Appendix A).

Description: View looking upstream of reconstructed channel immediately upstream of culvert.

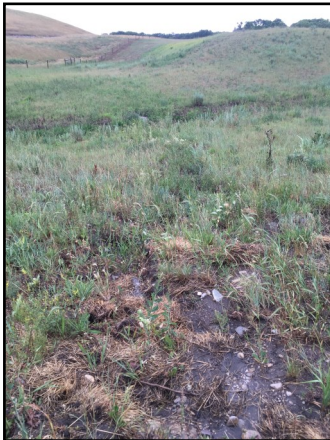
1. Formation of a small gully to the east of the newly constructed channel was noted in 2015. This gully formation appeared to be the result of a seep and surface water runoff flowing across newly vegetated areas within the project reach. Vegetation has matured along the length of the gully, and appears to have largely stabilized the erosion noted during previous monitoring events (see Additional Photo 3 in Appendix C).

Description: Gully formed east of new channel alignment has become better vegetated

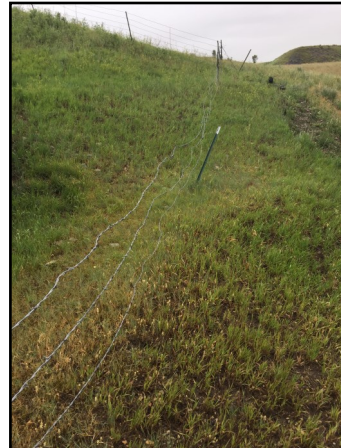
3. Newly installed fences surrounding the project reach have remained in good condition. No gaps or downed fence strands were observed along the newly installed fences. The barbed wire fence crossing Little Rock Creek at the downstream end and along the northeast corner of the project is in poor condition and allows livestock to cross into/out of the project reach (See Additional Photo 4 in Appendix C). The segments of fence in poor condition were installed well prior to the 2013 MDT project.

Description: Barbed wire fence on northeast corner of project reach

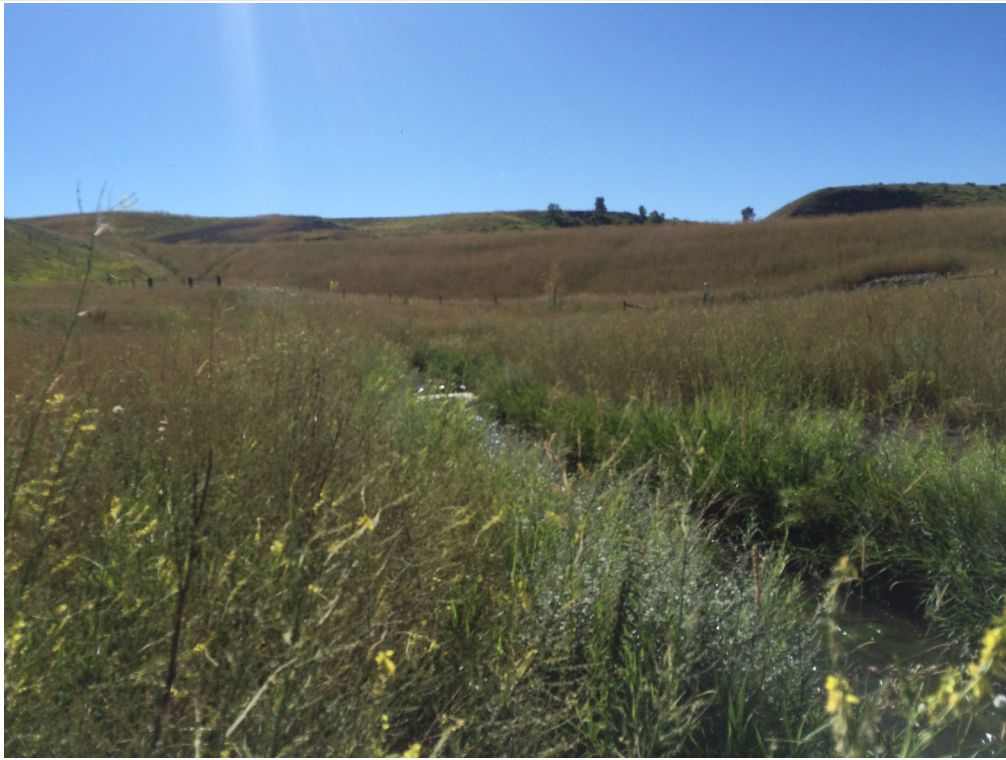
T4 RT: LOOKING UPSTREAM SOUTH

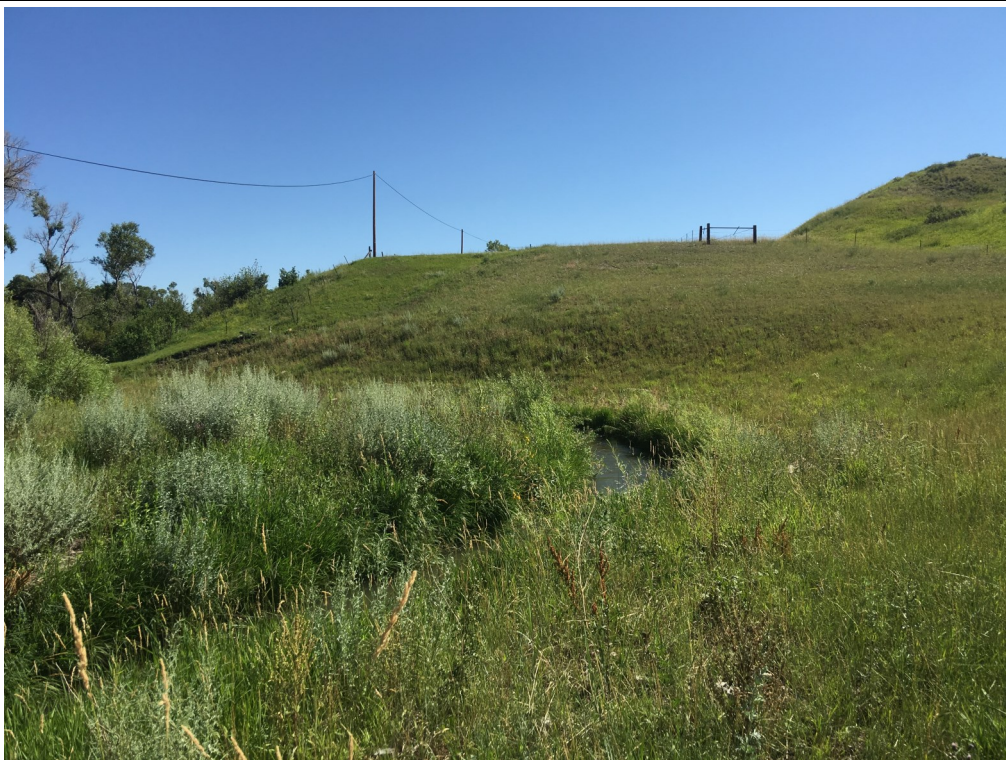
T4 RT: LOOKING DOWNSTREAM EAST
