MONTANA DEPARTMENT OF TRANSPORTATION STREAM MITIGATION MONITORING REPORT

*Ashley Creek
Flathead County, Montana*

*Project Completed: 2010
Monitoring Report #4: December, 2018*

MDT Project Number: NH-MT 5-3(59) FST
Control Number: 2038

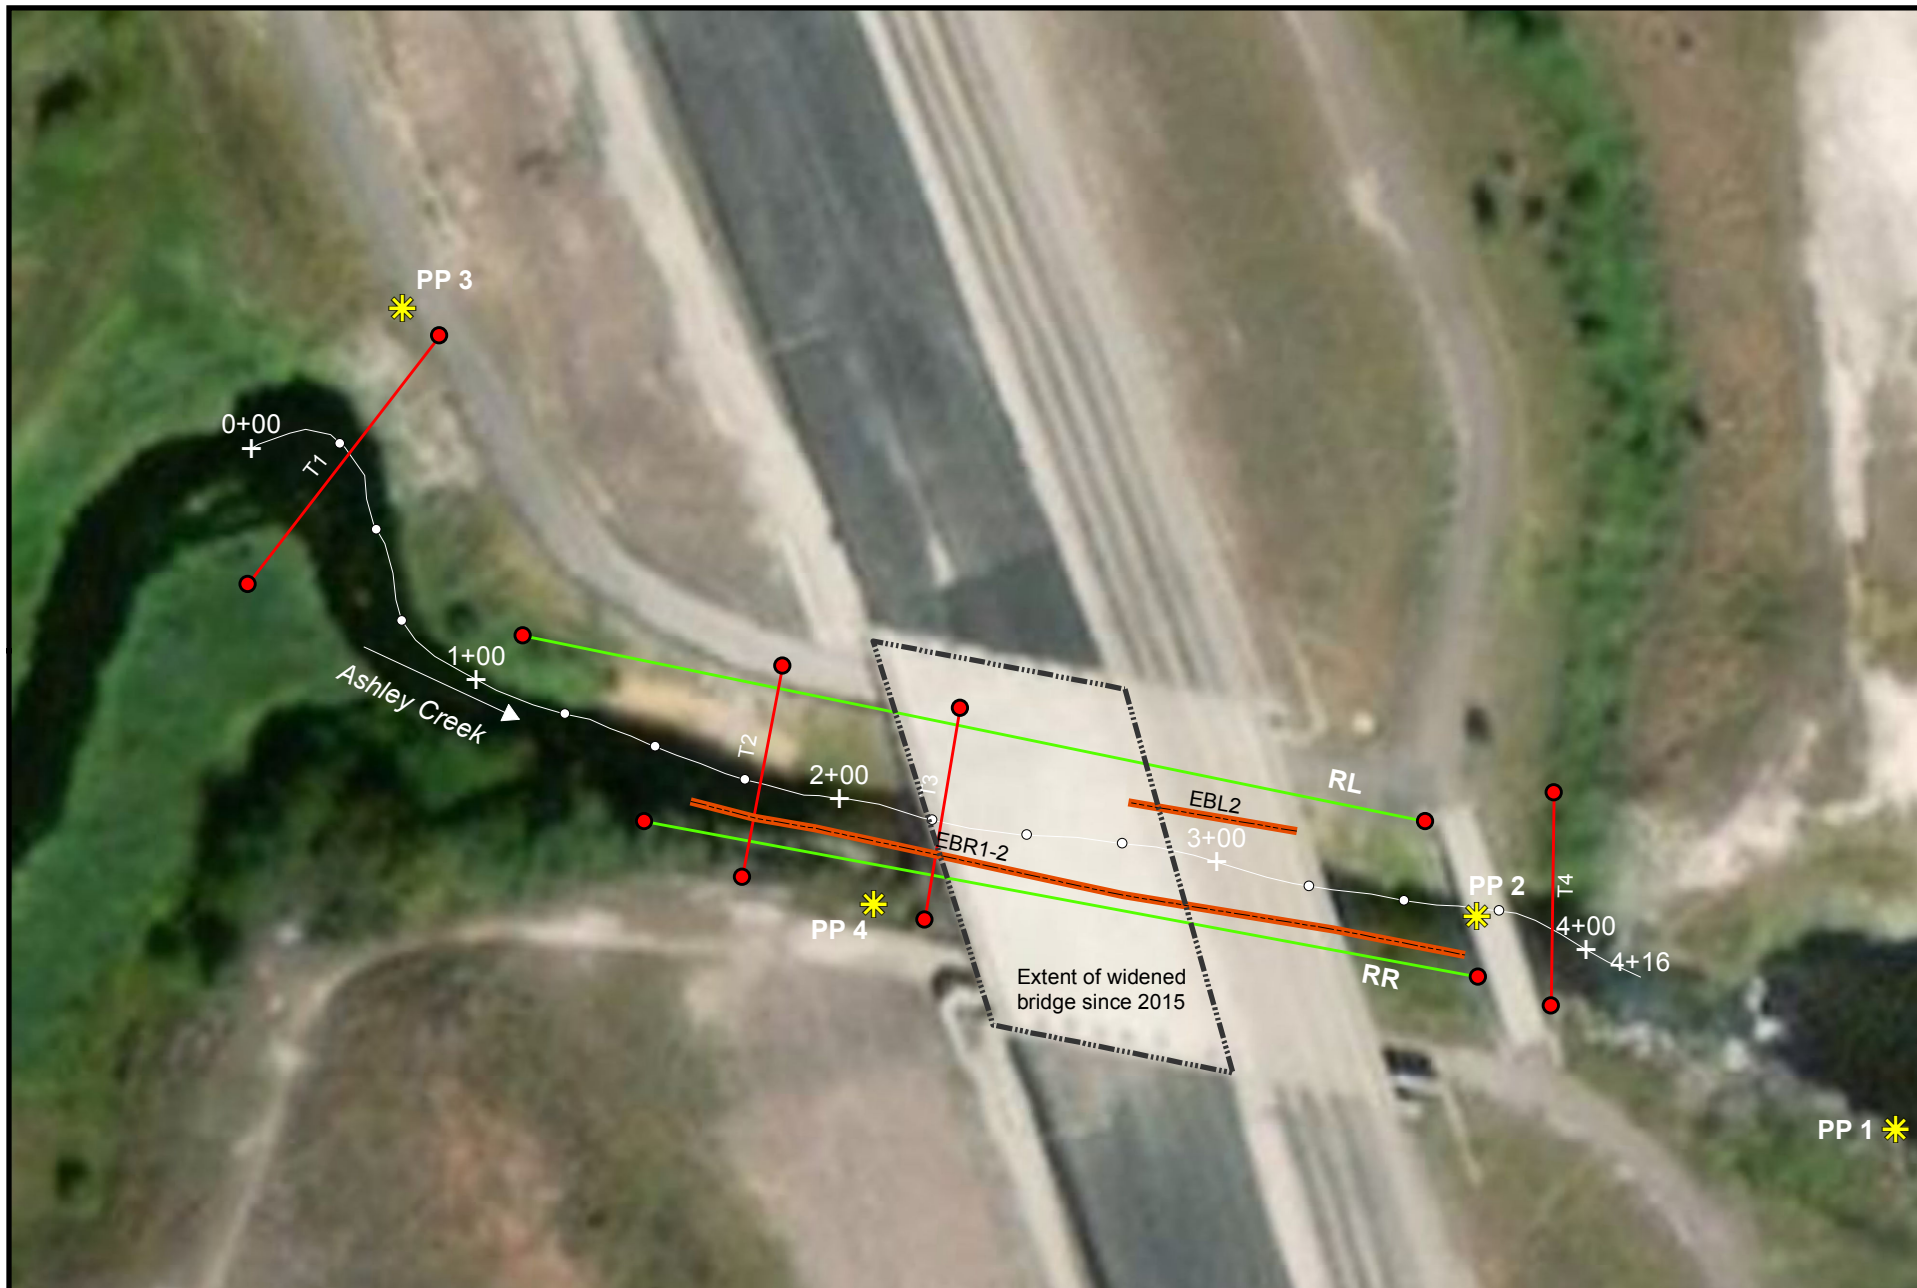
Previous monitoring reports documented bank erosion beneath the bridge and in the vicinity of a storm water culvert outlet. The following section provides an updated bank erosion inventory where new erosion is occurring and where previous erosion has been addressed. Photos of each eroding bank are included in Appendix C of this report, while Figure 2 in Appendix A provides the locations of each eroding bank. The total length of eroding bank along the reconstructed segment of Ashley Creek was 250 feet, or 29% of the total bank length of 860 feet. Of the 250 feet of eroding bank, 155 feet (62%) occurs beneath the highway bridge

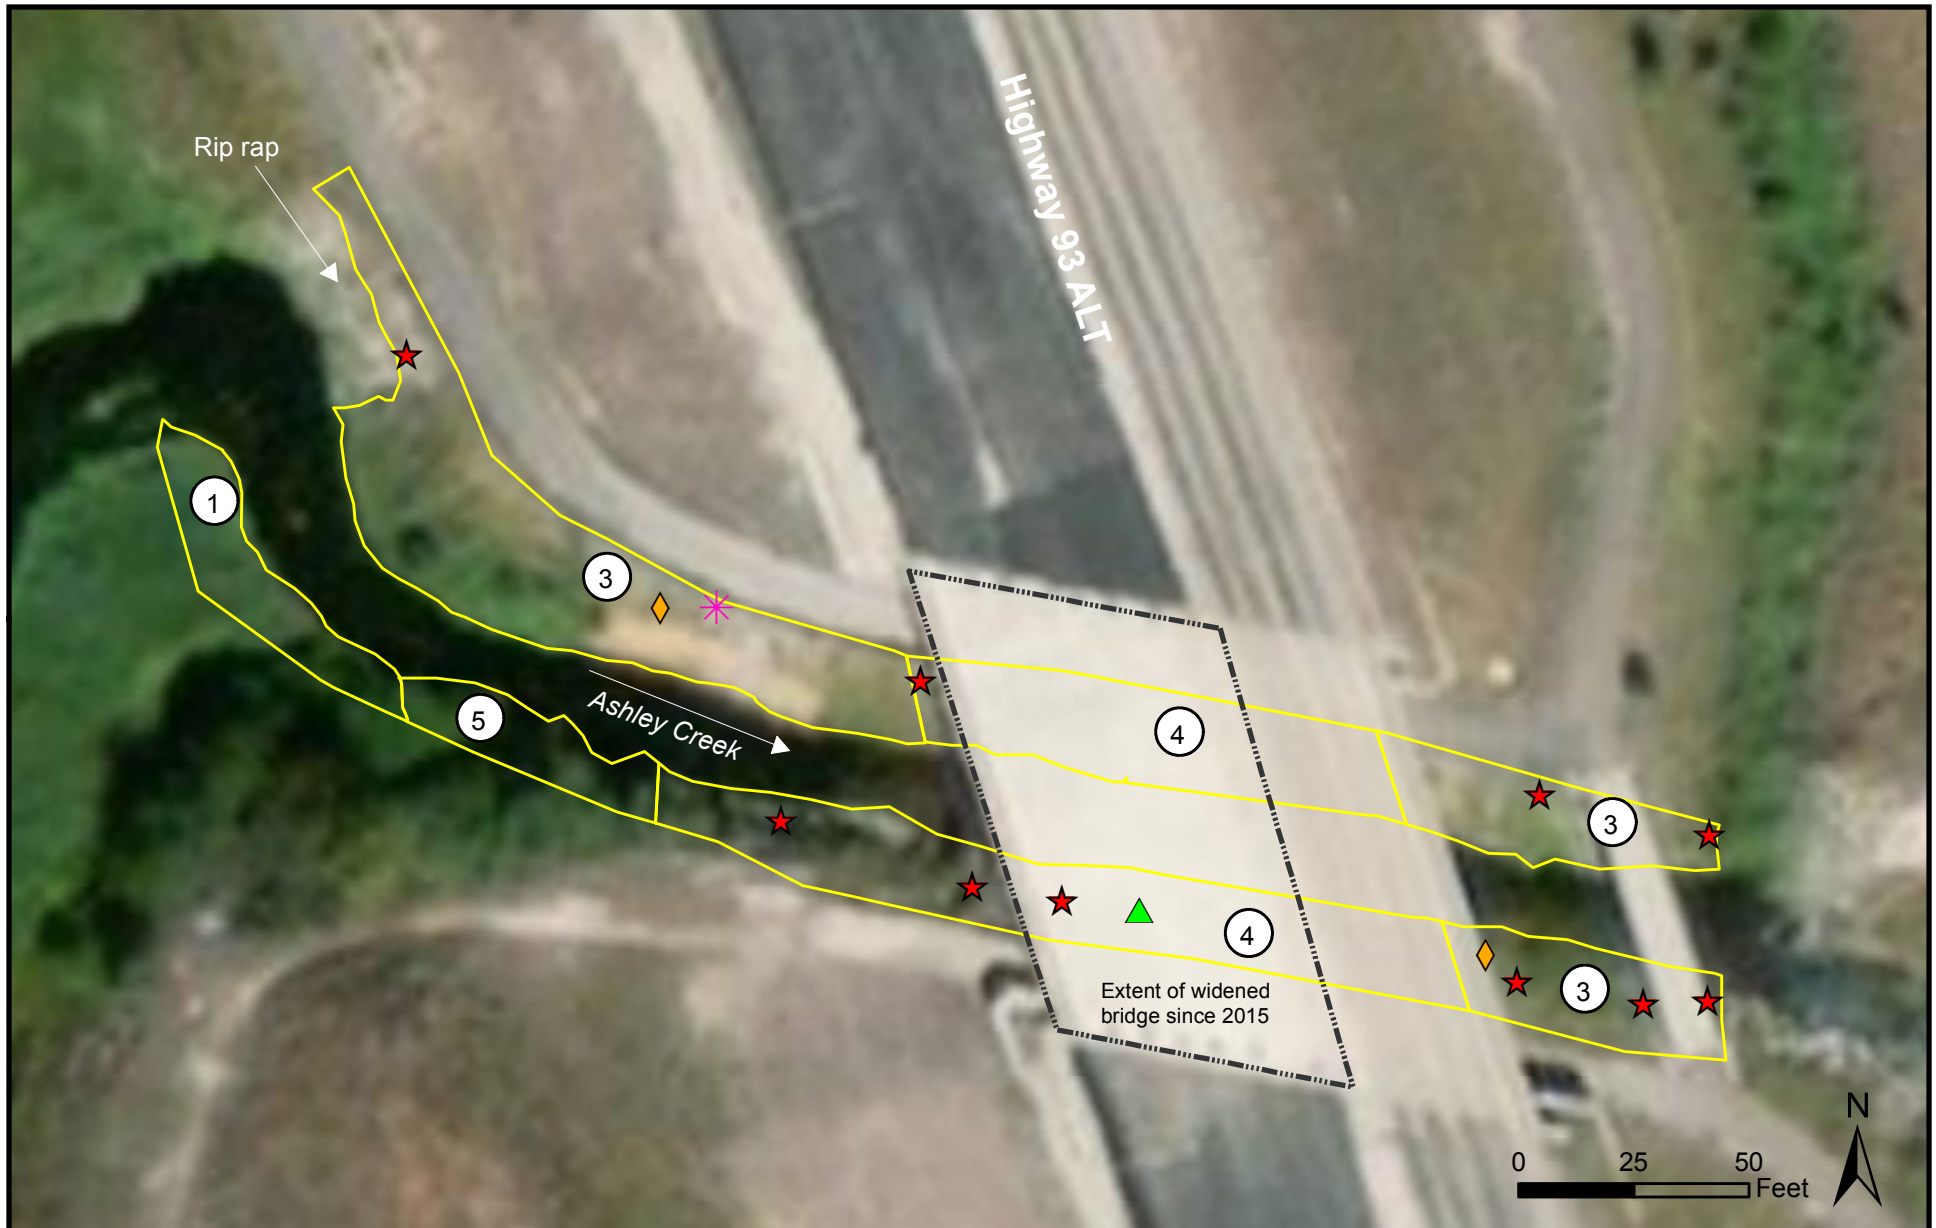
Dominant species recorded along the riparian transects were combined with visual observations in other areas to develop a vegetation community map (Figure 3, Appendix A). Four community types were observed in 2018, which included community Types 1 – *Phalaris arundinacea*, 3 – *Phalaris arundinacea/Elymus* spp., 4 – Bare Ground/*Elymus* spp., and 5 – *Cornus alba/Alnus incana*. Side slopes along the straight channel alignment are dominated by bare ground, wild rye (*Elymus* spp.), and reed canary grass (*Phalaris arundinacea*). As the planted shrubs mature and become larger over time, the corridor is expected to become more dominated by woody species. The right bank along the upstream extent of the project reach, which was not disturbed during construction, is dominated by reed canary grass. Community Type 3 on both the left and right stream banks has shifted since the 2015 monitoring event, to include community Types 4 and 5, due to the increase observed in 2018 in bare ground, red osier dogwood (*Cornus alba*), and speckled alder (*Alnus incana*). The majority of the bare ground observed within the riparian corridor was concentrated under the bridge overpass in an area that is permanently shaded. This lack of direct sunlight and precipitation beneath the overpass is contributing to the lack of vegetative cover and increase in bare ground (see additional photos 7, 8, and 9 on pages C-4 and C-5).

Fourteen infestations of four Montana Listed Priority 2B noxious weeds were mapped within the riparian corridor at the Ashley Creek stream mitigation site and are listed in Table 4. Noxious weed occurrences are displayed on Figure 3 in Appendix A with the exception of those observed in trace amounts, which were not mapped. Spotted knapweed (*Centaurea stoebe*) was observed in isolated trace amounts, and was therefore not mapped, but is included in Table 4. A low cover class (1 to 5 percent) was identified for all mapped weed occurrences within the project area. An estimated 6% of the project area has been colonized by noxious weeds, with common tansy (*Tanacetum vulgare*) identified as the most prevalent noxious weed observed on site. Cheatgrass (*Bromus tectorum*), a Priority 3 regulated weed species (not noxious), was also observed within the site.

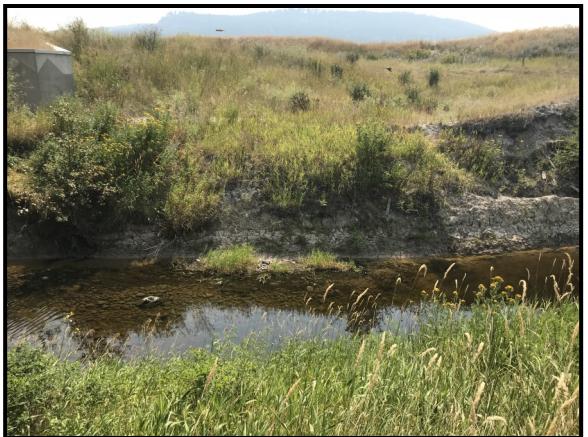
conditions and causes of erosion are identical to EBR1-2, with fine grained soils, relatively steep bank slopes, and lack of functional floodplain adjacent to the channel. A clay lens also protects the left bank from more accelerated erosion.

Additional Photo 2: Upper end of Eroding Bank EBR1 –2
