EXPERIMENTAL PROJECTS CONSTRUCTION REPORT AND EVALUATION

Barrier Reflector Durability Study

Location: Cascade County/Great Falls District: I-15 Deck Structures
Emerson and Sun River

Experimental Project: MT-19-06

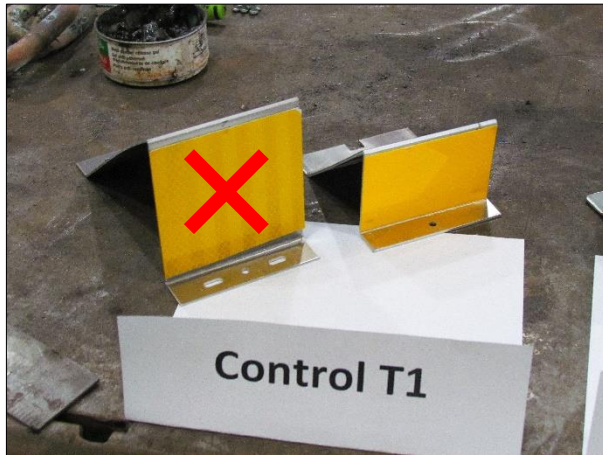
← Control **T1** is the conventional reflector that is currently used and proven to be unable to withstand accumulated reflector impacts.

T1 is installed on the **Emerson Jct. Southbound** structure.

Note: When this image was taken it was unclear which of the two conventional reflectors were to be used on the project; the unit on the right is the chosen unit.

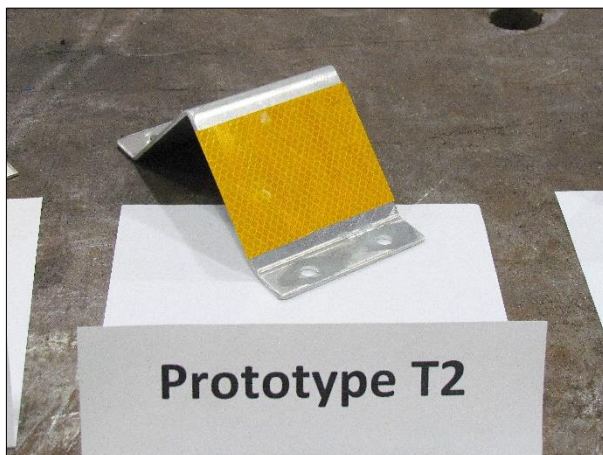
← Prototype **T2** is installed on the **Emerson Jct. Northbound** structure.

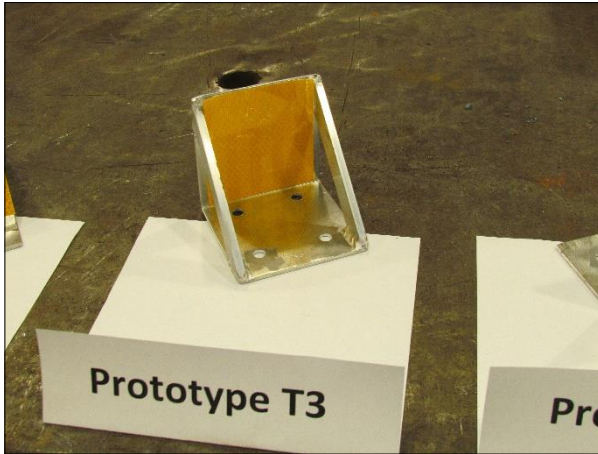
← Prototype **T3** is installed on the **Sun River Bridge Northbound** structure.

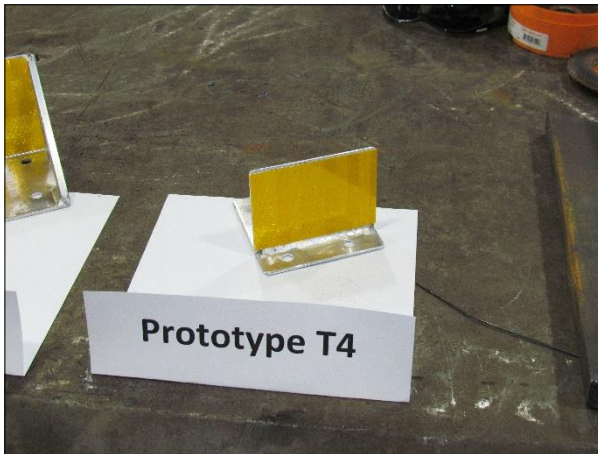
← Prototype **T4** is installed on the **Sun River Bridge Southbound** structure.

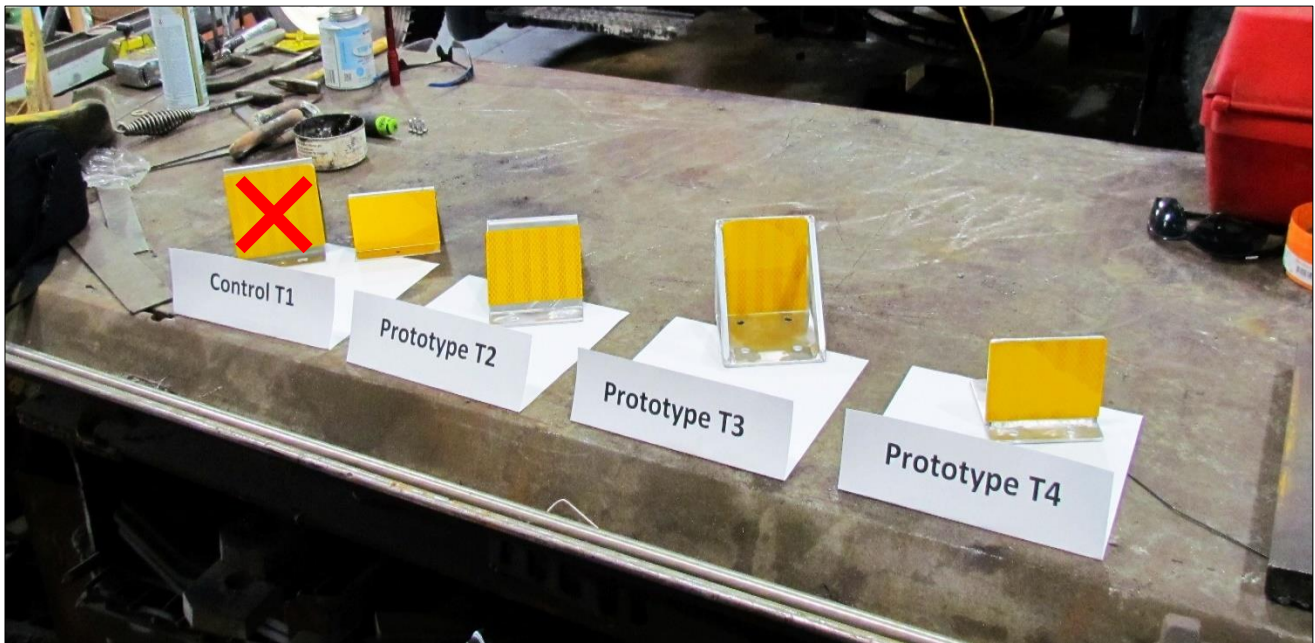
↑ Overview of control and prototype designs.

↓ The conventional reflectors had a thickness of $1/16$ "; whereas the prototypes design thickness was increased to $1/8$ " respectively. The alloy used was 6061 aluminum. Bracket supports used on T3 & T4 were $1/4$ " in thickness

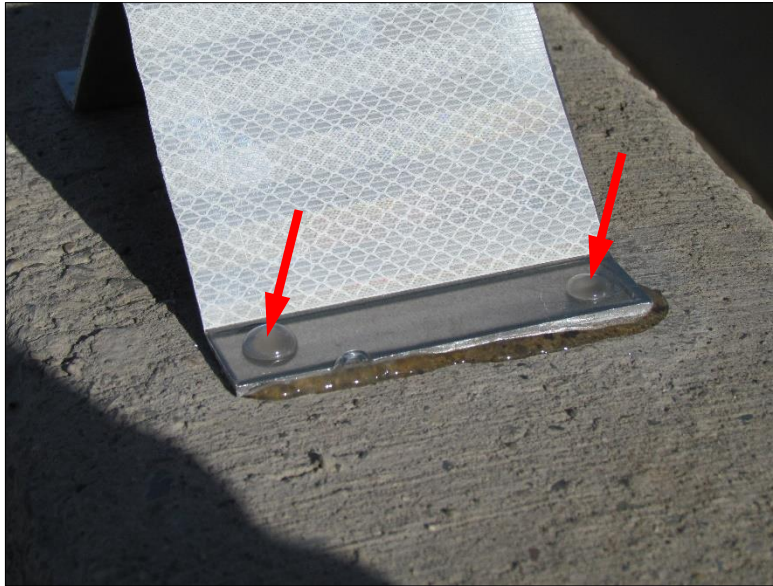
← Completed placement of a 'glue only' attachment.

Note: The red arrow shows the adhesive extruding through the unit's screw holes.

This excess *may* allow for a more efficient bond of the unit to the barrier with the glue-only units.
