EXPERIMENTAL PROJECTS CONSTRUCTION REPORT AND ANNUAL EVALUATION

CONTECH® A-2000 POLYVINYL CHLORIDE (PVC) PLASTIC PIPE

Project Name: Checkerboard - Martinsdale (CN 4803000)

Project Number: STPP 14-2(20)63

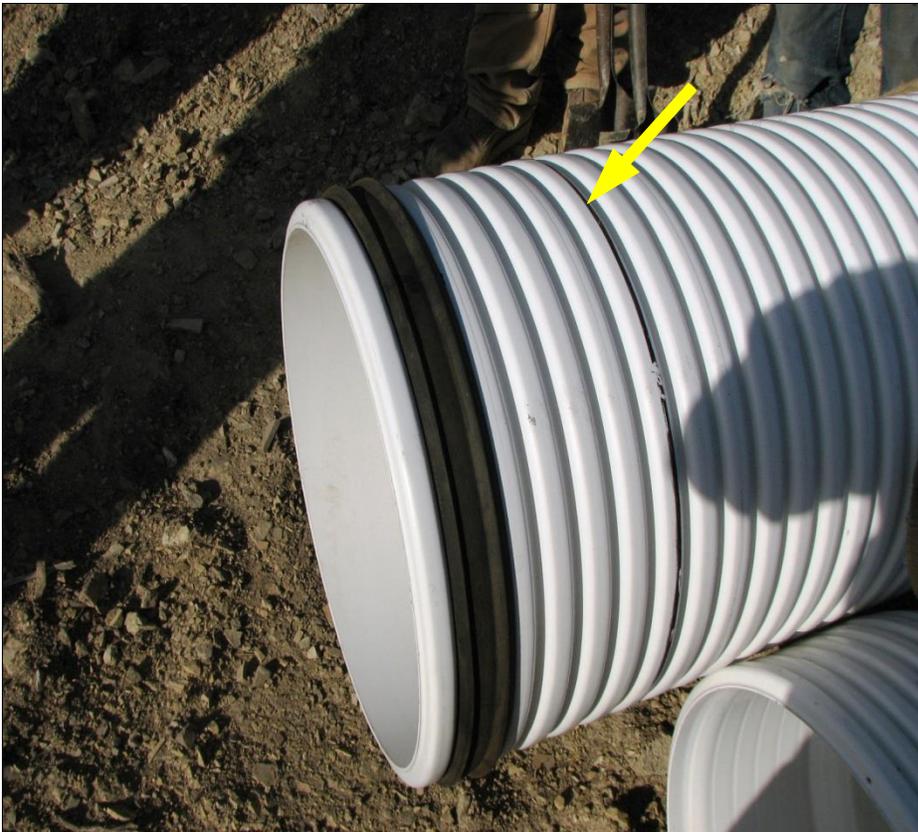
← The spigot end with the (double sealing surface) gasket is placed on the first two pipe corrugation valleys.

Note the black ring located approximately one foot from the spigot end (yellow arrow).

When the bell end of the pipe reaches this *home* mark within one corrugation it is seated correctly.

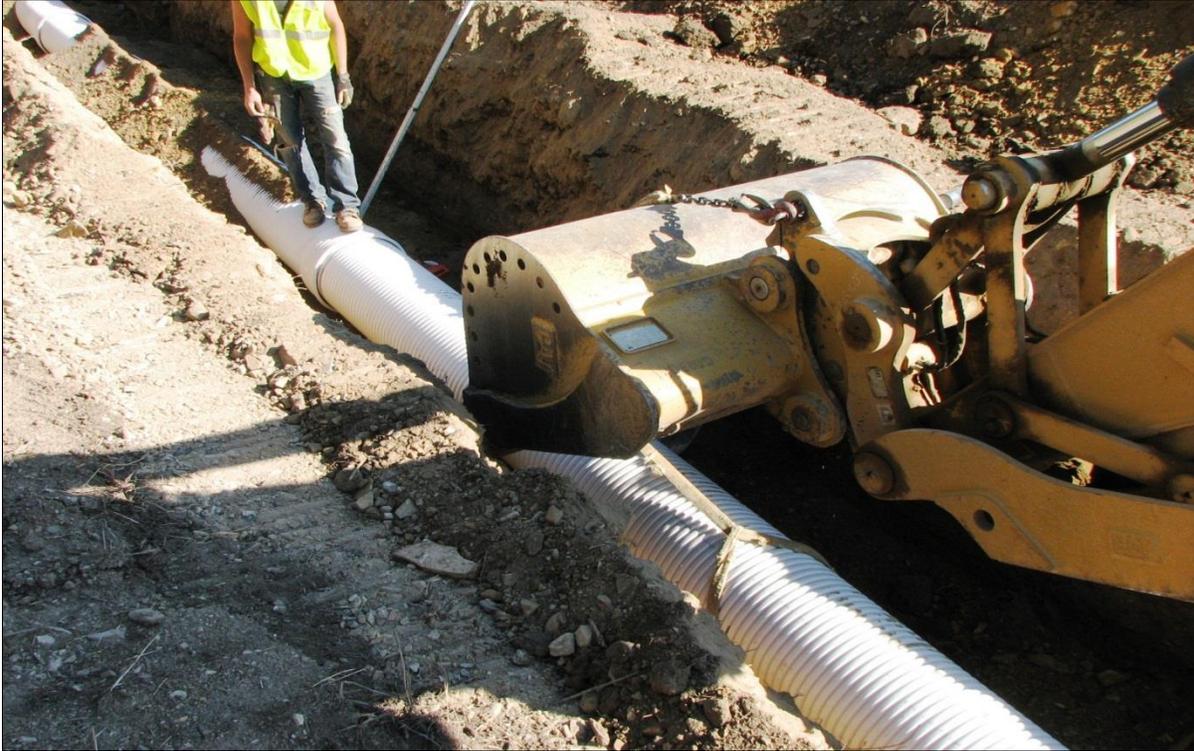
↑ The contractor found using a sling to stab the pipe sections was more efficient.

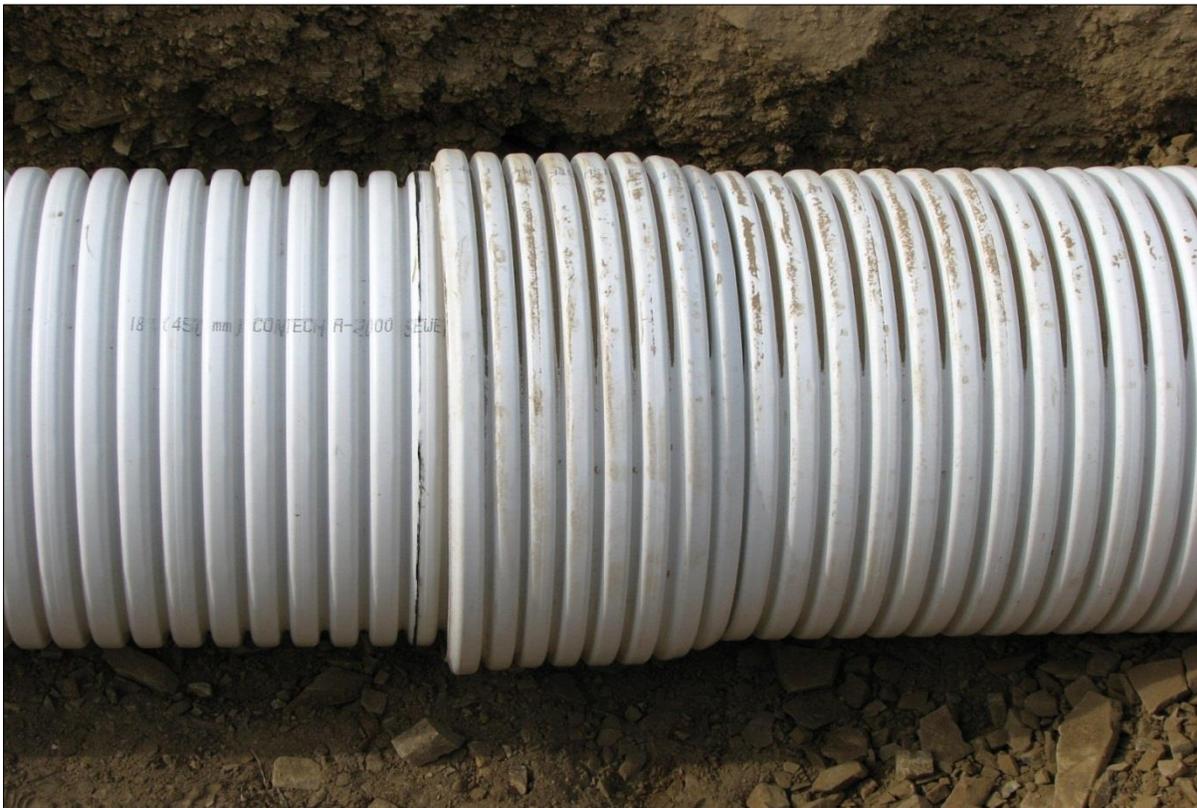
↓ Example of a properly homed bell and spigot connection.

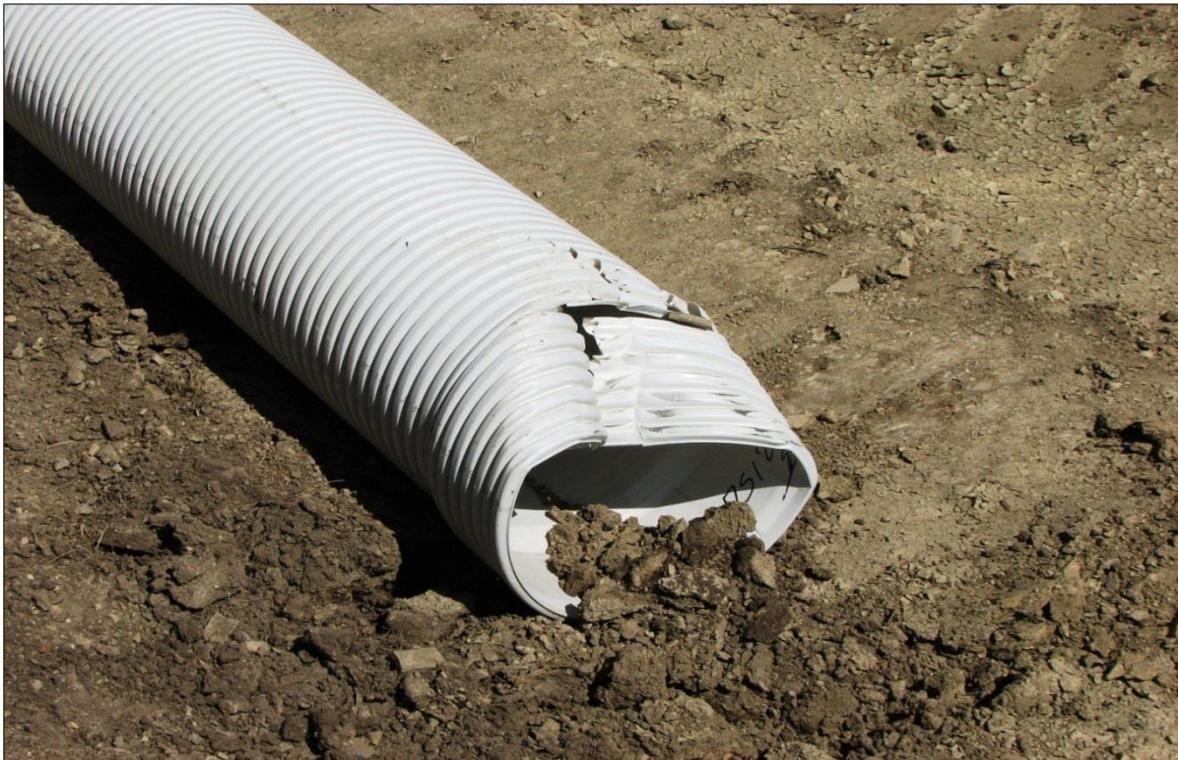
- ↑ Sample image of how pipe sections were shortened on site using a portable saw.
- ↓ Damaged pipe are saved and used when shorter sections are required during installation.

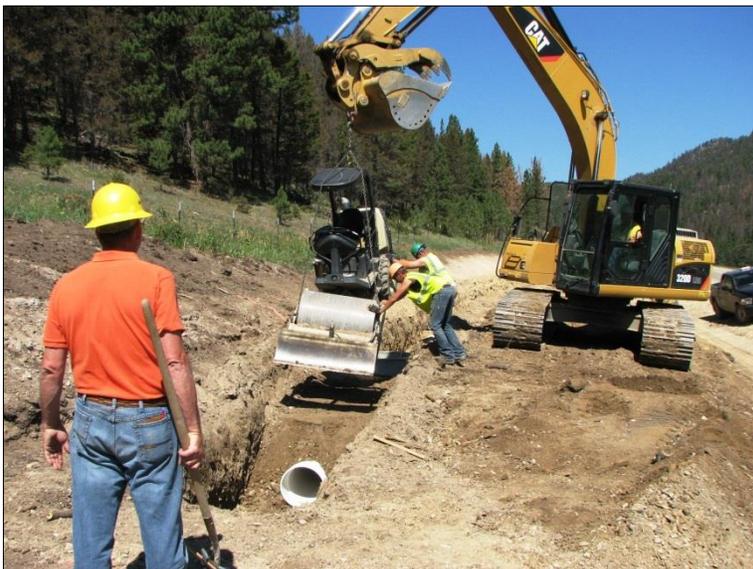
← The excavator is used to lower the single drum vibratory roller on top of the filled pipe section.

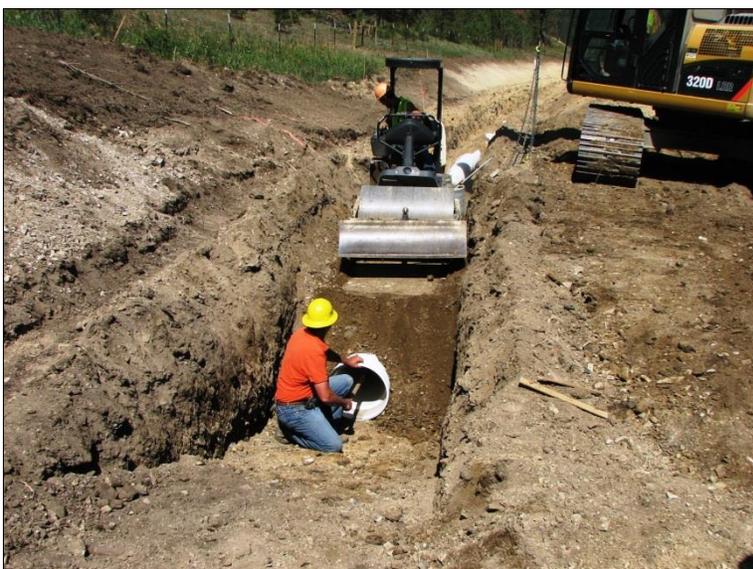
← The roller makes several passes using both static and dynamic modes to represent how it would be normally done throughout the project.
