FINAL REPORT

GEOSYNTHETIC REINFORCED SOIL - INTEGRATED BRIDGE SYSTEM (GRS-IBS)

Location: Highway 89 (P-3/C000003), Pondera County-South Fork Dry Fork Marias River Crossing

Project Type: Geosynthetic Reinforced Soil - Integrated Bridge System Installation (GRS-IBS)

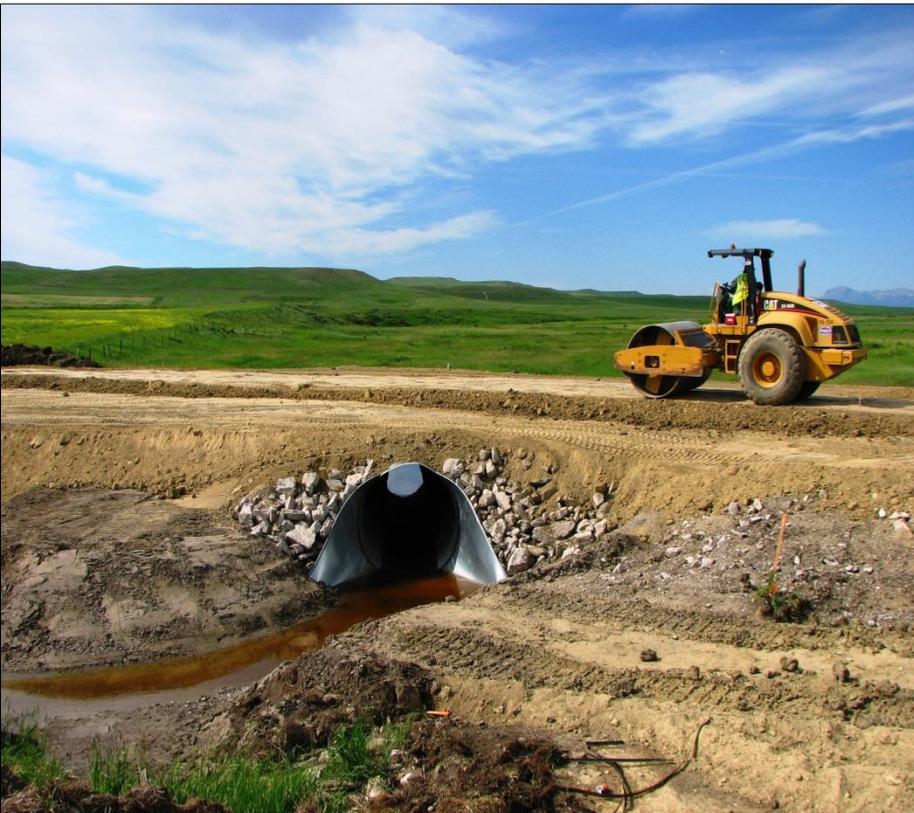
← A culvert was installed in the detour to transfer the stream which normally is dry but did have standing water at the time of this documentation. Rip rap was added, and later straw wattles were included.

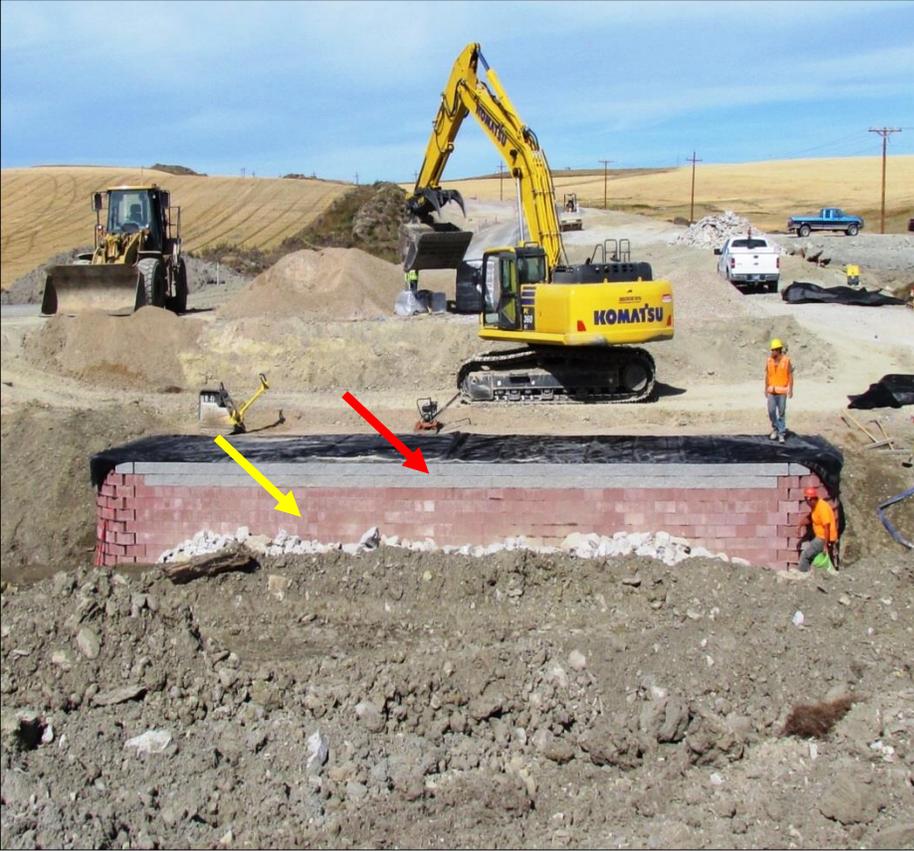
← During this site visit the north GRS abutment 2 has accumulated about ten (10) layers of the friction block facing unit. Geotextile reinforcement layers are applied at a depth of each block face layer at eight (8) inches.

The facing unit (considered a flexible facing element); is used as a façade to serve as a form for compaction, and protect the GRS mass from outside weathering. The red color block (yellow arrow) is solid core; the grey block (red arrow) is standard split-face hollow core (8"x8"x16").

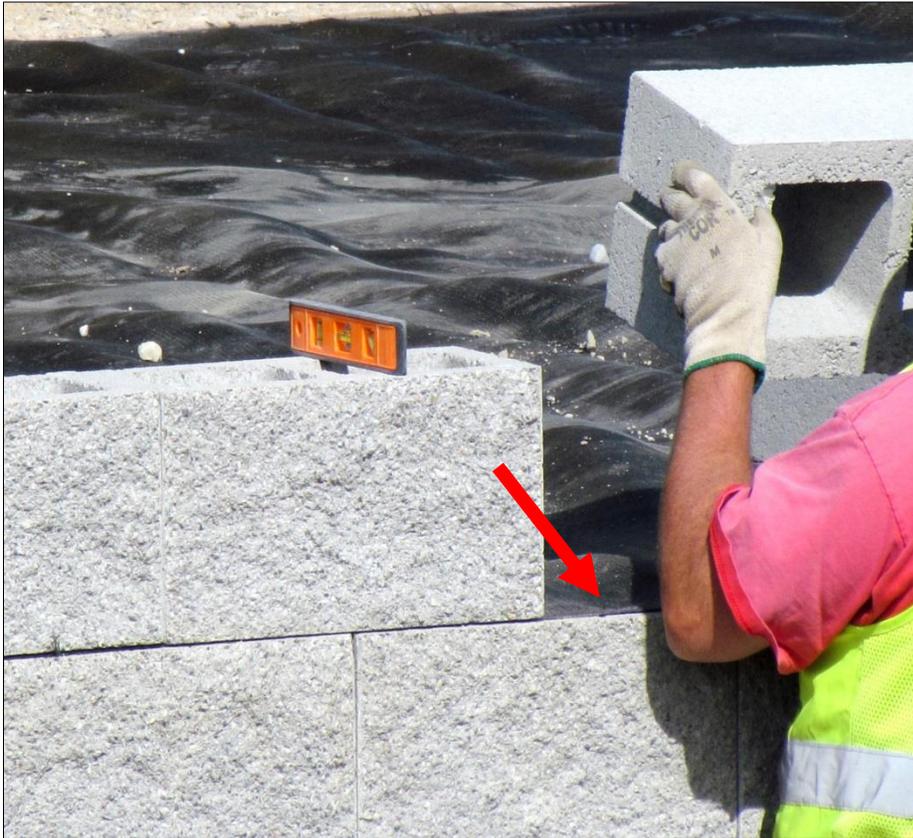
← Each facing block is carefully positioned and checked for proper placement.

Although not seen in this image, the workers would use pieces of asphalt shingles (as shims) to insure correct vertical and horizontal alignment of the facing block. The rough side of the shingle is placed on the surface of the geosynthetic.

Note that each layer of geotextile is extended to the edge of the CMU (red arrow).

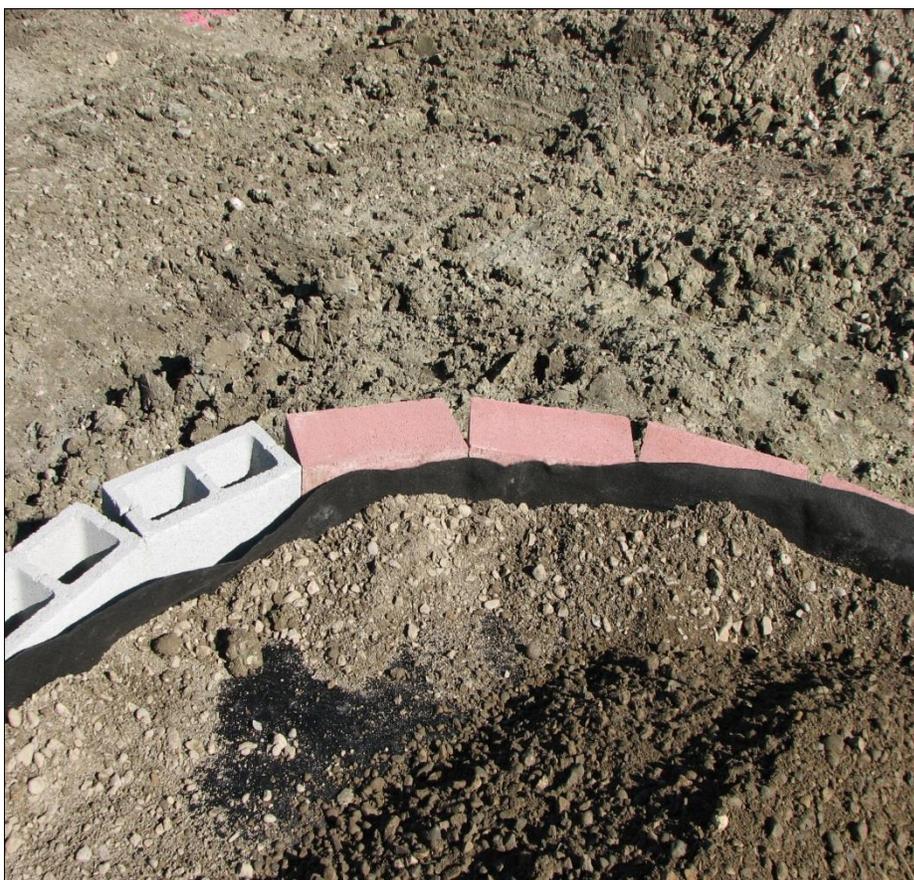
← A closer view of the separation fabric used in the interior of the radius.

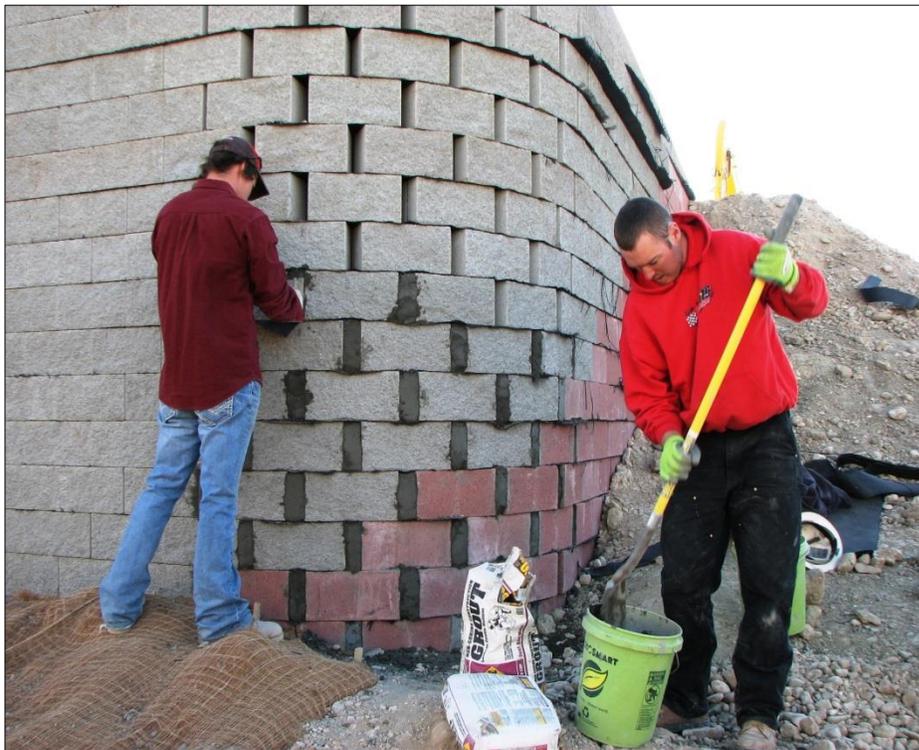
← To further prevent potential migration of fill material through the gap of the radius and for a more aesthetic appearance of the overall abutment structure, the cavities were filled with Sakrete structural hydraulic non-shrink cement (or grout).

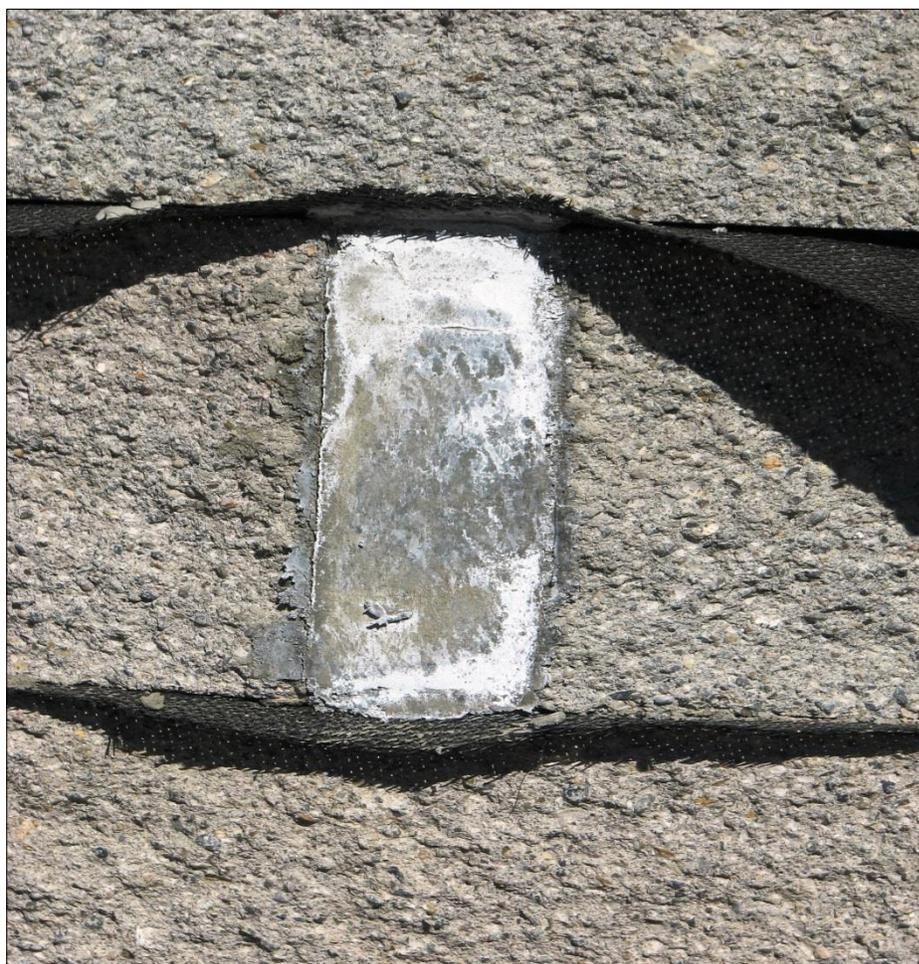
← Sample image of grouted radius gap.

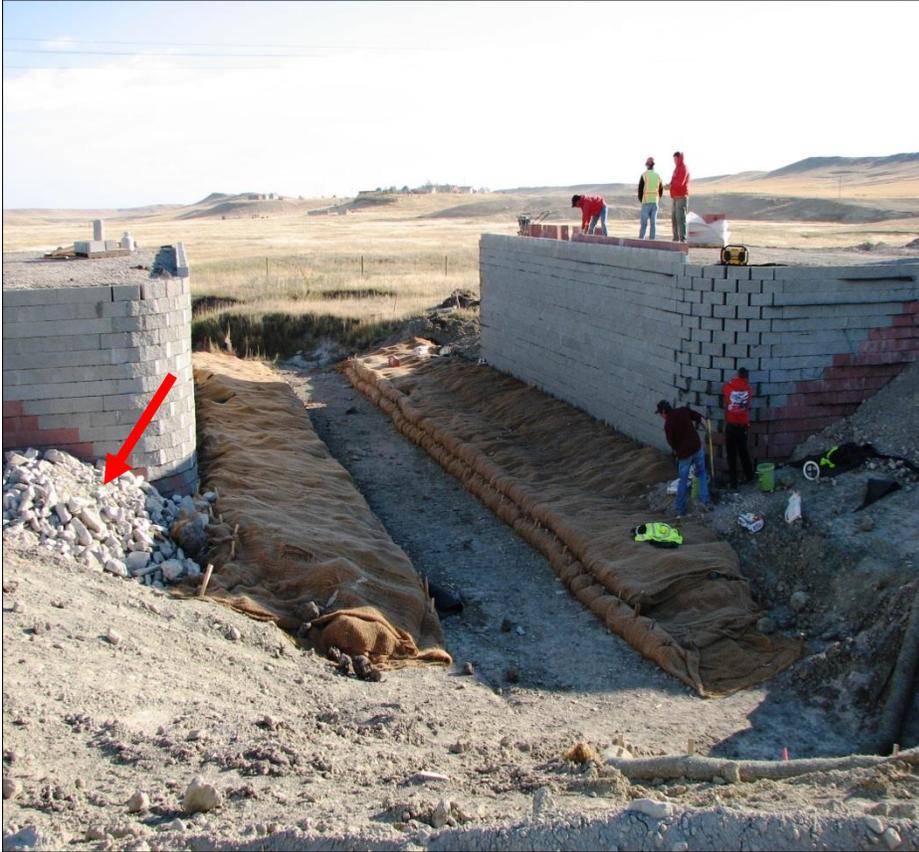
← Both north and south abutments are near completion. Erosion control coconut blankets and wattles are in place over the rip-rap, staked down and the stream channel established.

Workers continue grouting the gaps at the radius; rip-rap will be added around the radius (as seen on the north abutment 2, red arrow) once the grouting is complete.

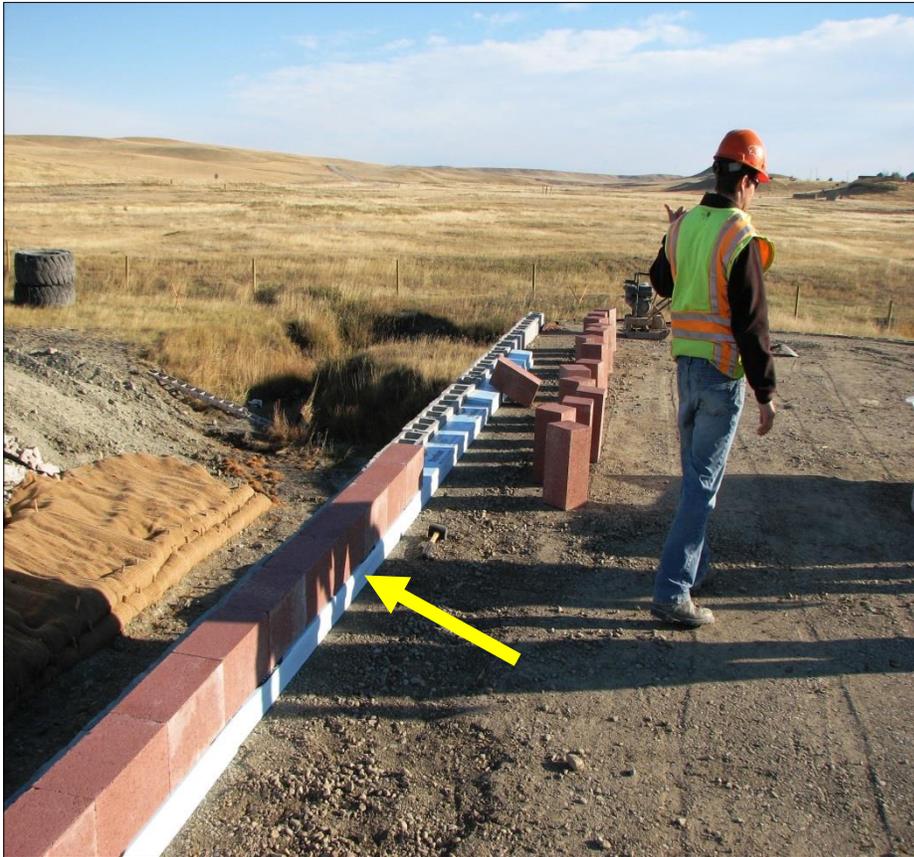
← Final preparation for the beam seat. One layer of 2"x8" foam board (yellow arrow) is placed directly behind the last top layer of CMU hollow core. Solid core block is positioned upon the 2" layer of foam board.

One of the purposes of the layer of foam board and solid CMU is to create a barrier to minimize any potential outside environmental factors which may affect the performance of the composite GRS base at the beam seat level.

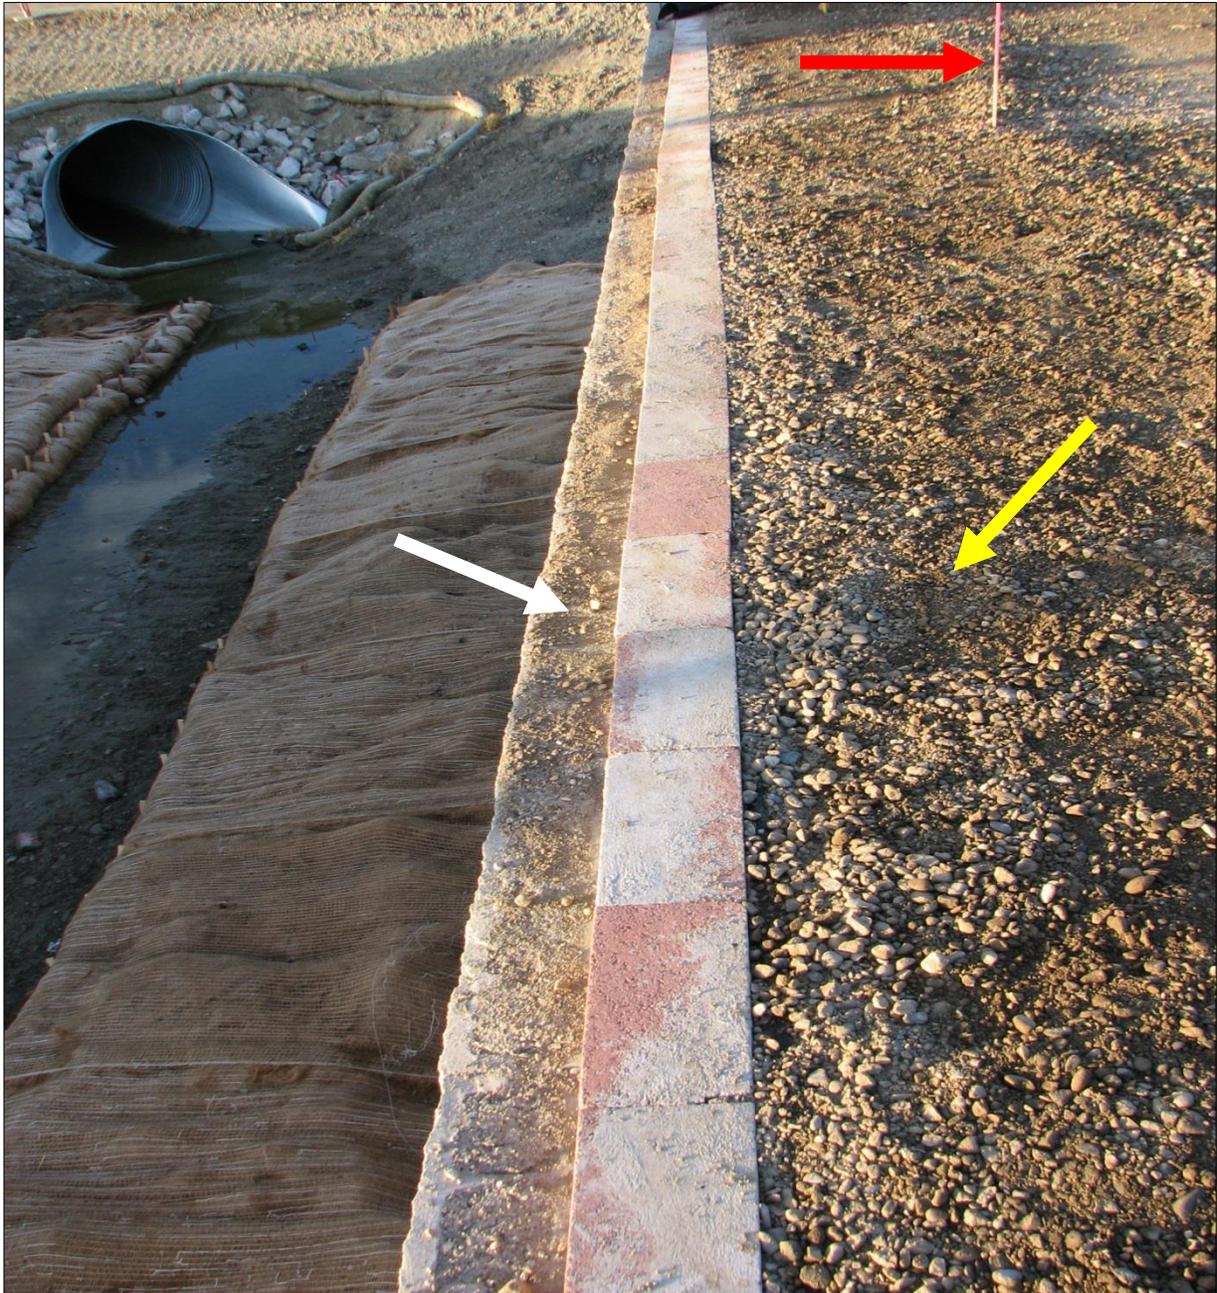
- ↑ The north abutment bearing bed has a topical layer of backfill with an elevation even with the solid core block (yellow arrow). This will insure when the pre-cast beams are set that equal distribution of weight is averaged on the beam seat and the CMU solid core. The foam beneath the solid core will compress if the block is too high or in case the beams have some settlement.

The survey stick (red arrow) in the background represents the centerline of the deck and the limit of the beam seat.

To better secure the top facing blocks (white arrow), they were pinned with no. 4 rebar to a depth of 20" within the core. Rebar penetrated the first two layers of geotextile membrane, once set the hollow core blocks were filled with concrete.

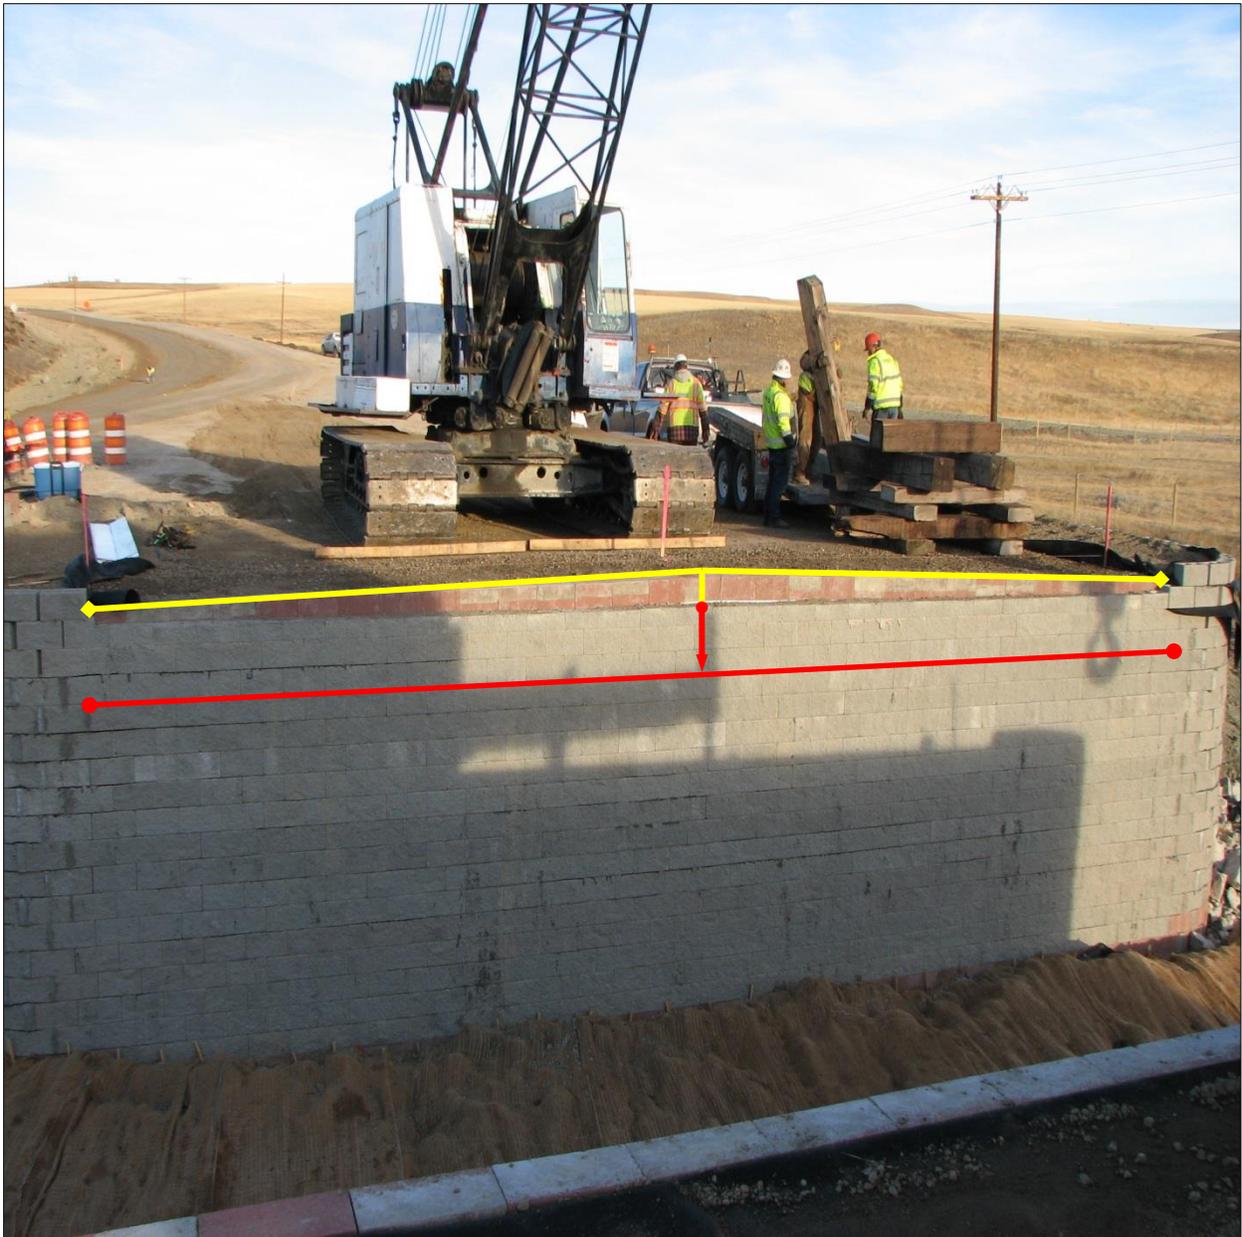
↑ The north and south abutments are now ready to receive the pre-cast beams. The superimposed yellow line is to show the GRS beam seat is set at an approximate 2% superelevation for deck placement.

The red superimposed line represents the depth of concrete poured and struck off into the fascia CMU hollow core blocks encompassing the beam seat area. As stated earlier, rebar was pinned into each of the cores to a depth of 20" as not to puncture the next layer of geotextile (past the third layer of CMU).

Once the beams are set and the wingwall facings are completed the same scenario of pinning and grouting the first three layers of blocks will be applied.

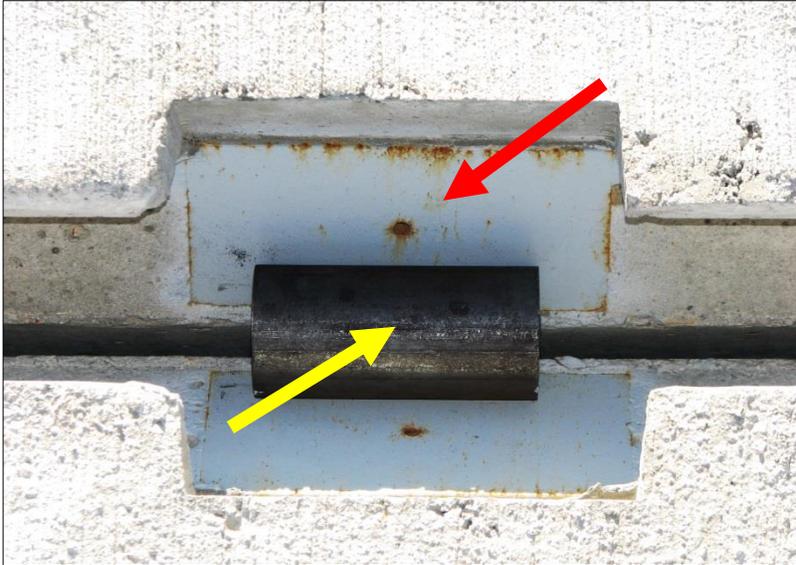
← After the slabs are placed the beam joints have pre-set welded bar and shears studs embedded in the pre-cast slabs (red arrow). A 2"x4" steel rod is laid in the groove channel of the joint to provide a welded tie (yellow arrow).

Each seven (7) slab joints will have eight (8) welded ties for a total of 56 for the entire deck.

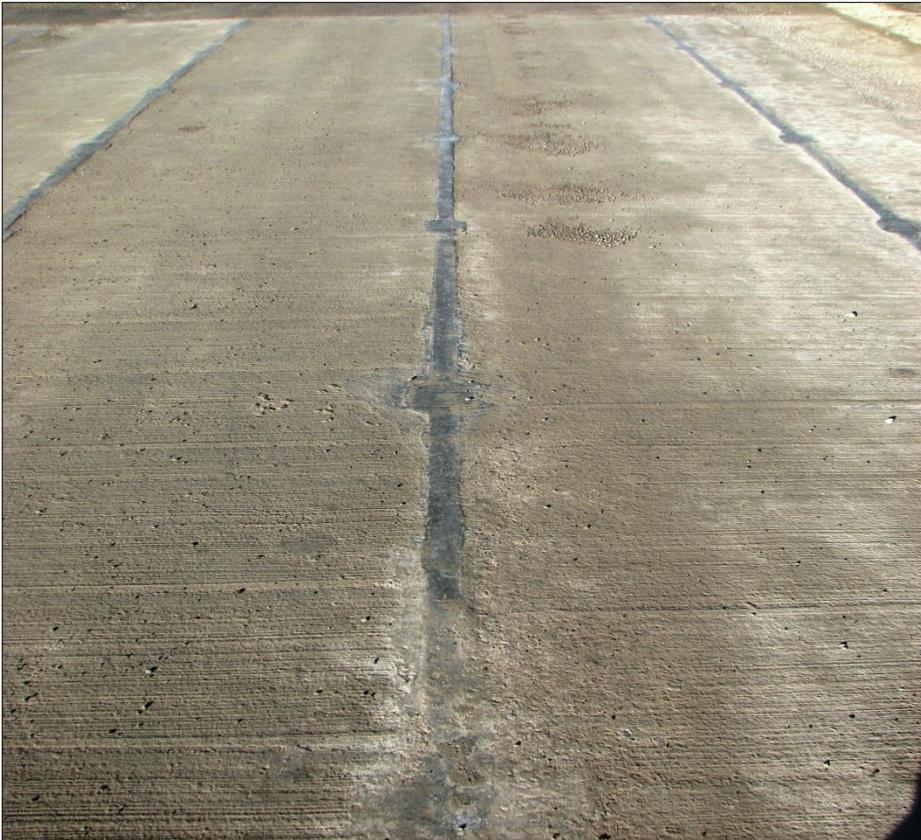
← Once all ties were welded the gap in the slab joints were plugged with foam backer rod then filled with non-shrink grout as seen in this image.

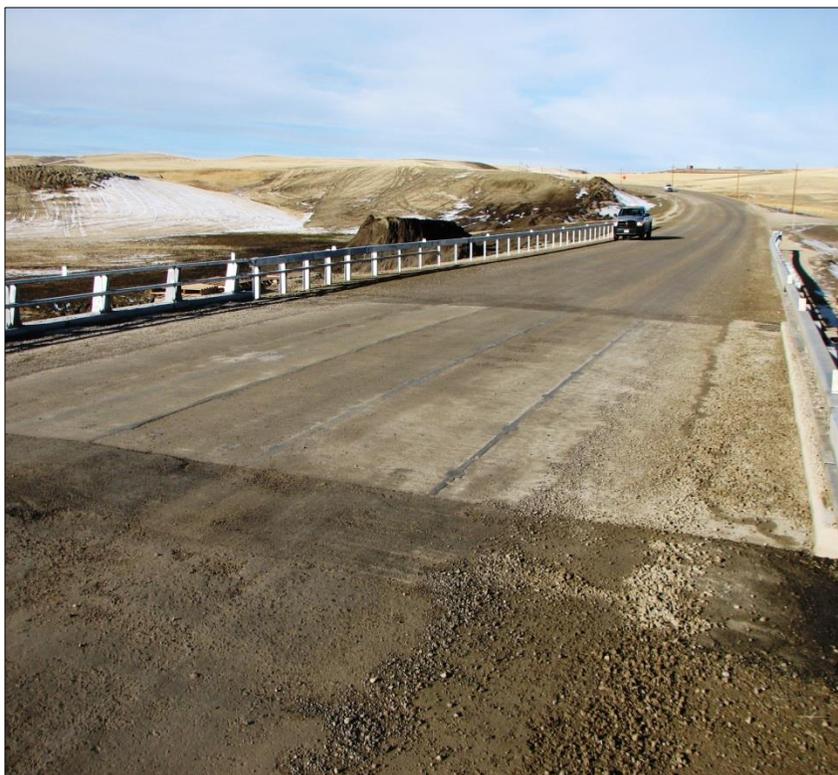
← North view of the completed GRS bridge and guardrail installation.

Due to weather constraints the contractor ran out of time for the paving phase and will resume work in the spring of 2014.

In the interim an asphalt and gravel approach will be in place over the winter season.

The contractor did comply in adding the integration zone (geosynthetic reinforcement layers) to the approaches.

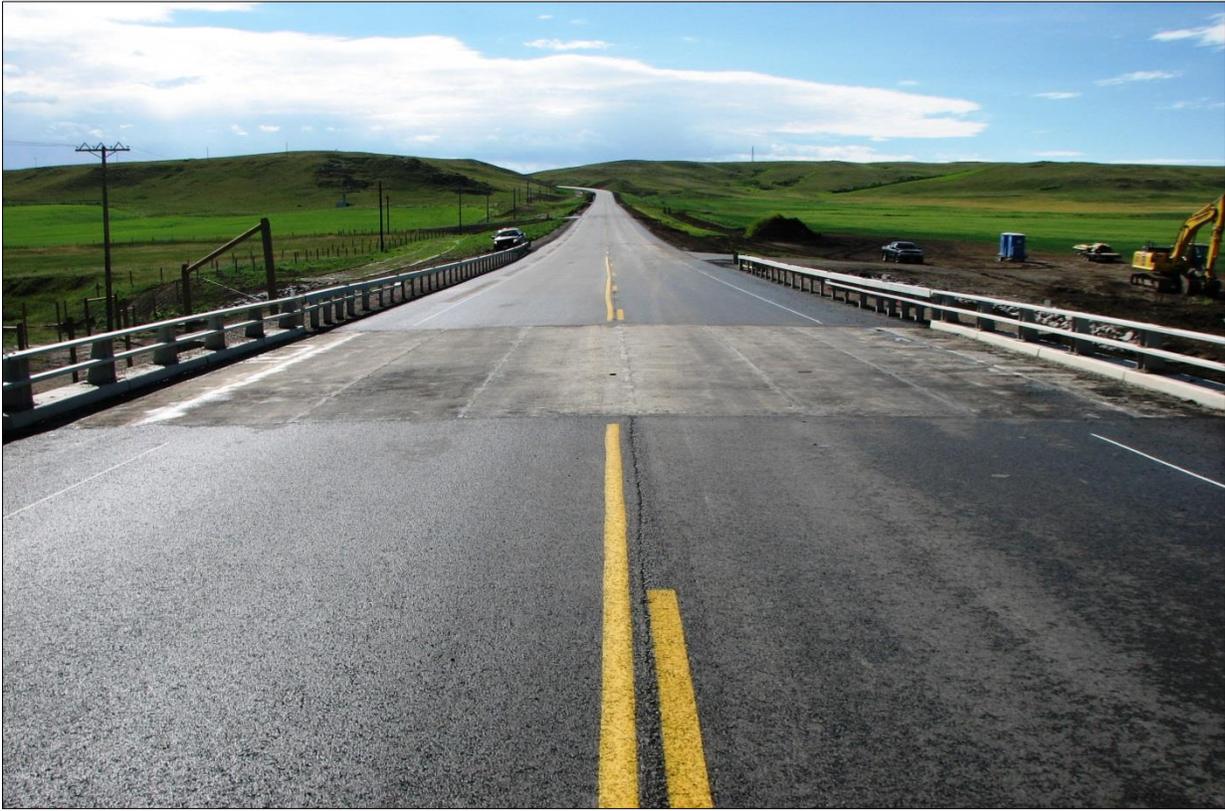
↑ Completed GRS structure; view south.

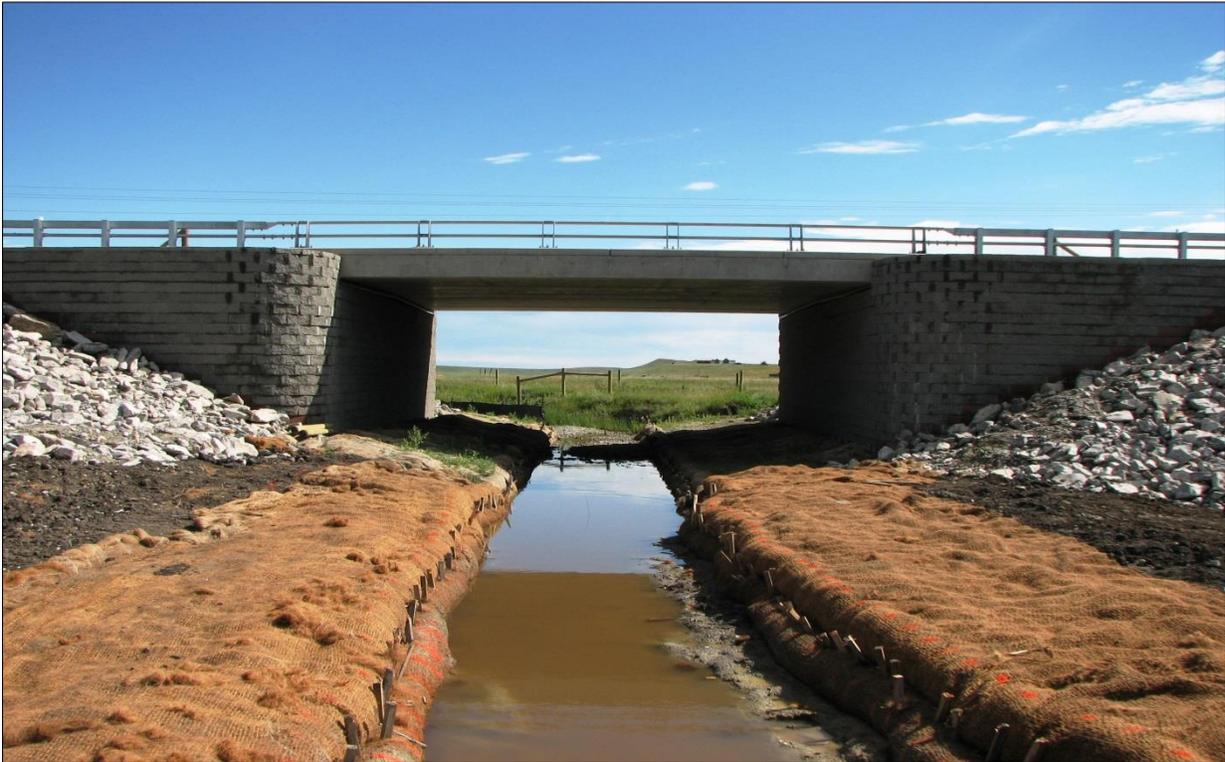
↓ Completed GRS structure; upstream view - east.

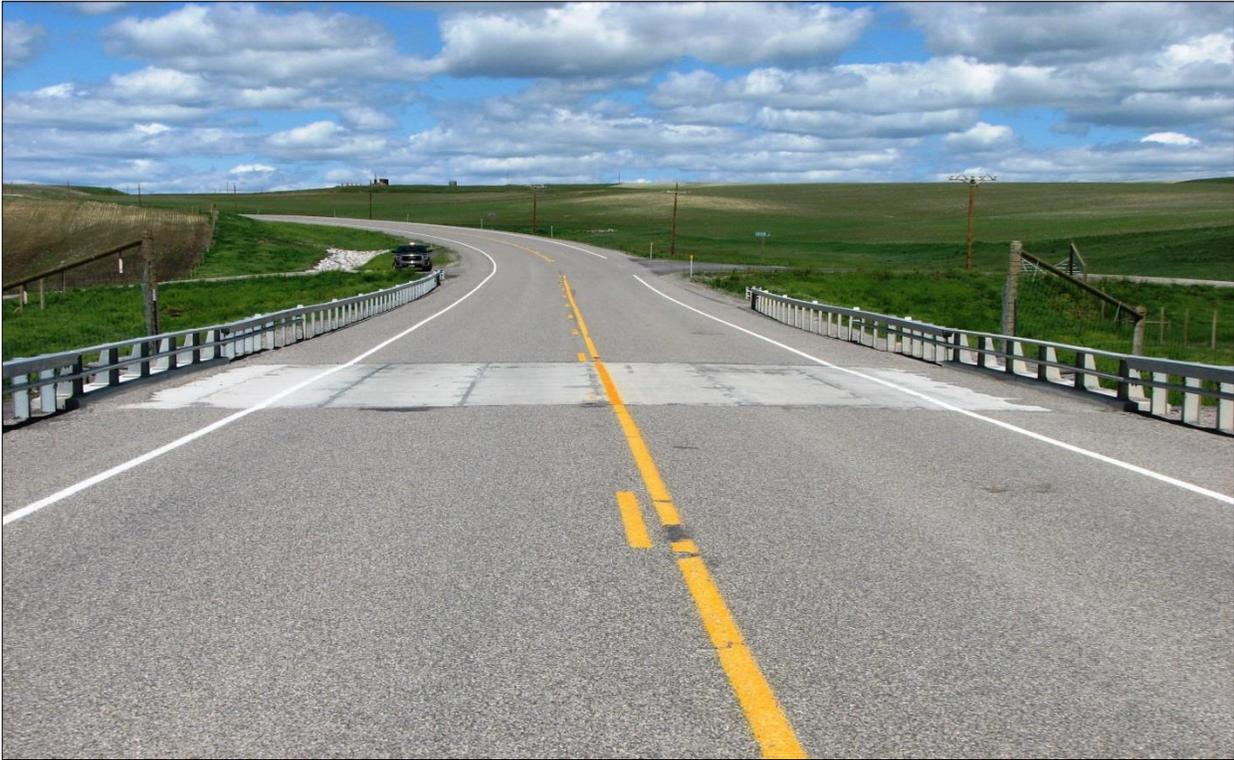
↑ Top view image of structure; view north.

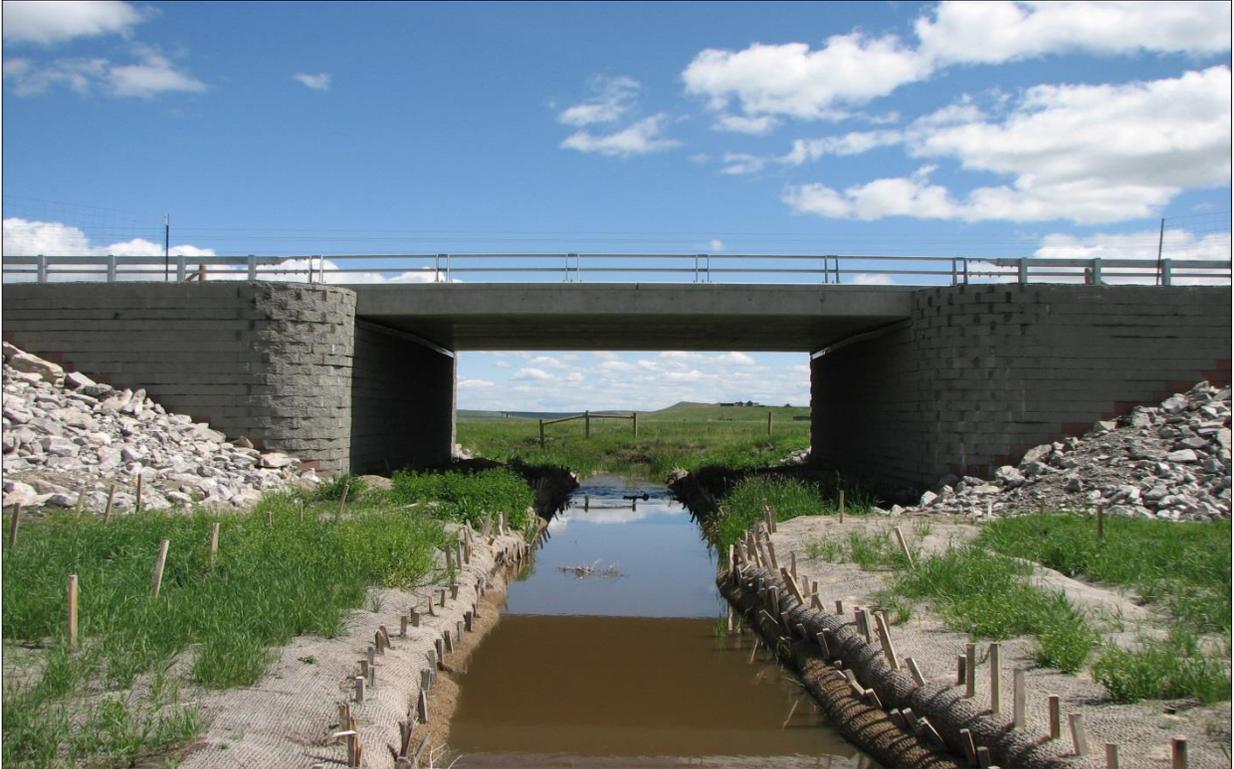
↓ Side view image of structure; view east.

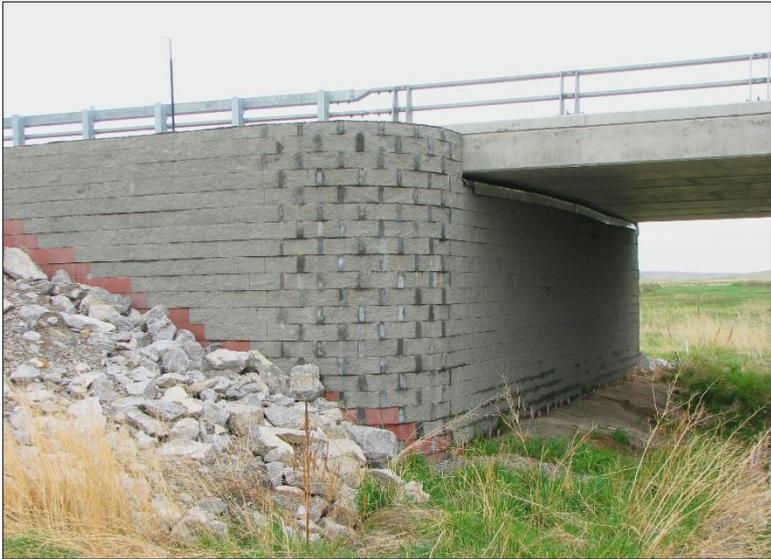
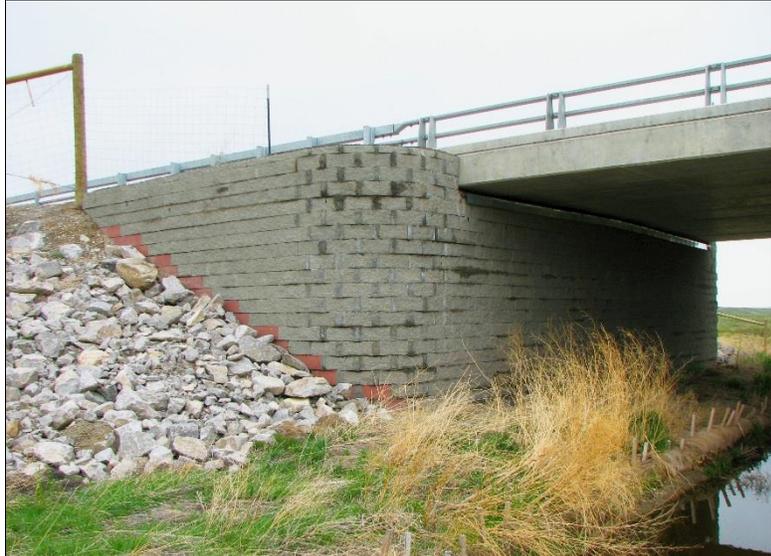
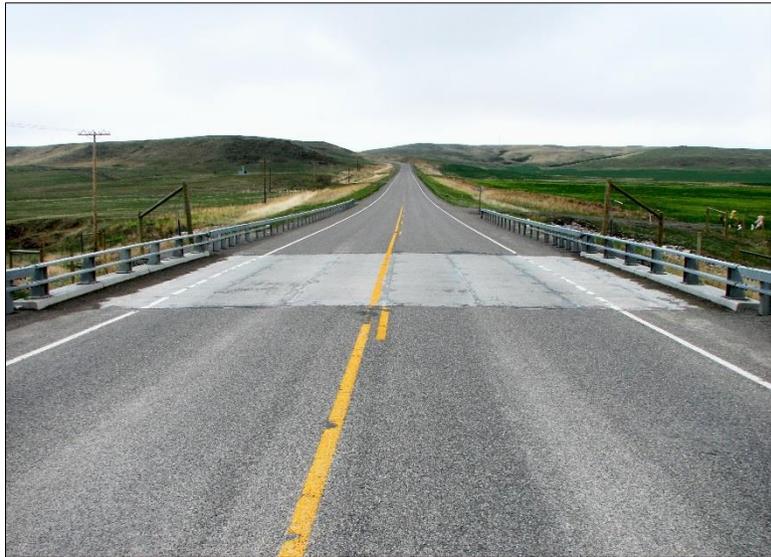
←↓ Representative images of the GRS structure:

Top image is north abutment; west side.

Center image is south abutment; east side.

Lower image is view of GRS deck (view south).

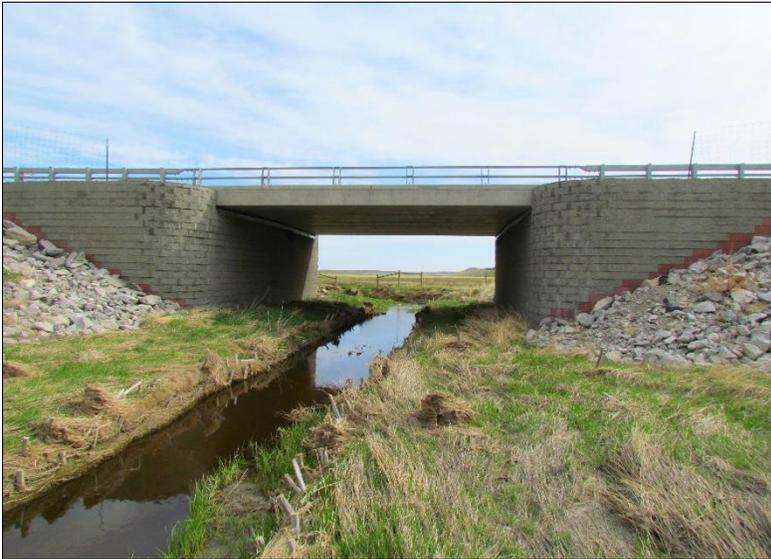
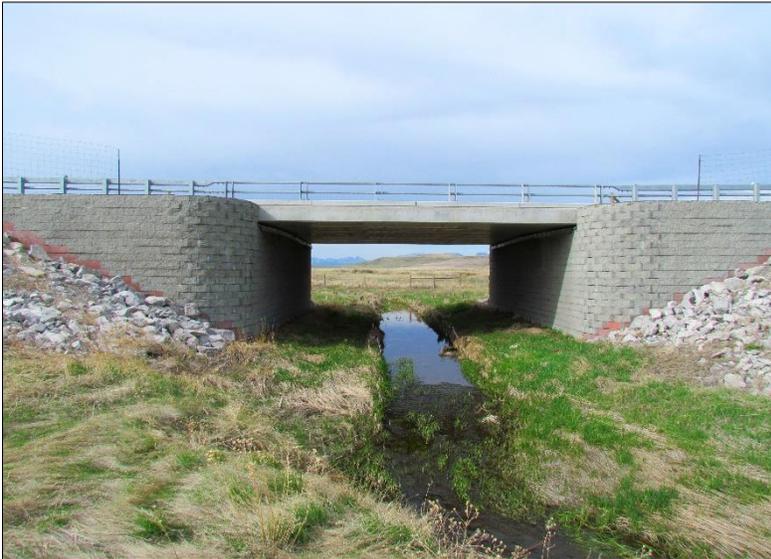
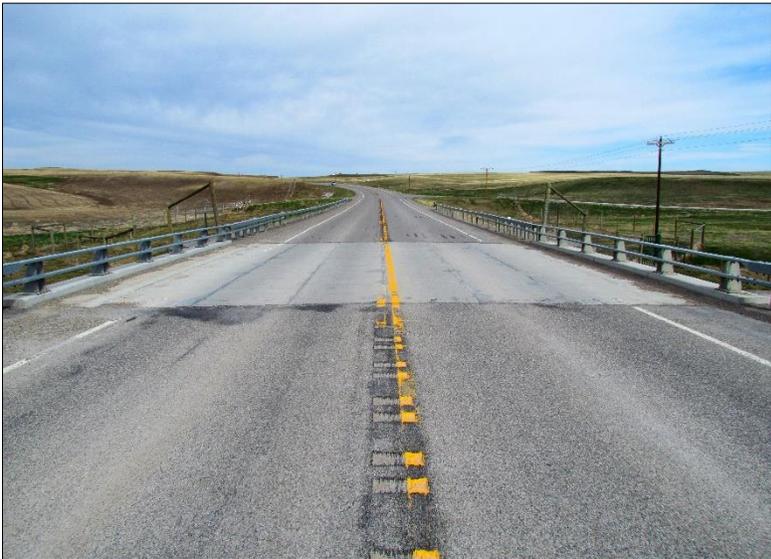
↙ ↘ Representative images of the GRS structure:

Top image is west side of structure; view east.

Lower image is view of GRS deck (view north).

No visual structural issues to report.

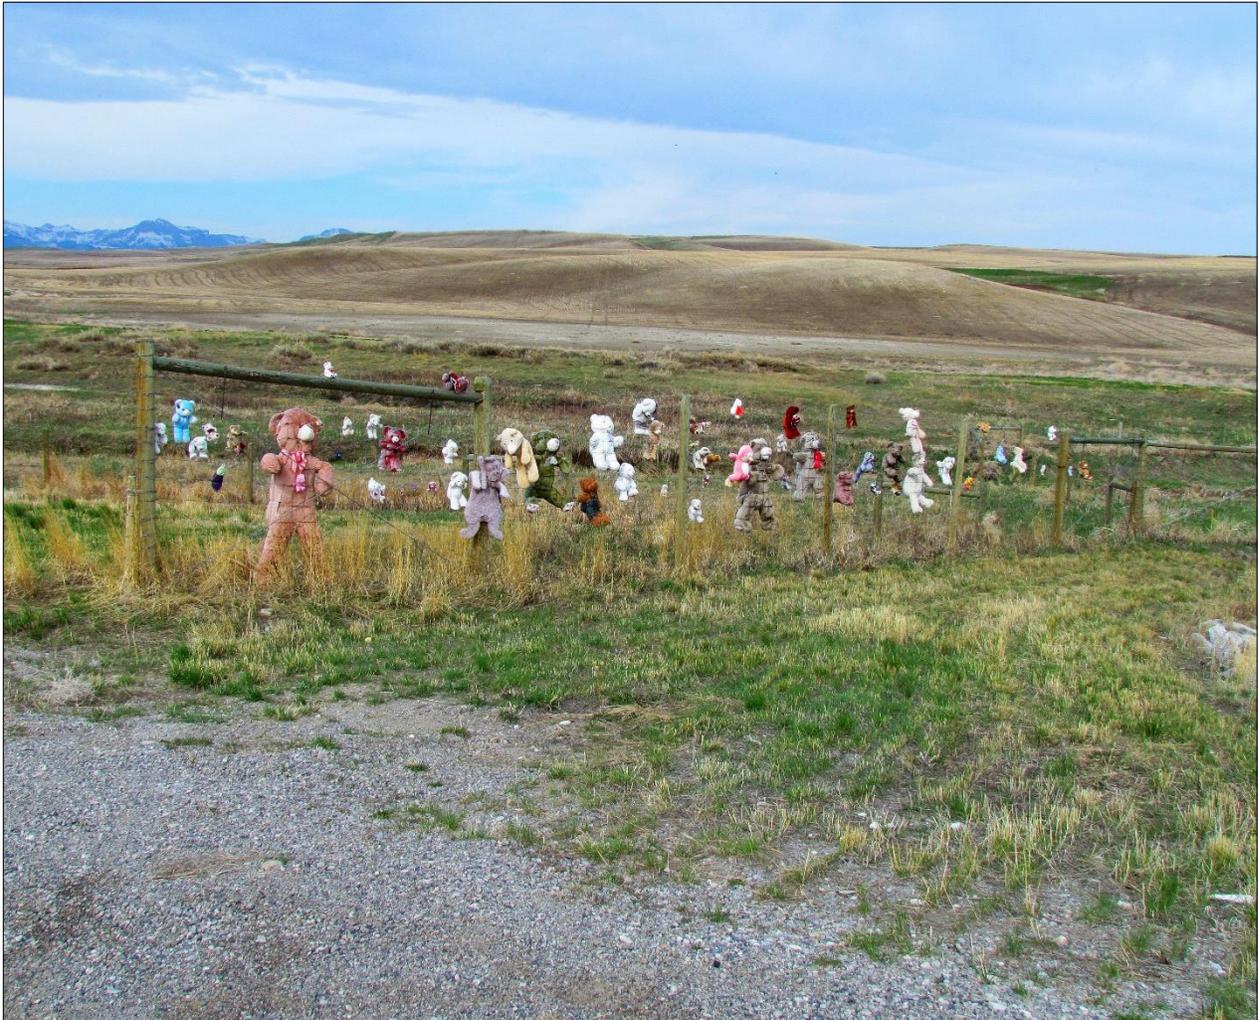
↑ A wildlife fencing project was installed on the project to steer species of Carnivora Ursidae (aka bears) to use the GRS-IBS as an underpass to circumvent crossing of the highway (view west at southern approach).

One of the unintended consequences of the project was that apparently, animals were permanently affixing themselves to the fence panels. It is unsure whether the animals are bored and like to watch traffic as it goes by; or are just too plain dumb.
