EXPERIMENTAL CONSTRUCTION REPORT

Jointbond Asphalt Cement (AC) Joint Stabilizer

Project Name: Bridger Canyon-UPN 8112000

Experimental Project: MT-19-5

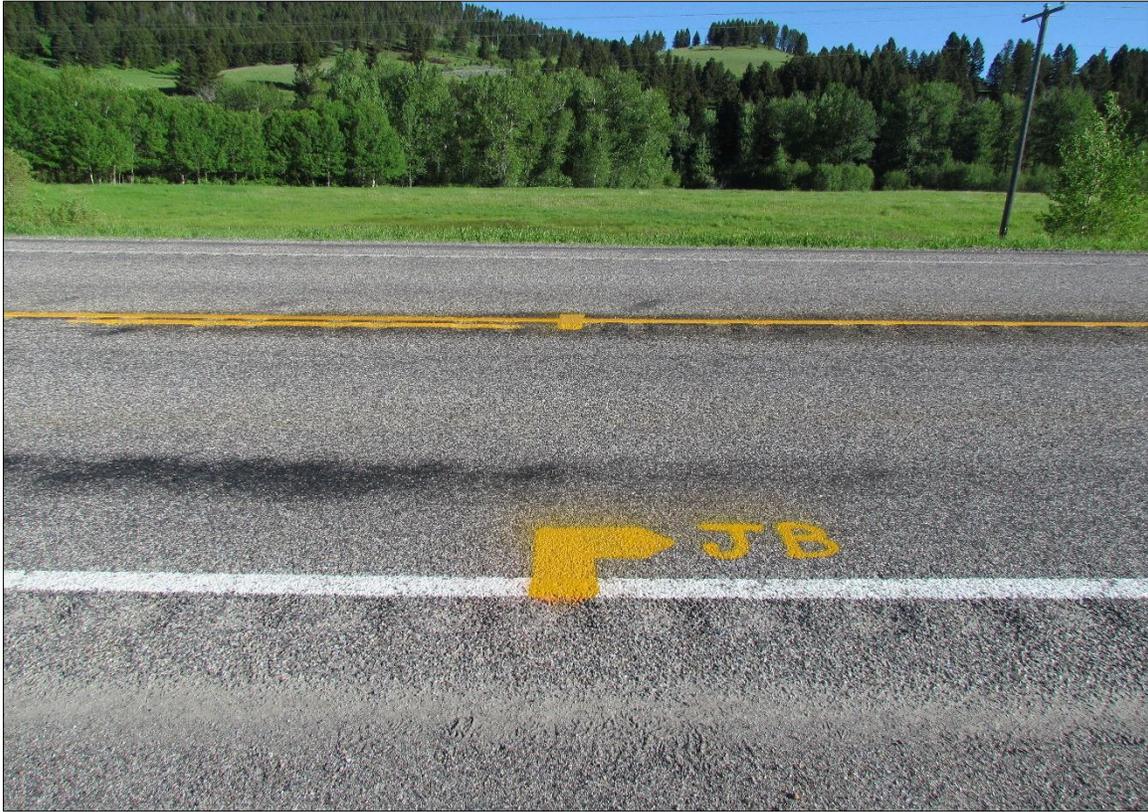
- ↑ Reference point 11; showing how start of project is delineated in the field.
- ↓ Reference point 12-8; end of project field delineation.

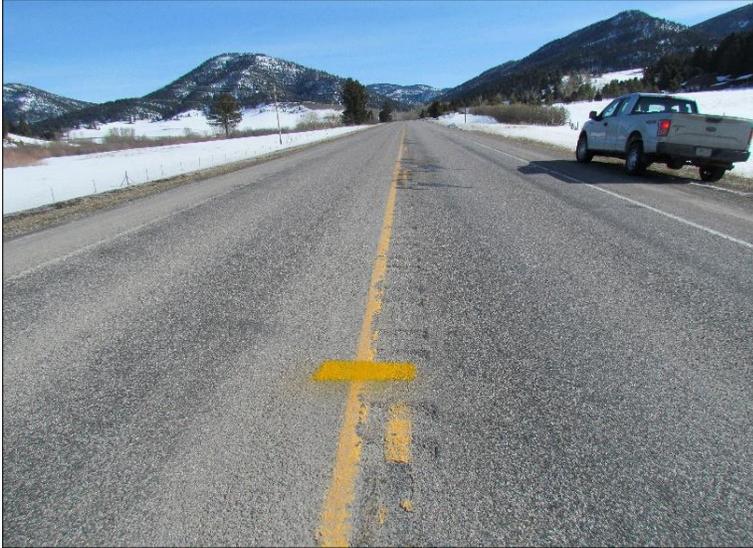
← Reference point 11 at start of project; view north.
