EXPERIMENTAL EVALUATION FINAL REPORT

Thin-Whitetopping Bonded Composite

Project No.: STPP 1-2 (93)121, East Idaho St.

Evaluation Date: August 2010

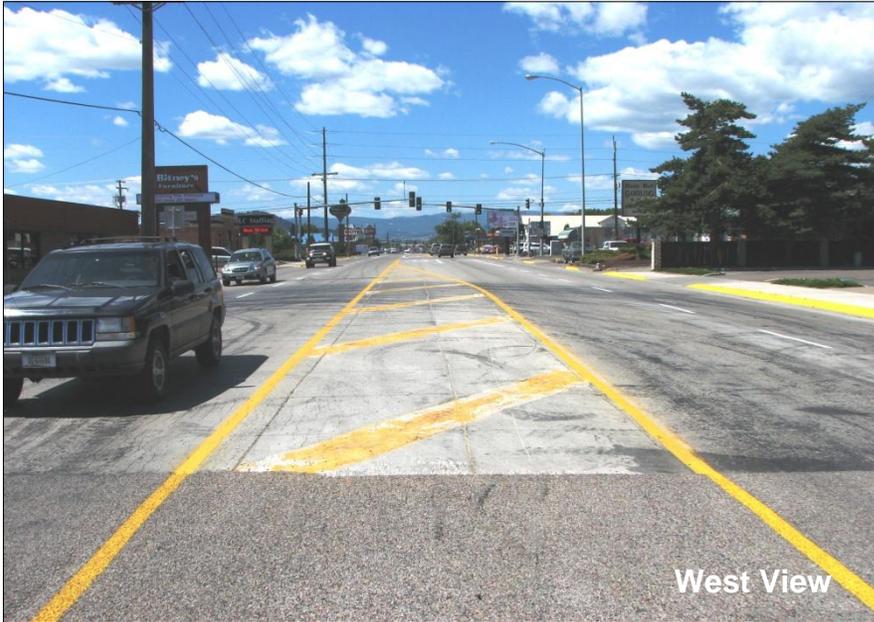
Figure 3 is showing the east-end transition area of the project. It is important to point this feature out due to the innovative way this approach was placed, please refer to the construction report for details. No evidence of distress to the east or west transitions was noticed during this evaluation. Transfer of load from AC to PCCP is intact.

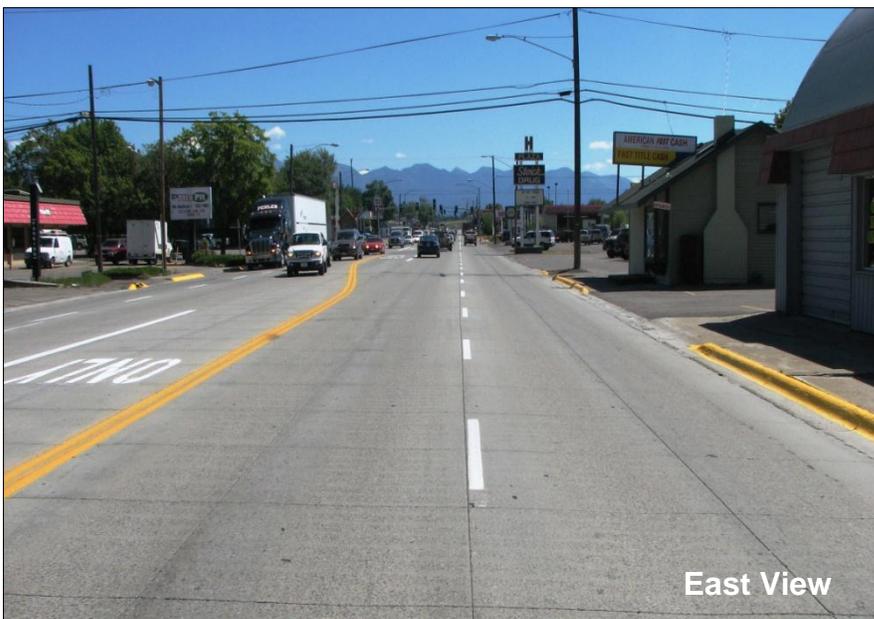
The following images are the east and west views of the project at each ends.

The whitetopping project is rated as performing well.
