EXPERIMENTAL PROJECTS CONSTRUCTION REPORT

Evaluation of Durable Traffic Pavement Marking Tape (PMT)

Project Name: Lyndale Intersections

Experimental Project: MT-14-02

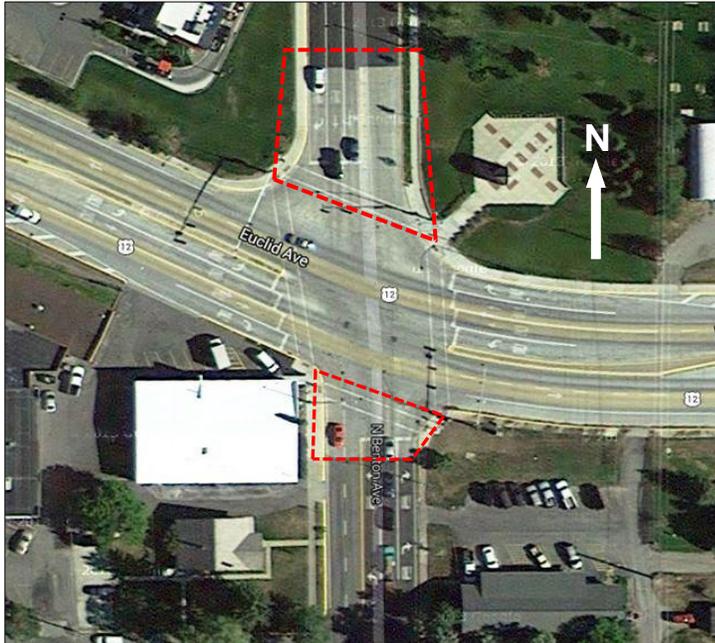
← Overview view of the Euclid/Lyndale & North Benton Ave. Intersection (TS1).

This site received the Swarco Director 35 tape application installed on June 10.

Note the areas of the N. Benton Ave. intersection denoted by the red dash received the 3M Stamark pavement tape approximately one month after the Swarco installation.

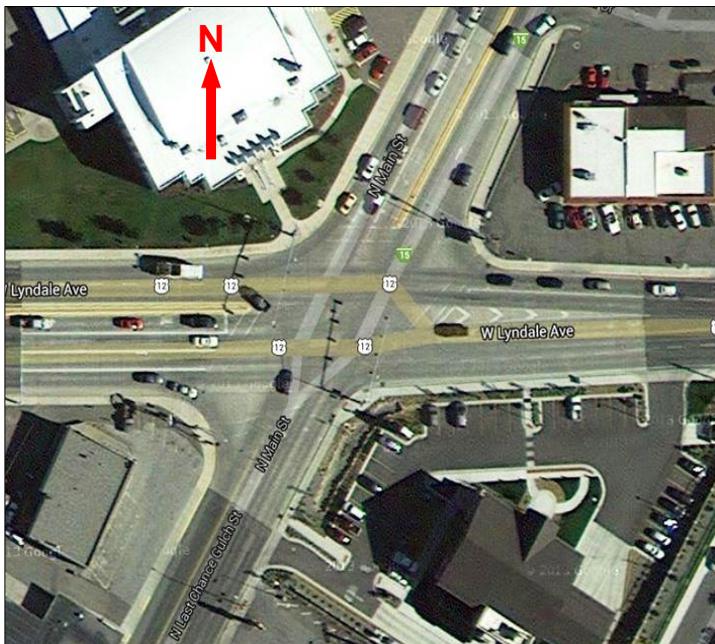
← Overview view of the Lyndale & Last Chance Gulch Intersection (TS2).

This site received the 3M Stamark tape application installed on June 3.

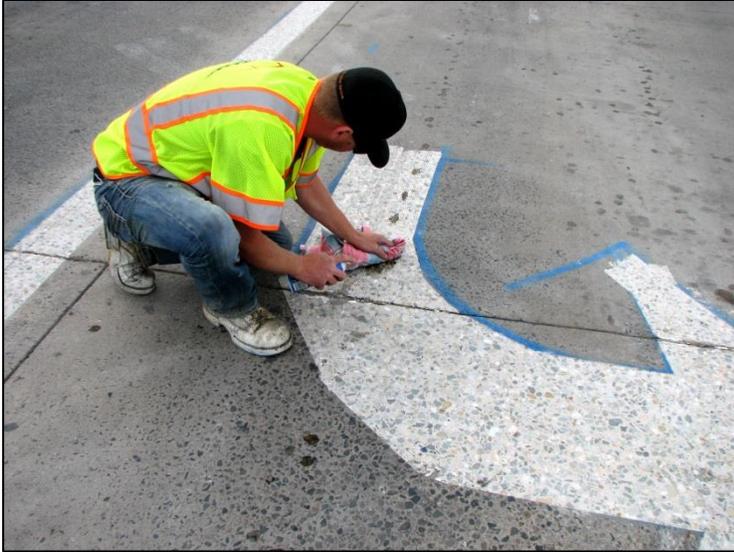
← In areas where the grooving machine deposited oil on the surface of the grind; the contractor used spray solvent to remove the oil prior to the application of the Stamark Contact Cement E-44T.

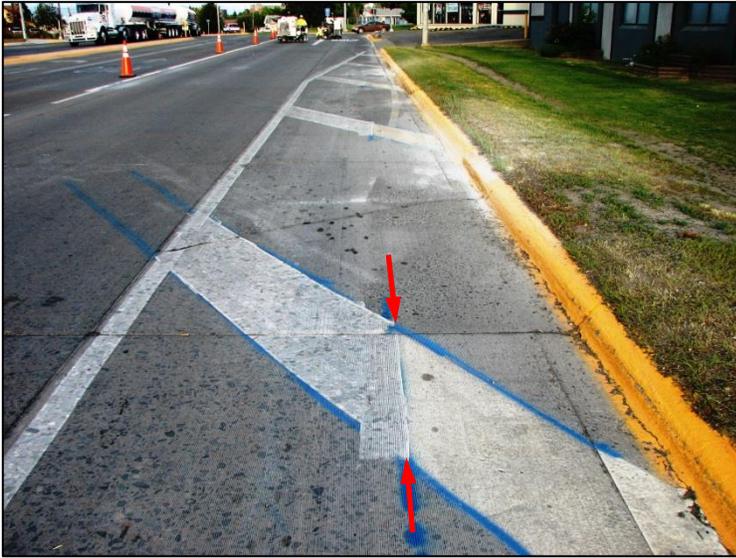
← Note that the cross hatch lines (eastbound/west side Euclid) were not placed directly to the curb but at halfway (red arrows).

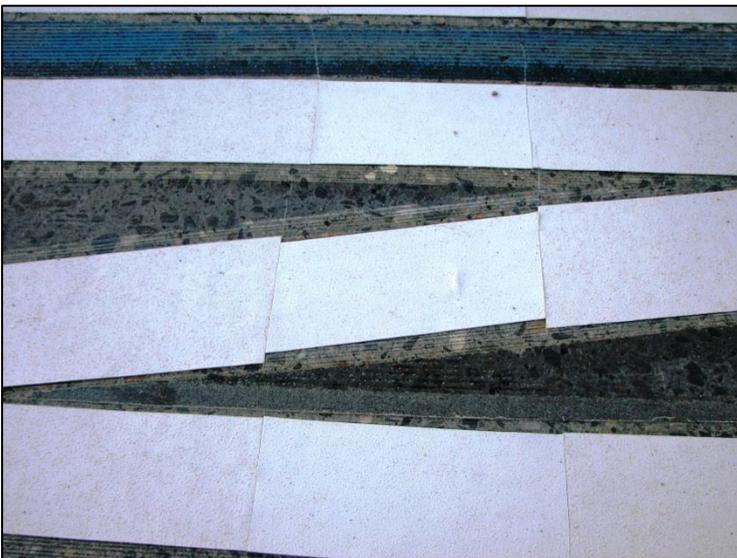
← The ONLY legends did not meet the Manual on Uniform Traffic Control Devices (MUTCD) requirements and had to be modified in the field.

Here you can see the gap in the letters needed to make the legend in compliance.

← A cut and paste approach was used to modify the markings.

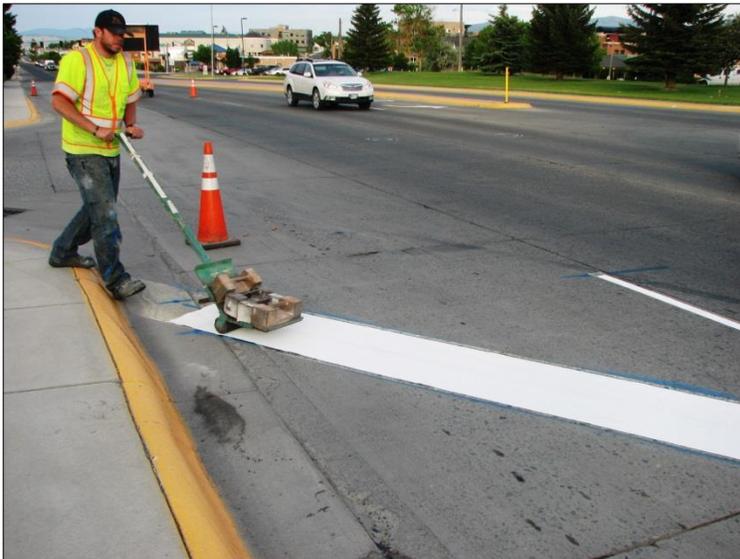
← All marking applications were tamped with a 200 lb. roller cart.

It was observed while during tamping the cart would track up reflective beads on the roller.

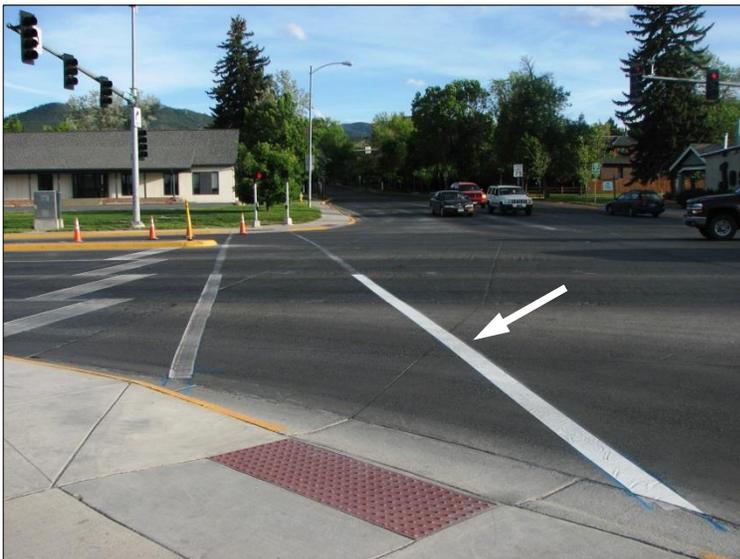
← Note that the contractor elected to install a section of Methyl Methacrylate (MMA) at the eastside pedestrian crosswalk marking, westbound West Lyndale Ave. and North Benton Ave.

The length of MMA runs approximately 37' of the pedestrian line.
