## EXPERIMENTAL PROJECTS FINAL REPORT

### HIGH FRICTION SURFACE TREATMENTS (HFSTs) FOR BRIDGE DECKS

- FHWA Project Number:** MT-12-10/13-01/14-05
- Principal Investigator:** Craig Abernathy, Experimental Project Manager (ExPM)
- Date of Installations:** <sup>1,2,3</sup>June 2014/<sup>4</sup>June 2015

- Date of Inspections:** March 2015/April-May 2016/May-October 2017/April 2018  
April 2019/April & May 2020

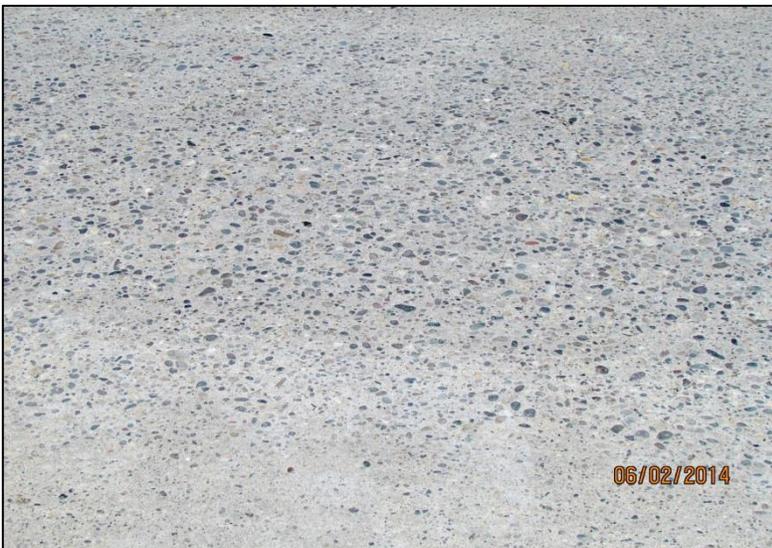
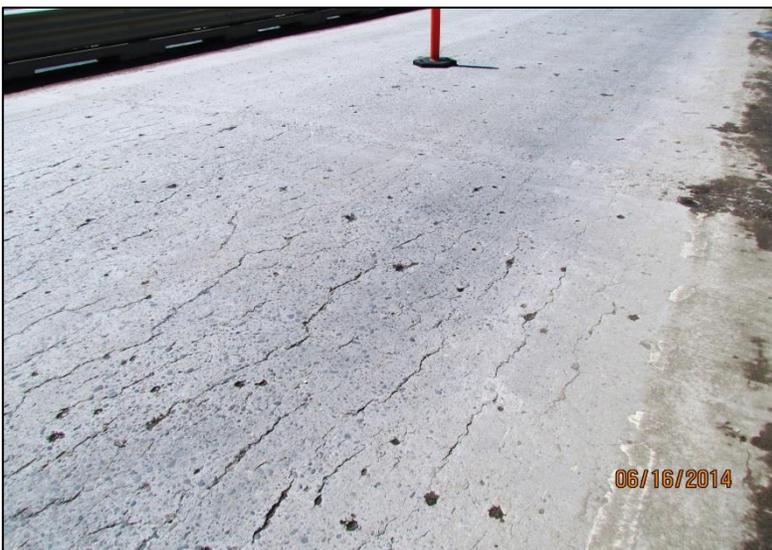
↙ Sample images of average deck surface condition. Most of the deck exhibited polished aggregate, minor pop outs and longitudinal cracking.

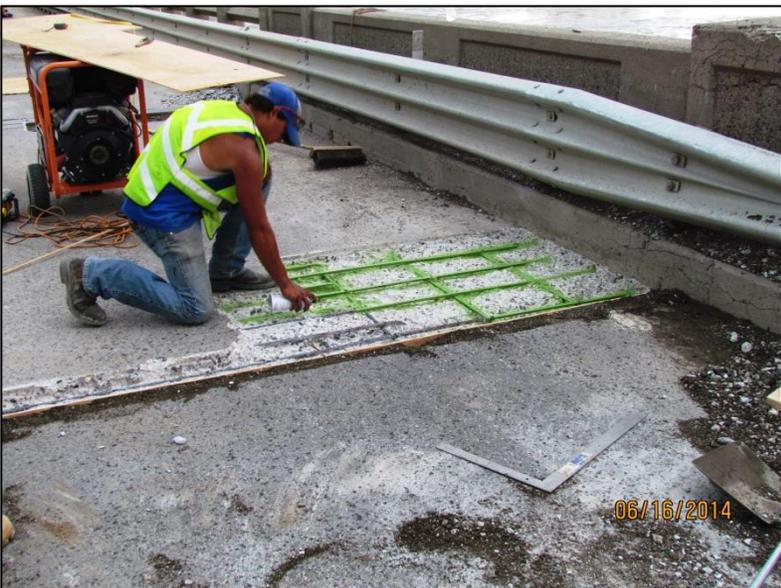
← Exposed rebar was coated with two-component aerosol epoxy.

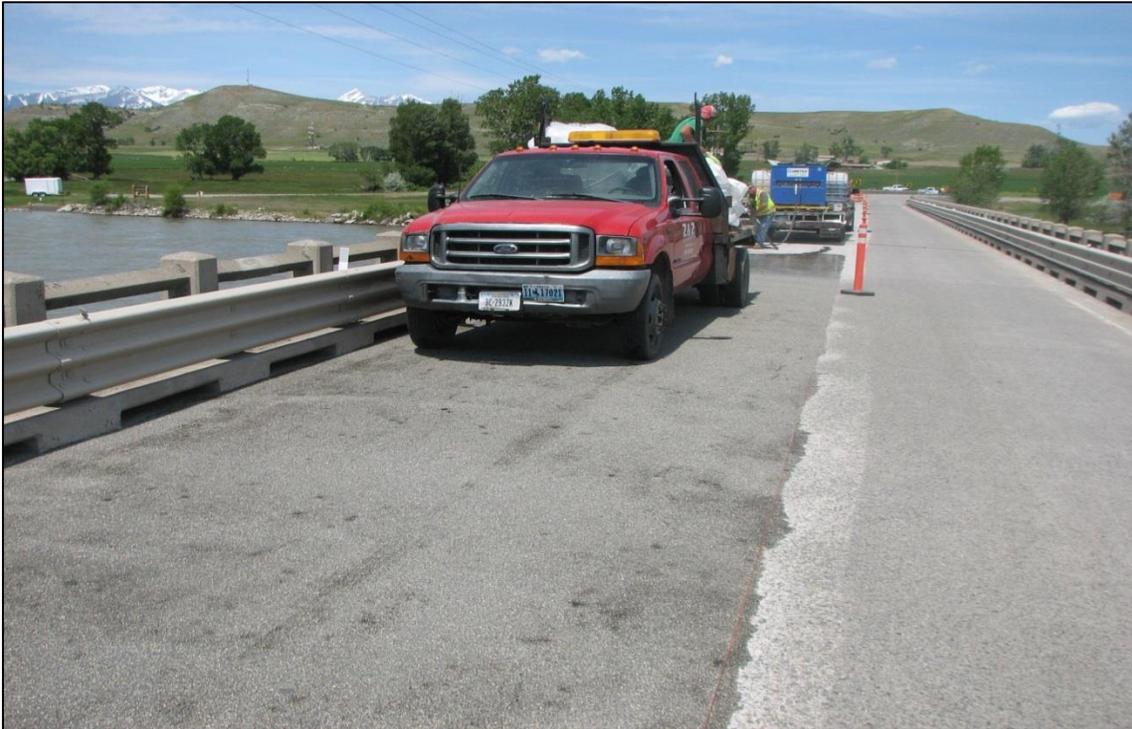
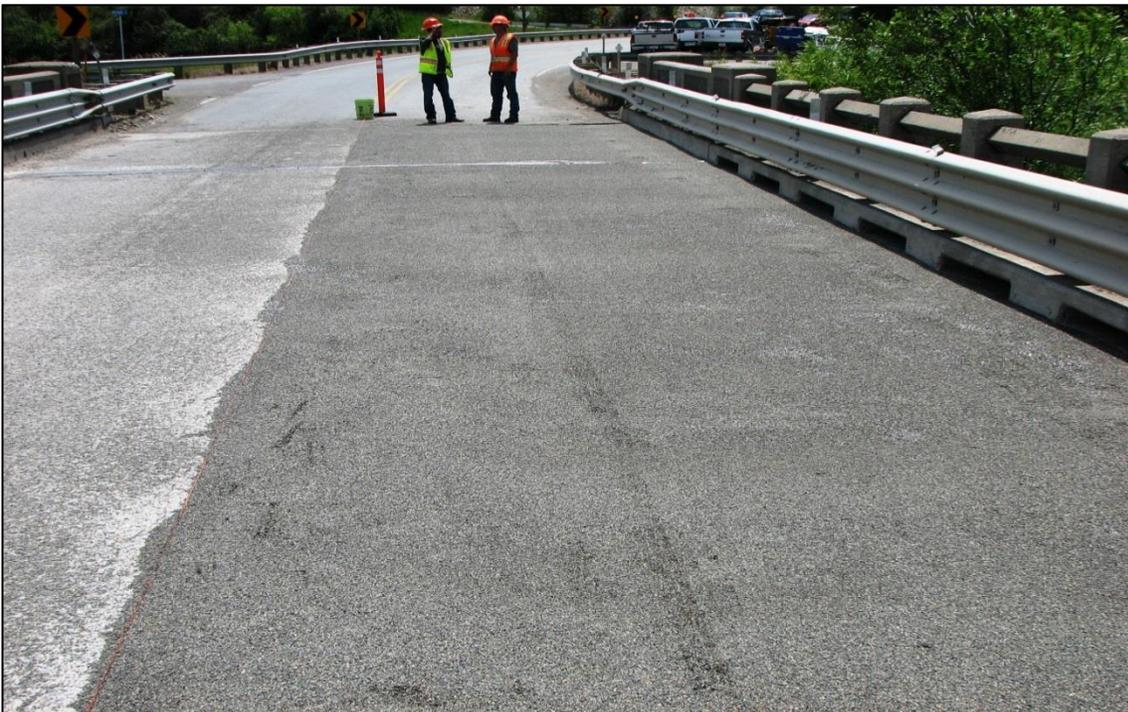
↑↓ These images show the level of aggregate layer with the first of run about midway through the length of the bridge. Note there are areas of epoxy bleeding through the aggregate. The contractor was not concerned since it was stated that they apply a very heavy first coat and material bleed through was common. The second lift will create a more uniform appearance.

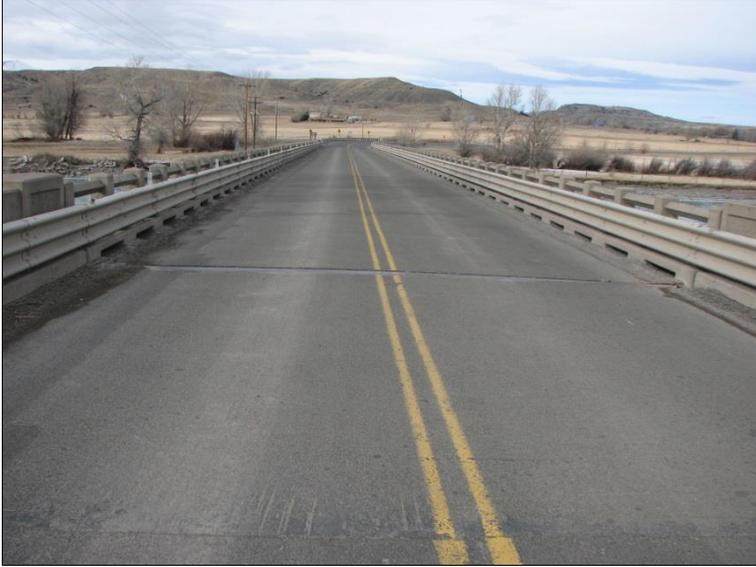
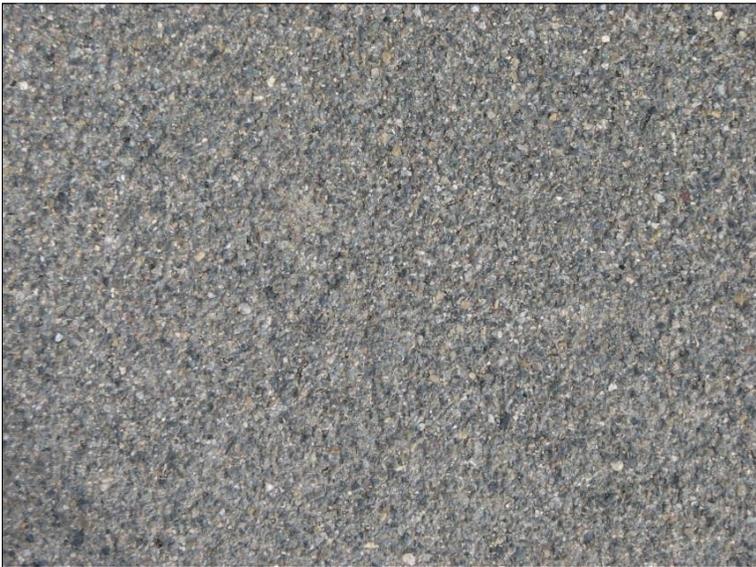
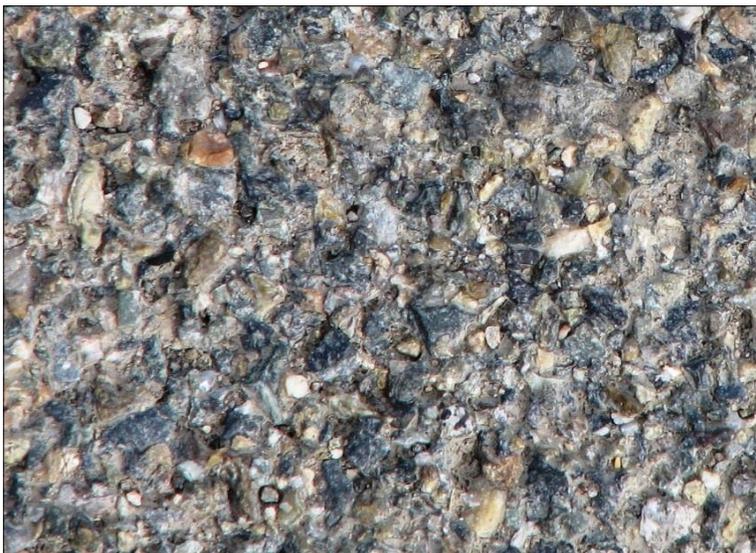
**Big Timber – Dayton Superior Unitex: March 2015**

No issues to date to report; aggregate surface has uniformity in texture and appearance. No areas of raveling or debonding visible.

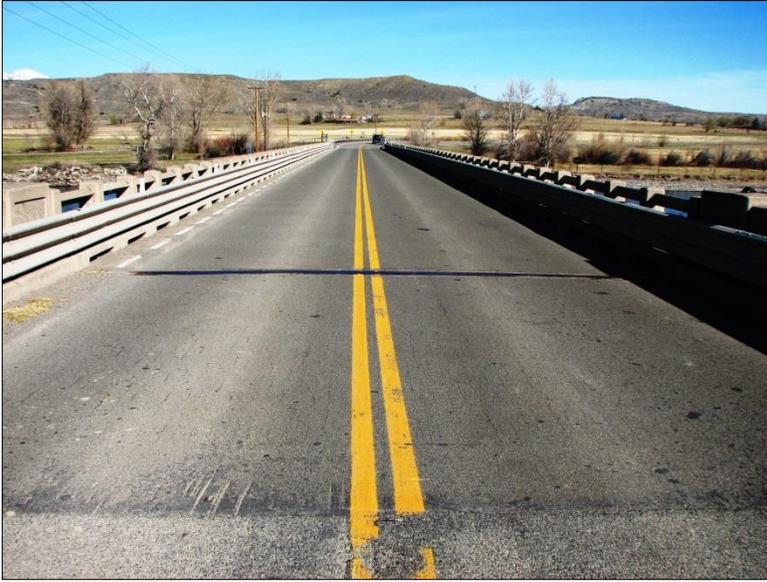
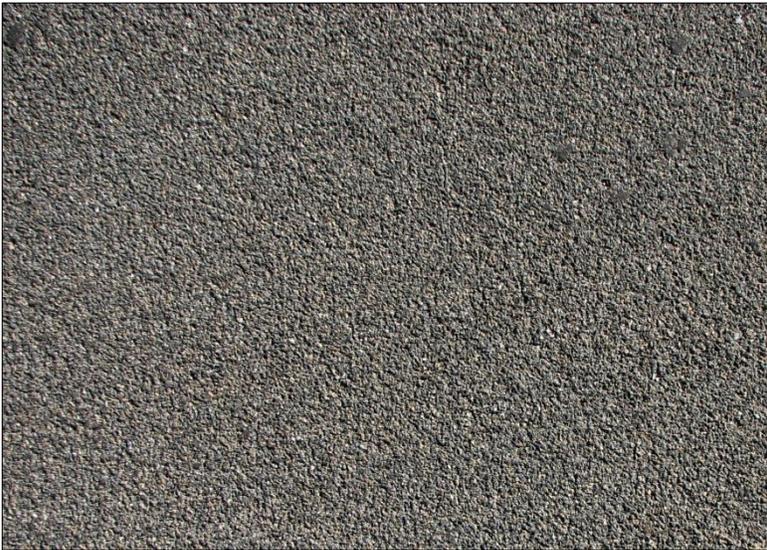
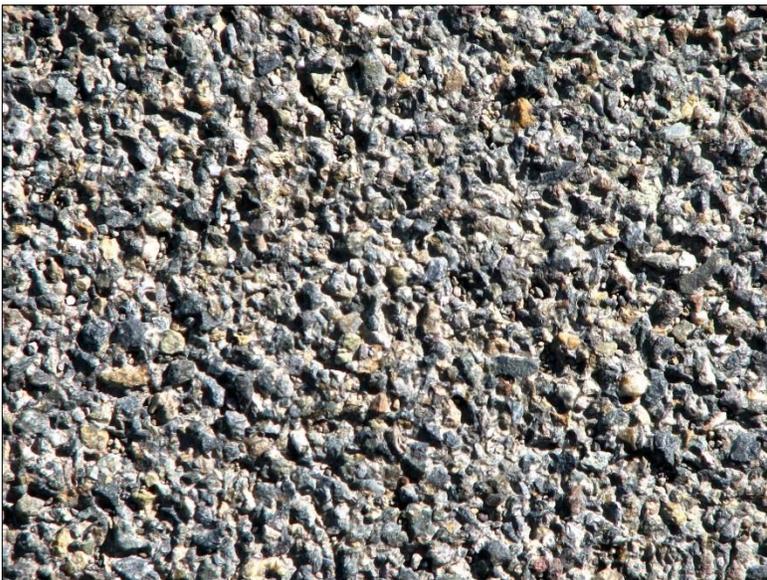
**Big Timber – Dayton Superior Unitex: April 2016**

No issues to date to report; aggregate surface has uniformity in texture and appearance. No areas of raveling or debonding visible.

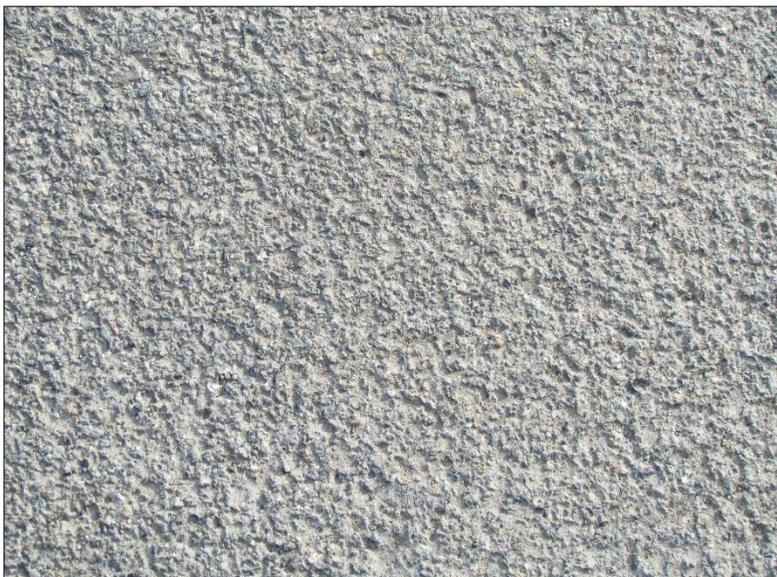
The topical condition of the HFST deck treatment is uniform, and may be attributed to snowplow activity

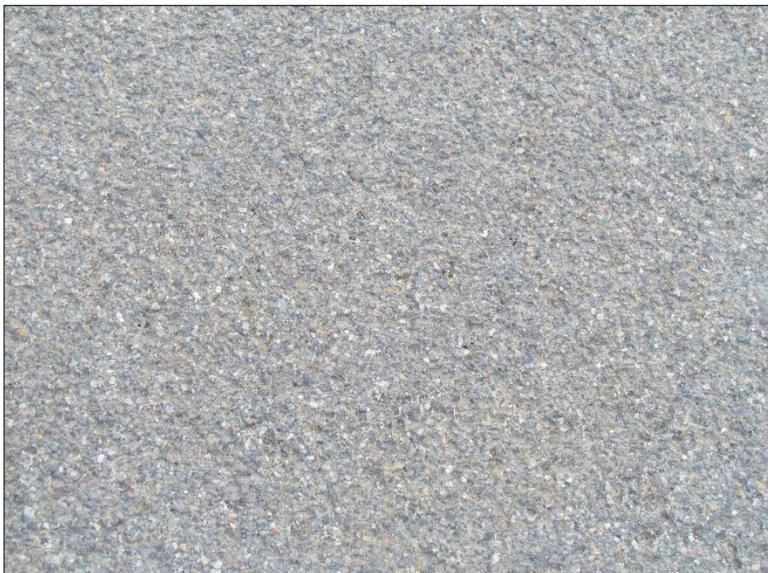
Visually the topical condition of the HFST deck treatment is uniform and may be attributed to snowplow activity and/or general traffic attributes.

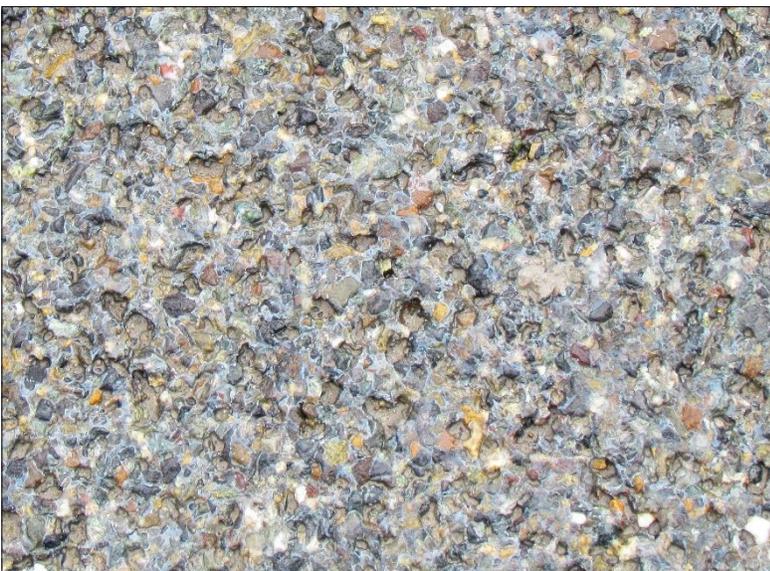
Visually the topical condition of the HFST deck treatment has topical aggregate pop-outs and surface polishing and may be attributed to snowplow activity and/or general traffic attributes.

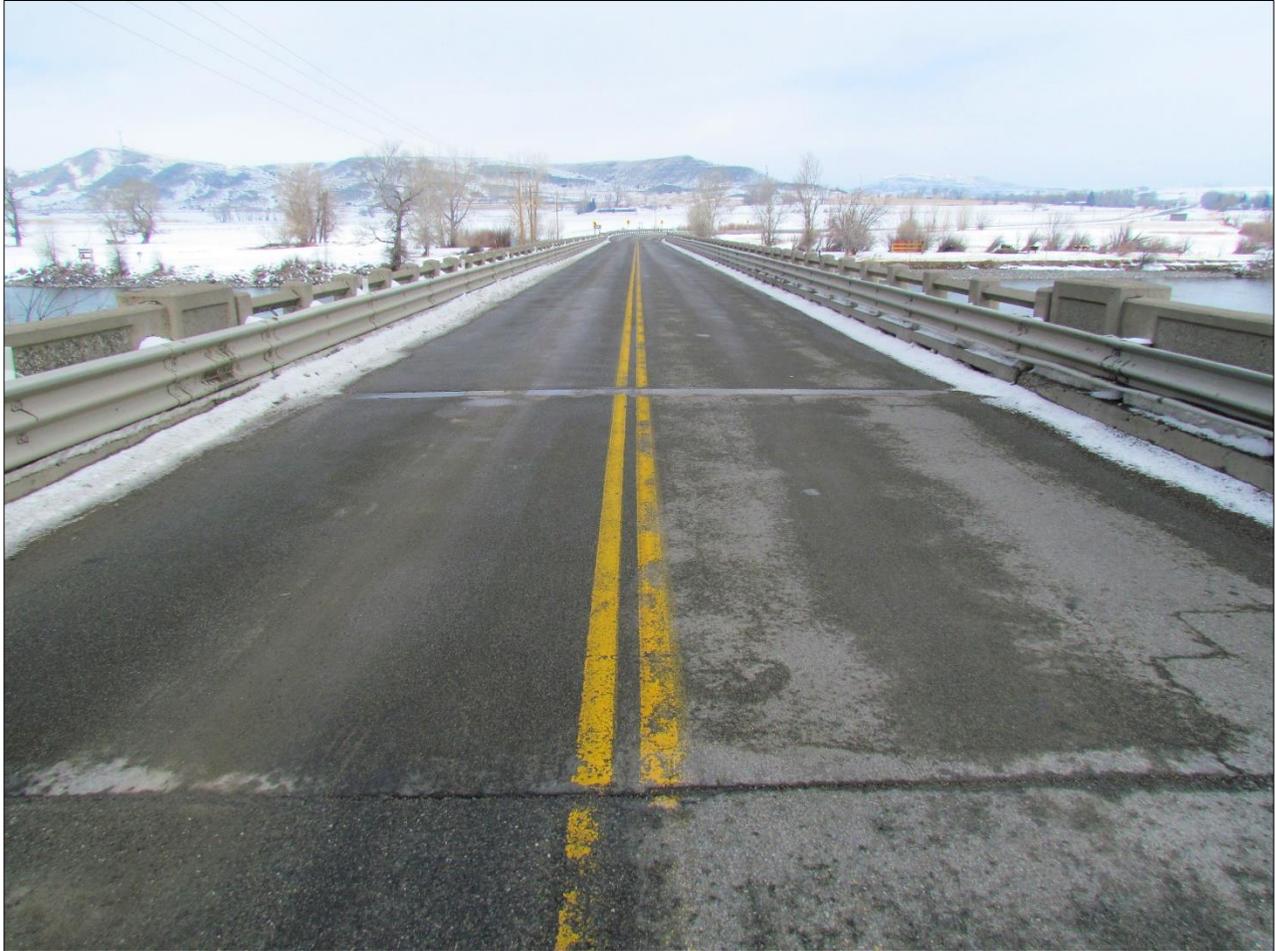
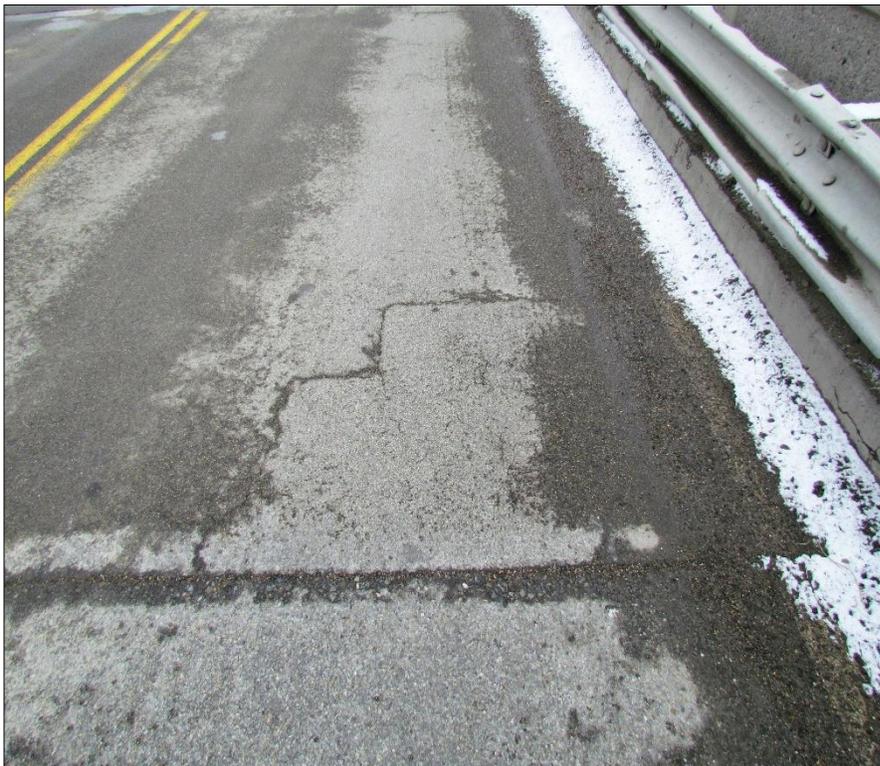
**Big Timber – Dayton Superior Unitex: April 2020**

↑ Deck as seen in April 2020.

As reported in 2019; no areas of raveling or debonding visible. However, the surface textures continue to appear polished with noticeable pock marks indicative of loss aggregate (lower image is close-up of surface texture).

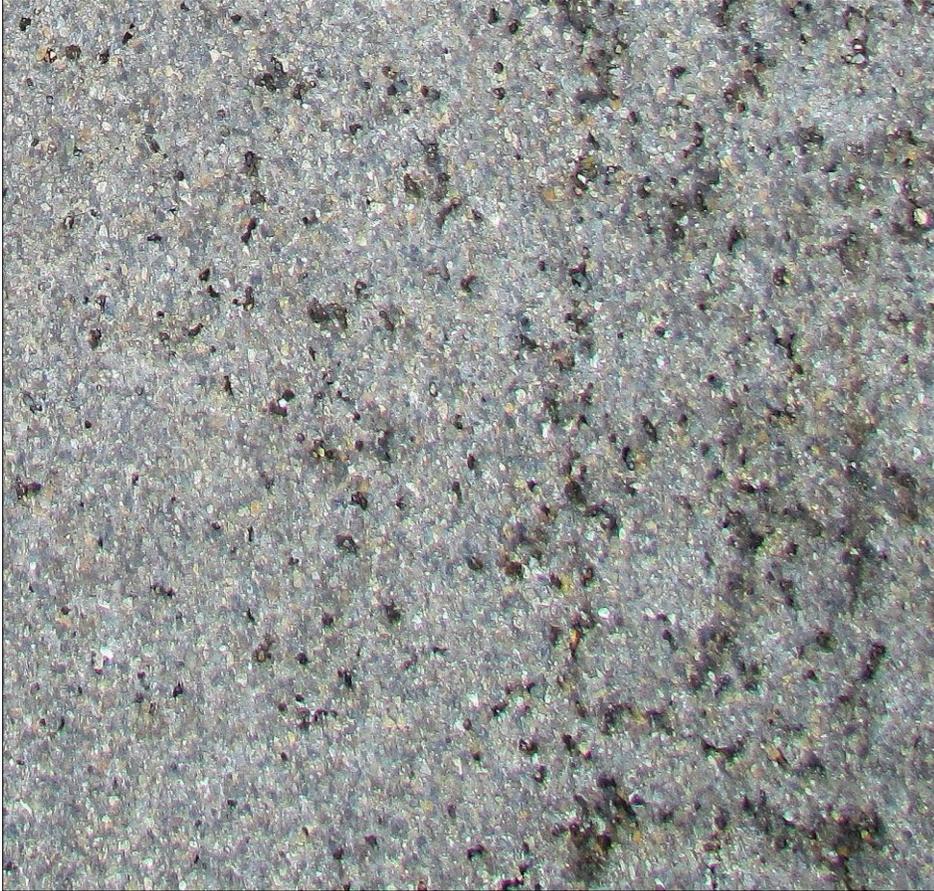
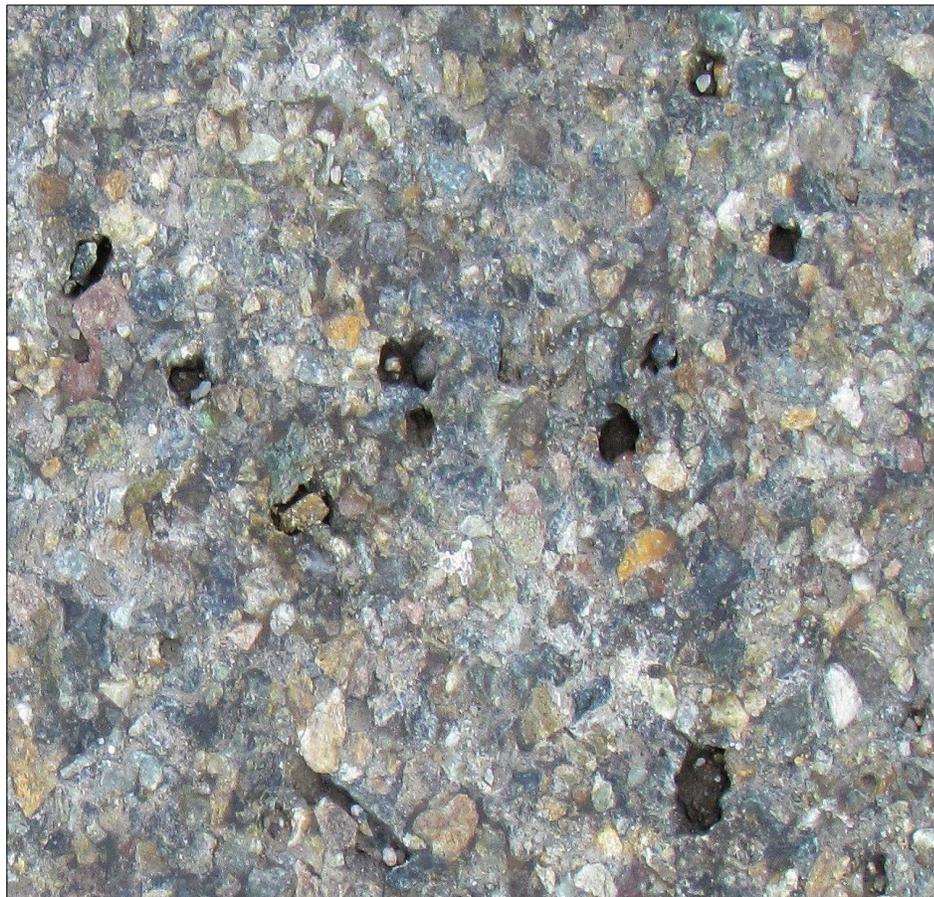
↙ ↓ Several close-ups of surface texture.

Lower image shows continued polishing of aggregates and pop-outs, mainly in the wheel paths.

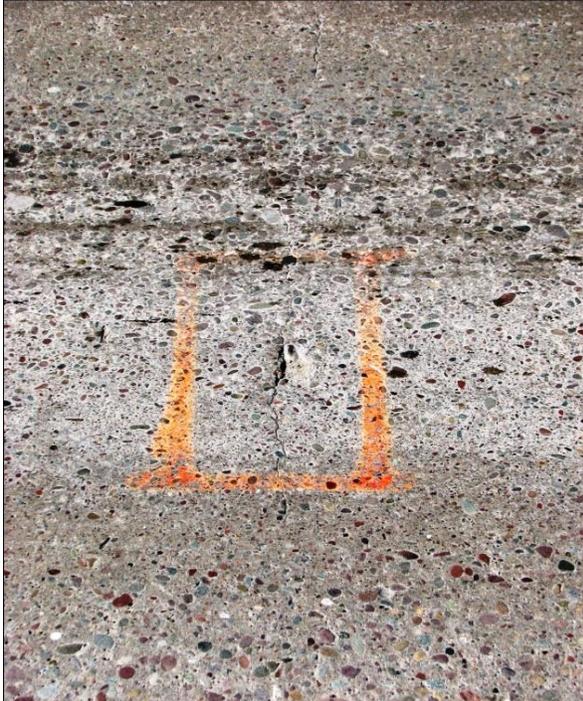
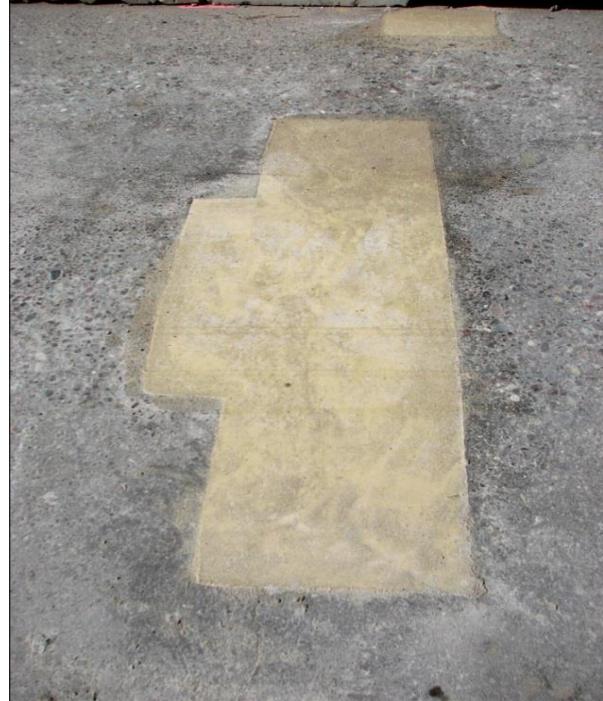
↑ The project begins with the Class A deck repairs; orange paint delineates selected areas to be chiseled out to the top layer of rebar. Image on right shows completed section using Dayton Sure Patch: See pages 6 & 7 (Big Timber site), for specific examples of the repair which were similar to this deck.

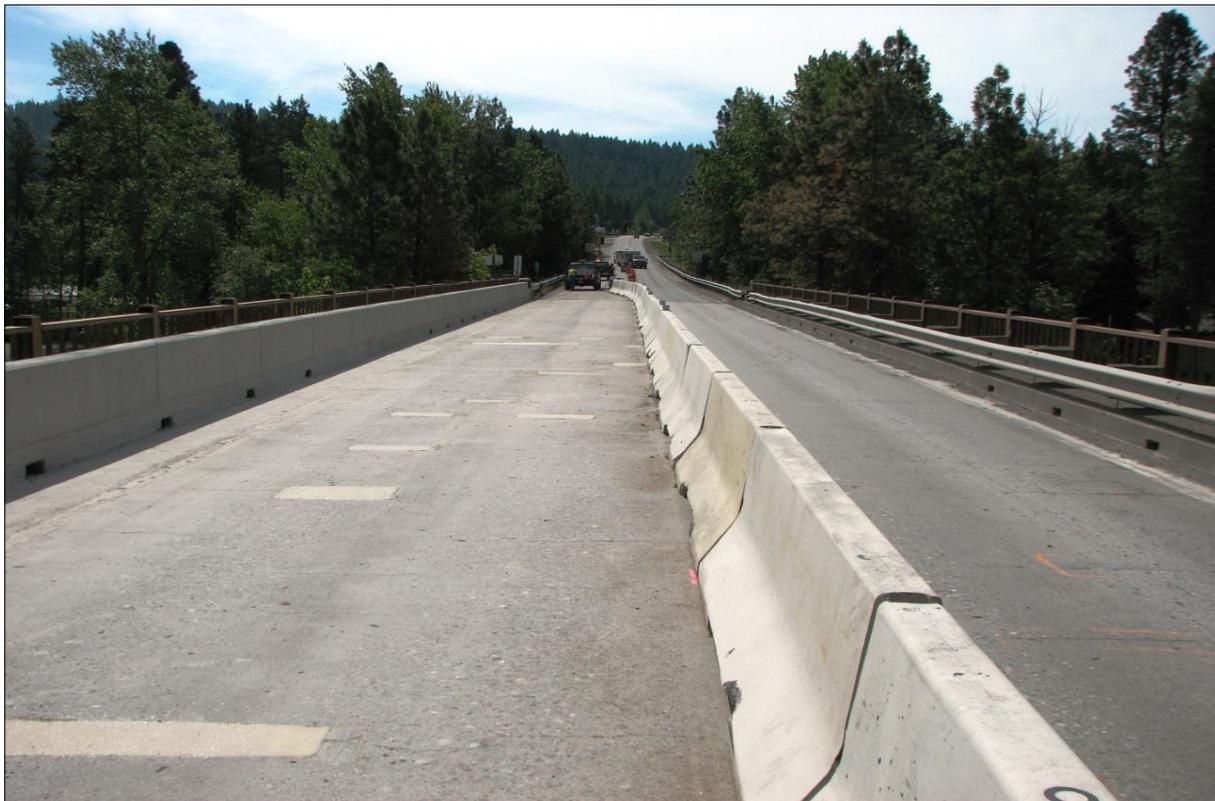
↓ Class A repair completed on the north bound lane, view south.

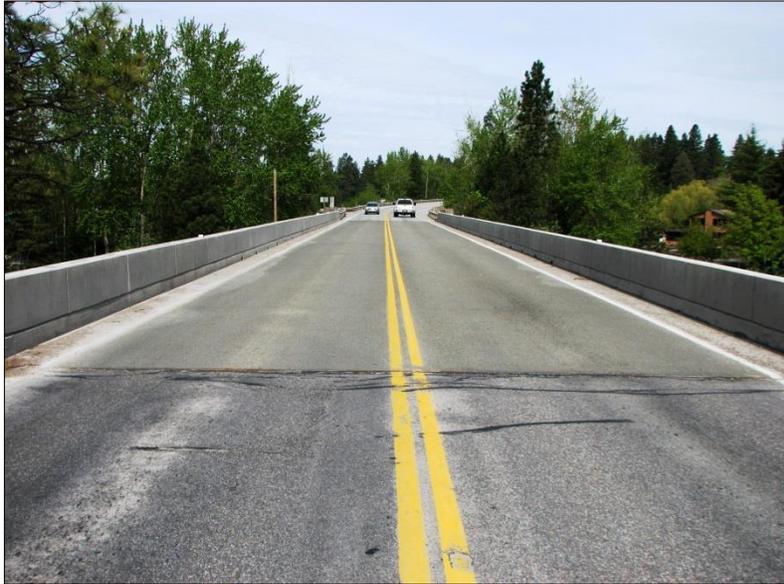
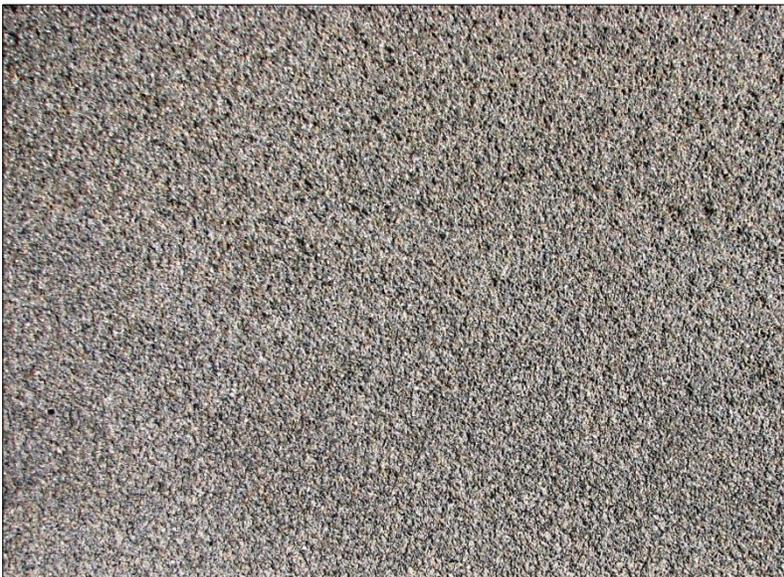
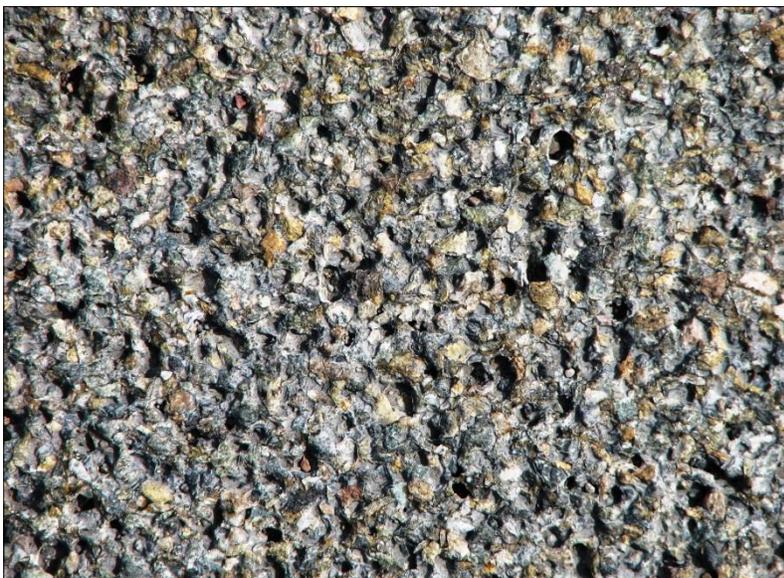
↩️ The following are images (deck overview and surface texture) depicting the general condition of the HFST.

No issues to date to report; aggregate surface has uniformity in texture and appearance. No areas of raveling or debonding visible.

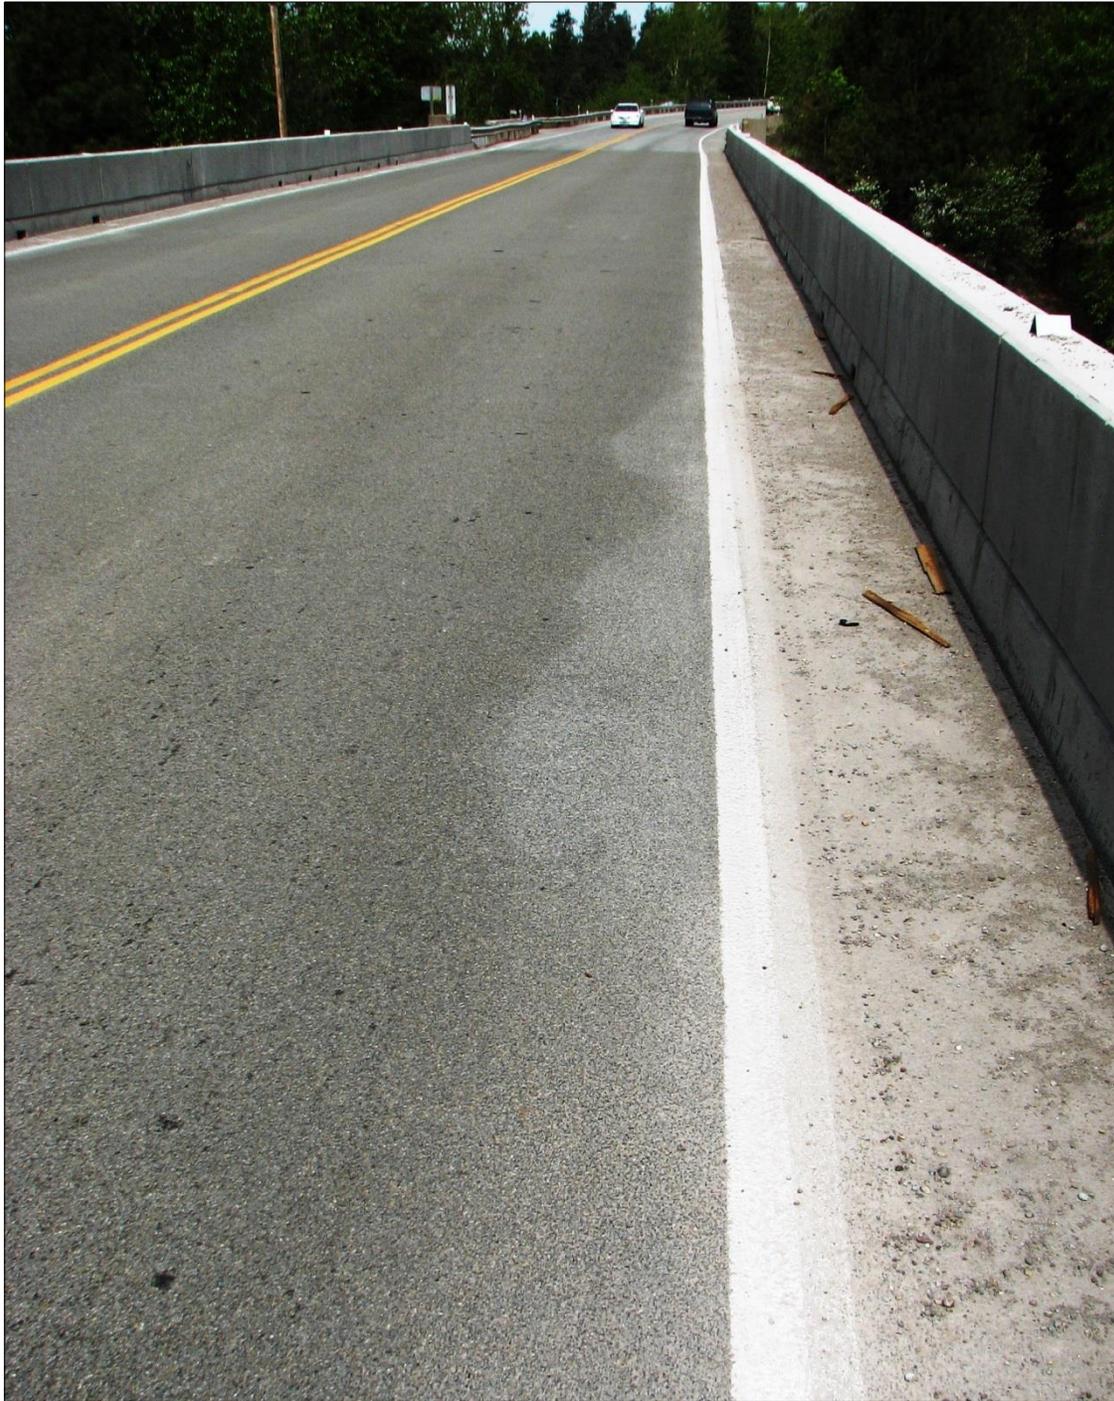
**↑ June 2016; view north.**

Several areas on the deck, mainly at the shoulder, displayed minor abrasion (assuming from snowplow passes); most likely due to an uneven layer of epoxy and aggregate during application.

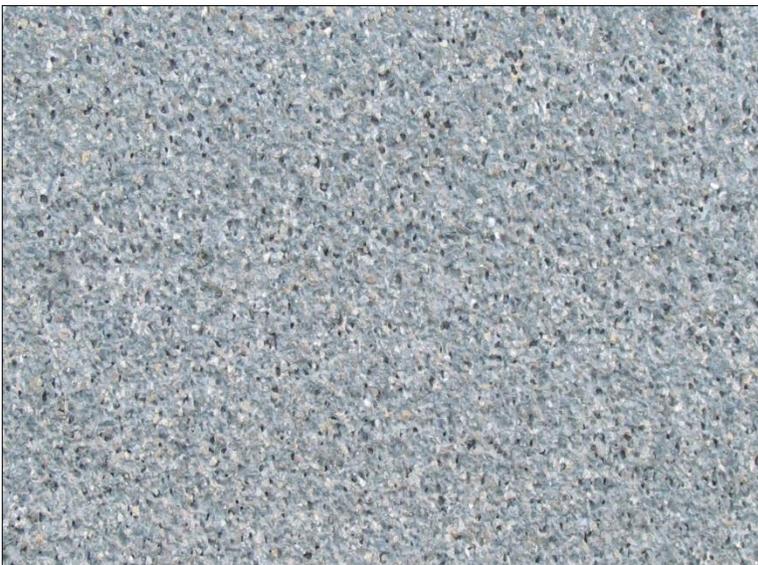
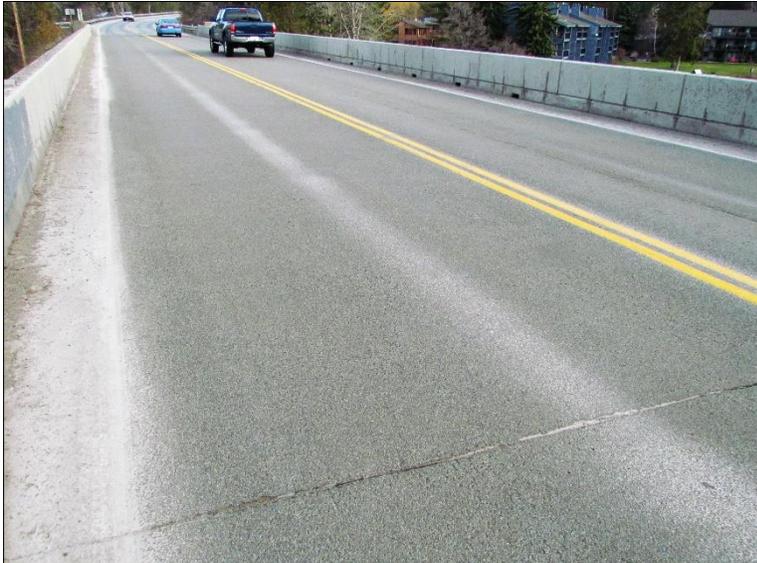
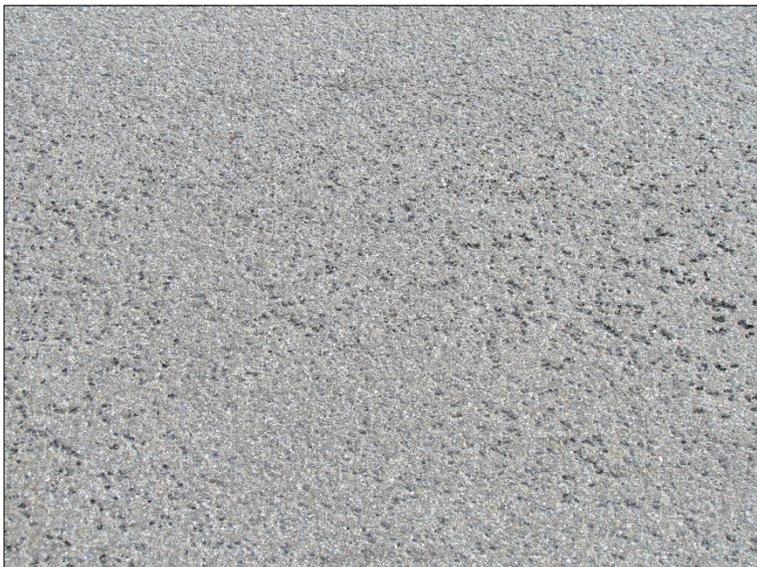
↙ The following are images (deck overview and surface texture) depicting the general condition of the HFST as documented in spring of 2018 (top image view north).

No areas of raveling or debonding visible. However, as reported in earlier inspections; the surface textures appear polished and less textured since installation, with noticeable pock marks indicative of loss aggregate (lower image is close-up of surface texture).

The topical condition of the HFST appears uniform across the deck; and may be due to snowplow activity or other traffic attributes.

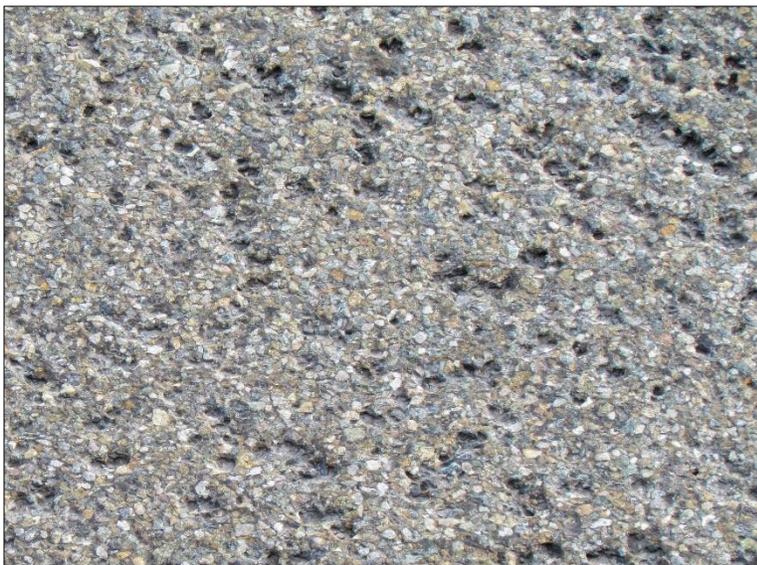
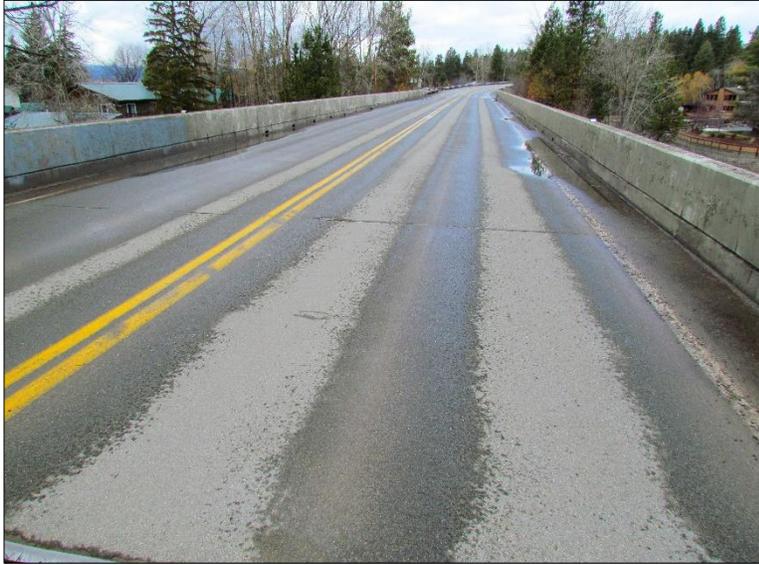
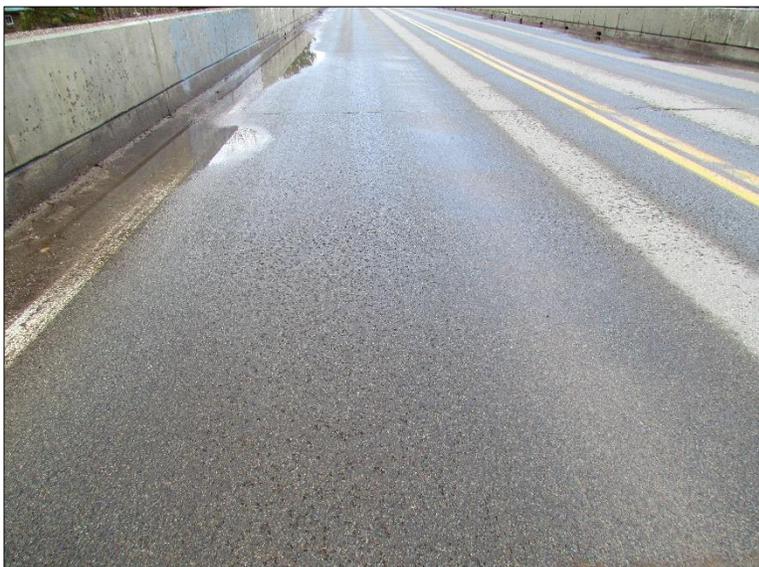
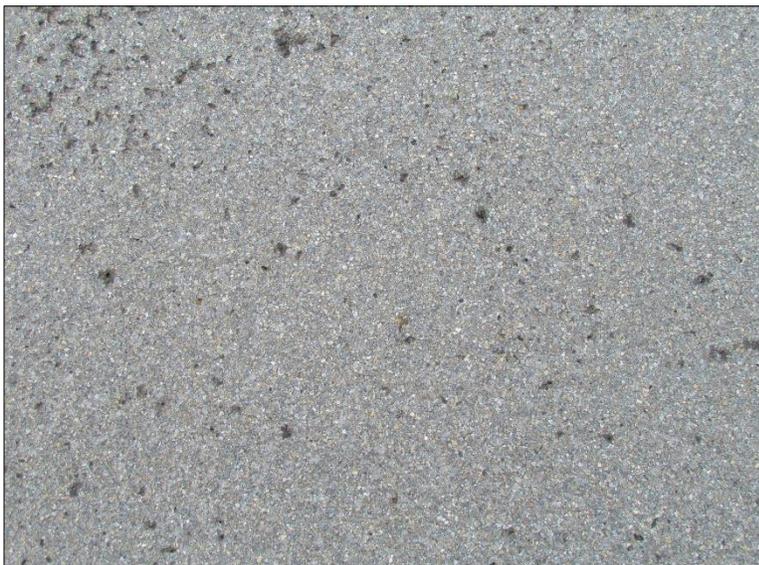
↙↓ The following are images (deck overview and surface texture) depicting the general condition of the HFST as documented in spring of 2019 (top image view north).

No areas of raveling or debonding visible. However, as reported in earlier inspections; the surface textures appear polished and less textured since installation.

The topical condition of the HFST appears uniform across the deck; and may be due to snowplow activity or other traffic attributes.

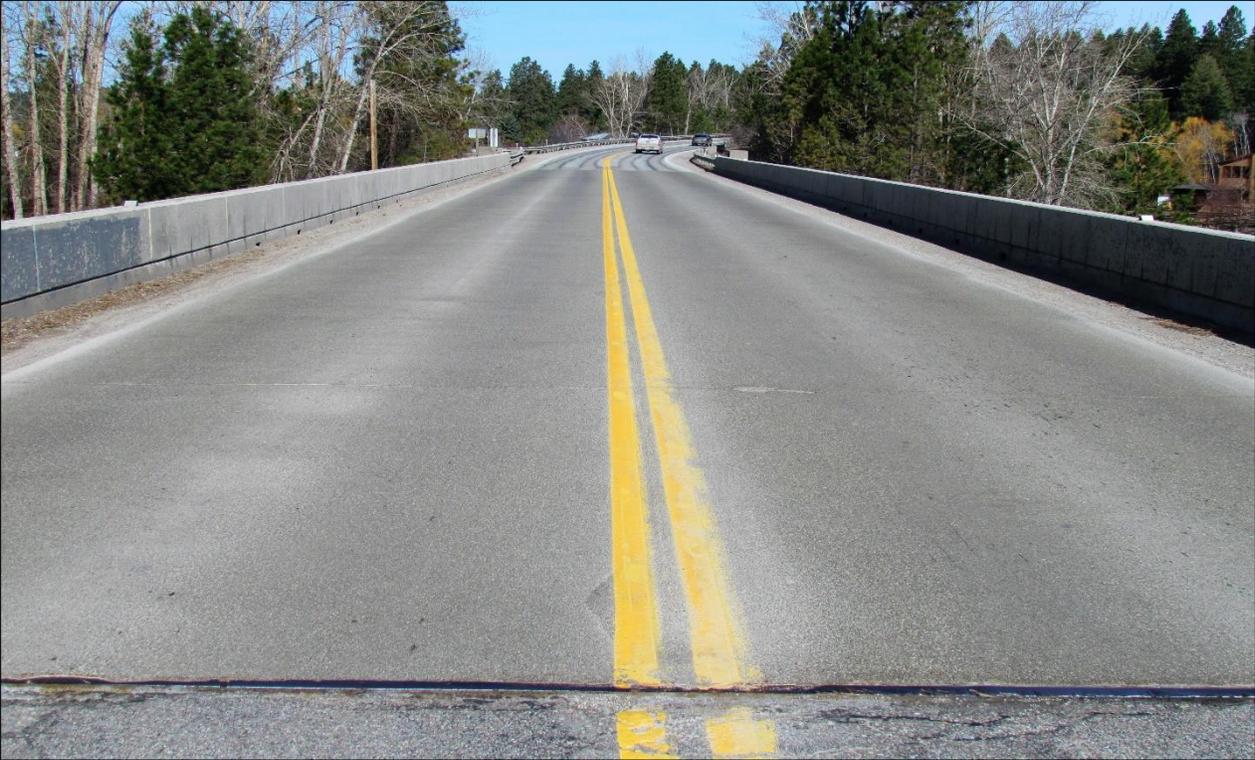
↑ South end of deck; view north.

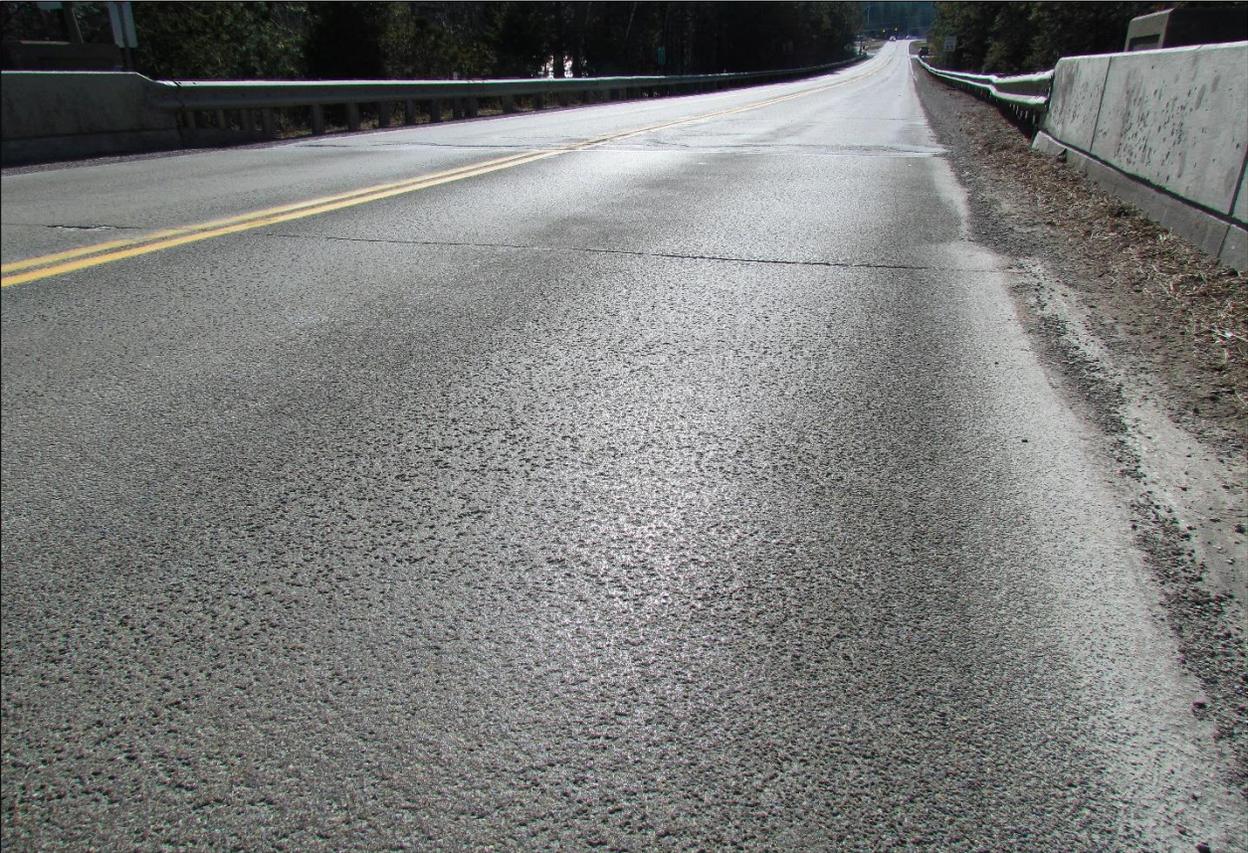
↓ South end of deck showing polished appearance of aggregate; view south.

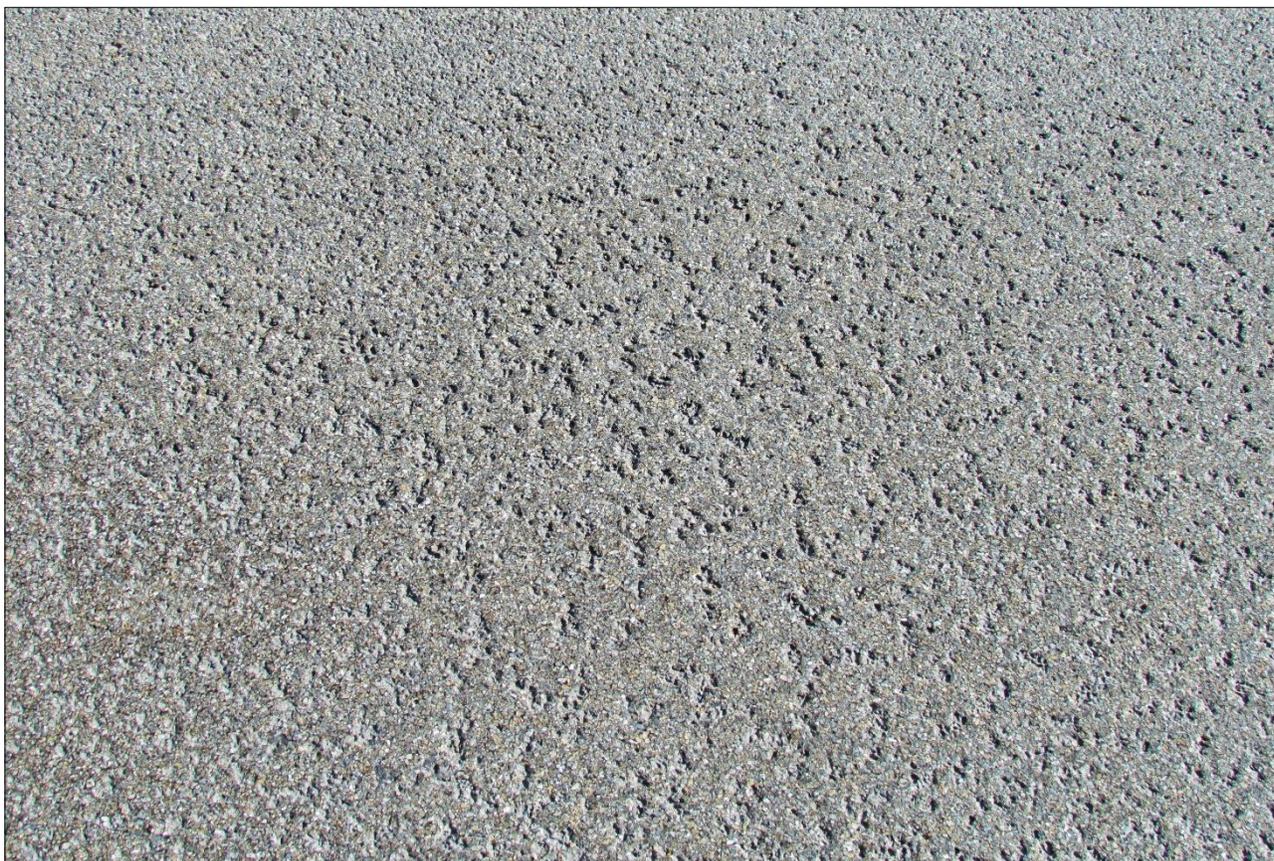
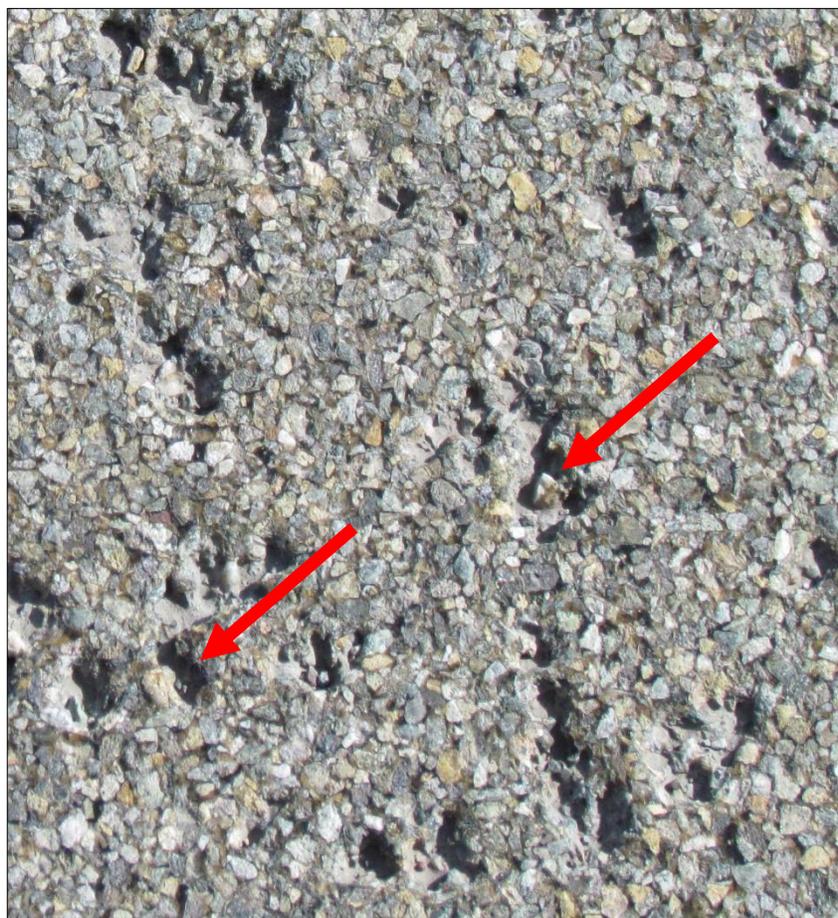
↑ Close-up of pavement texture in wheel path.

← Closer view of pavement surface; red arrow shows where aggregate has popped out of epoxy matrix difficult to see in the above image.
