## EXPERIMENTAL PROJECTS FINAL REPORT

### HIGH FRICTION SURFACE TREATMENTS (HFSTs) FOR BRIDGE DECKS

- FHWA Project Number:** MT-12-10/13-01/14-05
- Principal Investigator:** Craig Abernathy, Experimental Project Manager (ExPM)
- Date of Installations:** <sup>1,2,3</sup>June 2014/<sup>4</sup>June 2015

- Date of Inspections:** March 2015/April-May 2016/May-October 2017/April 2018  
April 2019/April & May 2020

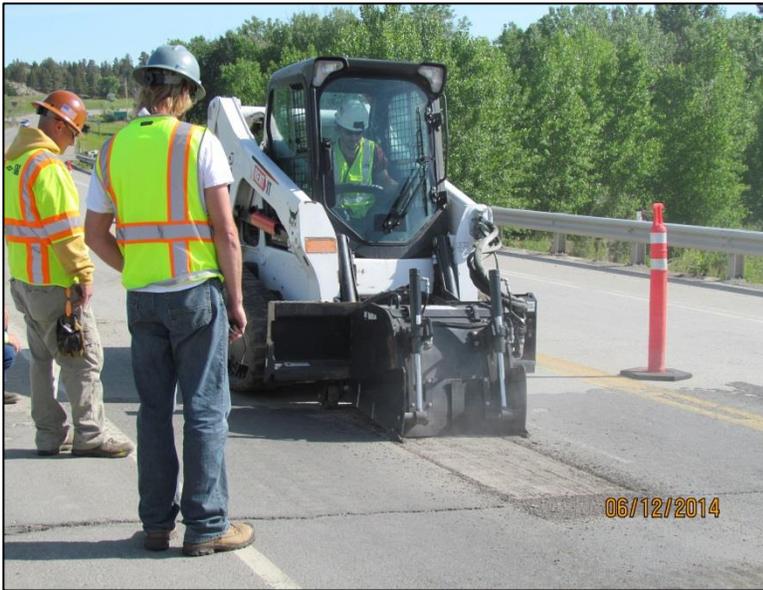
← A previous maintenance patch placed a layer asphalt cement (AC) beyond both approaches of the PCCP deck which will require removal prior to the HFST.

← A Bobcat 18" (inch) planer attachment is used to remove the excess asphalt.

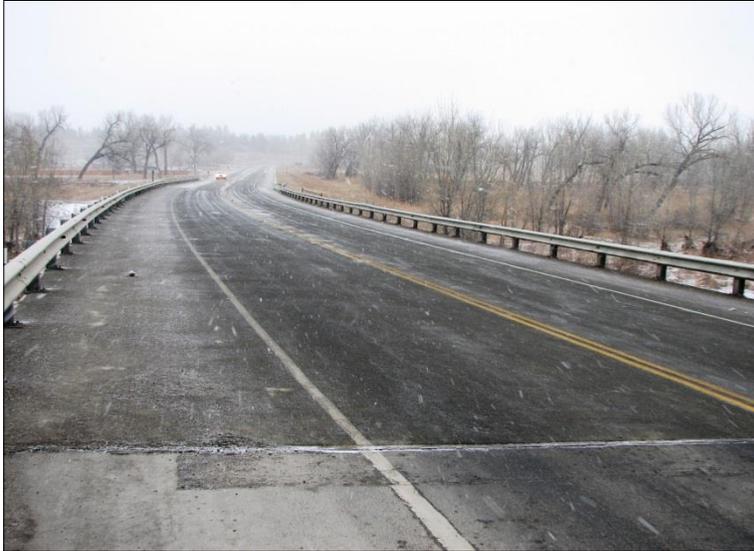
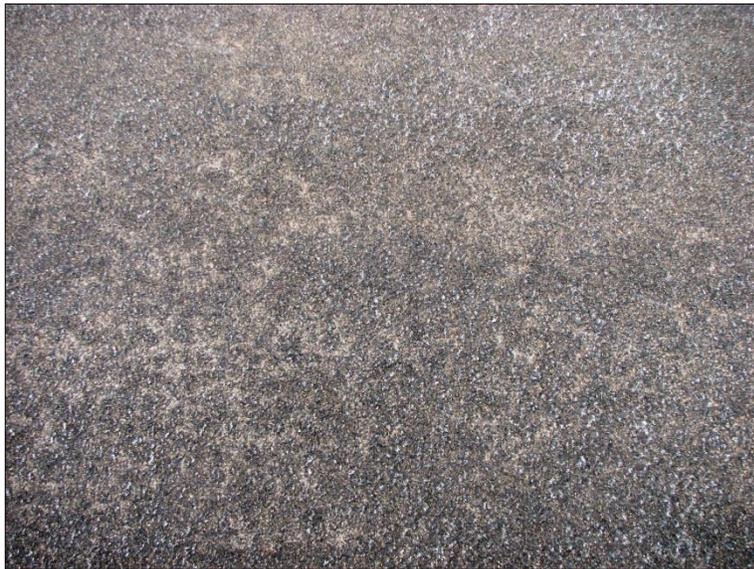
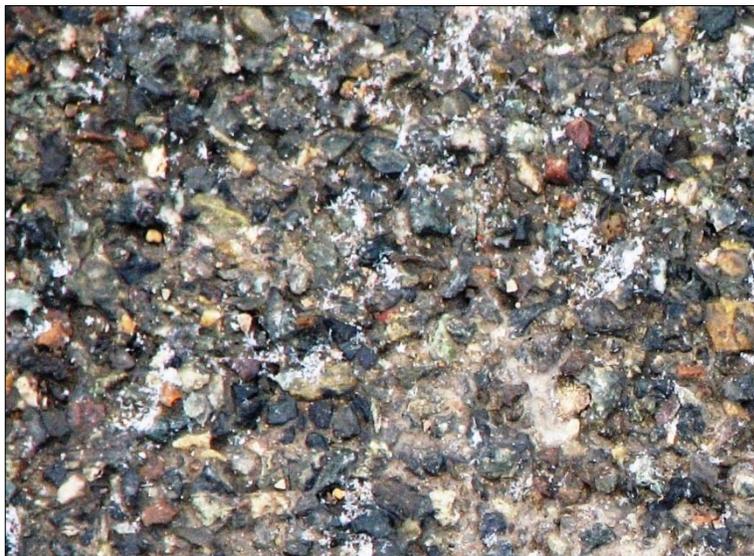
↙↘ The following are images (deck overview and surface texture) depicting the general condition of the HFST (view north).

No issues to date to report; aggregate surface has uniformity in texture and appearance. No areas of delamination or debonding visible.

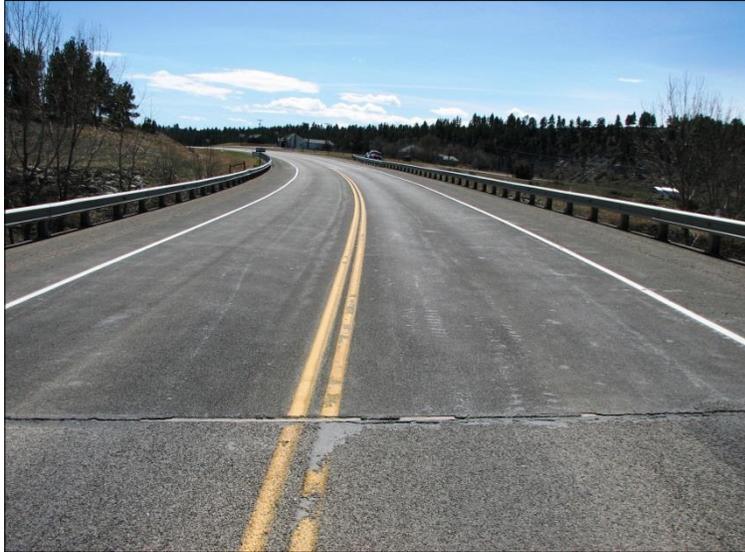
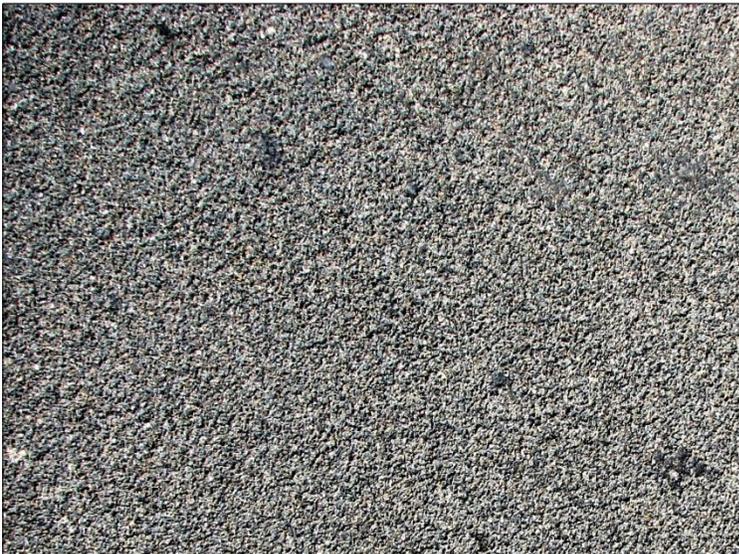
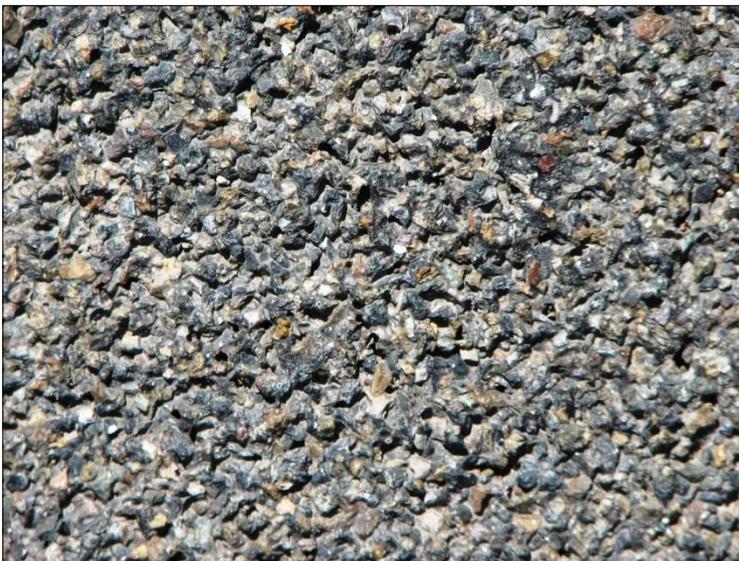
↙↘ The following are images (deck overview and surface texture) depicting the general condition of the HFST (view south).

No issues to date to report; aggregate surface has uniformity in texture and appearance. No areas of delamination or debonding visible.

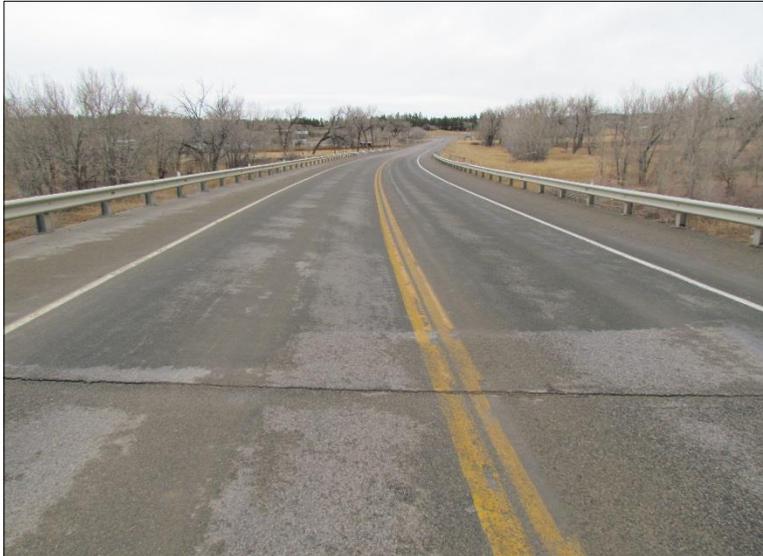
↩️ The following are images (deck overview and surface texture) depicting the general condition of the HFST as documented in 2017 (view north).

No areas of raveling or debonding visible. However, the surface textures appear polished and less textured since the last inspection, with noticeable pock marks indicative of loss aggregate (lower image is close-up of surface texture).

The topical condition of the HFST may be attributed to snowplow activity.

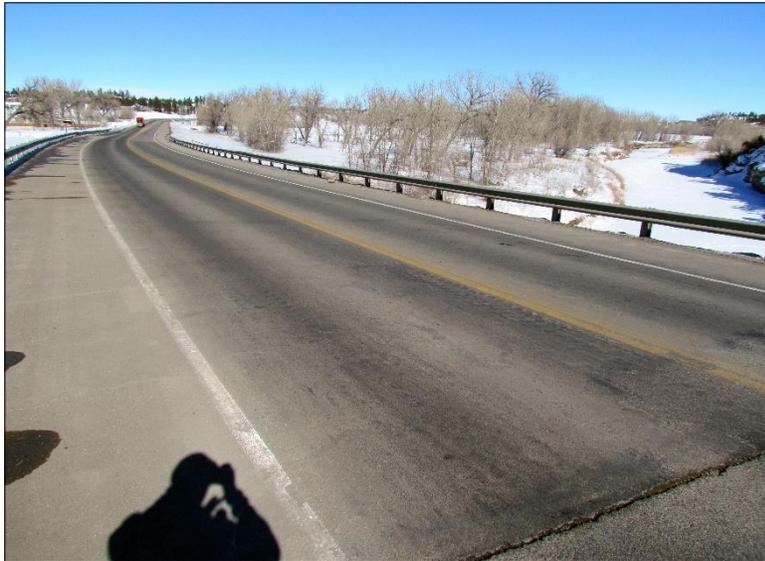
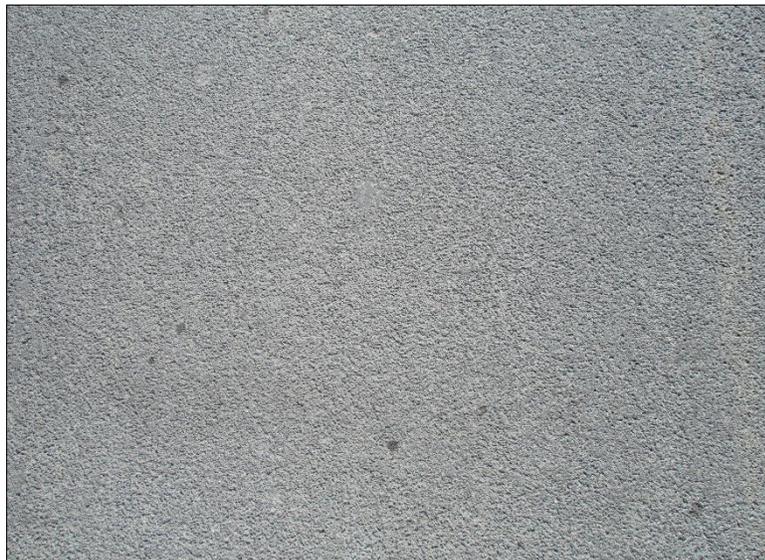
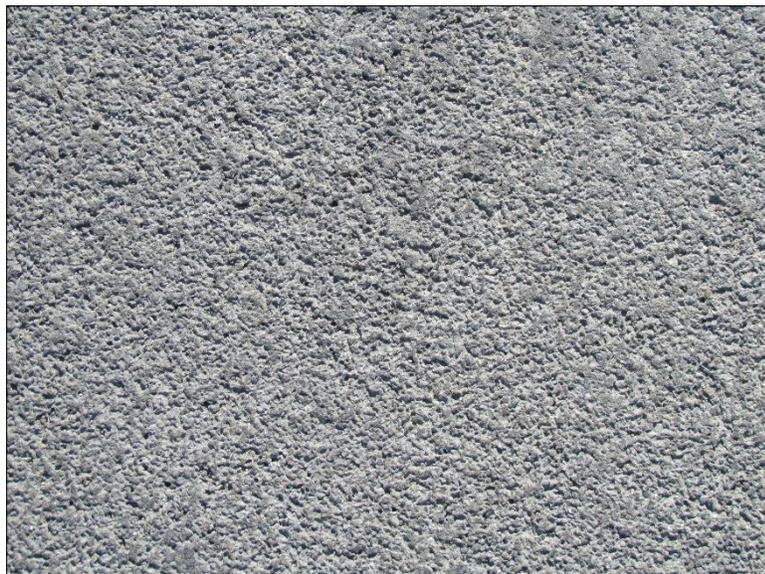
↙ The following are images (deck overview and surface texture) depicting the general condition of the HFST as documented in the spring of 2018 (view north).

No areas of raveling or debonding visible. However, the surface textures appear polished and less textured since the last inspection, with noticeable pock marks indicative of loss aggregate (lower image is close-up of surface texture).

The topical condition of the HFST may be attributed to snowplow activity and/or other traffic attributes.

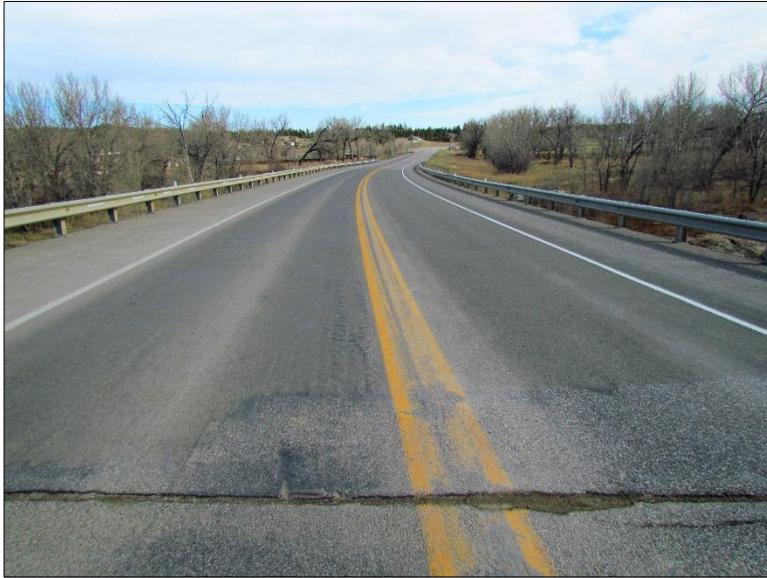
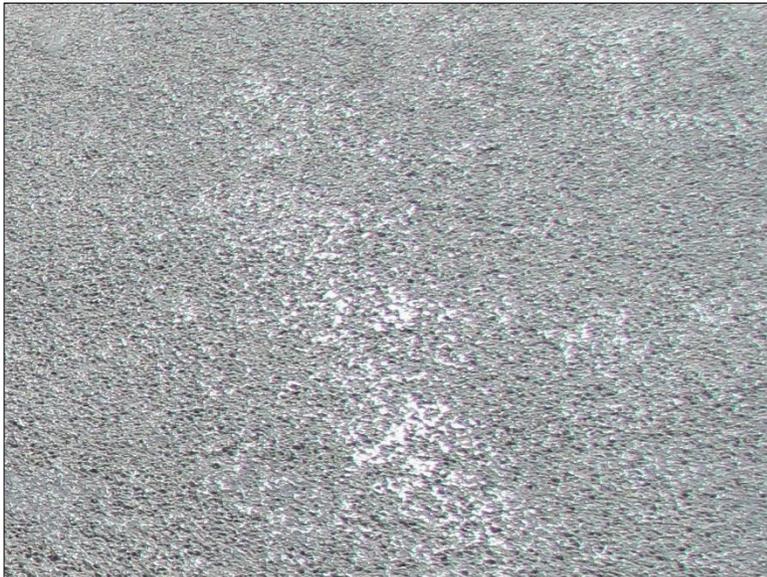
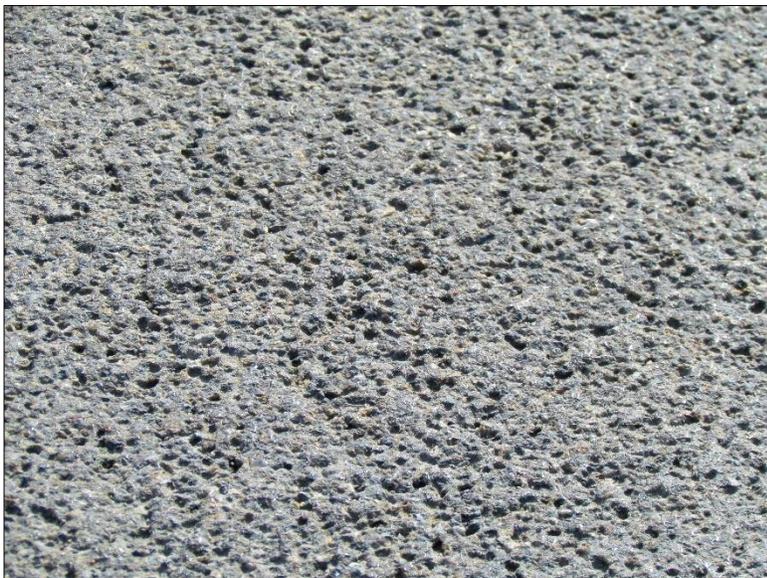
↩️ The following are images (deck overview and surface texture) depicting the general condition of the HFST (view north).

No areas of raveling or debonding visible, the surface texture appears polished and less textured since the last inspection and continued noticeable pock marks indicative of loss aggregate (lower image is close-up of surface texture).

The topical condition of the HFST may be attributed to snowplow activity and/or other traffic attributes (AADT, studded tires, etc.).

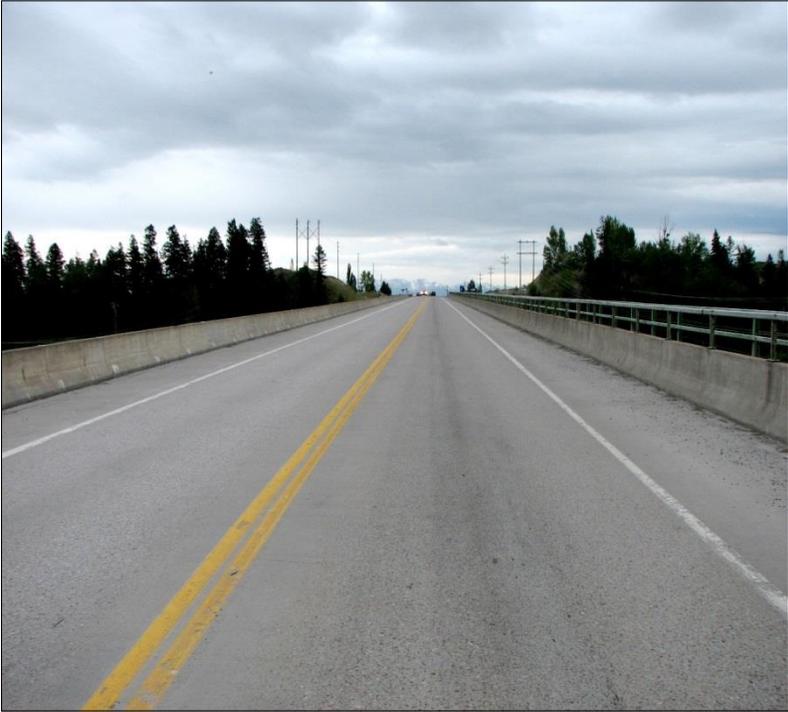
← Representative image of deck prior to overlay (view east).

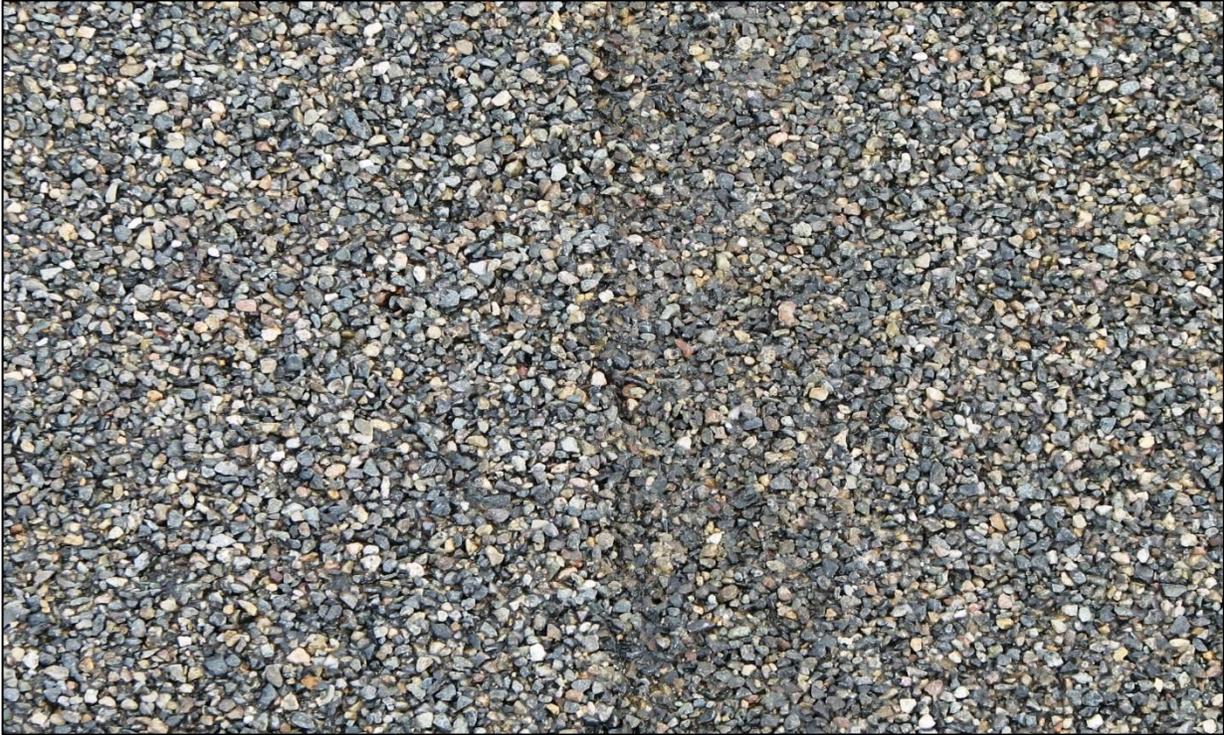
↑ Close-up of the difference of surface texture of the first lift (right side of image) and the second lift (left side of image).

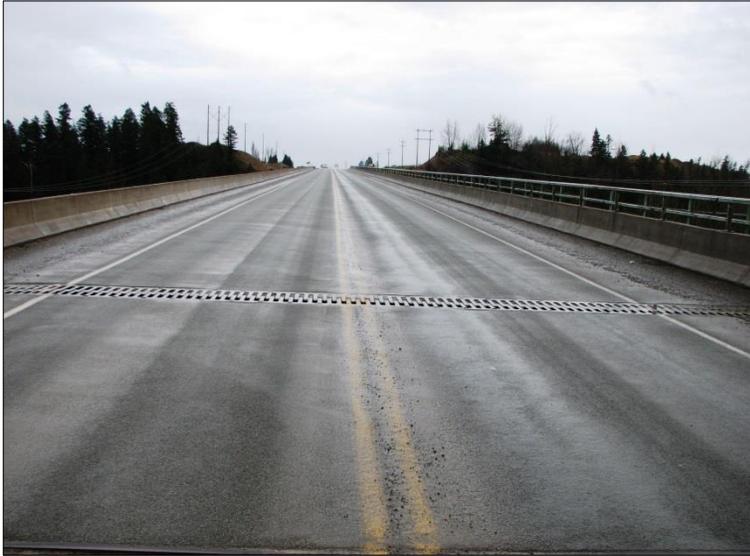
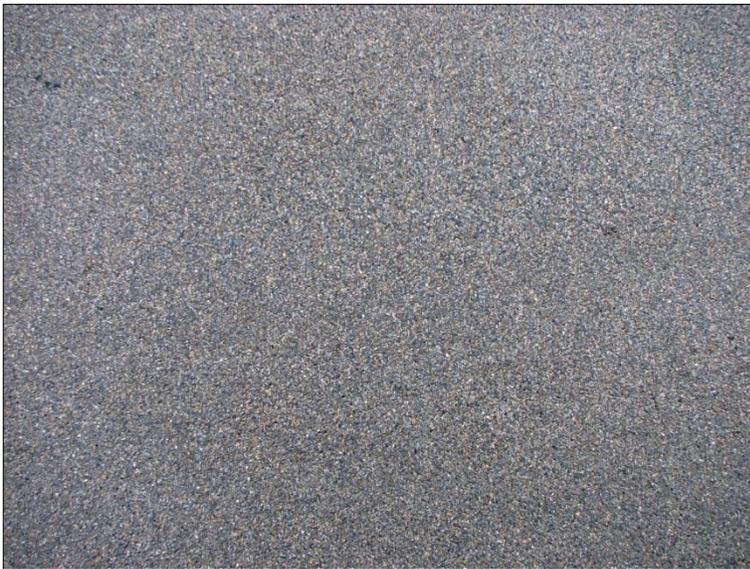
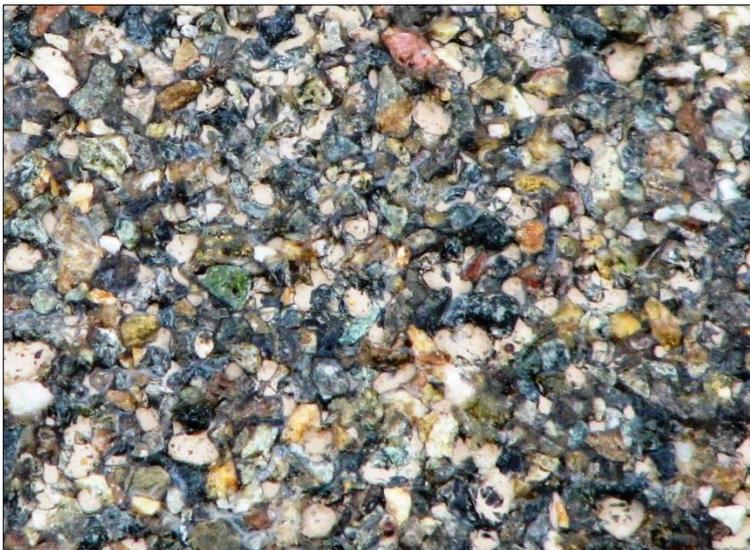
**Kalispell – Poly-Carb 135 Safe-T-Seal/163 Flexogrid Overlay: March 2015**

↙ The following are images (deck overview and surface texture) depicting the general condition of the HFST (view east).

No issues to date to report; aggregate surface has uniformity in texture and appearance. No areas of delamination or debonding visible.

The deck surface was wet during the inspection.

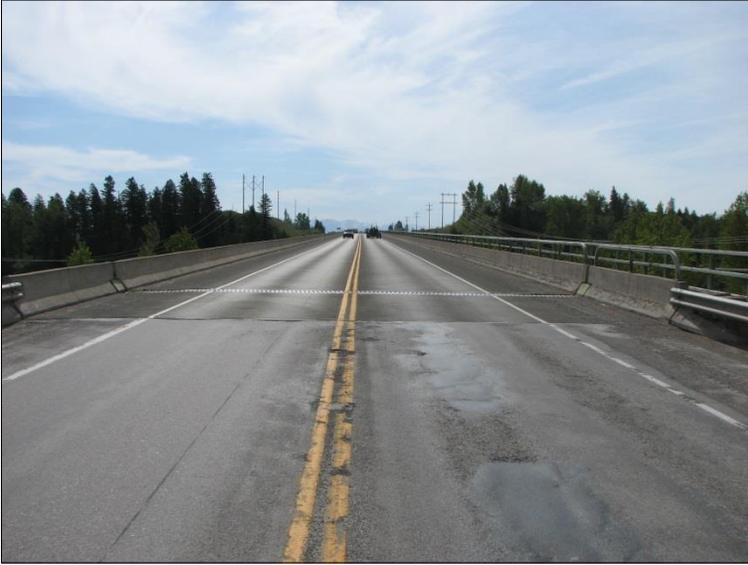
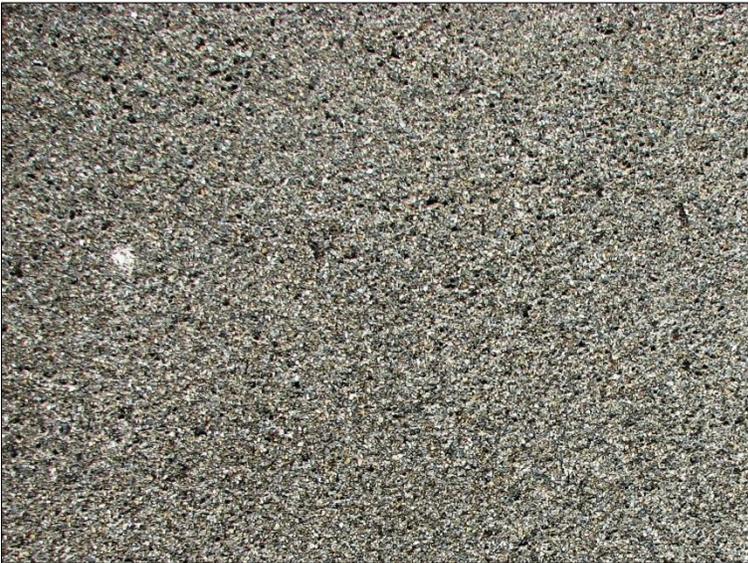
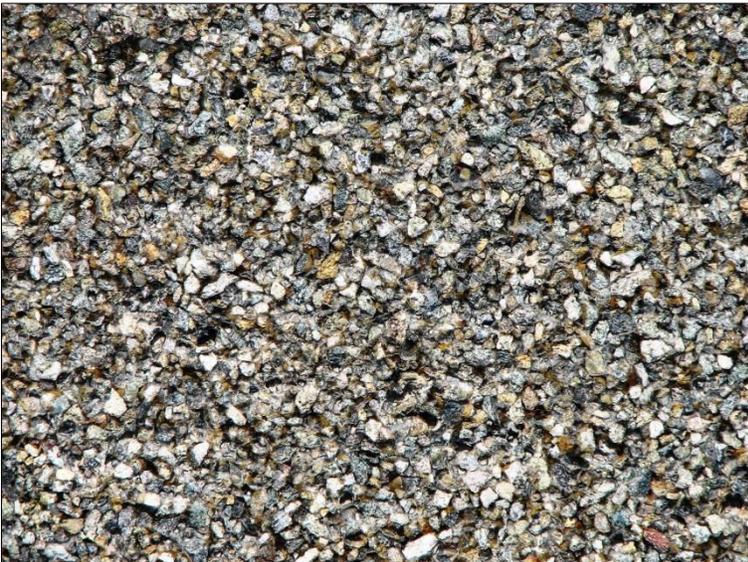
**Kalispell – Poly-Carb 135 Safe-T-Seal/163 Flexogrid Overlay: May 2016**

↙↓ The following are images (deck overview and surface texture) depicting the general condition of the HFST (view east).

No issues to date to report; aggregate surface has uniformity in texture and appearance. No areas of delamination or debonding visible.

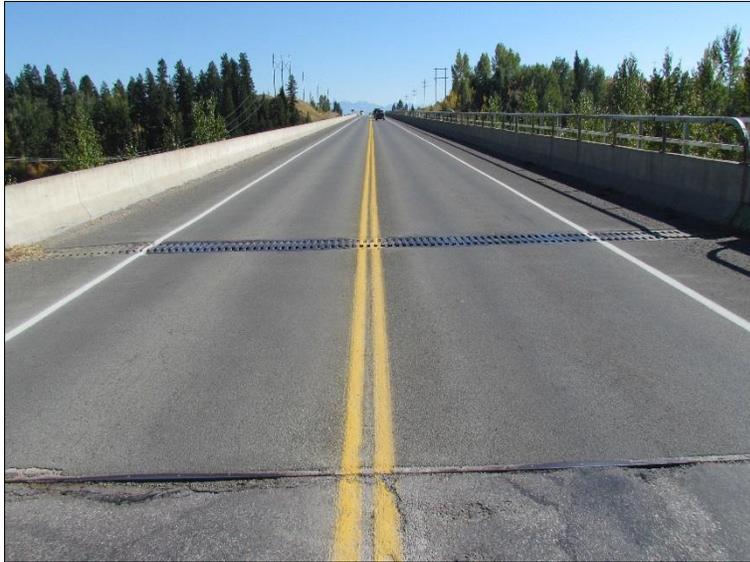
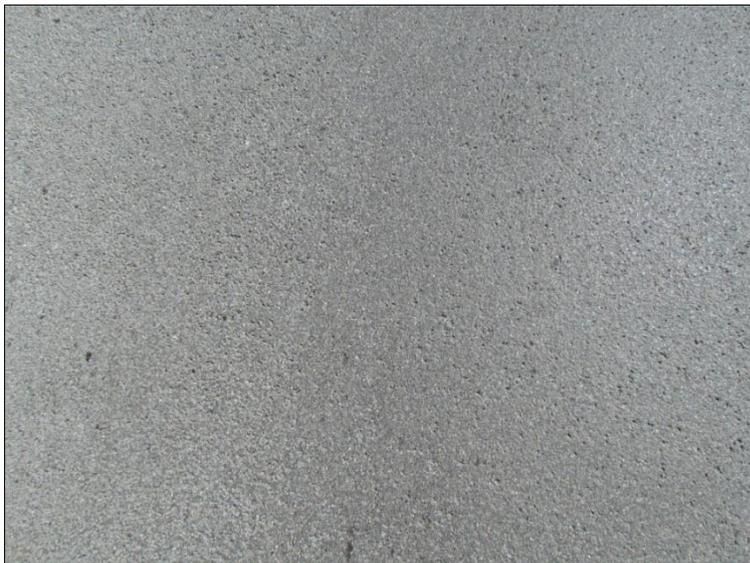
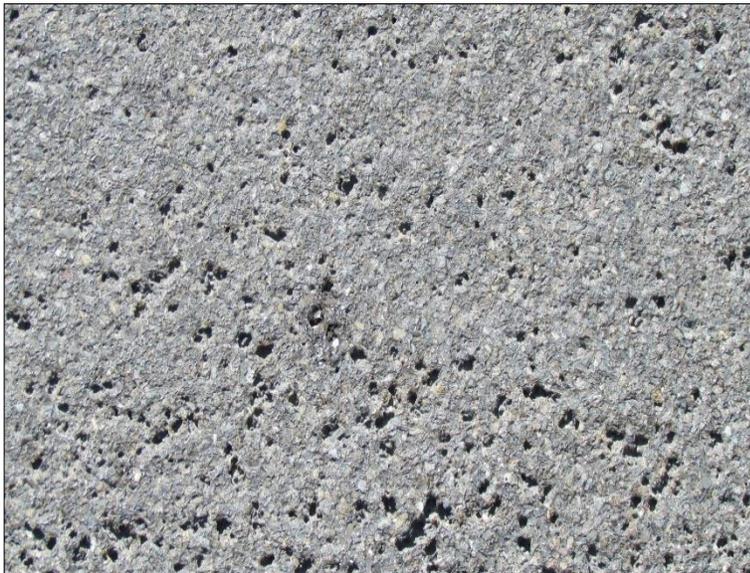
**Kalispell – Poly-Carb 135 Safe-T-Seal/163 Flexogrid Overlay: July 2017**

↙ The following are images (deck overview and surface texture) depicting the general condition of the HFST as documented in 2017.

No areas of raveling or debonding visible. However, the surface textures appear polished and less textured since the last inspection, with noticeable pock marks indicative of loss aggregate (lower image is close-up of surface texture).

The topical condition of the HFST may be attributed to snowplow activity.

Current skid test numbers (wheel path area) are at (on average) 20 for the deck surface.

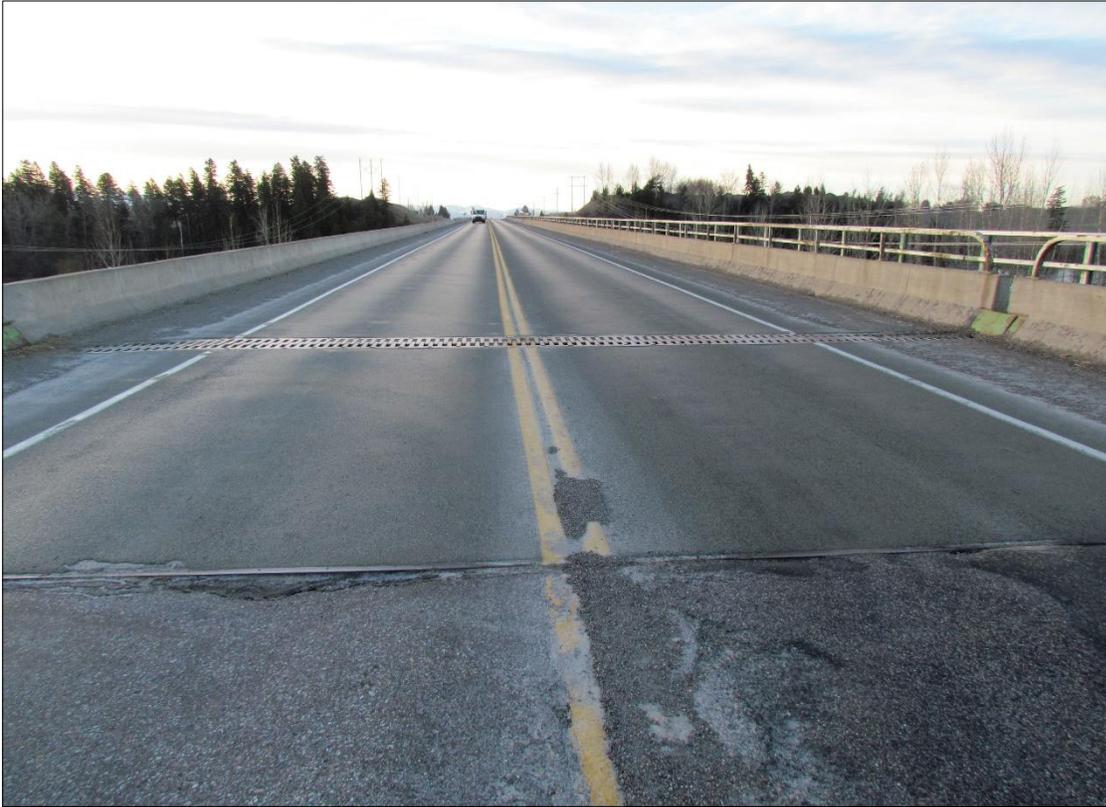
↑ Overview of deck approach; west span, view east.

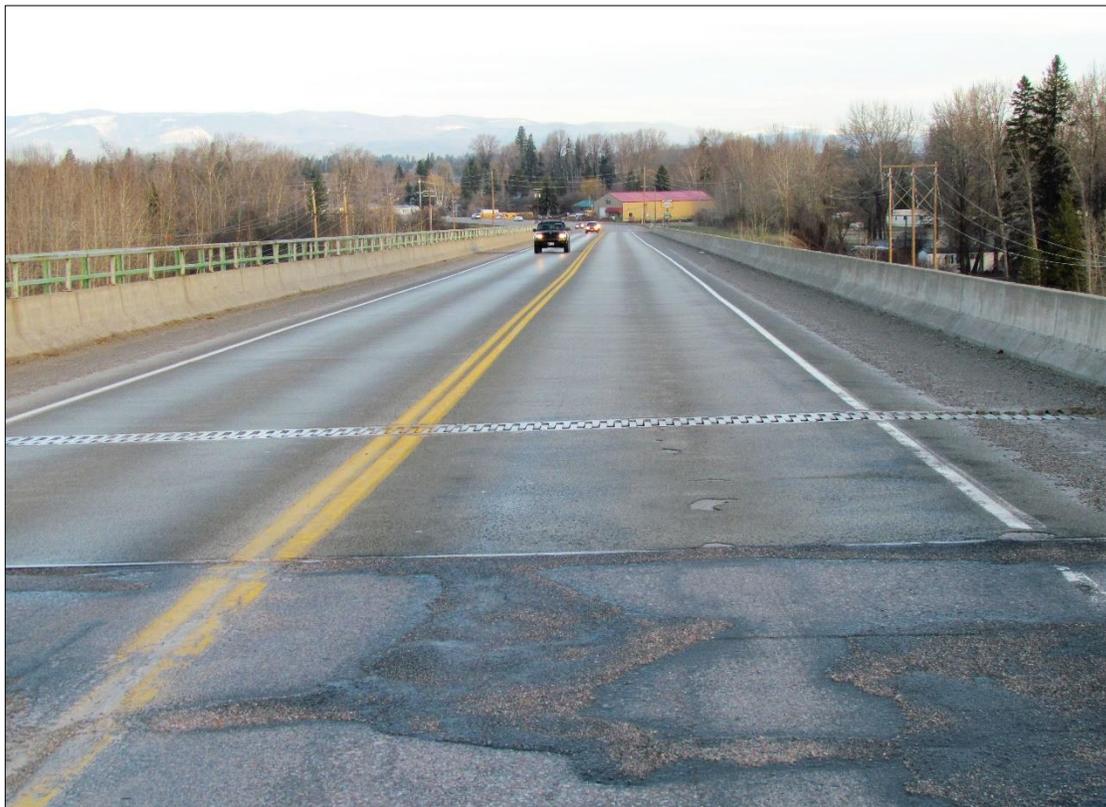
↓ Overview of deck approach; east span, view west.

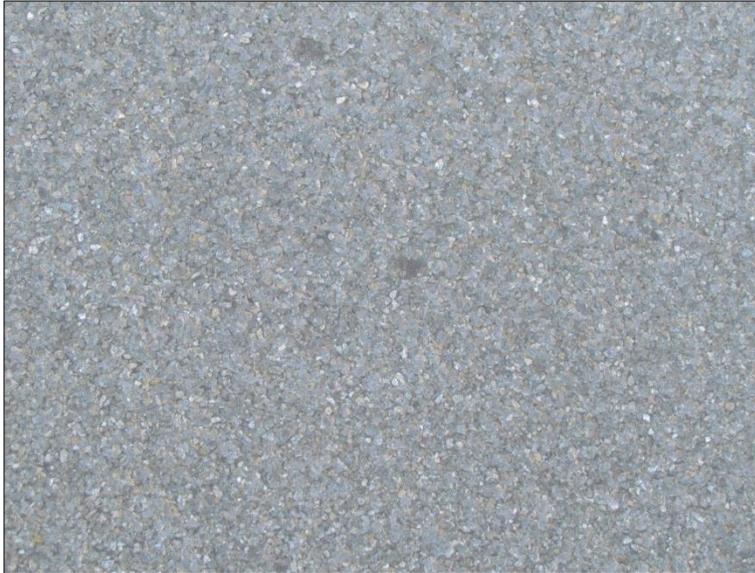
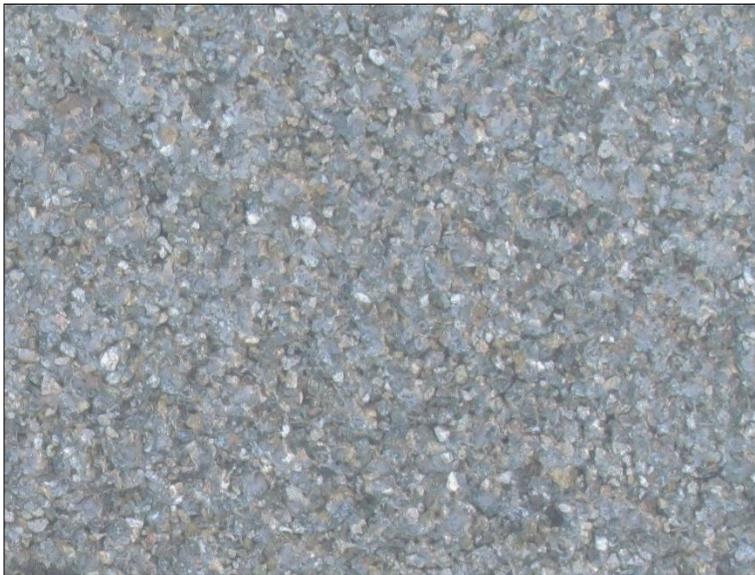
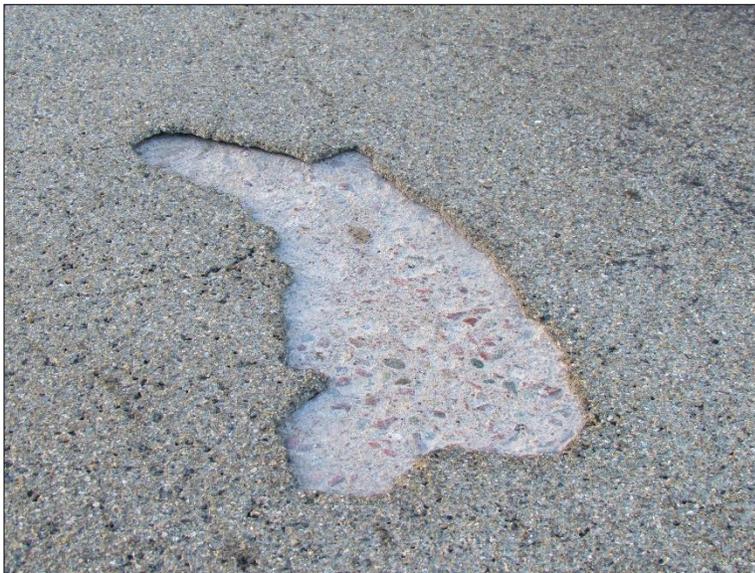
←↓ Several images of the deck's surface texture (middle image closer view).

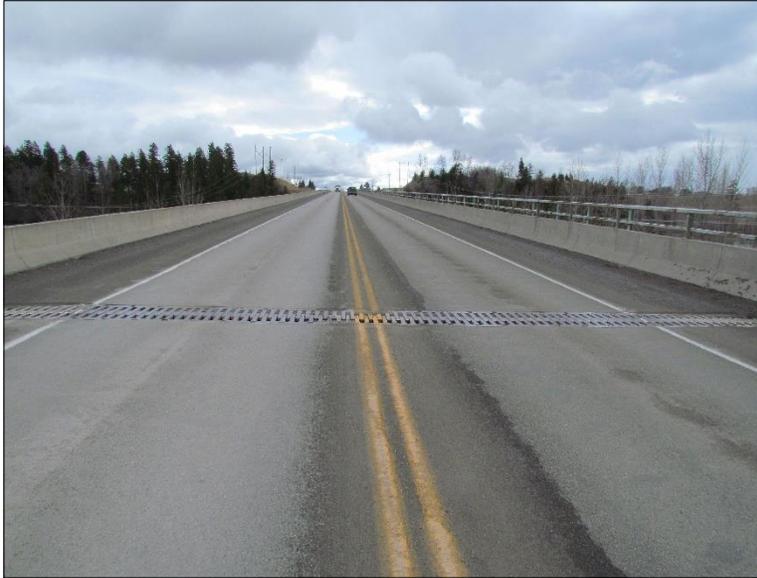
← Overview of reappplied single layer of Unitex Polymer layer installed in September 2018 (view east).

← Due to the progressive deterioration of skid resistance mainly in the wheel paths; the District elected to repair the delaminated areas and to reapply a single layer of the Unitex polymer to the entire deck.

Repairs were conducted by L&J Construction using the Dayton Superior (DS) process in adding a single lift of HFST.

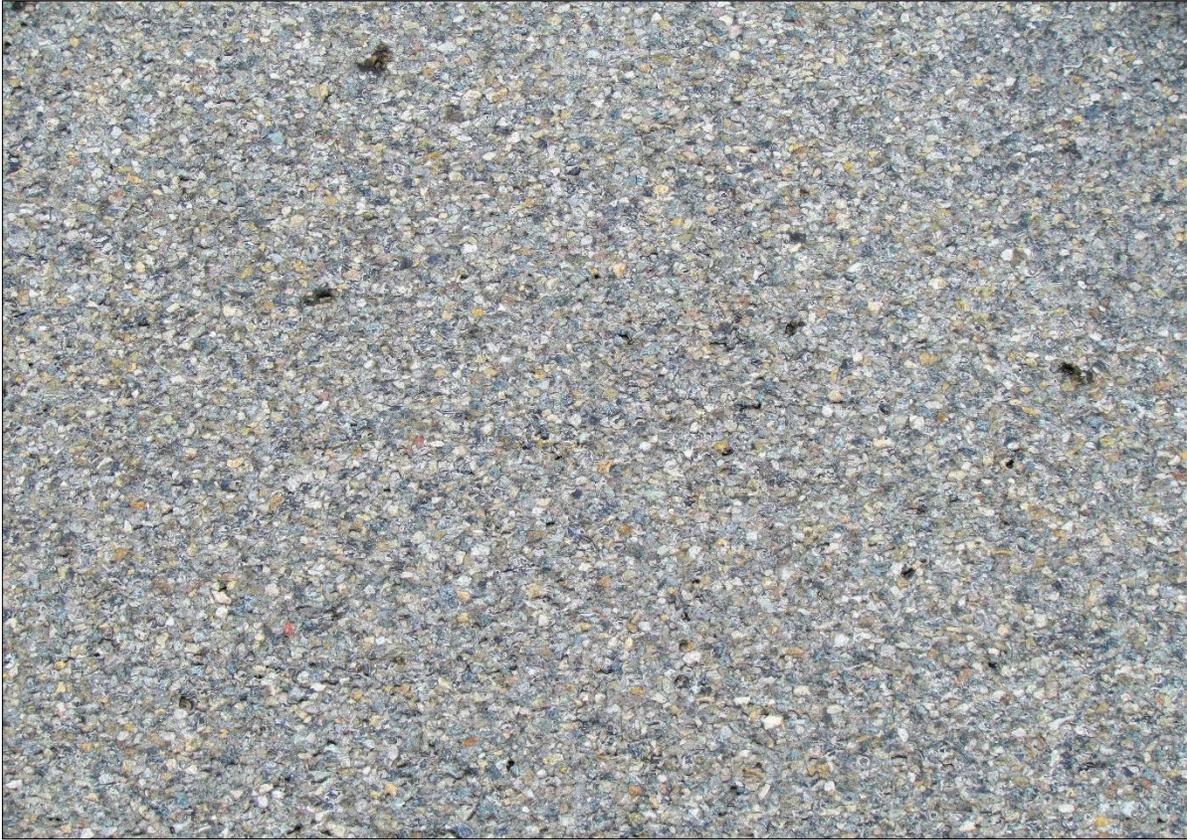
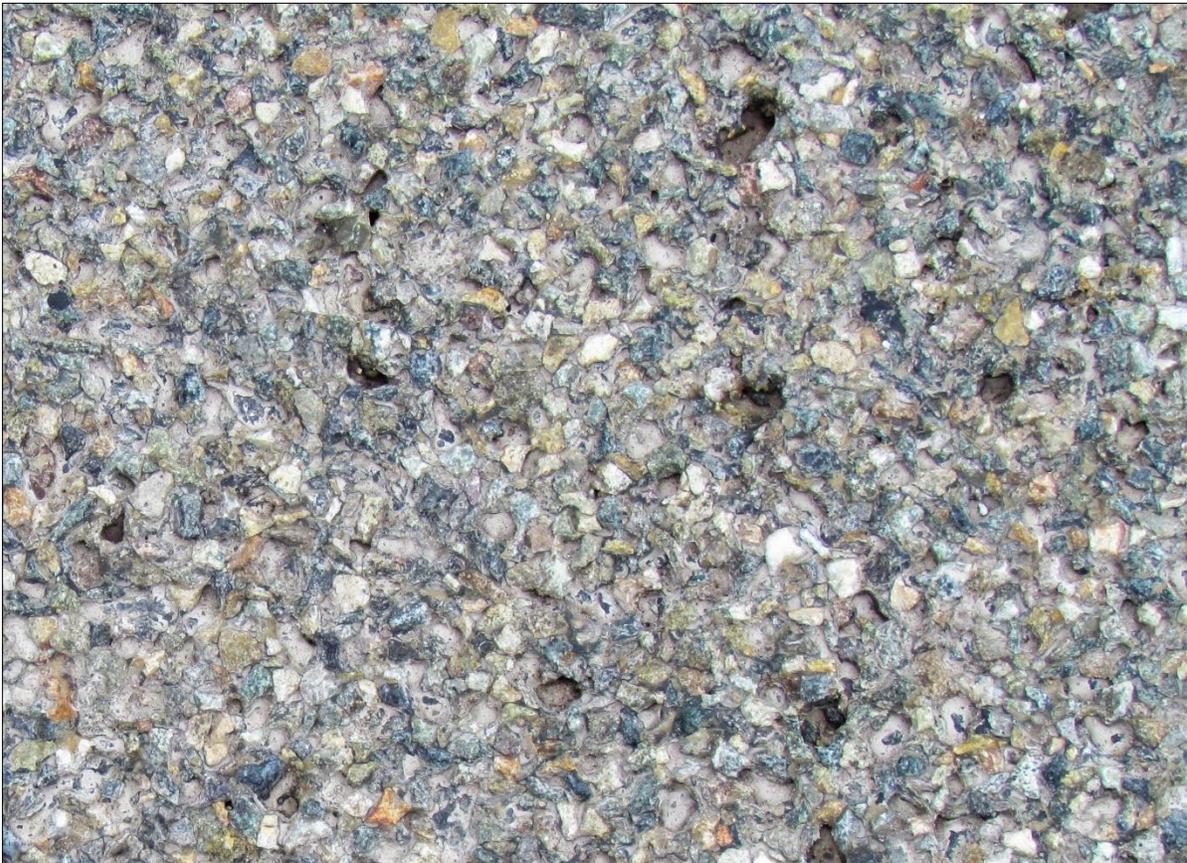
↕ Representative images of surface texture of reappplied HFST layer.

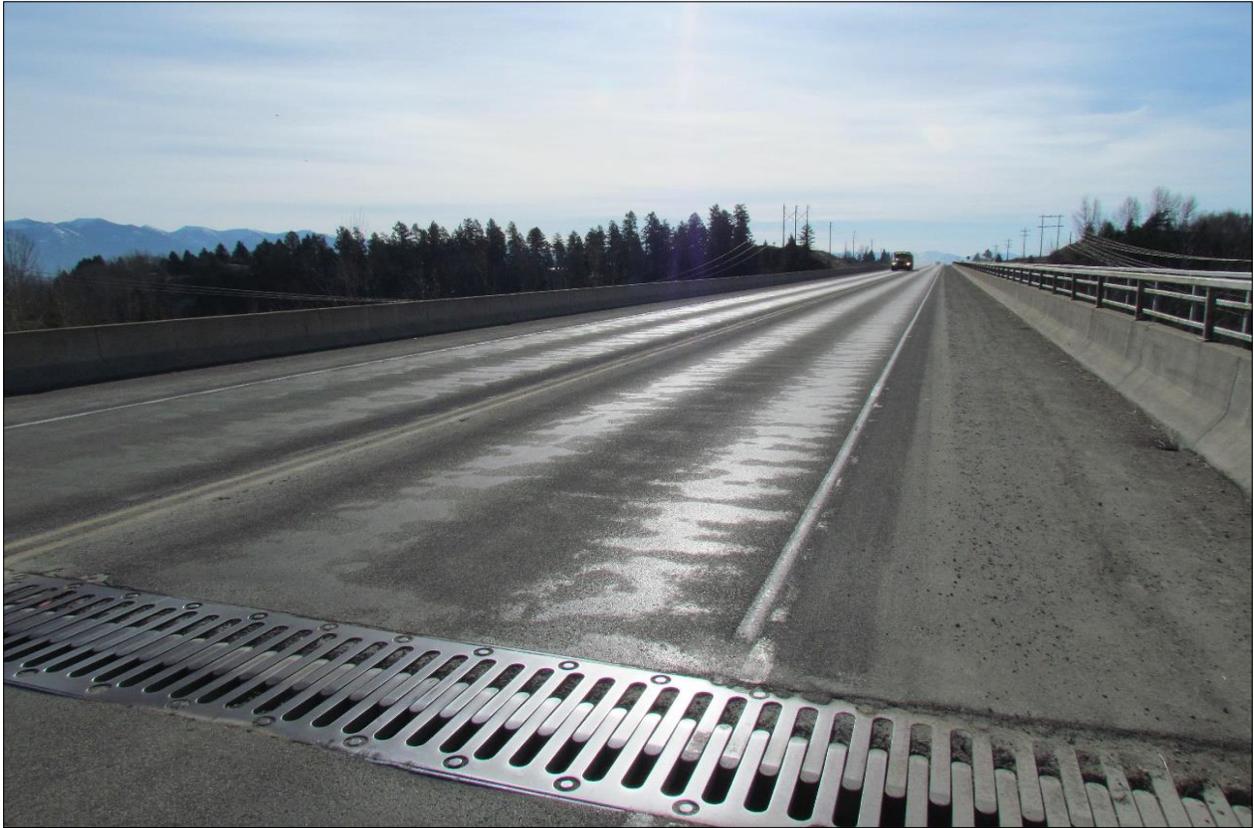
↑ West end of Flathead River/MT 35 bridge deck; view east.

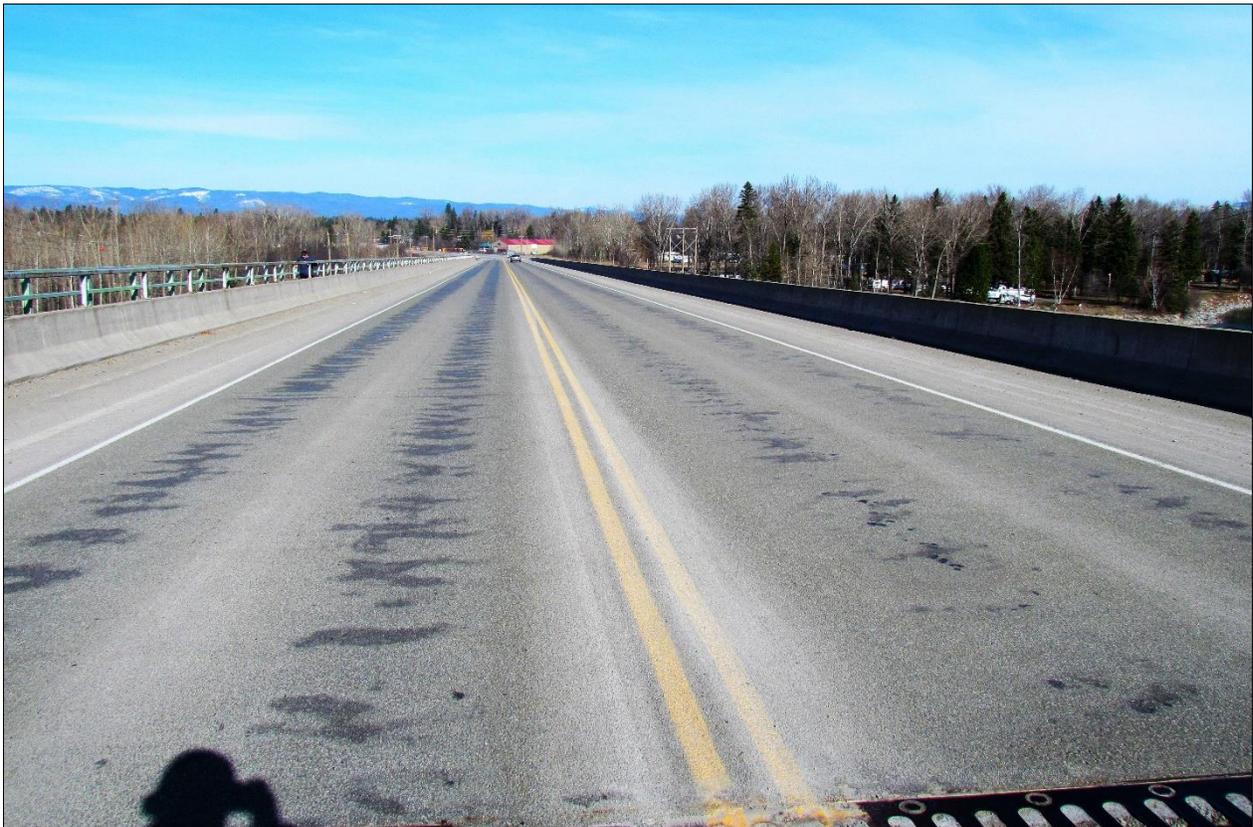
↓ East end of Flathead River/MT 35 bridge deck; view west.

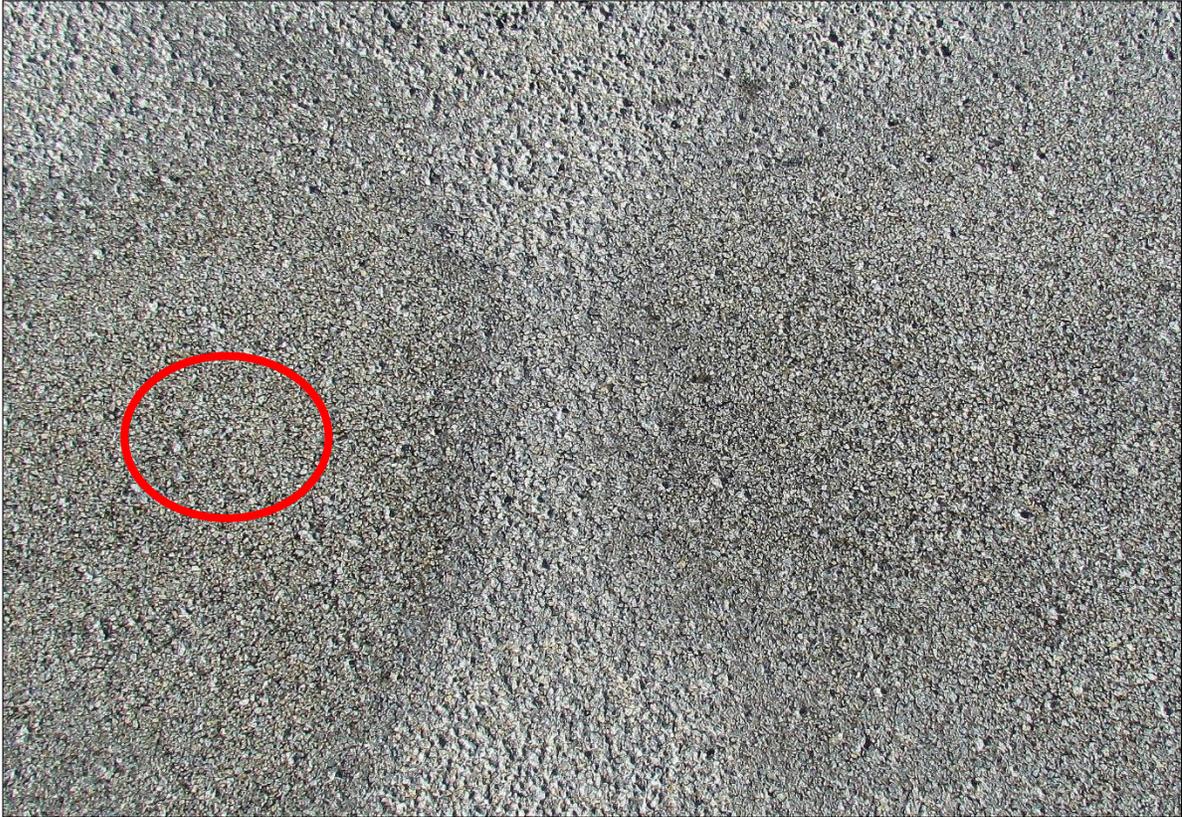
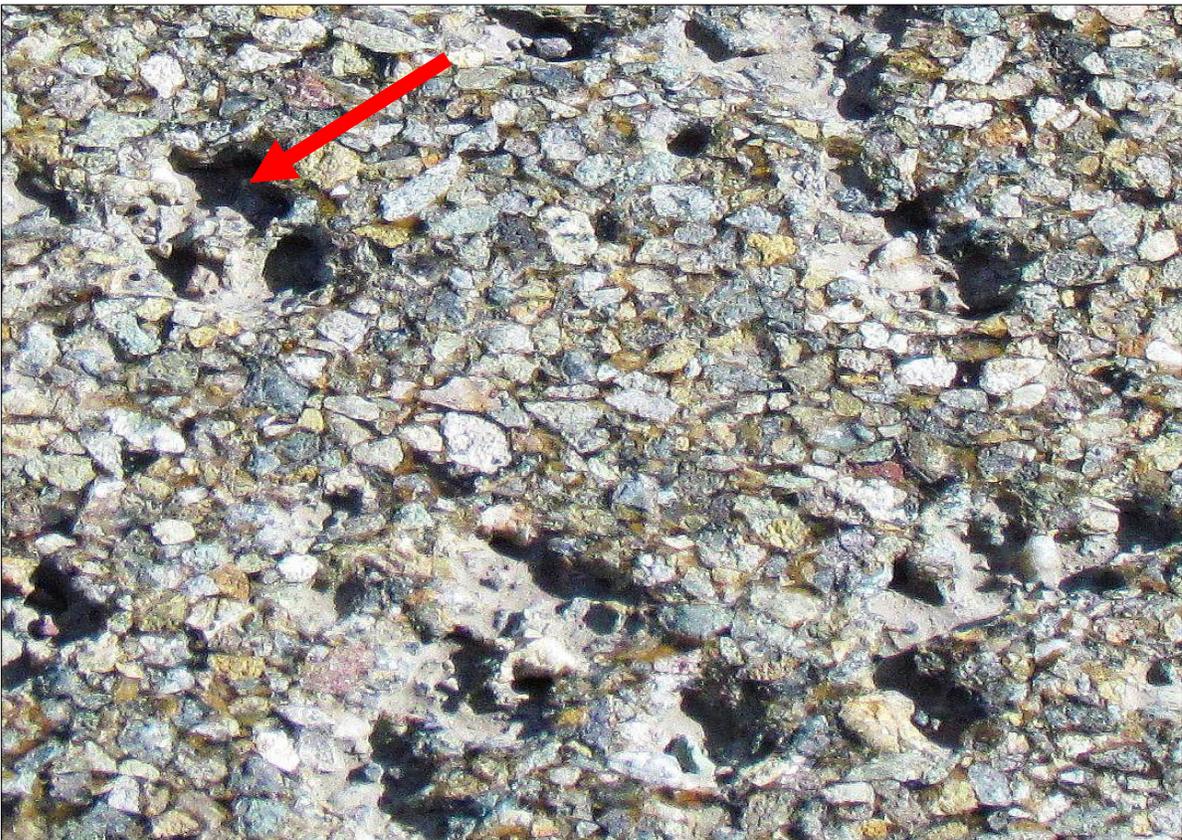
↑↓ Several representative images of the overlay surface texture in the wheel paths; the image below is a close-up of the area specified in the red circle in the above image, which shows the polished aggregate. The red arrow in the image below shows aggregate that has popped out of the epoxy matrix.
