## EXPERIMENTAL PROJECTS FINAL REPORT

### HIGH FRICTION SURFACE TREATMENTS (HFSTs) FOR BRIDGE DECKS

- FHWA Project Number:** MT-12-10/13-01/14-05
- Principal Investigator:** Craig Abernathy, Experimental Project Manager (ExPM)
- Date of Installations:** <sup>1,2,3</sup>June 2014/<sup>4</sup>June 2015

- Date of Inspections:** March 2015/April-May 2016/May-October 2017/April 2018  
April 2019/April & May 2020

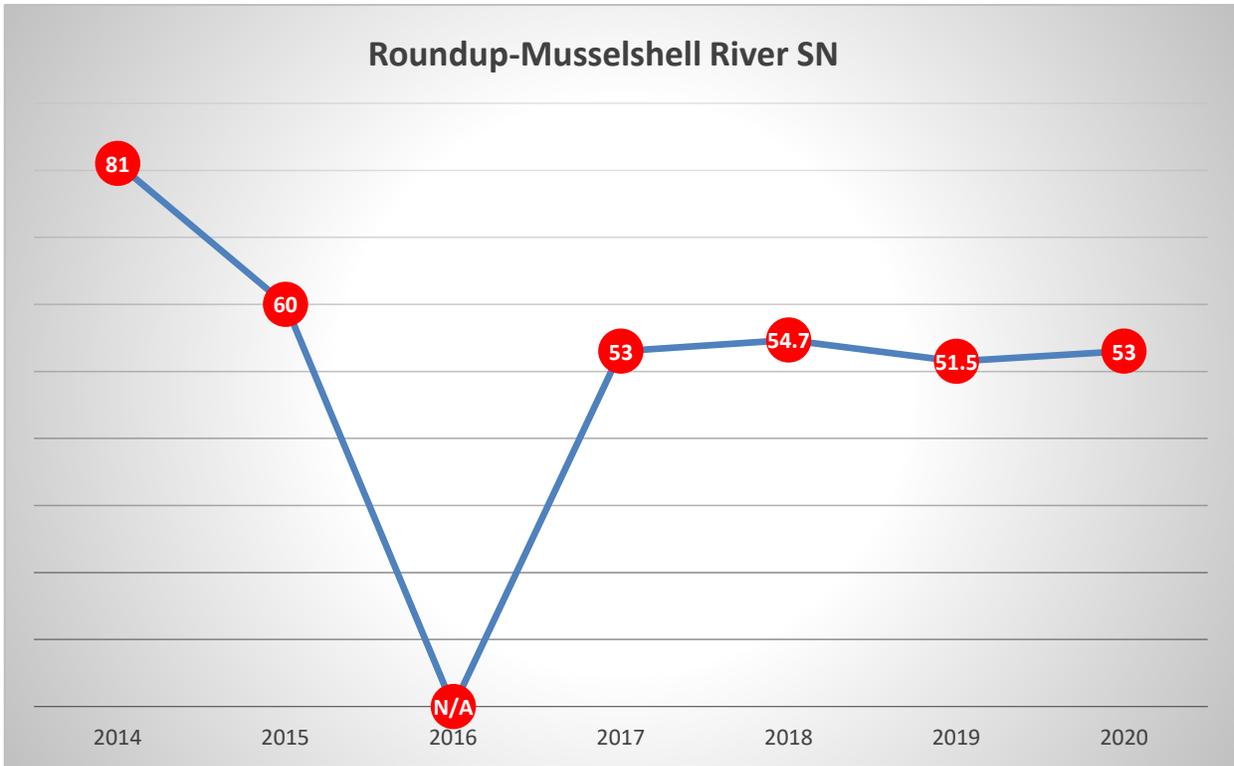
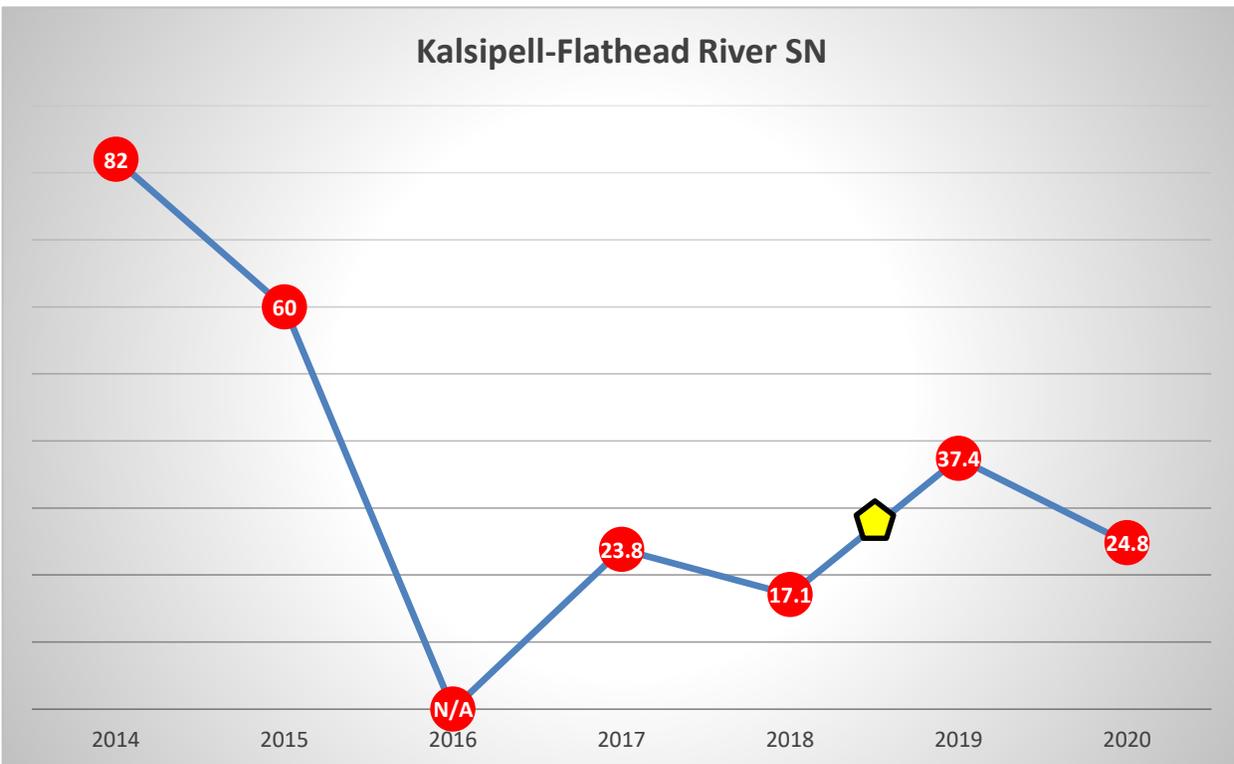
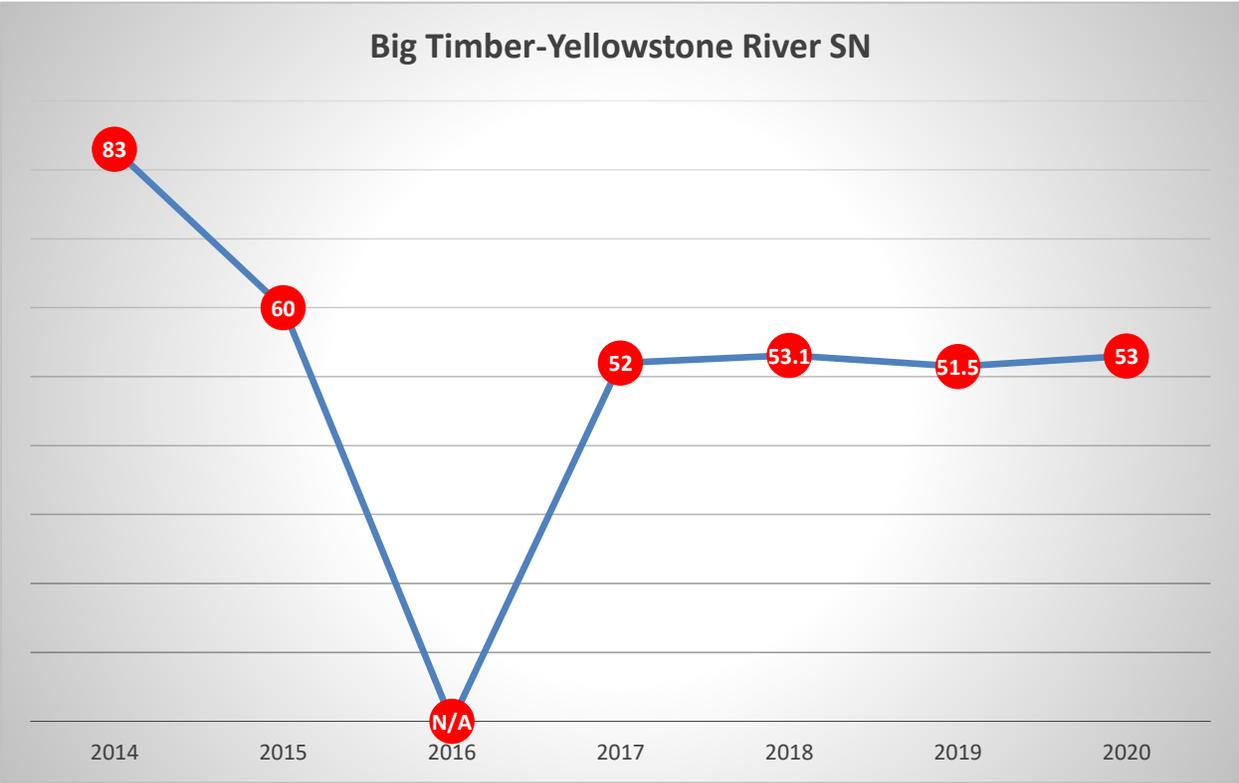
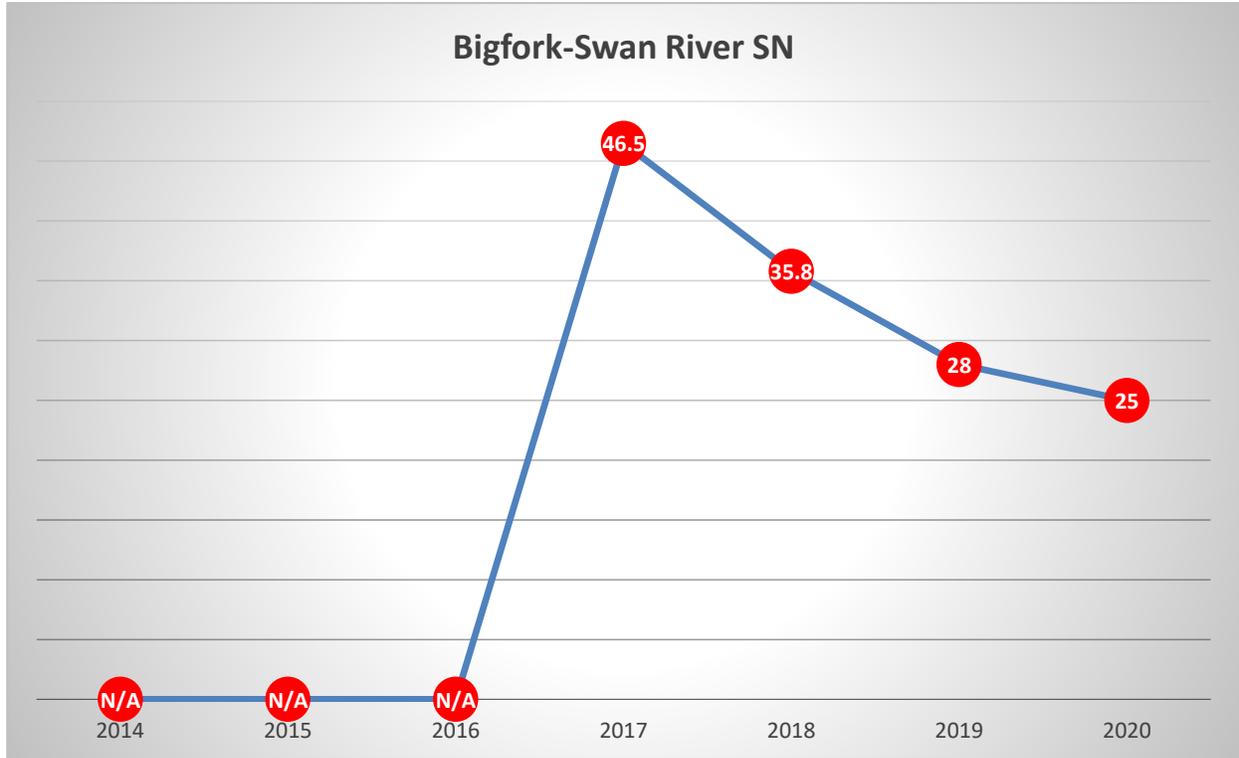
**\*Project Skid Numbers (SN): 2014-2019**

Due to low skid numbers documented in 2018 and several areas of HFST delamination; the District repaired the delamination and reapplied a single lift of HFST in September of 2018.

\*For all listed decks, the 2016 Skid Tests did not take place. The Bigfork Deck was applied in 2015 but was not skid tested until 2017.
