## INSTALLATION REPORT AND ANNUAL EVALUATION

### The Use of 3D Synthetic Geocomposite for Added Subsurface Drainage Layer in Asphalt Cement (AC) Pavement

**Project Name:** Jct. Reynolds Pass - Quake Lake

**Experimental Project:** MT-15-02

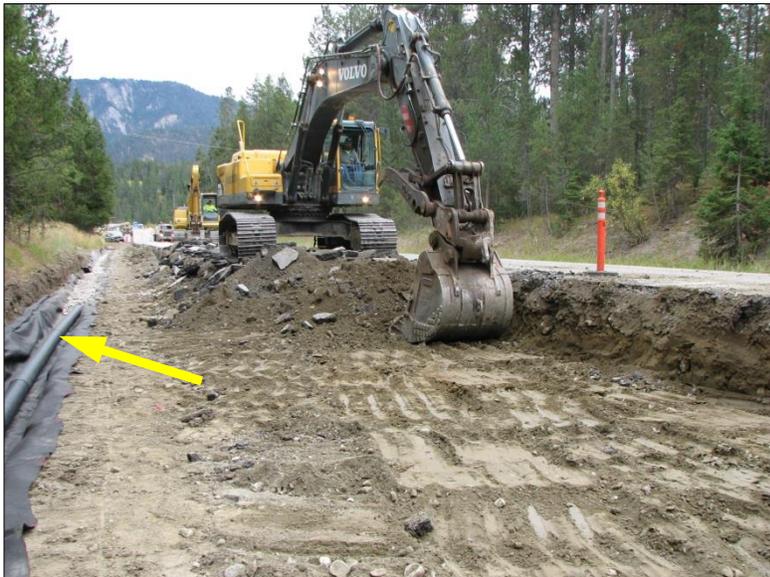
← Beginning with the northbound lane, the subgrade was excavated to an average depth of 40" (102cm), view south.

The edge drain may be seen at the left of the image (yellow arrow).

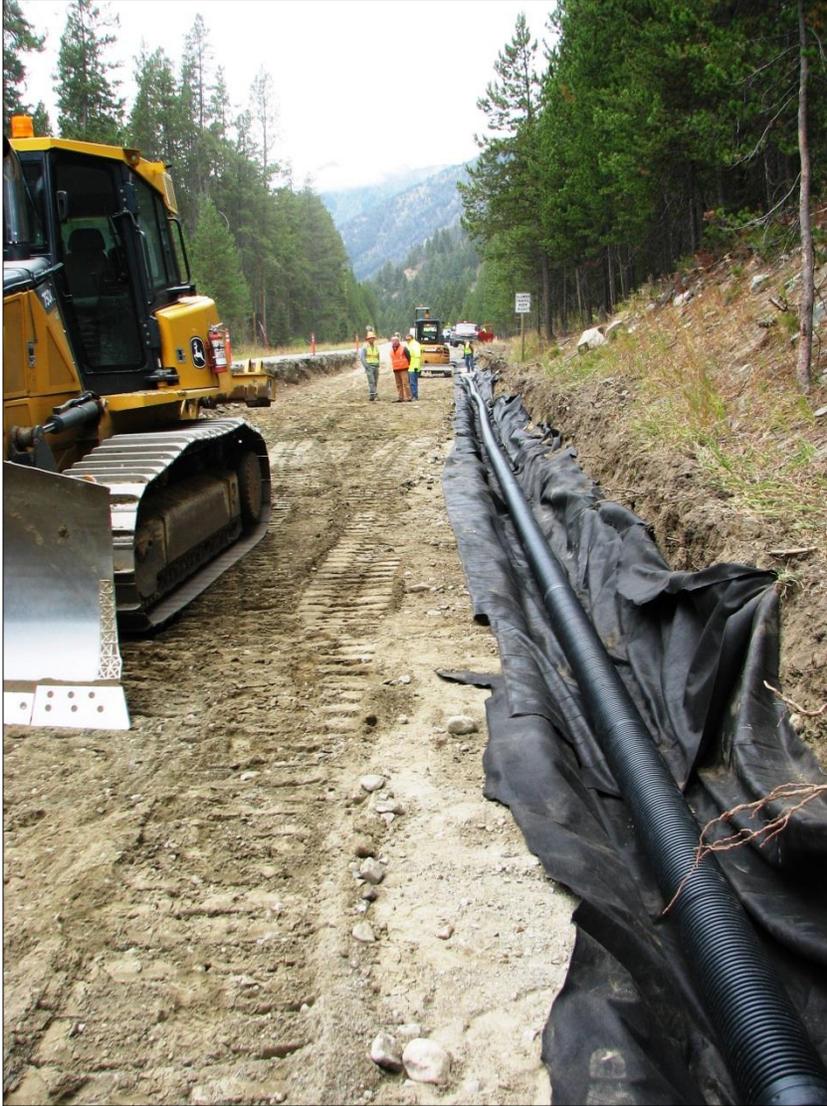
← Geotextile lined ditch with 8" (20cm) corrugated perforated plastic pipe.

Northbound lane; view north.

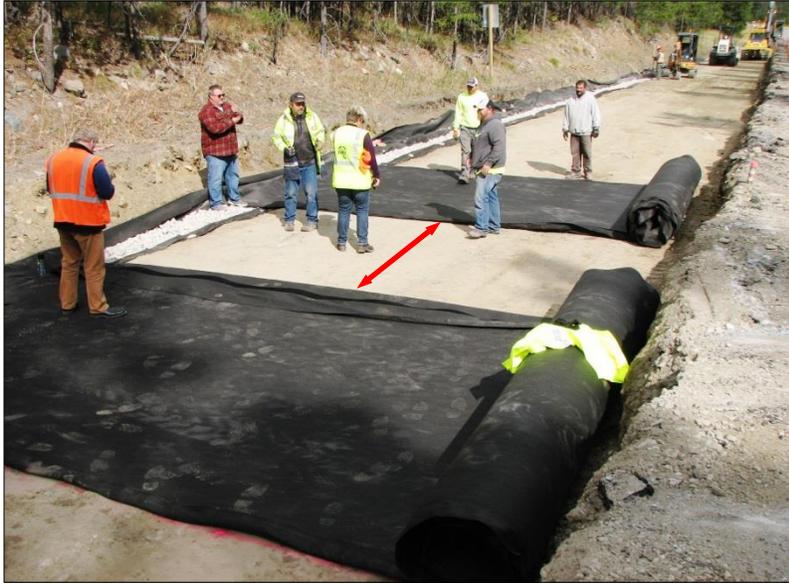
← With direction from the vendor's representative, the SSDL segments were alternately placed at a required spacing during installation in order to allow the cores to be butted together; and to have the bottom fabric layers completely cover the base.

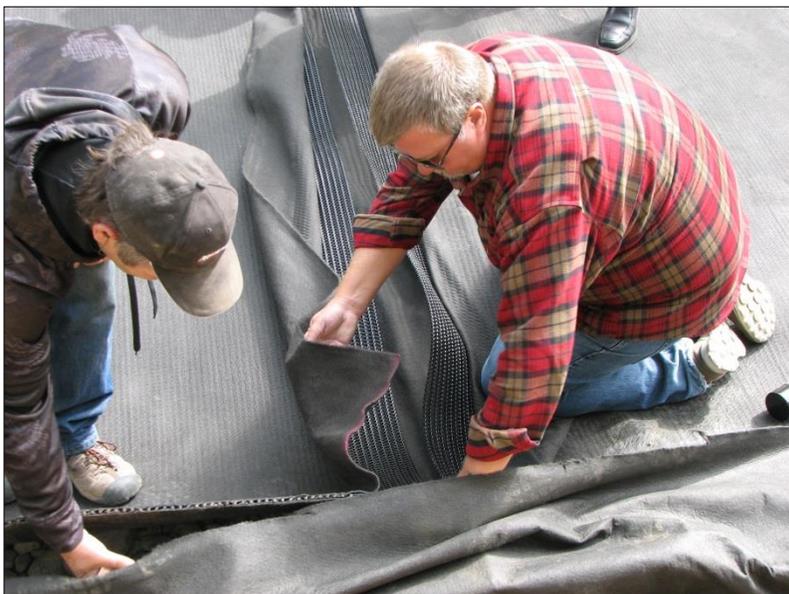
← The contractor overlaps the bottom fabric layers and to create the core seams.

This procedure maximizes the drainage properties of the SSDL units.

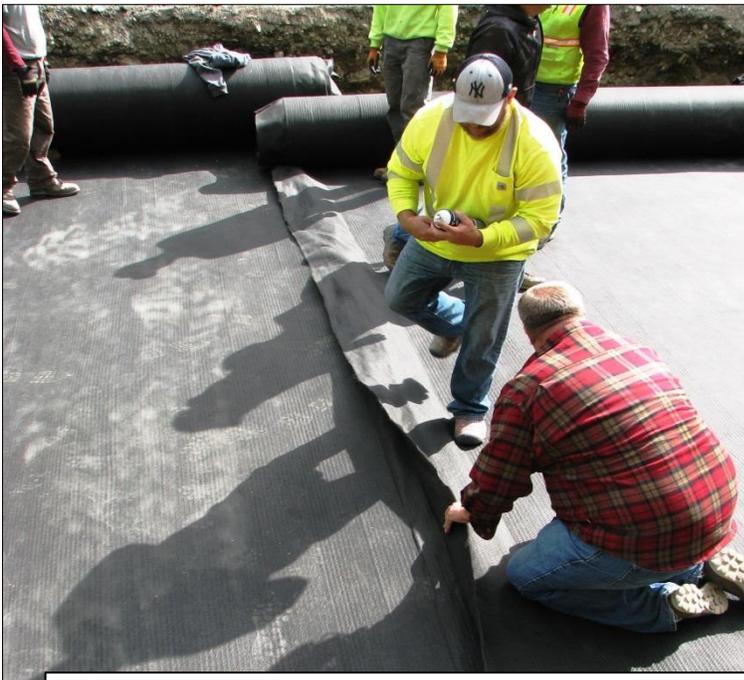
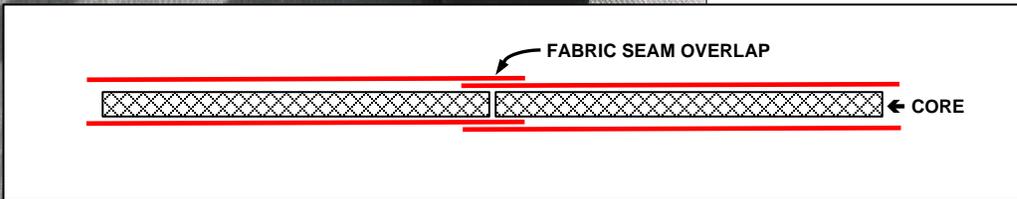
← To prevent movement and maintain alignment during fill placement; high-strength spray adhesive is applied at the seam overlap.

The insert below is a cross-section depiction of the butted cores and overlapping of fabric seams to the individual sections of SSDL.

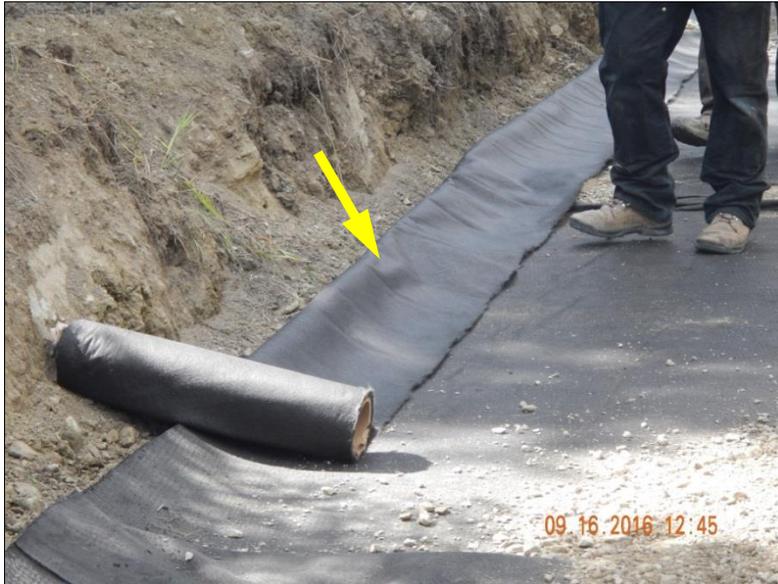
← To prevent possible migration of sediment into the core of the SSDL, a section (or cap) of geosynthetic fabric was folded under and over the edge prior to placement of the CAC.

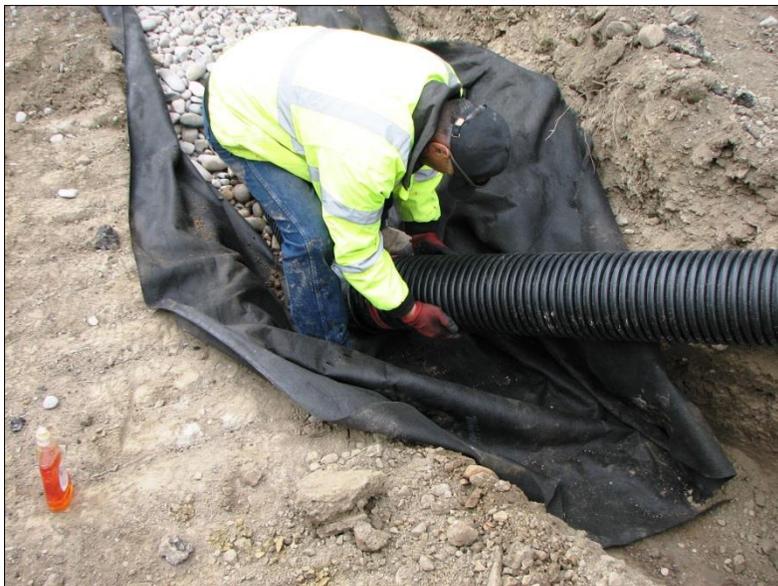
← The edge drain outlet (located at the south end of the northbound lane), was completed by attaching a non-perforated corrugated pipe angling away from the roadbed.

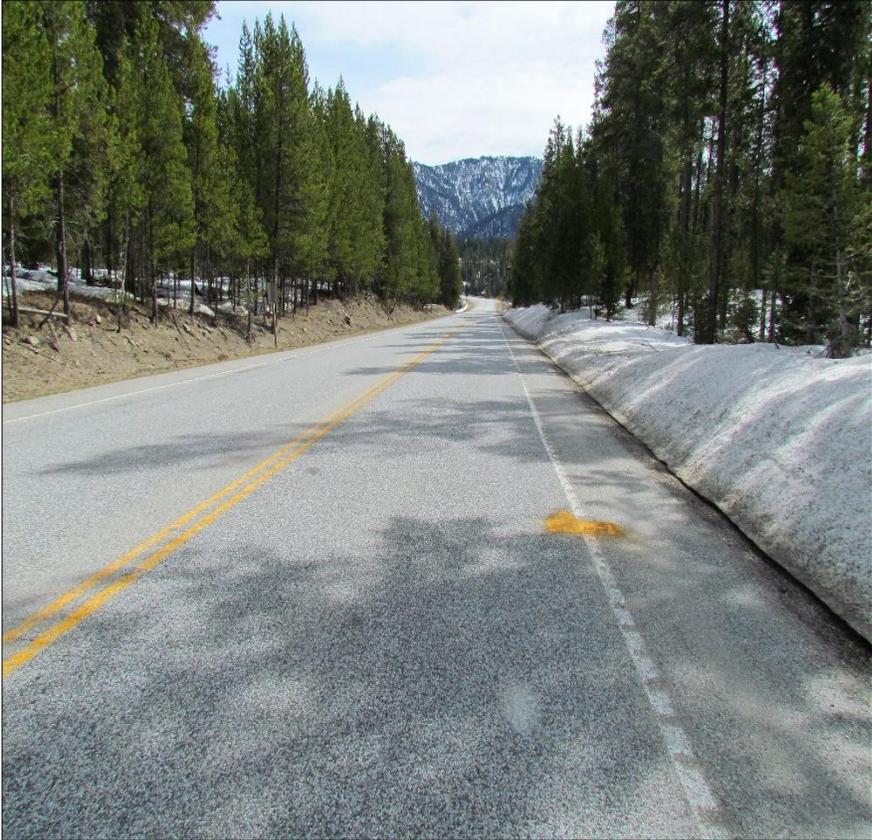
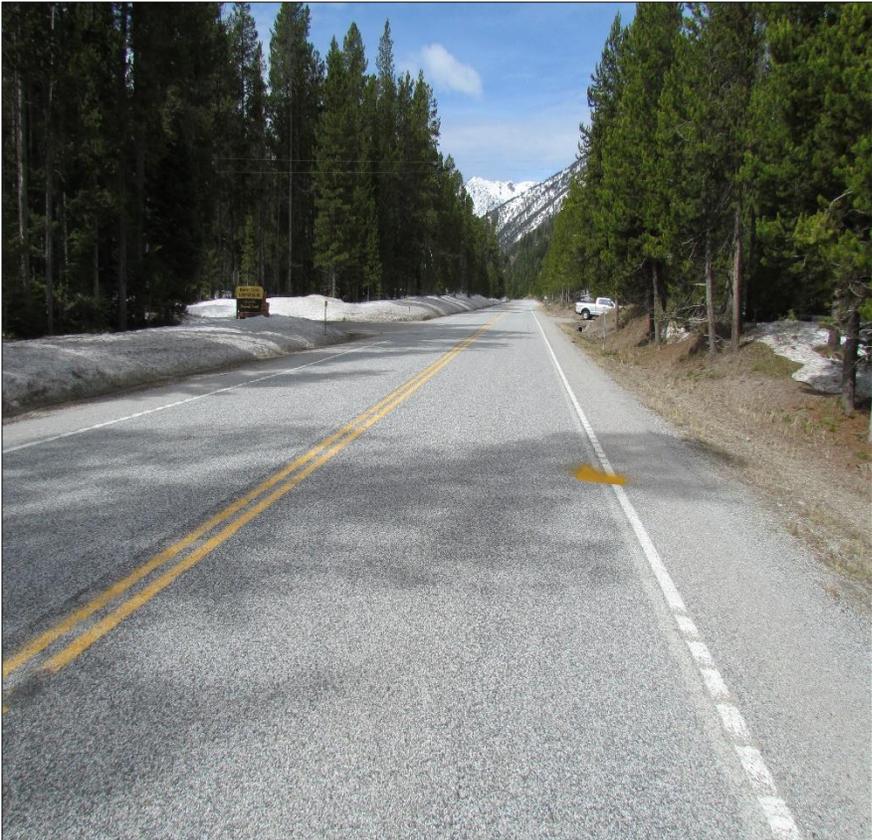
← ↓ Representative images of pavement section condition; views east and west respectively.

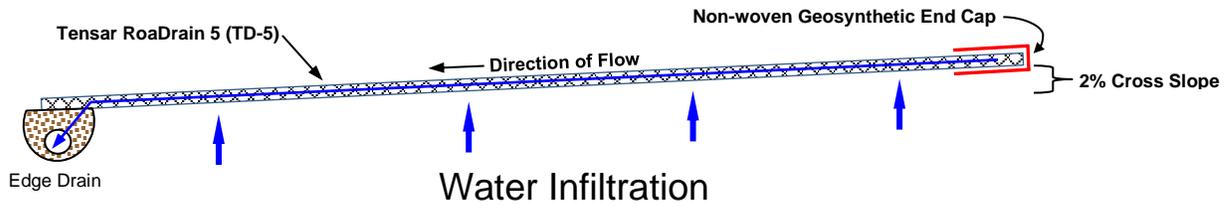
## Cross Section of Road Drain Design Properties

The illustration describes the basic intent of the Road Drain SSDL:

As subsurface water migrates through the filter fabric and into the geonet composite core; with the excavated base at a cross slope approximately 2%, channels the moisture to the path of least resistance to the edge drain and funneled down-slope to the drain outlet.

The edge of the SSDL away from the drain is covered (or capped) by a section of geosynthetic fabric (as seen in the diagram as a red box) to prevent any intrusion of sediment which may clog the internal channels of the core.
