**EXPERIMENTAL FEATURES PROJECT  
CONSTRUCTION REPORT**

**EVALUATION OF WARM MIX ASPHALT (WMA) PAVEMENT**

<u>Project Name</u>	<u>Project Number</u>	<u>Project Location</u>	<u>Project Length</u>
Monida-Lima (SB)	IM 15-1(109)0	Interstate 15, Beaverhead County, Butte District- approximate RP 0.0 to RP 17.1	17.1 miles

**FHWA Project Number:** MT 10-02

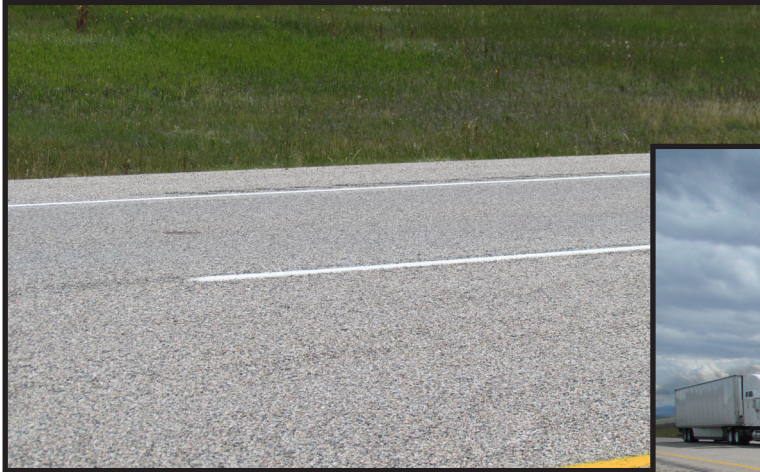
Research staff visited the project site late August 2014. Similar to 2013's visit, there were no visible differences between all sections of the WMA technology or the HMA pavement in either the southbound or northbound lanes. Reflective cracking was present and cover material from the seal and cover was missing from the roadway throughout whole project. The figures below represent the visual condition of the pavement in the southbound and northbound lanes.

Figure 14- I 15 southbound (top) and northbound (right) approximately RP 16

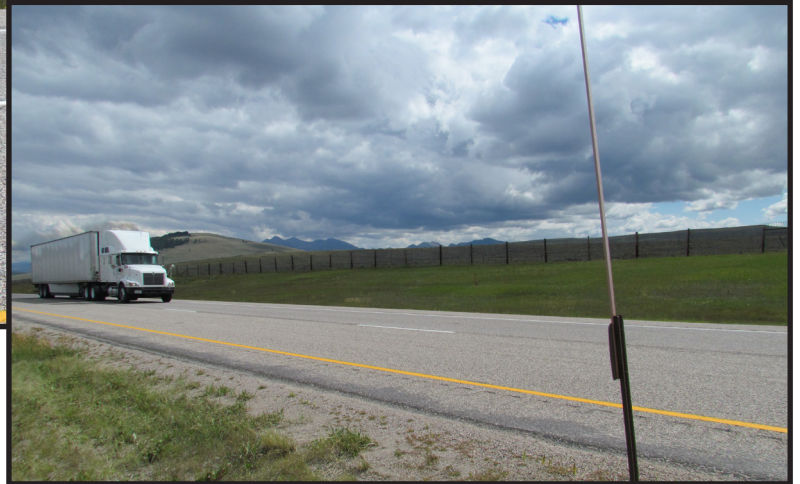
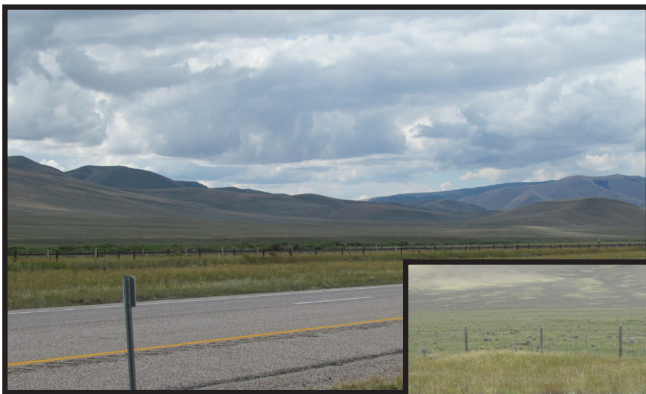
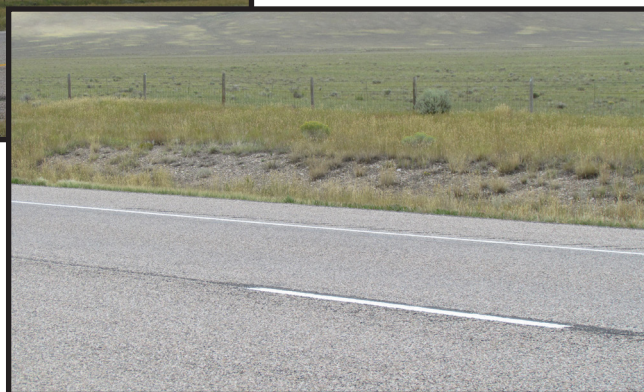
Figure 15- I 15 southbound (top), northbound close-up (middle) and northbound (right) approximately RP 6

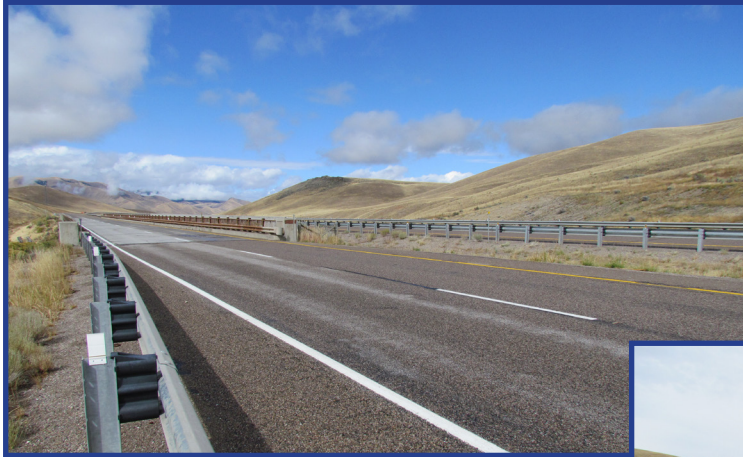
Research staff visited the project site mid-September 2015. Similar to previous visits, there were no visible differences between all sections of the WMA technology or the HMA pavement in either the southbound or northbound lanes. Reflective cracking was present and cover material from the seal and cover was missing from the roadway throughout whole project. The figures below represent the visual condition of the pavement in the southbound and northbound lanes.

Figure 16- Sasobit treatment southbound (left) and HMA northbound (below) approximately RP 17

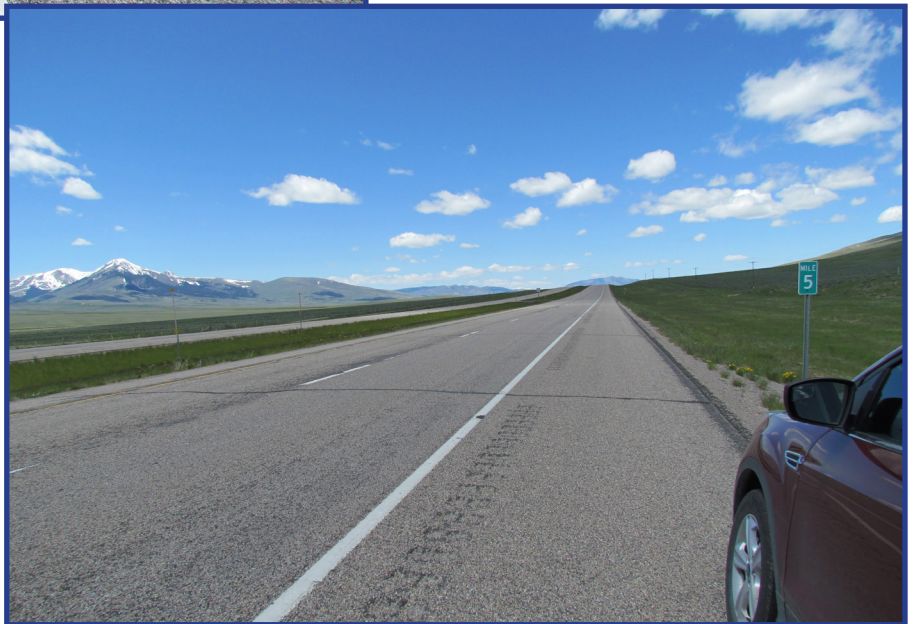
Some areas throughout the project had missing seal and cover material, such as near RP 1.5 where a bridge construction project from the previous year.
