**MONTANA DEPARTMENT OF TRANSPORTATION  
(MDT)  
Investigation of Bridge Decks**

**Final Report**  
April 21, 2017  
WJE No. 2016.3598

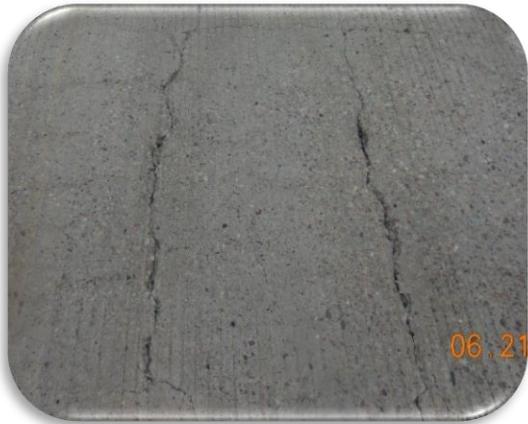
*Figure 1. Example of typical bridge deck cracking noted by MDT. Superior Area Structures MP 49.3*

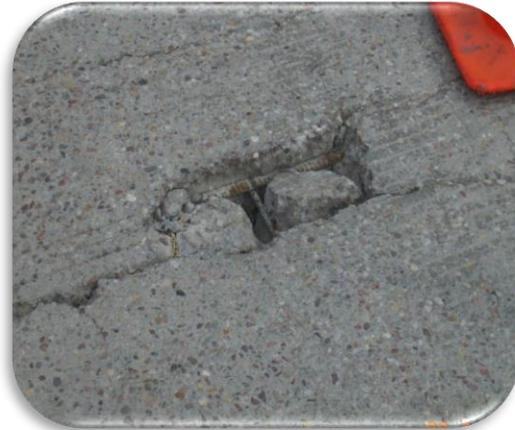
In June of 2016, MDT noted severe cracking on two bridge decks, Superior Area Structures - MP 49.397 EB and Lozeau-Tarkio Structures - MP 57.472. For both of these bridges, the cracking led to holes in the decks after small sections of concrete deck fell (Figure 2 through Figure 4). The decks for these two bridges were replaced in 2010 and 2011, respectively. Further review of additional bridge decks in western Montana by MDT revealed widespread deck cracking with potential of future deck penetrations. MDT noted that the widespread cracking was occurring on bridge decks at relatively early ages. Similar deck penetrations were also found in the westbound lane of Keyser Creek, MP 407.862, and east bound lane of Hensley Creek, MP 414.235 (both in the Billings district). These two bridge decks were cast with experimental mixes that included silica fume, fibers, and a shrinkage reducing admixture and may not be representative of the decks investigated and reported herein. WJE did perform brief petrography on concrete cores provided from these two bridges and reported the results in July of 2016; however, this report does not discuss these two bridges.

*Figure 2. Hole in bridge deck. Superior Area Structures MP 49.3*

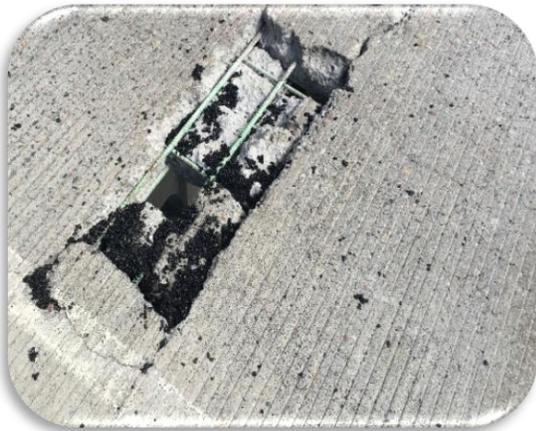
*Figure 3. Bridge deck cracking that has led to holes in the concrete deck and subsequent concrete falling. Lozeau - Tarkio MP 57.4*

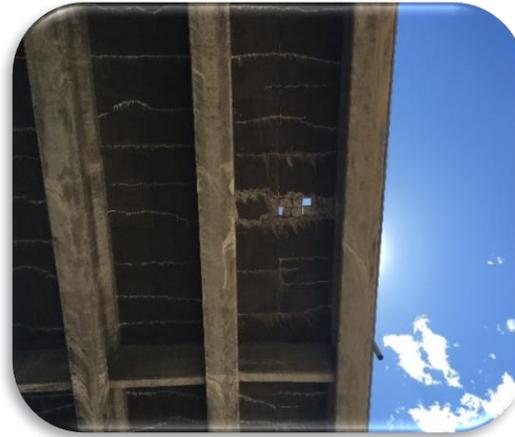
*Figure 4. Underside of bridge deck in Figure 3 showing hole in bridge deck. Lozeau - Tarkio MP 57.4*

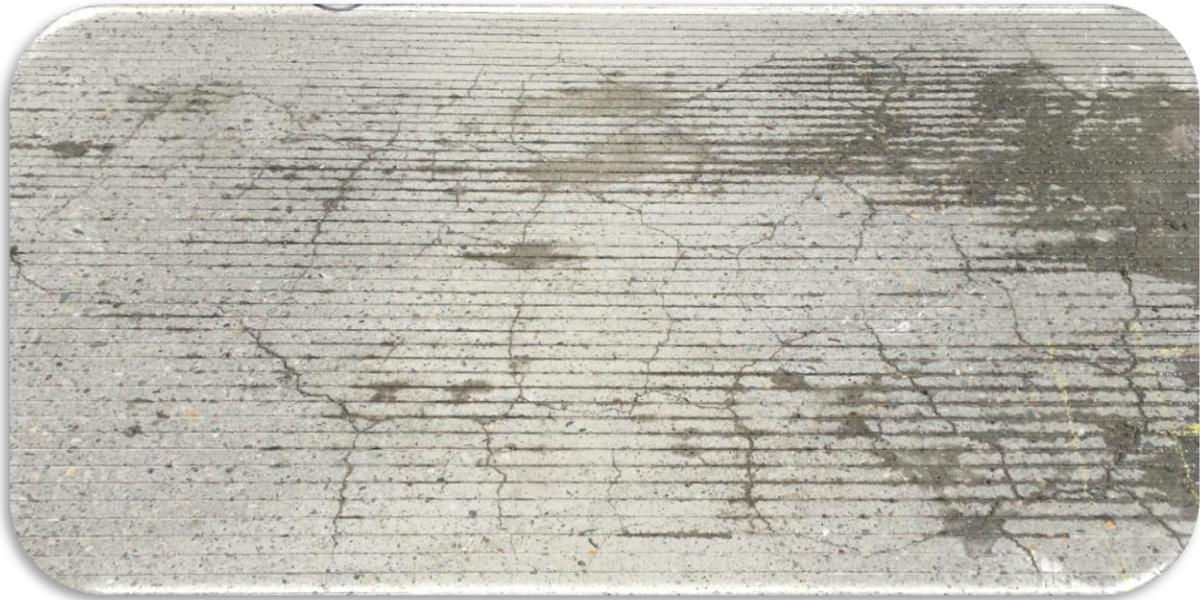
*Figure 5. Typical plastic shrinkage cracks. Surface was wetted to accentuate the cracking pattern*

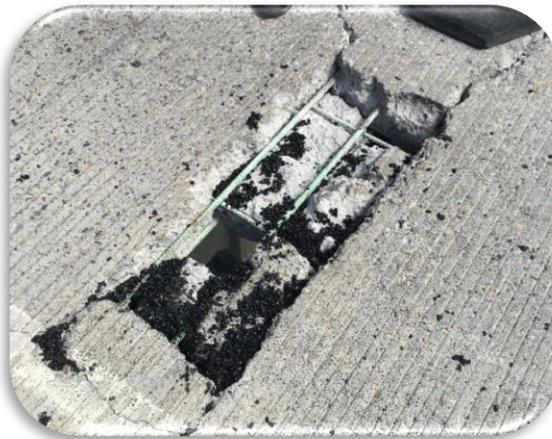
Two of the Missoula-area bridge decks exhibited severe cracking that broke the concrete free from the reinforcing steel. The Lozeau-Tarkio Bridge over the Montana Rail Link (MP 57.472) developed a full-depth crack that dropped a “chunk” (approximately 4 in. by 4 in.) of the deck concrete onto the ground below. A portion of this “chunk” was retrieved for laboratory study prior WJE’s field investigation. The Superior Area Bridge over the Clark Fork River (MP 49.397) also developed a deep crack that dislodged a “chunk” of concrete from the top of the deck, but not through the full depth of the deck. Photographs of the two holes were similar, with the cracks appearing directly above (or below) the reinforcing bars along their lengths. The coatings of the bars in all photographs appeared to be in satisfactory condition, and no corrosion products were visible within the cracks.

*Figure 8. Through-hole in east-bound Lozeau-Tarkio bridge at MP 57.472 (photo provided by MDT).*

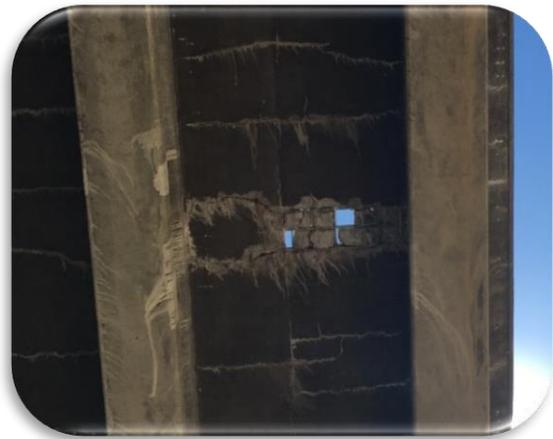
*Figure 9. Through-hole in east-bound Lozeau-Tarkio bridge at MP 57.472, as seen from the underside of deck (photo provided by MDT).*

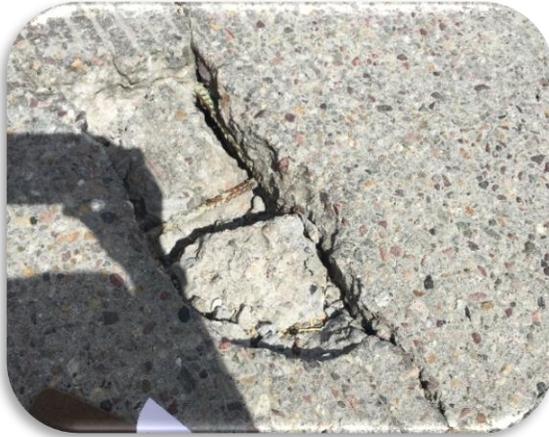
*Figure 10. Delaminated “chunk” in deck of east-bound Superior Area bridge at MP 49.397 (photo provided by MDT).*

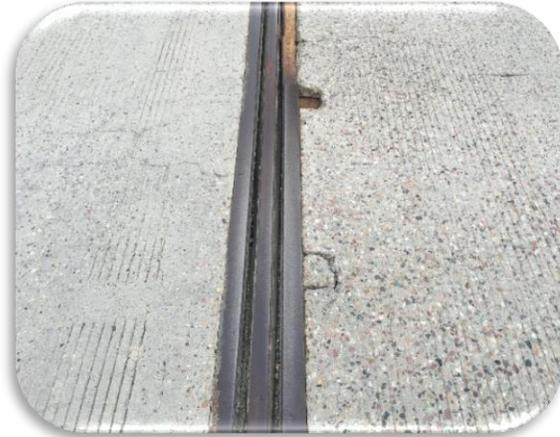
*Figure 11. Delaminated “chunks” along expansion joint of east-bound Superior Area bridge at MP 49.397 (photo provided by MDT).*

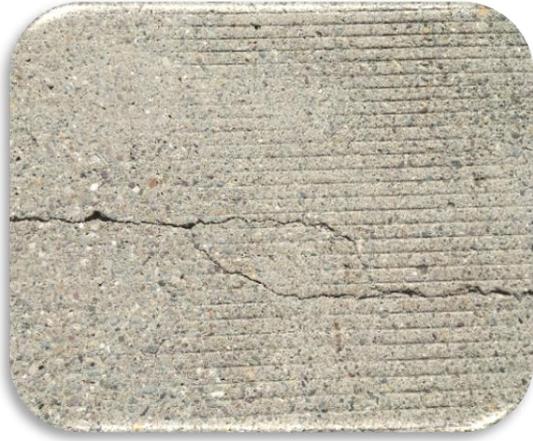
Based on the progression of the crack patterns from the youngest decks to the oldest decks, it is hypothesized that the transverse cracks initiate near the girders, where the restraint is the greatest, and propagate away from the girders with time. When the transverse cracks propagate past one another in close proximity (typically, within 6 to 18 inches), the crack tips bend toward one another, eventually “jumping” from one crack to another. Such “jump” crack patterns were observed in Bridges 2, 6, and 10, and were reflected on the top and bottom surfaces of the deck in Bridge 6 (see Figure 12 and Figure 13). It is hypothesized that the holes previously observed in Bridges 2 and 10 may have initiated at such “jump” crack locations.

*Figure 12. “Jump” cracks in top side of Bridge 6. Transverse cracks are spaced approximately 6 inches apart.*

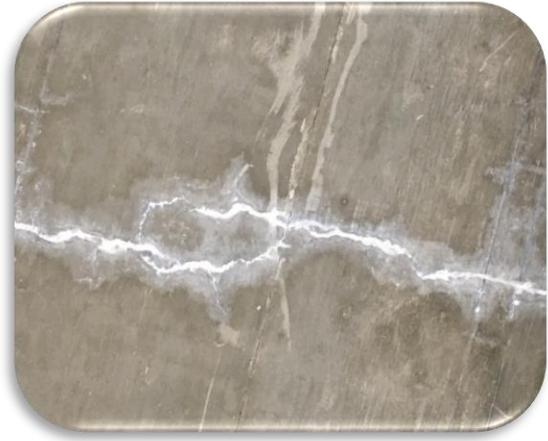
*Figure 13. “Jump” cracks from Figure 12, as reflected in the underside of the deck of Bridge 6.*

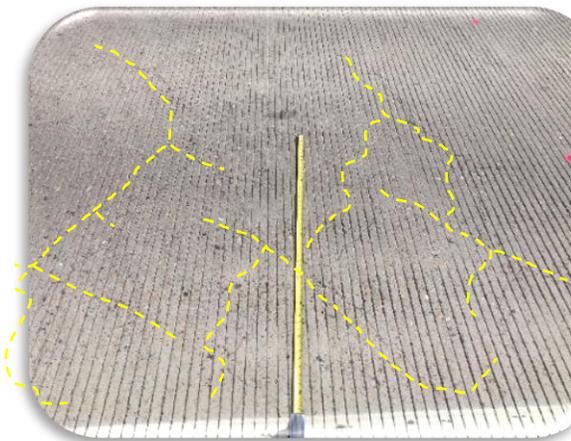
Plastic shrinkage cracking was observed on all of the inspected bridges, with varying degrees of severity. The primary cracking pattern on Florence East (Bridge 1) was related to plastic shrinkage cracking (Figure 16). This bridge likely has the highest density of plastic cracks. Core 1D was extracted over a plastic crack, and petrography showed this plastic crack extended to a depth of 3 inches mostly propagating around aggregate particles. Crack width was estimated to be less than 15 mils. Core 2B, 2G, and 3A, were also extracted over plastic cracks, and crack depths varied from 1 to 2 1/2 inches with tight crack widths (less than 15 mils). The plastic cracking in Florence East is likely more pronounced because of the inclusion of silica fume (6 % replacement rate); fly ash (25 % replacement rate); and low as-placed w/cm (estimated to be 0.38 to 0.43); thereby reducing the bleeding rate and quantity of available bleed water. In addition, the fly ash will slow the setting characteristics, prolonging the period of time the concrete is in a plastic state.

*Figure 16. Plastic shrinkage cracks noted on Bridge 1 (Florence East). Note random, “map cracking.”*

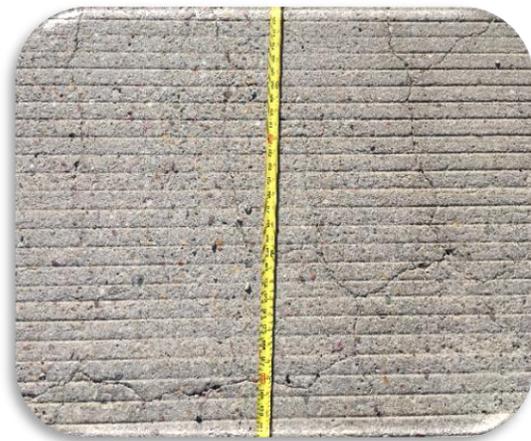
*Figure 17. Plastic cracking observed on Bridge 2 (Lozeau Tarkio, MP 57.412 EB).*

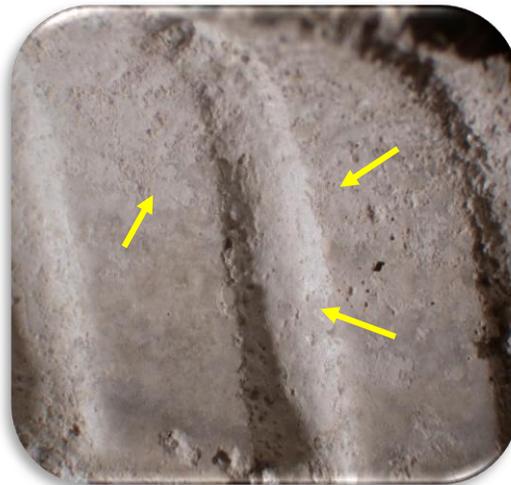
*Figure 18. Arrows showing white glaze in the imprint of the reinforcing steel, 6 times magnification.*

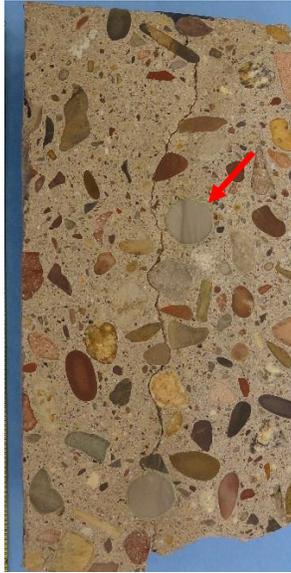
The following cores were extracted directly over top mat reinforcing steel: 1F, 1I, 2C, 6A, and 12C. Cores 2C, 6A, and 12C were specifically selected because of the characteristic transverse crack that has potential for future distress (deck penetrations). None of the cores show any evidence of settlement related cracking. Typically, a settlement crack would be directly above the reinforcing steel, with characteristics of plastic tearing of the paste. Also, voids underneath the reinforcing steel are very common with plastic settlement cracks. None of these characteristics were noted. The deeper concrete cover (specified 2 3/8 inch) and relatively small reinforcing bars (No. 4s and 5s) were helpful in preventing subsidence cracking. Subsidence is not a primary contributing cause to the potential for deck penetrations.

Figure 19. Lapped section of Core 22, extracted on a transverse crack directly over a reinforcing steel bar (red arrow).

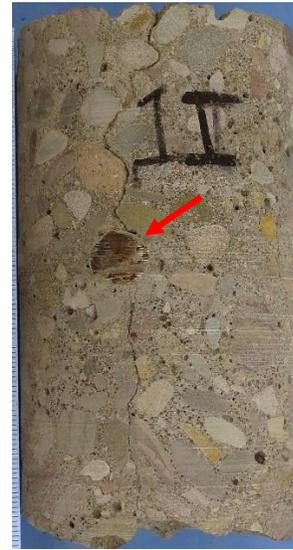
Figure 20. As-received condition of Core 11, extracted on a transverse crack directly over a reinforcing steel bar (red arrow).

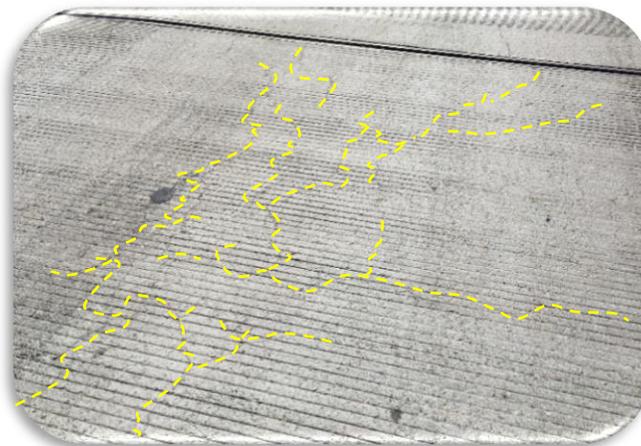
Plastic shrinkage cracks were noted on all overlays; with Bridge 3 having substantially more map cracks (Figure 21). The width of plastic cracks in the overlays appeared to be much tighter than the non-overlay bridges.

*Figure 21. Map cracking noted in the overlay of Bridge 3. Cracks are very tight, but frequent. Dotted yellow lines help identify crack locations*

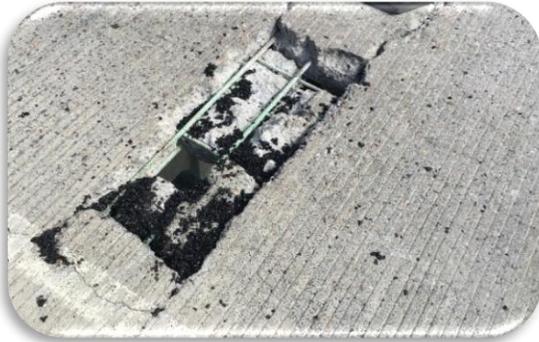
- Each penetration had closely spaced transverse cracks leading up to the penetration and outlining the perimeter.
- The characteristic transverse cracks appeared to have occurred directly over transverse reinforcing bars and have experienced significant raveling. Raveling is described as erosion of the crack edges due to traffic loading.
- A semi-longitudinal crack likely formed and connected the two transverse cracks. This crack is referred to as the “jump” crack.
- The top and bottom mat of transverse reinforcing steel bars appear to be aligned, i.e. in the same vertical plane.

*Figure 23. Deck penetration noted by MDT, Lozeau-Tarkio*

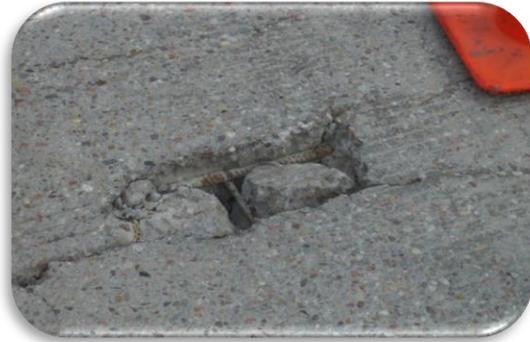
*Figure 24. Deck penetration noted by MDT, Superior Area Structures*

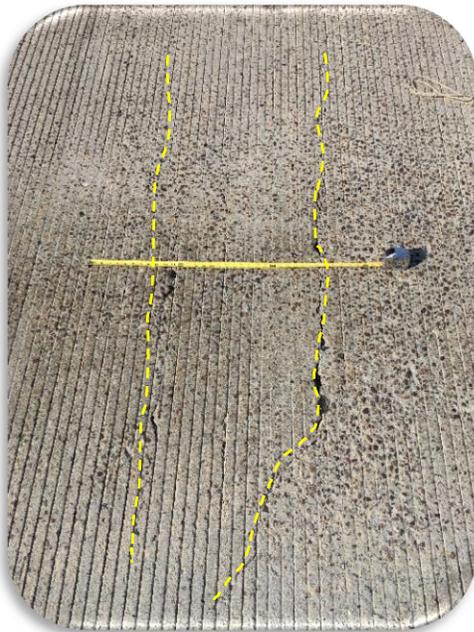
Many concrete bridge decks develop transverse cracking, with some transverse cracking occurring at early ages (within 3 days) and some at later ages. Typical spacing of transverse cracks are 5 to 10 ft.<sup>4</sup>. During WJE's field investigations, very closely spaced transverse cracks, 6 to 18 inches, were noted on occasion. WJE observed closely spaced transverse cracks on Bridges 2, 5, 6, 8, 9, 10 and 12, with varying degrees of severity (Figure 25 and Figure 26). These cracks were identified as characteristic transverse cracks that may lead to future deck penetrations.

*Figure 25. Closely spaced transverse cracks, Bridge 11, transverse cracks running up and down on the photo.*

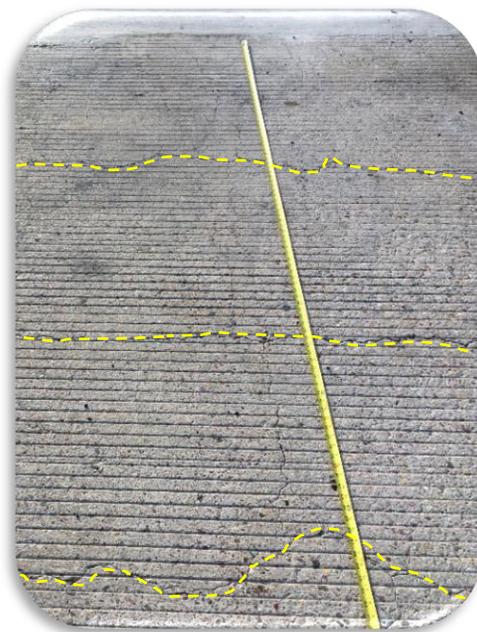
*Figure 26. Closely spaced transverse cracks, Bridge 2, transverse cracking running left to right on photo.*

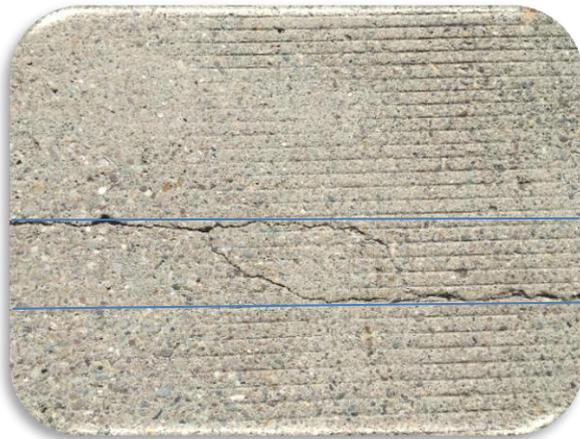
thickness, which is characteristic of the later age crack progression (Figure 28 through Figure 31). With continued traffic loading and volumetric movement, the section of concrete encompassed by the transverse and “jump” cracks loses aggregate interlock, essentially being unreinforced, and disengages. When the top and bottom mats of steel are aligned, this allows concrete to dislodge and fall. During field investigations, the mobility of the deck was measured using impulse response. The higher measured mobility between the girders helps explain the occurrence of “jump” cracks and that through-deck failures are most likely to occur mid-way between girders.

*Figure 28. Top side of Bridge 6, showing transverse cracking and “jump” cracks between rows of reinforcing.*

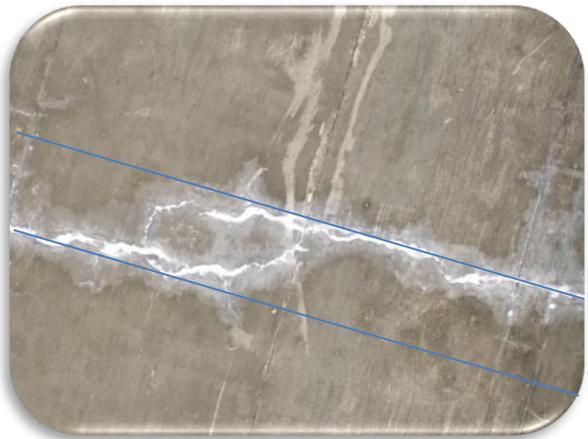
*Figure 29. Underside of Bridge 6, same location as Figure 28.*

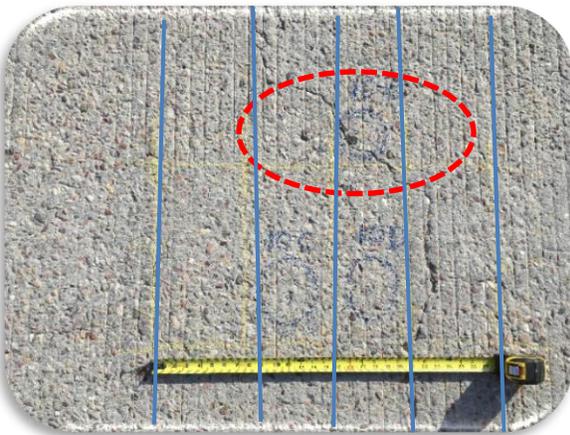
*Figure 30. Bridge 10, transverse cracking with “jump” crack, prior to extraction of Core 10 B. Note jump crack crosses two transverse bar lines (blue/yellow lines).*

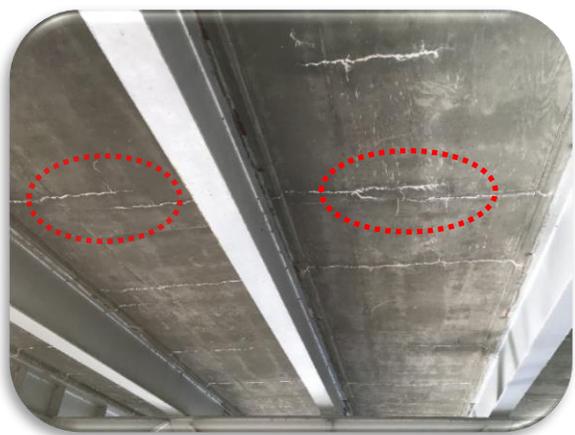
*Figure 31. Bridge 10, left side showing early stages of transverse deck cracking (no through thickness “jump” cracks). Right side of photograph showing underside of Figure 30, later stages of “jump” crack between transverse deck cracks.*

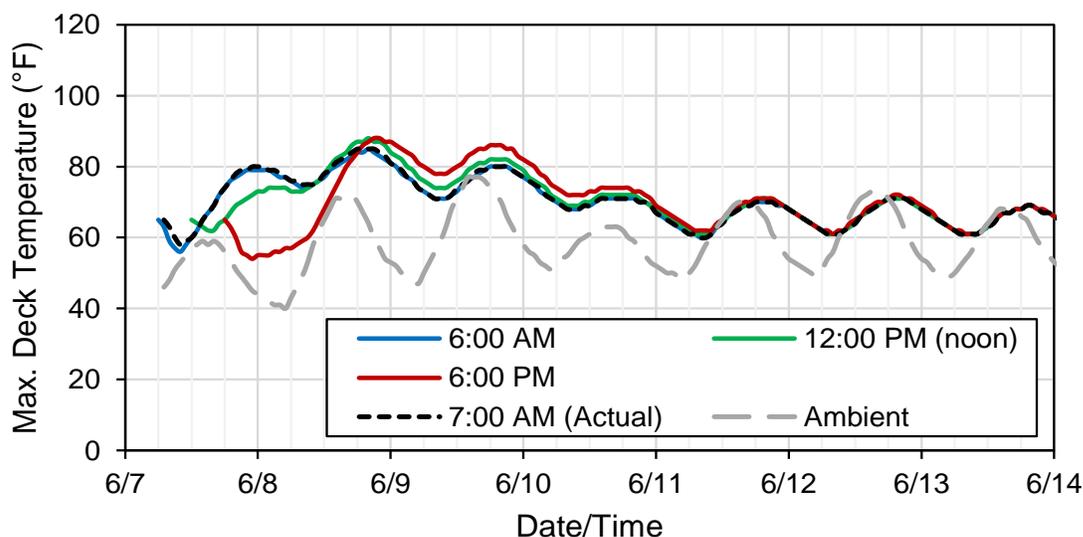
The modeling performed by WJE showed that placement times and diurnal temperatures had a significant effect on the potential for early-age transverse cracking. Figure 32 shows simulated deck temperatures for Bridge 6. Concrete placement times were simulated at 6 AM, 12PM (noon), and 6PM. The initial peak hydration temperatures for the 6AM simulation and actual 7AM placement are approximately 15 hours after placement. The initial peak temperatures for the 12 PM and 6 PM placements shift to 30 hours. At this later age, the concrete has developed additional tensile strength and will be more resistant to stresses developed during cooling. For this reason, early-age cracking is expected to be mitigated. In addition, the modeling shows that the concrete peak temperatures and associated cooling are affected by the ambient conditions. The peak ambient temperatures will exacerbate the peak concrete hydration temperatures and thereby accelerate cooling. Other researchers have provided similar recommendations on placement times and maximum diurnal temperature changes such as: avoiding large temperature variation on the day of concrete placement, greater than 50 °F<sup>7</sup>; best results for mitigation of transverse cracks when ambient temperatures varied between 65 to 70 °F (highs) and 45 to 50 °F (lows)<sup>2</sup>; and avoid morning and early afternoon placements and use later afternoon and evening placements<sup>4</sup>.

Figure 32. Temperature simulations for Bridge 6.

- **Recommendation** - Move concrete placement times to late afternoon or evening; preferably from 4 to 8PM. This recommendation is based on not allowing peak concrete temperatures to coincide with cooling evening ambient temperatures and on increasing the concrete strength prior to the cooling period. This recommendation assumes similar concrete mixes will be used in the future.

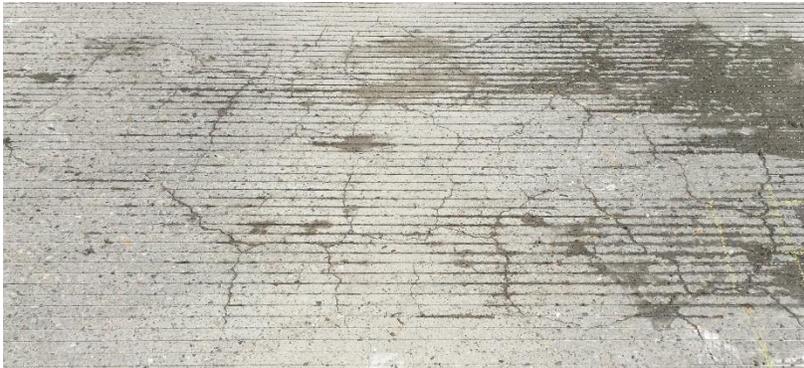
Figure 1. Random map cracking, EB lane.

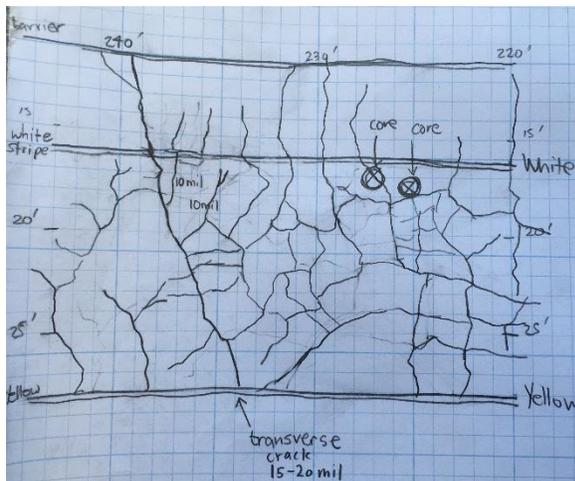
Figure 2. Sketch of cracks, 240' to 220' EB. Cores identified are cores 1A and 1B. Transverse crack at 240' is located over pier.

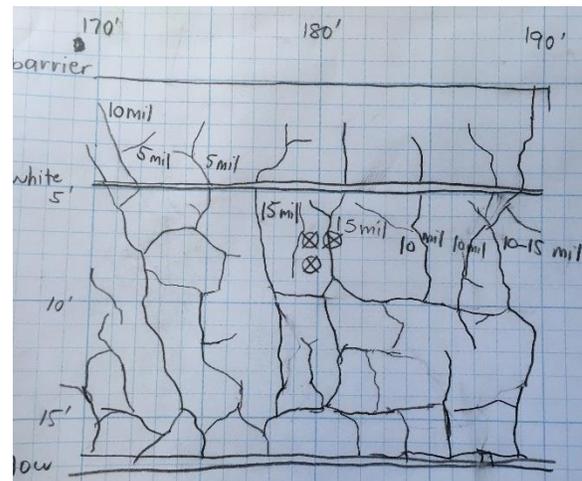
Figure 3. Sketch of cracks, 170' to 190' WB. Cores identified are cores 1I, 1J, and 1K.

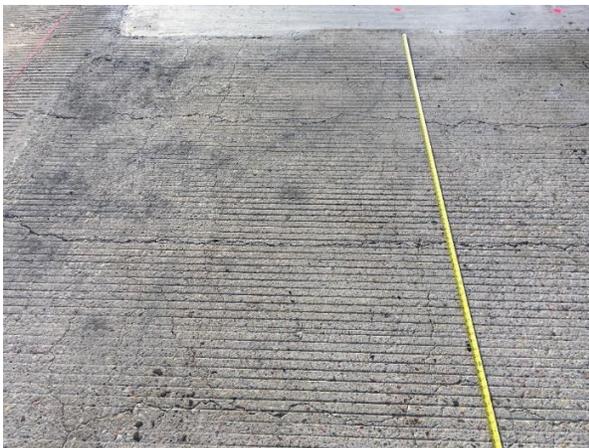
*Figure 6. General crack appearance for Bridge 2. Transverse cracks are regularly spaced at 2 to 4 ft intervals. Longitudinal cracks tend to lie along the girders. The tape measure in the photo is positioned over one of the girders.*

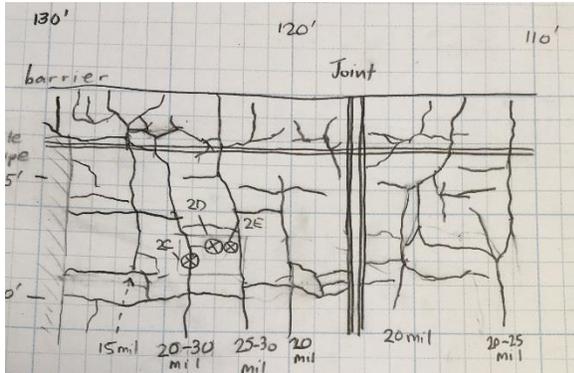
Figure 7. Sketch of cracks, 130' to 110' (Spans 2 and 3), right lane. Longitudinal cracks generally follow girders; location of girders changes between Span 3 (left) and Span 2 (right). Cores identified are cores 2C, 2D, and 2E.

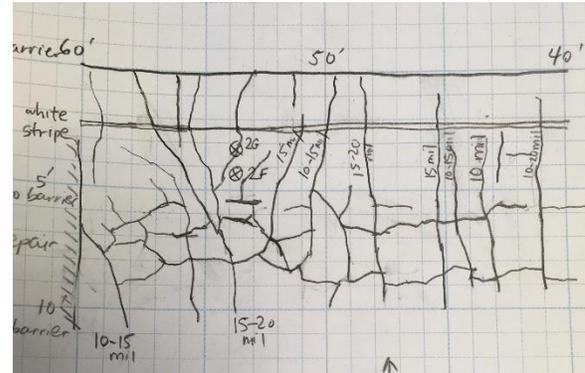
Figure 8. Sketch of cracks, 60' to 40' (Spans 1 and 2), right lane. The long transverse crack near 56' is located over Bent 2. Cores identified are cores 2F and 2G.

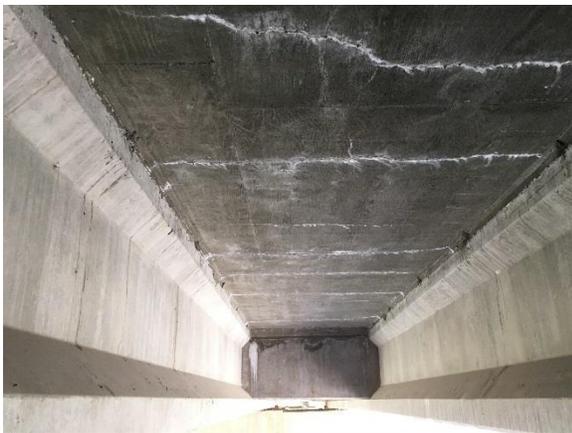
Figure 9. General underside appearance for Bridge 2. Transverse cracks are regularly spaced and generally exhibit thick deposits of efflorescence. Longitudinal cracks branch off from some of the transverse cracks.

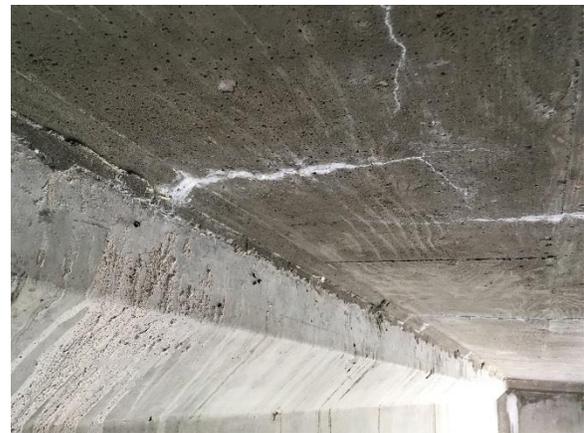
Figure 10. Thick deposits of efflorescence along cracks on the underside of deck. A longitudinal crack branches between two adjacent transverse cracks.

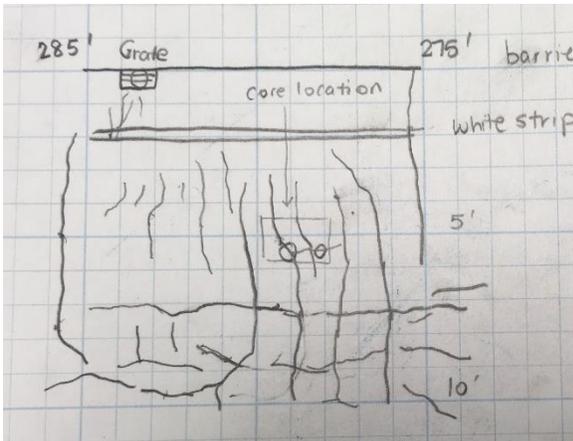
Figure 12. Sketch of cracks 285' to 275'. Cracks are similar in appearance to Bridge 2 cracks.

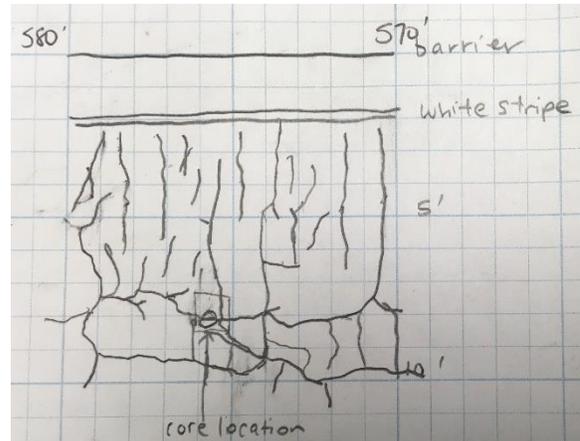
Figure 13. Sketch of cracks 580' to 570'. Cracks are similar in appearance to Bridge 2 cracks.

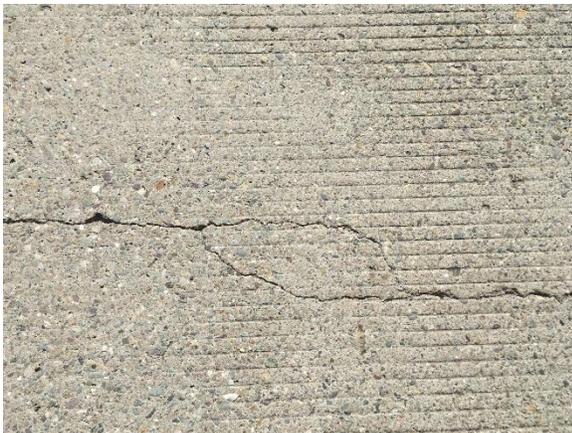
The underside of the deck showed frequent transverse cracks filled with thick deposits of efflorescence (Figure 20). Two areas were identified on the underside of the deck where closely-spaced transverse cracks appeared to "jump" to the adjacent cracks, forming a closed loop. One of the closed-loop areas was reflected in the cracks on the top of the deck (Figure 21 and Figure 22); core 6G was taken over a "progression" (jumping) crack at this location.

*Figure 21. "Jump" crack at location of core 6G, topside of deck.*

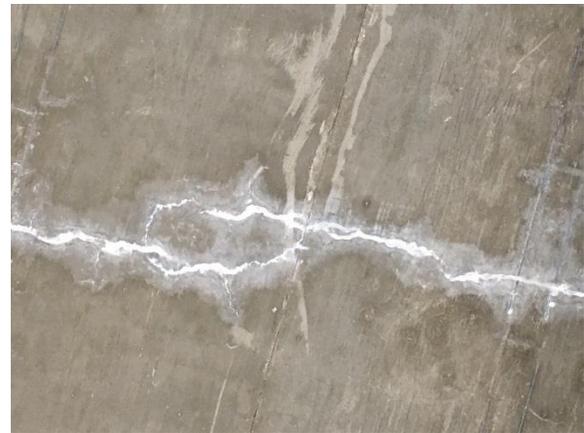
*Figure 22. "Jump" crack at location of core 6G, reflected in underside of deck.*

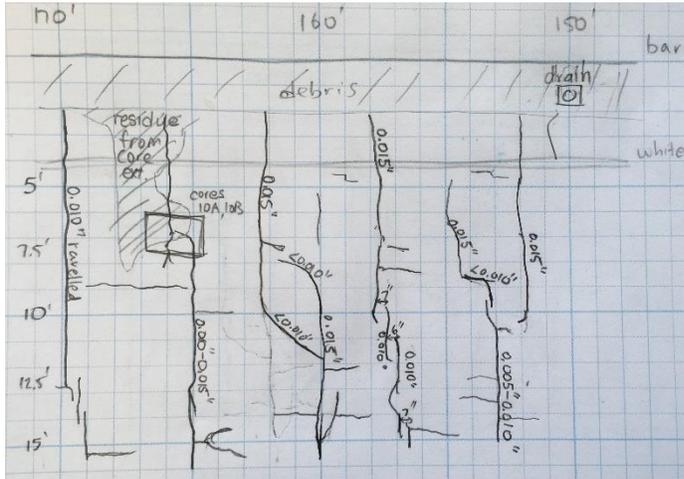
Figure 36. Sketch of cracks, 170' to 150'. Long bending cracks near 160' and long "jumping" crack near 162' are the same cracks shown in Figure 35. Sketch is drawn at 180 degrees rotation from Figure 35.

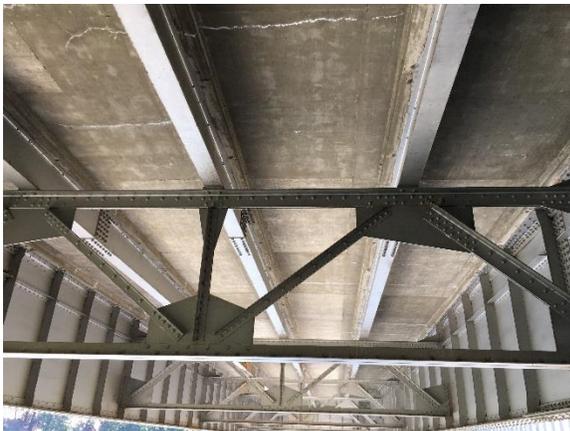
The underside of Bridge 11 generally looked better than the underside of Bridge 10. Transverse cracks were more sparsely spaced, but also contained efflorescence (Figure 41 and Figure 42).

Figure 41. General underside appearance, Bridge 11. Transverse cracks are more widely spaced, but showed efflorescence.

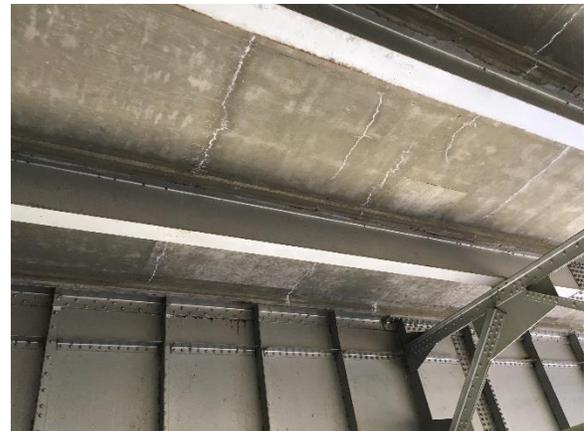
Figure 42. General underside appearance, Bridge 11.

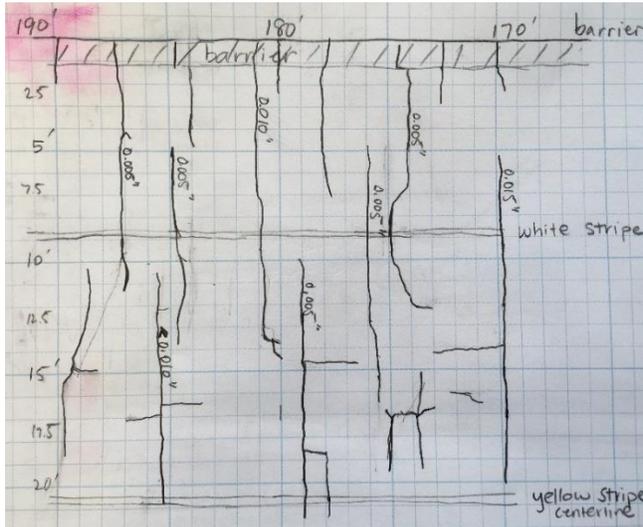
Figure 43. Sketch of cracks, 190' to 170'. Transverse cracks appear with similar frequency as for other bridges, but are typically less than 10 mil and width; longitudinal cracks are hairline.

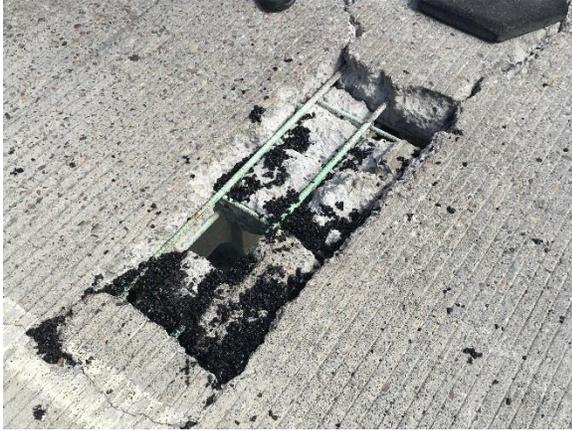
Two of the Missoula-area bridge decks exhibited severe cracking that broke the concrete free from the reinforcing steel. The Lozeau-Tarkio Bridge over the Montana Rail Link (MP 57.472) developed a full-depth crack that dropped a “chunk” (approximately 4 in. by 4 in.) of the deck concrete onto the ground below. A portion of this “chunk” was retrieved for laboratory study prior to WJE’s field investigation. The Superior Area Bridge over the Clark Fork River (MP 49.397) also developed a deep crack that dislodged a “chunk” of concrete from the top of the deck, but not through the full depth of the deck. Photographs of the two holes were similar, with the cracks appearing directly above (or below) the reinforcing bars along their

lengths. The coatings of the bars in all photographs appeared to be in satisfactory condition, and no corrosion products were visible within the cracks.

*Figure 3. Through-hole in east-bound Lozeau-Tarkio bridge at MP 57.472 (photo provided by MDT).*

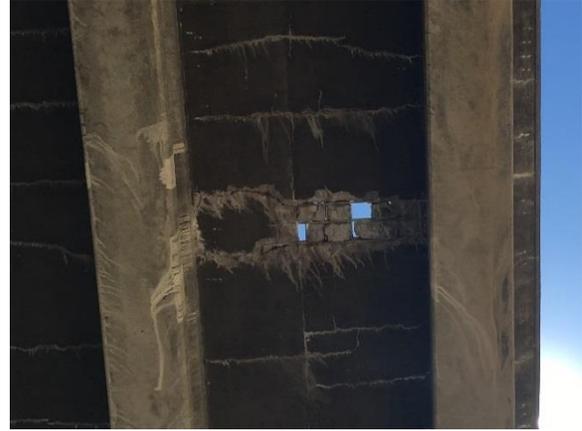
*Figure 4. Through-hole in east-bound Lozeau-Tarkio bridge at MP 57.472, as seen from the underside of deck (photo provided by MDT).*

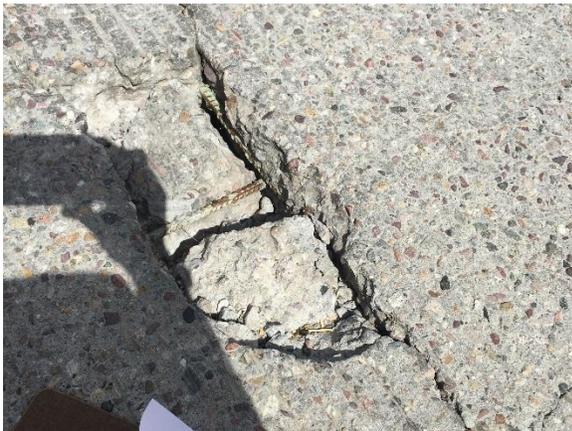
*Figure 5. Delaminated “chunk” in deck of east-bound Superior Area bridge at MP 49.397 (photo provided by MDT).*

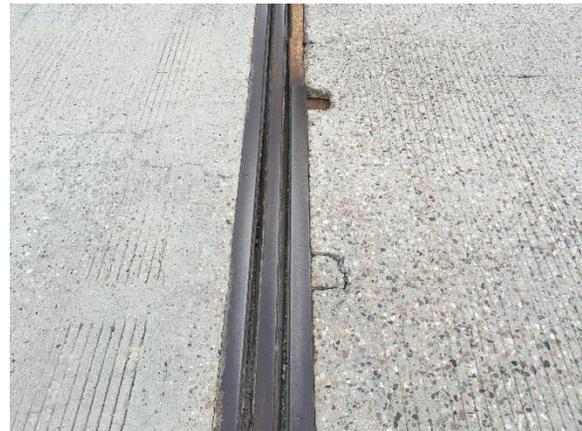
*Figure 6. Delaminated “chunks” along expansion joint of east-bound Superior Area bridge at MP 49.397 (photo provided by MDT).*

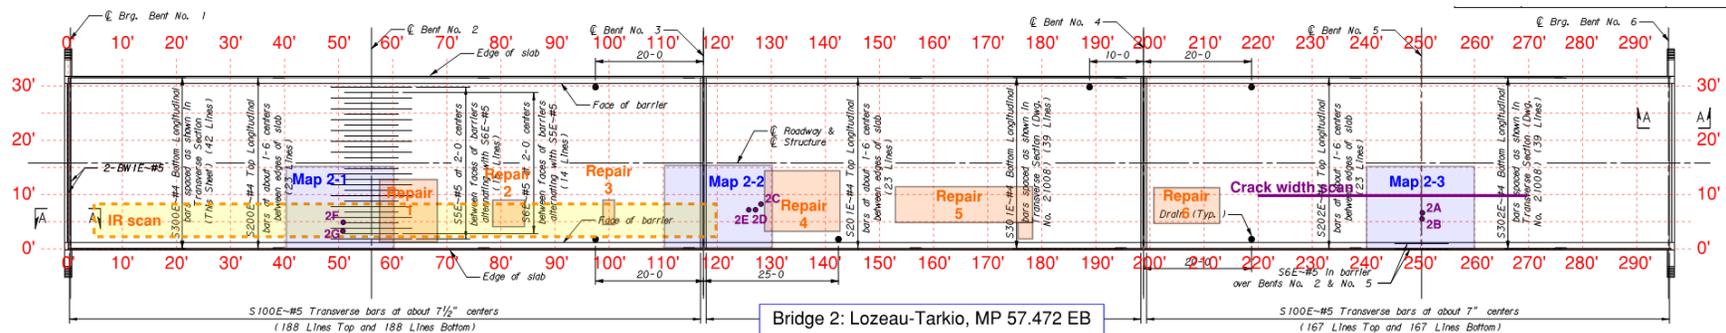
Figure 8. Annotated drawing of Bridge 2, Lozeau-Tarkio, MP 57.472 EB. Station markings are shown in red. Cores are indicated by purple circles and crack maps by blue rectangles. Previously repaired areas are shown in orange.

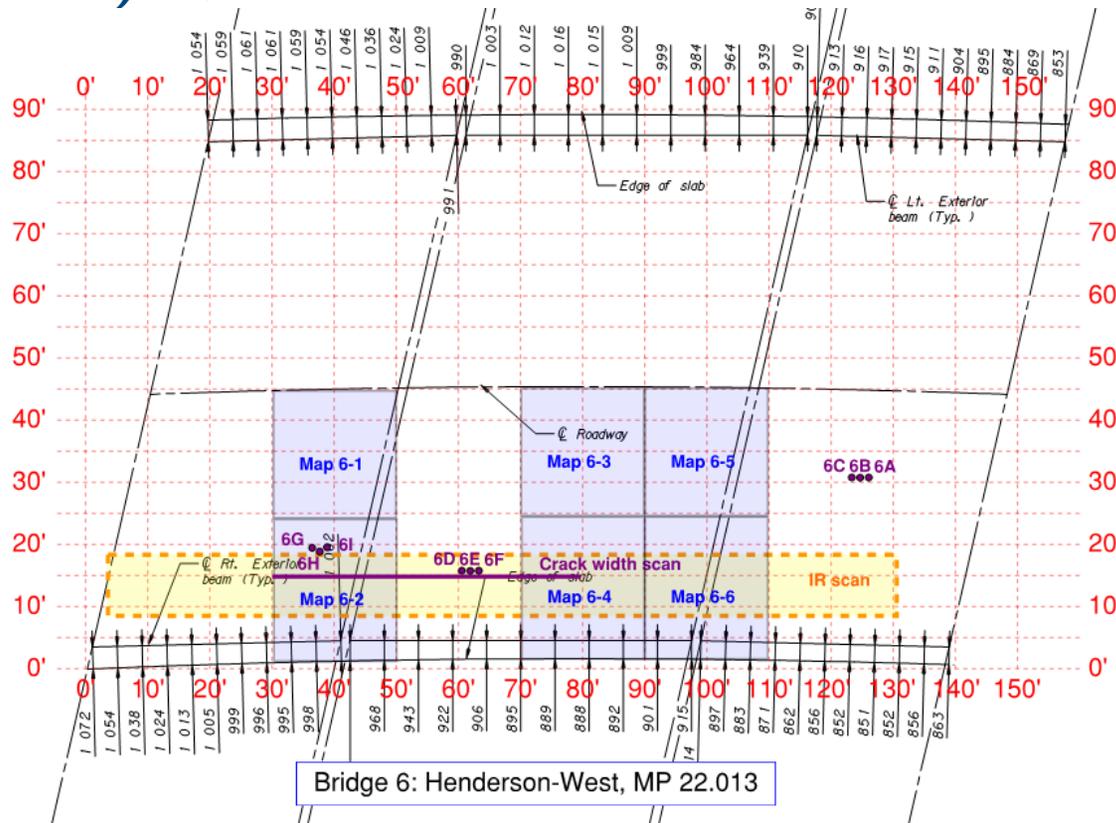
Figure 9. Annotated drawing of Bridge 6, Henderson-West, MP 22.013. Station markings are shown in red. Cores are indicated by purple circles and crack maps by blue rectangles. The slight curvature of the deck with respect to the longitudinal (East-West direction) was ignored in the subsequent sketches and analyses.

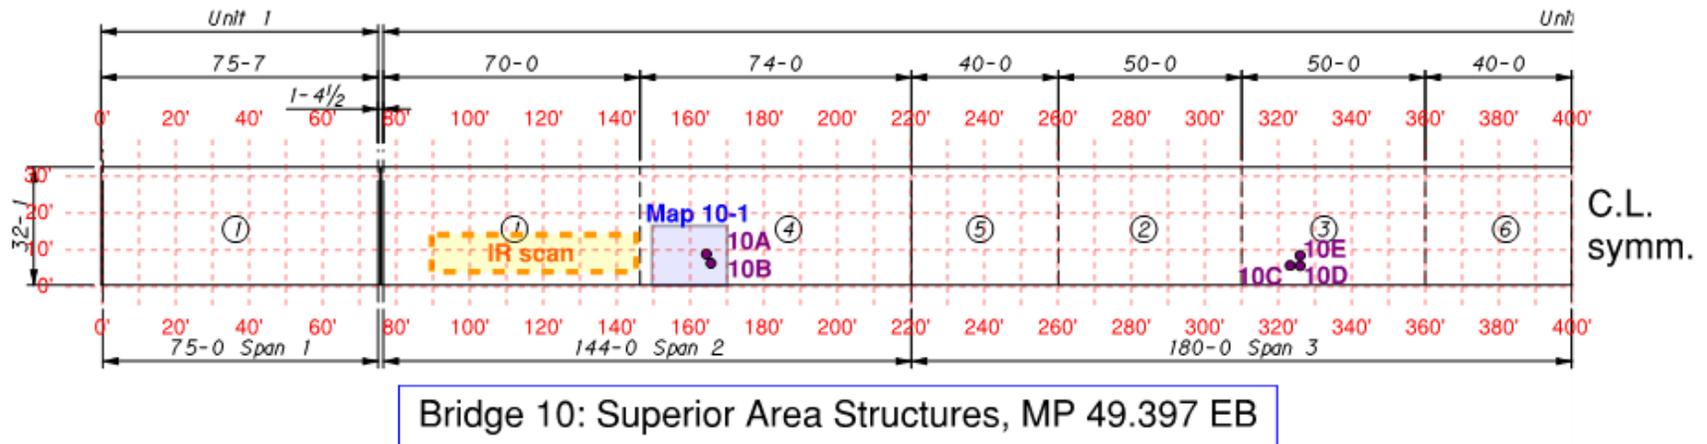
Figure 10. Annotated drawing of Bridge 10, Superior Area Structures, MP 49.397 EB. Station markings are shown in red and are reversed for the parallel span, Bridge 11. The structure is symmetric about its centerline (400' station marking). Cores are indicated by purple circles and crack maps by blue rectangles.

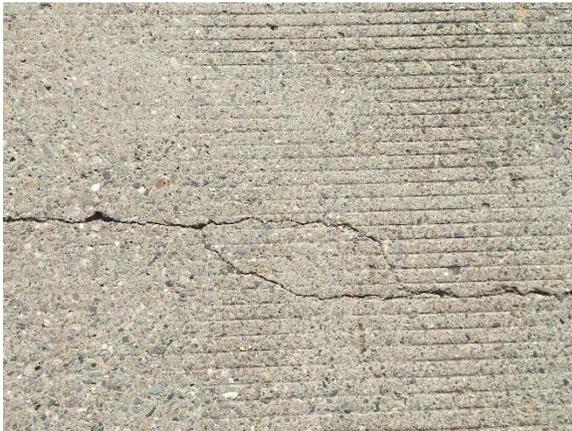
Figure 22. “Jump” cracks in top side of Bridge 6. Cracks are spaced approximately 6 inches apart.

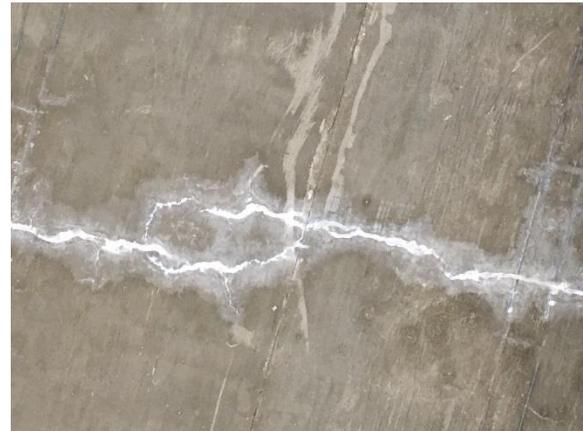
Figure 23. “Jump” cracks from Figure 22, as reflected in the underside of the deck of Bridge 6.

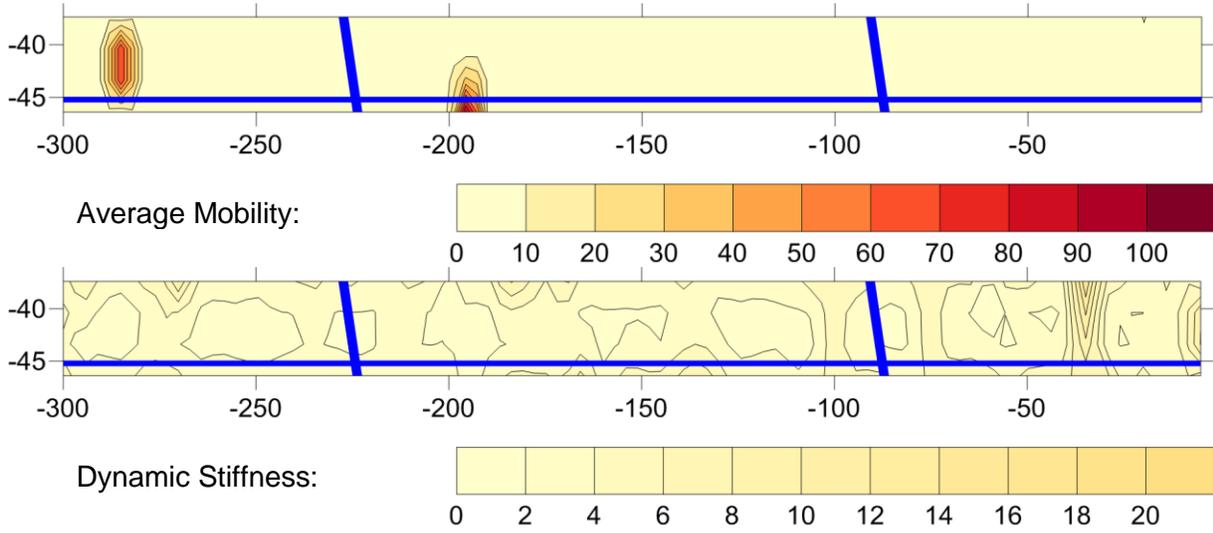
Two scanned areas of the Bridge 1 deck had significantly higher average mobilities than the surrounding bridge deck. Average mobilities in excess of 50 units were detected near the 285' and 195' station markings. Although delaminations or voids were not detected by chain drag at these locations, other delaminations of similar size were detected in the vicinity of these high-mobility regions, suggesting that intense cracking, delaminations, or voids may be present in the concrete at these locations. No other areas of high average mobility were identified for the other three bridge decks, which had infrequent incidence of delaminations and voids detected by chain drag. Due to the locality of the characteristic cracking that causes the deck penetrations, a general survey of the deck mobility may not pick up incipient areas of distress. Although IR testing was informative, identification of incipient deck distress is more easily done by visual inspection and recognition of tell-tale indicators rather than by measuring deck mobility.

Figure 24. Mobility and stiffness contour plots, Bridge 1. Note: Station markings in this figure are shown with a negative sign to preserve orientation shown in Figure 7. Increased mobility may indicate incipient distress.

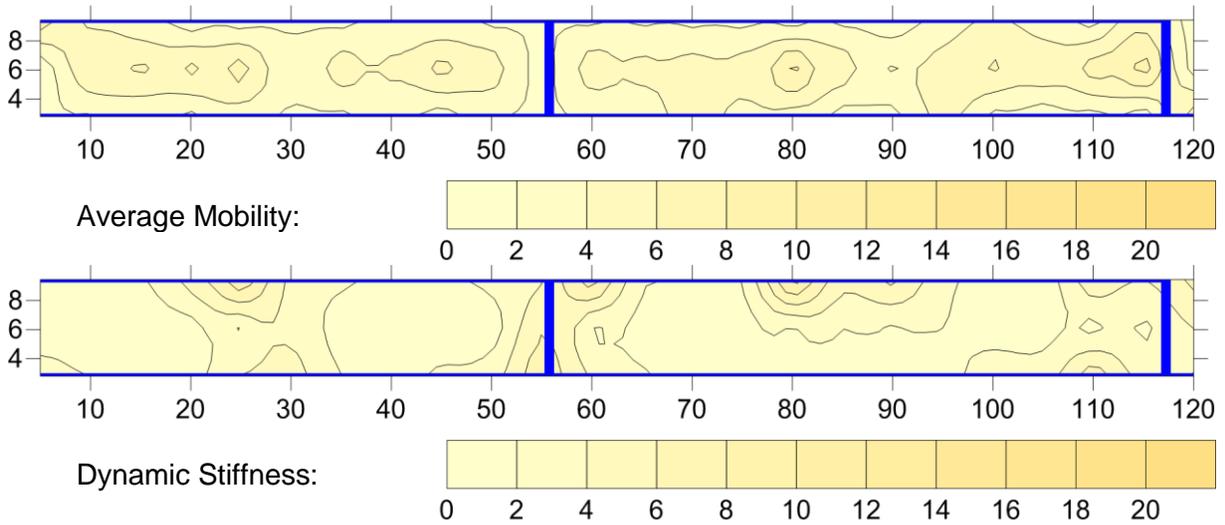
Figure 25. Mobility and stiffness contour plots, Bridge 2.

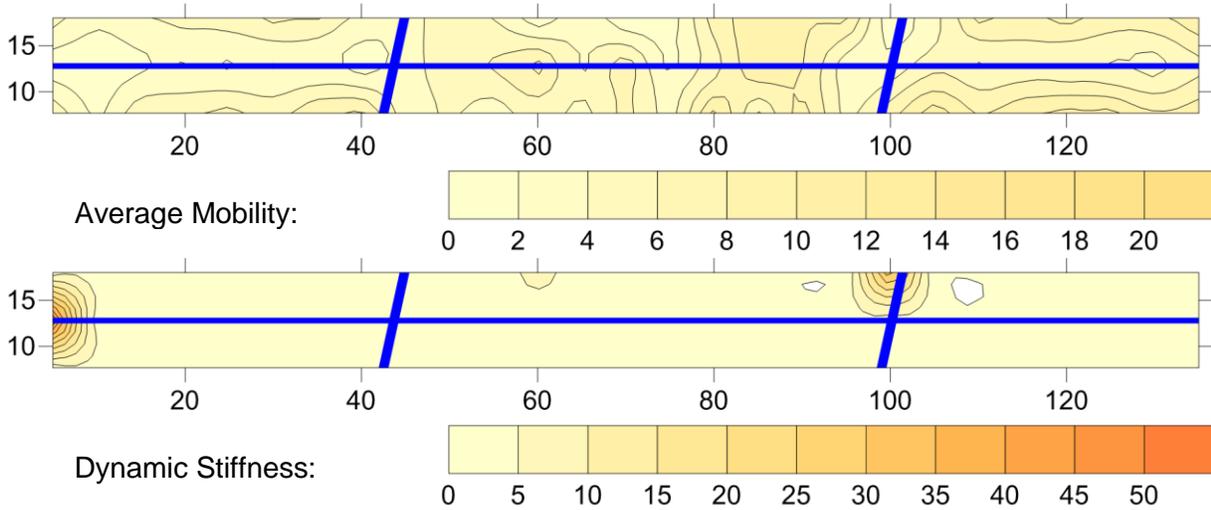
Figure 26. Mobility and stiffness contour plots, Bridge 6.

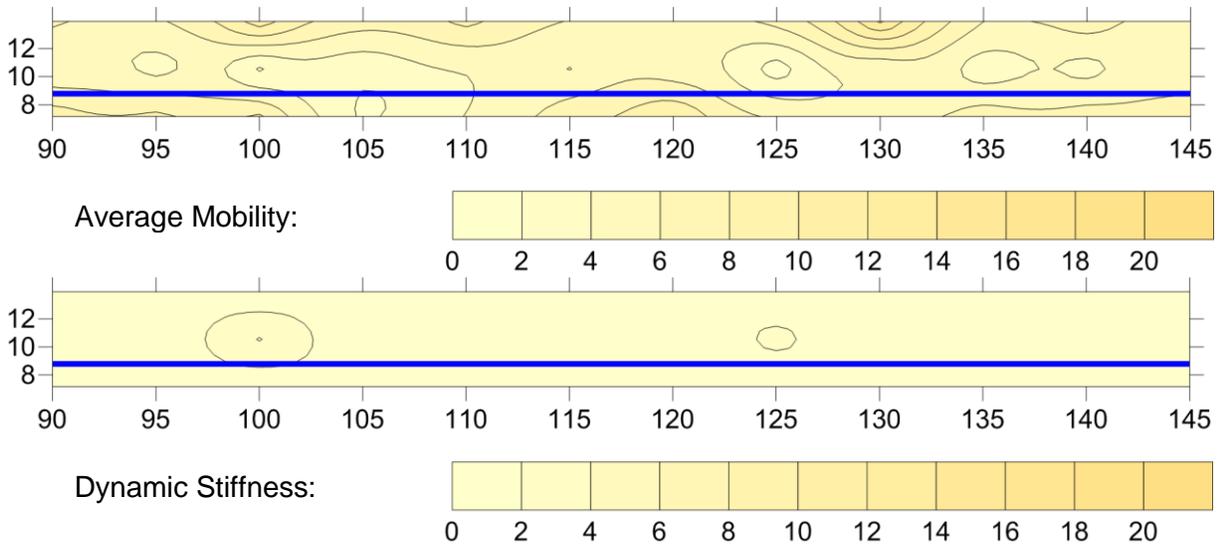
Figure 27. Mobility and stiffness contour plots, Bridge 10.
