**MONTANA DEPARTMENT OF TRANSPORTATION  
(MDT)  
Investigation of Bridge Decks**

**Final Report**  
April 21, 2017  
WJE No. 2016.3598

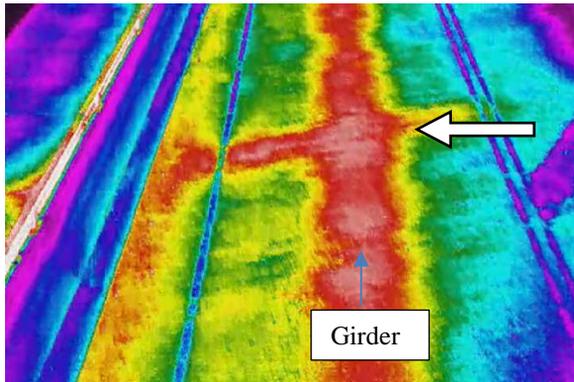
Figure 28. Overhead infrared photograph of Bridge 1 deck surface. A large transverse crack over Pier 3 of Bridge 1 is indicated by the arrow. Girder G3 and line stripping are also visible.

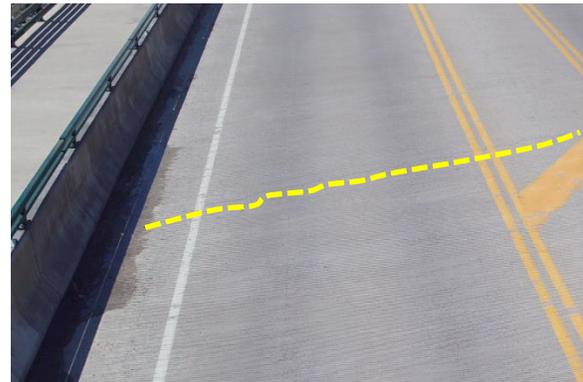
Figure 29. Overhead drone photograph of Bridge 1 deck surface. The large transverse crack over Pier 3 shown in Figure 28 is outlined by the dashed line.

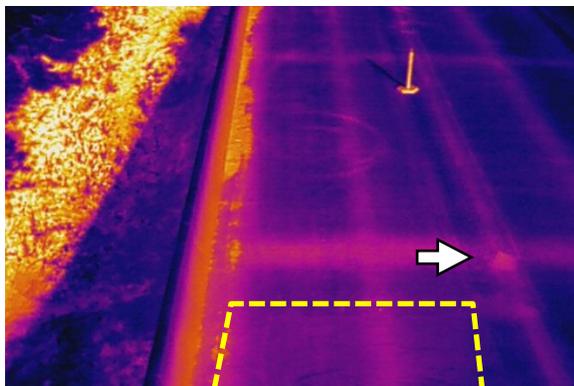
Figure 30. Overhead infrared photograph of Bridge 2 deck surface. The area shown approximately corresponds to the area mapped in Figure 14. Girders, piers, and diaphragms are clearly visible. A possible delamination or void is indicated by the arrow. Repair #1 (as shown in Figure 8) is outlined by the dashed line.

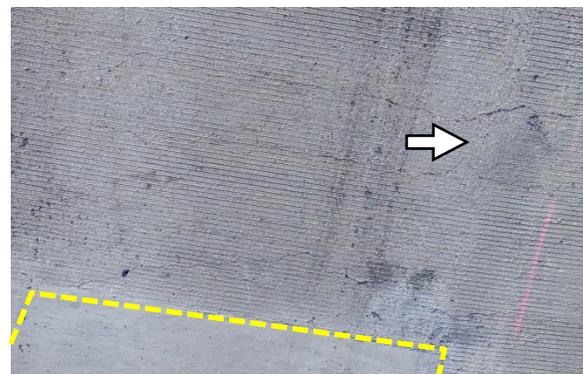
Figure 31. Overhead drone photograph of Bridge 2 deck surface. The area shown is a close-up of the area indicated in Figure 30. The possible delamination or void indicated by the arrow is surrounded on both sides by wide transverse cracks over Pier 2. Repair #1 is outlined by the dashed line.

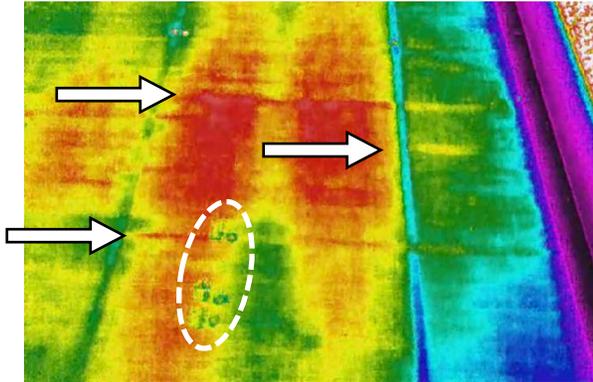
Figure 32. Overhead infrared photograph of Bridge 12 deck surface. Three transverse cracks (sealed) are indicated by white arrows. Cores 12A, 12B, and 12C were taken at the locations circled.

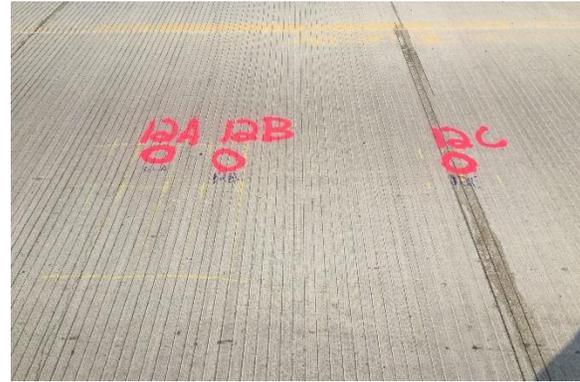
Figure 33. Photograph of Bridge 12 deck surface, near location shown in Figure 32. The sealed transverse crack through Core 12C was clearly visible by infrared imaging, while the narrower crack through Core 12A was not.

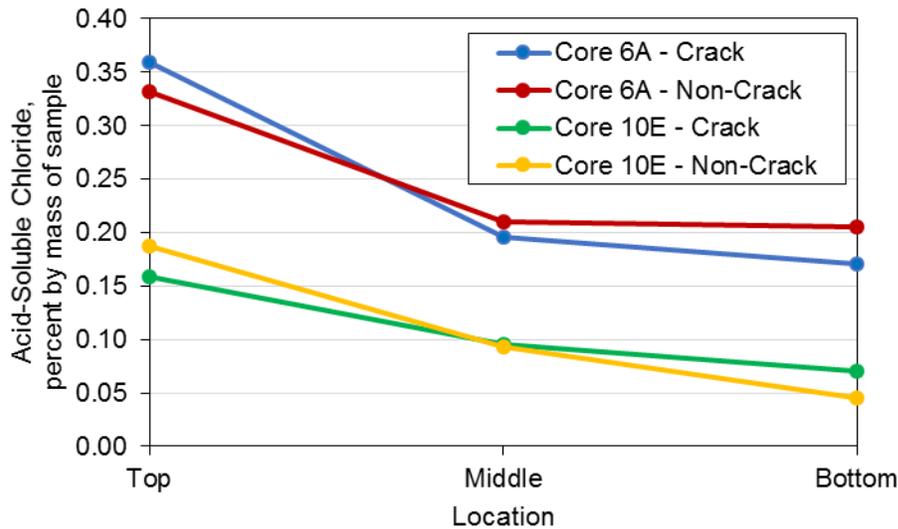
Figure 34. Acid-soluble chloride contents measured along the cracks (“crack”) and away from cracks (“non-crack”) in cores 6A and 10E.

The chloride concentrations were similar in both the cracked and non-cracked areas of both cores. Studies have shown that chloride contents above 0.02 to 0.03 percent by mass of concrete, depending on the cement content, can promote corrosion of embedded uncoated carbon steel in non-carbonated normal weight concrete. The chloride contents of all the samples analyzed were above to well above this threshold level, and therefore, may promote the corrosion of uncoated or damaged spots on coated steel in the presence of sufficient moisture and oxygen.

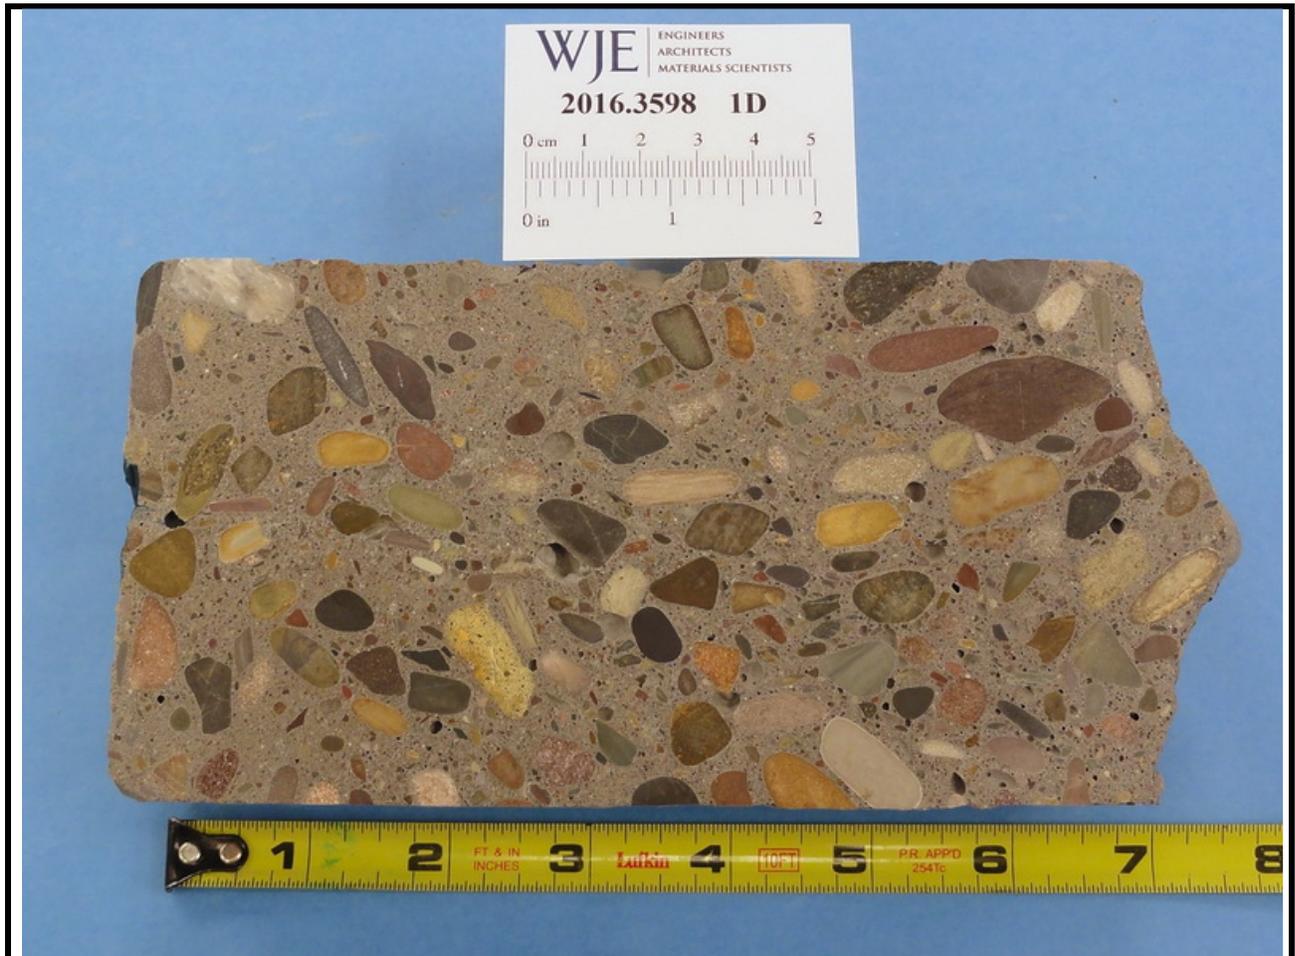
<b>Secondary Deposits</b>	Traces of ettringite in several air voids, but overall uncommon.
<b>Microcracking</b>	Minor microcracks near the major crack. Infrequent microcracks in remainder of concrete.
<b>Comments and Distinctive Features</b>	<p>Interfacial transition zone appears narrow. No gaps or regions of high w/cm were observed adjacent to the sedimentary aggregate particles.</p> <p>Substantial amount of clastic sedimentary rocks in coarse and fine aggregate but no specific distress associated with higher absorption and weaker rock types.</p>

Figure 4. Lapped cross section showing the appearance and condition of the concrete. Top surface is on left.

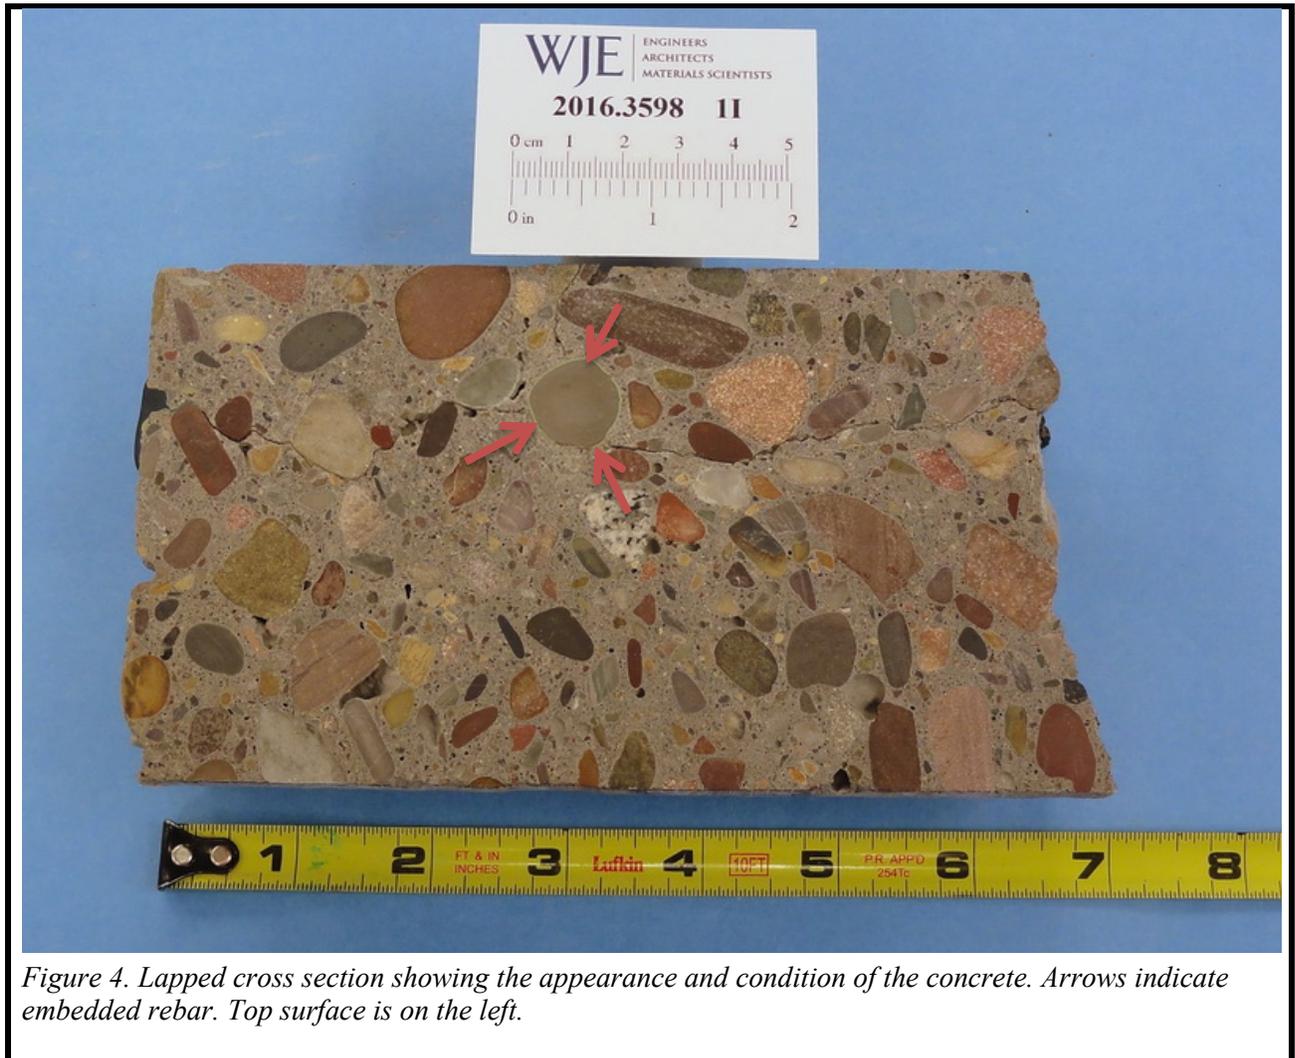
<b>Microcracking</b>	Microcracks were infrequent. Where observed, microcracks pass between aggregate particles.
<b>Distinctive Features</b>	<p>The interfacial transition zone between the paste and the sedimentary aggregate particles appears to be narrow. No gaps or regions of high w/cm were observed.</p> <p>Concrete characteristics were similar to Core 1D overall. The core appeared to contain slightly higher residual cementitious materials than Core 1D.</p>

*Figure 4. Lapped cross section showing the appearance and condition of the concrete. Arrows indicate embedded rebar. Top surface is on the left.*

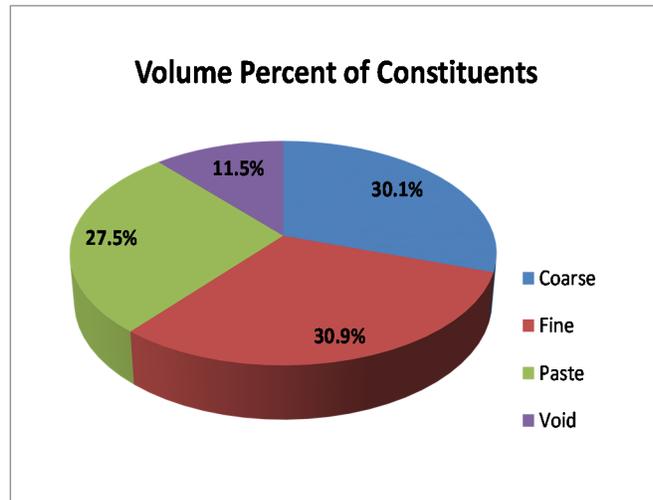
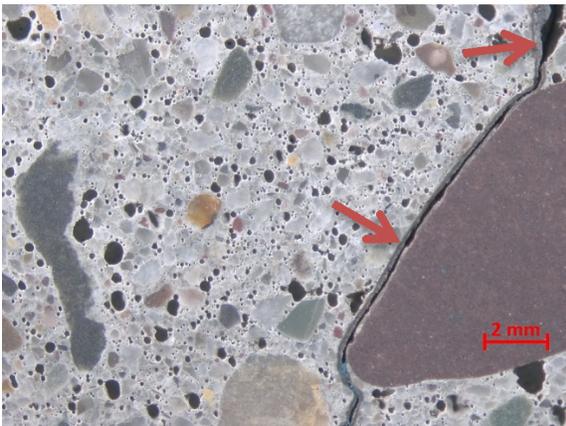
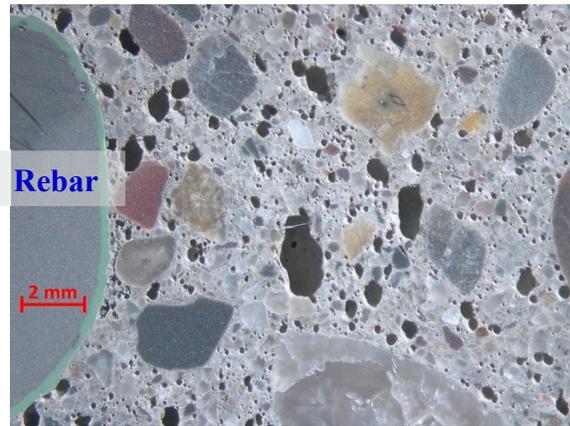
Appearance of air-void system. Arrows indicate crack and crack filler/sealer.

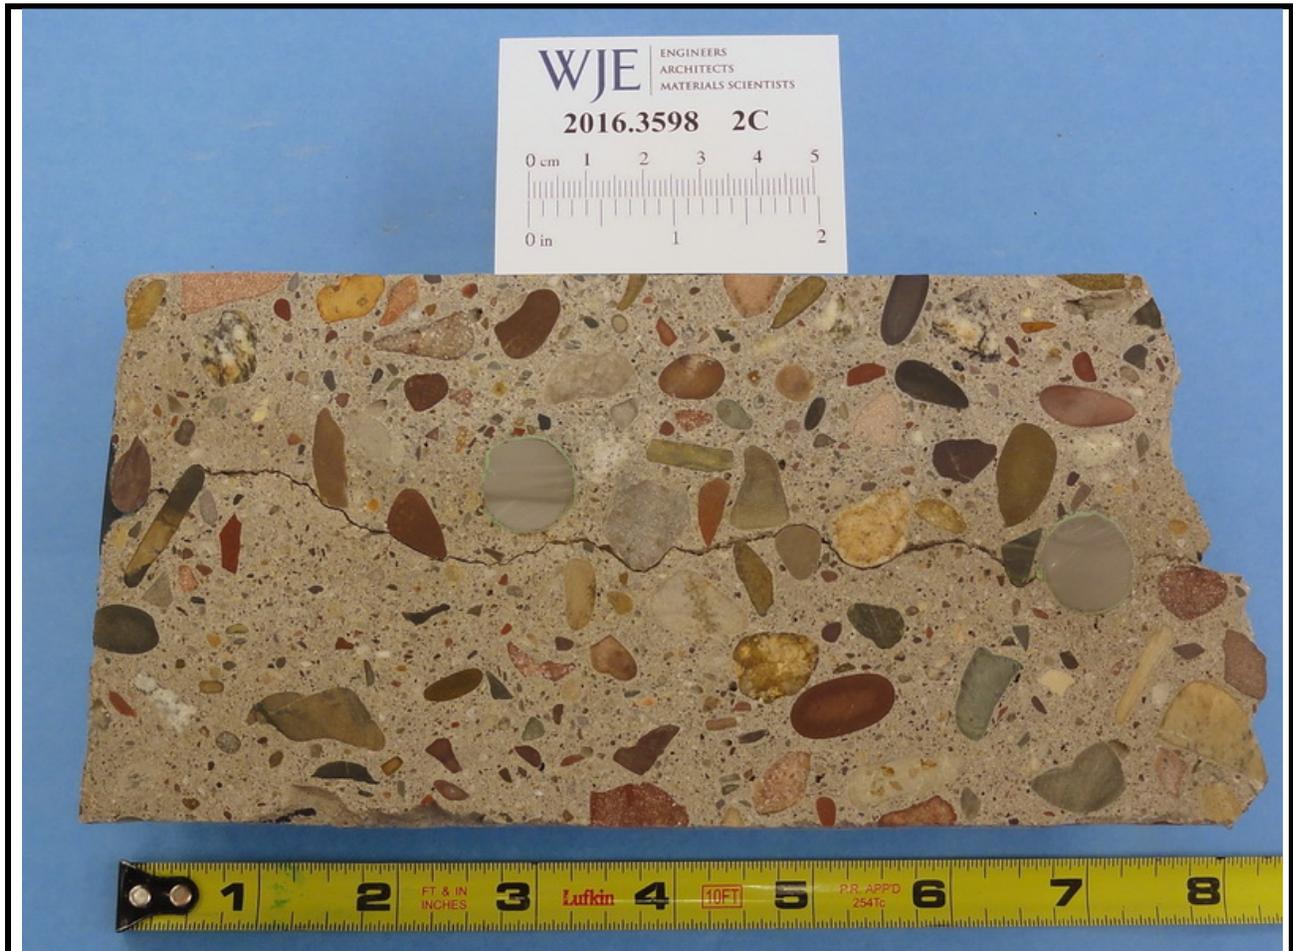
<b>Dimensions</b>	Diameter: 3.7 inches Length: 6.7 to 7.6 inches
<b>End Surfaces</b>	Substantially worn, saw-grooved or tined top surface; fractured bottom surface broke mainly around aggregate.
<b>Reinforcement</b>	Two transverse No. 5 rebars with concrete cover 2.5 and 6.2 inches. No.4 rebar with 5.6-inch concrete cover, longitudinal and above the bottom No. 5 bar. Rebars are in good condition. No gaps, separations, or secondary deposits were observed between the rebar and the paste.  No evidence of relative displacement at concrete plastic stage was observed.
<b>Consolidation</b>	Well consolidated. No large entrapped voids were observed.
<b>Distribution of Constituents</b>	Aggregate and paste are uniformly distributed.
<b>Cracks, Joints</b>	Full-depth crack transverse to the deck lanes in the field. The crack intercepts the upper and lower rebar and is up to 0.025 inch wide in the top region. Crack extends around coarse aggregate particles.

Figure 4. Lapped cross section showing the appearance and condition of the concrete. Top surface is on the left.

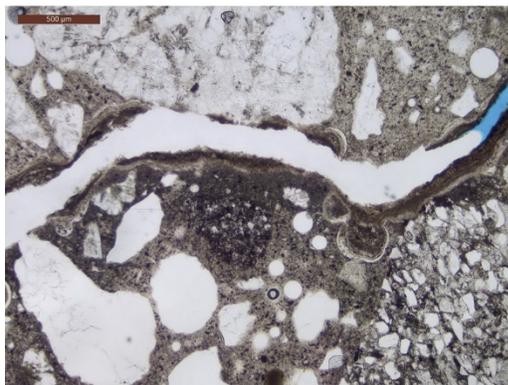
Figure 5. Thin-section photomicrograph showing a brown material lining the vertical crack (rotated in micrograph). Plane-polarized light.

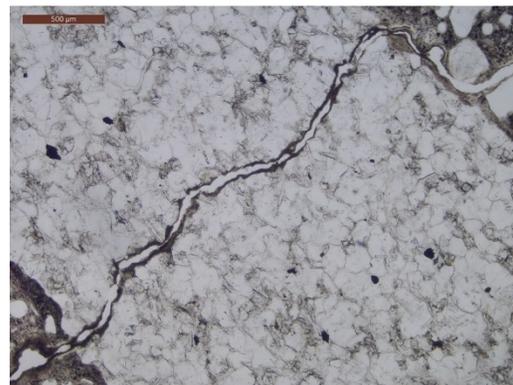
Figure 6. Thin-section photomicrograph showing a branch crack extending through a sandstone particle. Note brown material lining the crack. Plane-polarized light.

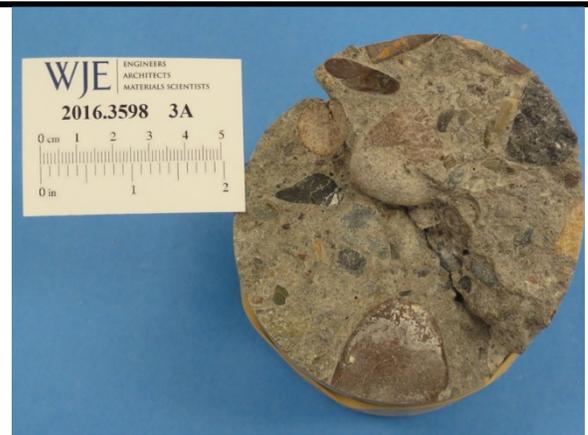
Figure 3. Core 3A. Bottom surface

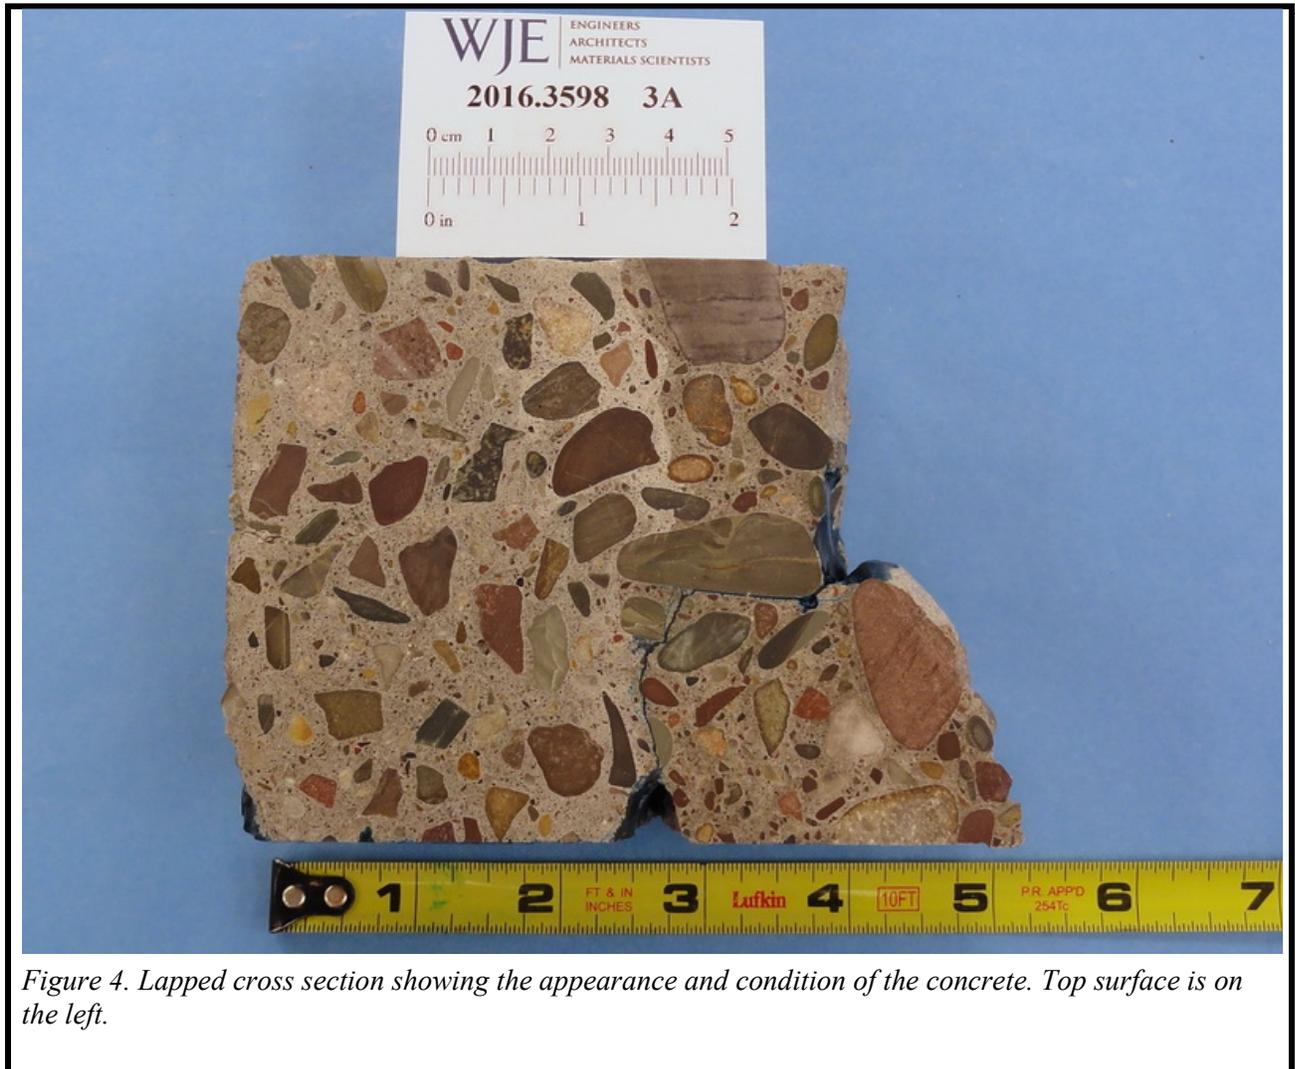
<b>Overlay-Substrate Interface</b>	Substantially roughened substrate top surface. The two concretes are tightly adhered.
<b>General Observations: Substrate Concrete</b>	Concrete is mainly composed of natural siliceous sand and gravel aggregates uniformly dispersed in medium-dark gray, air-entrained cementitious paste. Air content estimated at 5 to 6%. Top size: 3/4 inch.

*Figure 4. Lapped cross section showing the appearance and condition of the concrete. Top surface is on the left.*

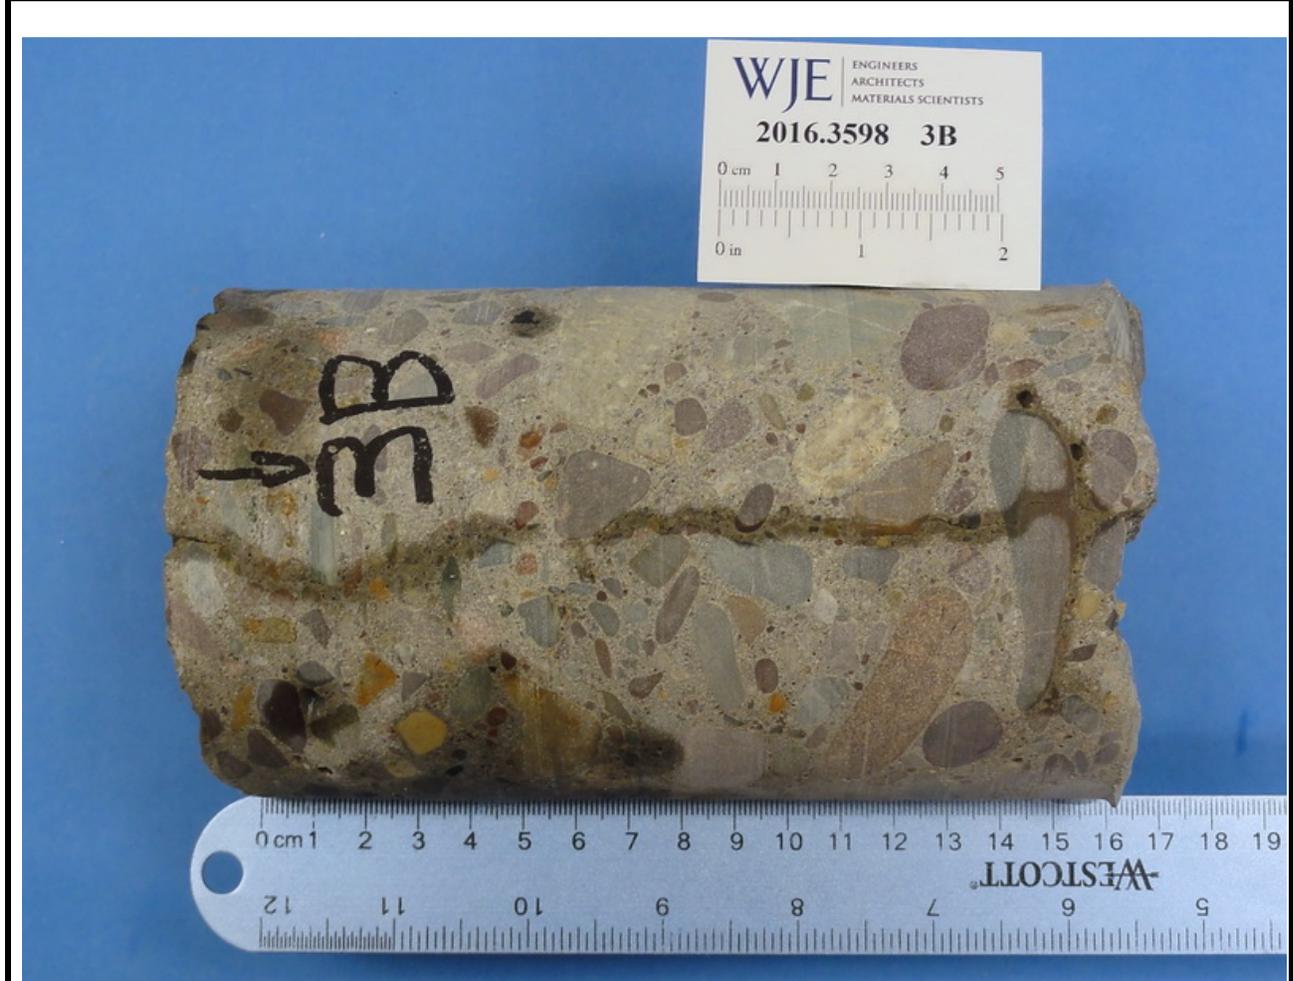
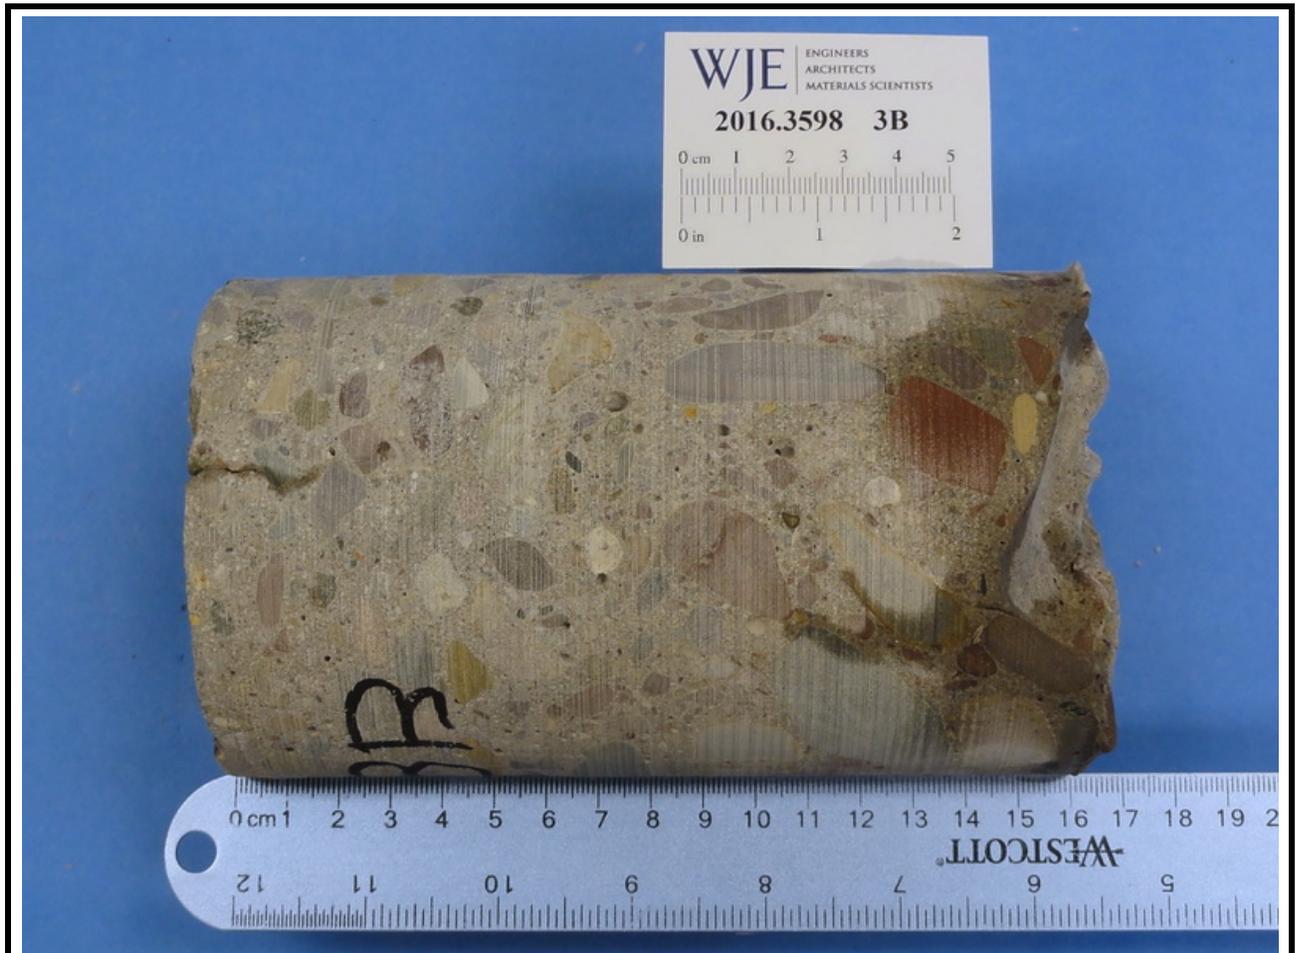
Figure 1. Core 3B. Side views. Top surface is on left. Top surface is on the left.

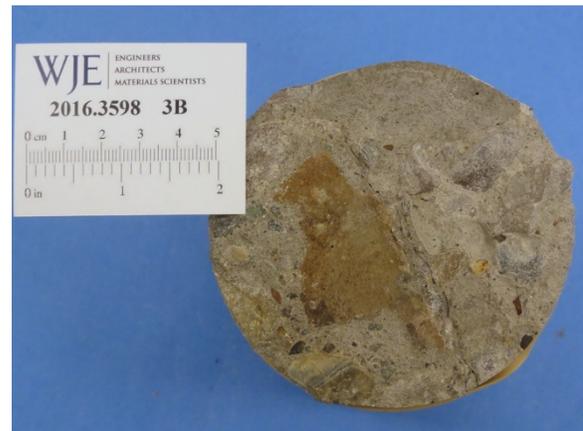
Figure 3. Core 3B. Bottom surface

<b>End Surfaces</b>	Saw-grooved top surface. Mainly uneven fractured bottom surface with a small area of flat formed surface.
<b>Reinforcement</b>	None in core.
<b>Consolidation</b>	Generally well consolidated.
<b>Distribution of Constituents</b>	Aggregates and paste are uniformly distributed in both overlay and substrate concrete.
<b>Cracks, Joints</b>	A full-depth vertical hairline crack, approximately 0.004 inch wide, mainly passes around aggregates; a few aggregate particles in the substrate are transected by the crack.
<b>General Observations: Overlay Concrete</b>	The concrete is mainly composed of natural siliceous sand and gravel or partially crushed gravel aggregates with a top size of 3/8 inch uniformly dispersed in light to medium gray, air-entrained cementitious paste. Air content estimated at 6 to 8%.
<b>Overlay-Substrate Interface</b>	Substantially roughened substrate top surface; tightly bonded each other.

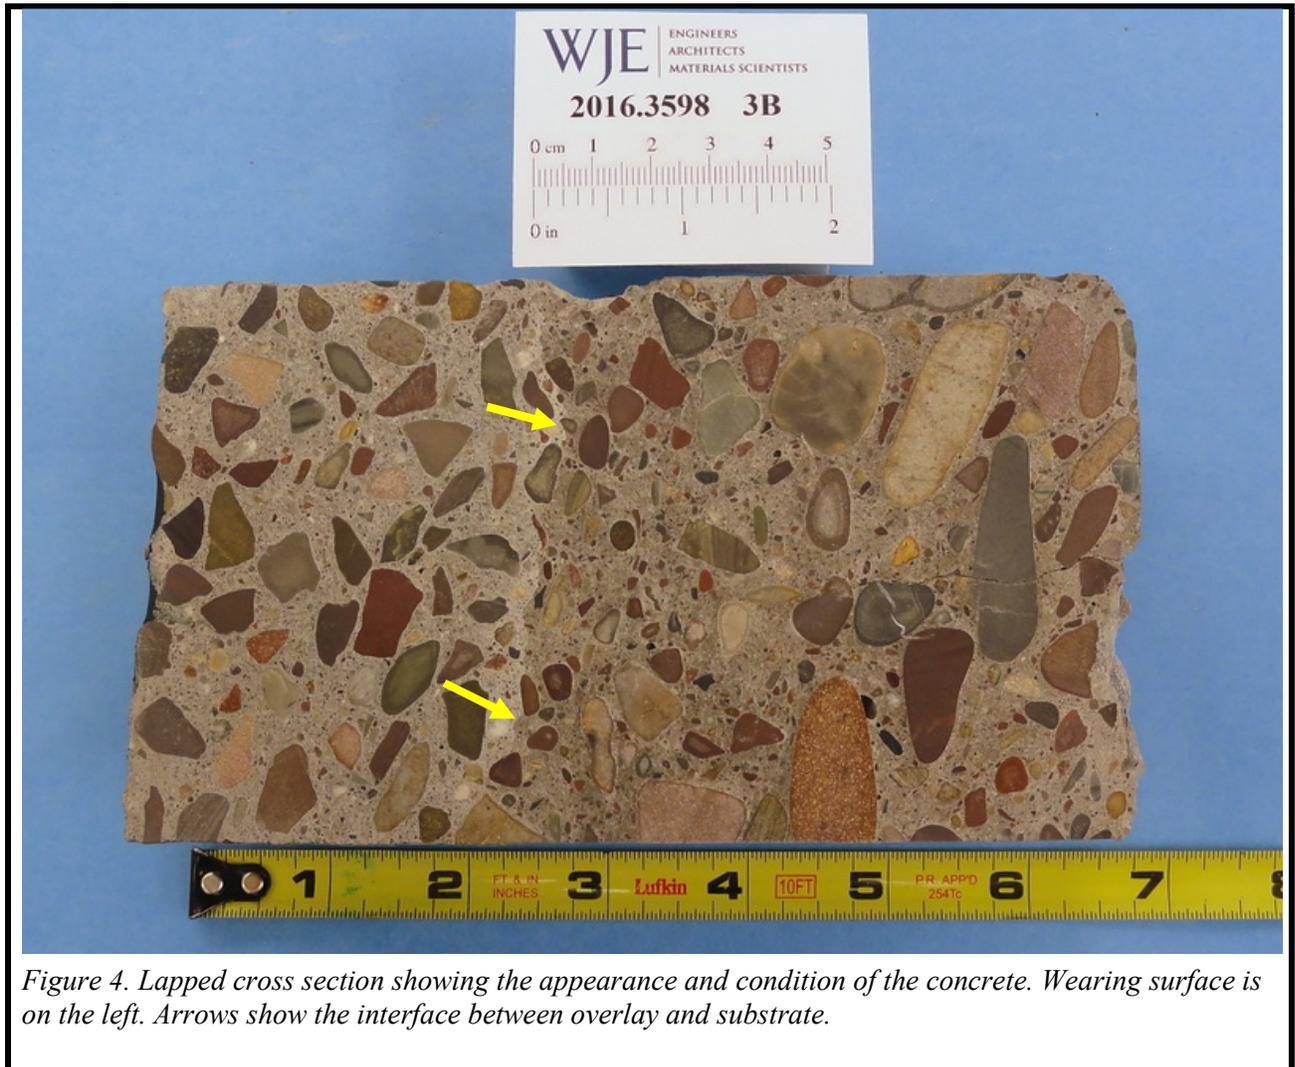
*Figure 4. Lapped cross section showing the appearance and condition of the concrete. Wearing surface is on the left. Arrows show the interface between overlay and substrate.*

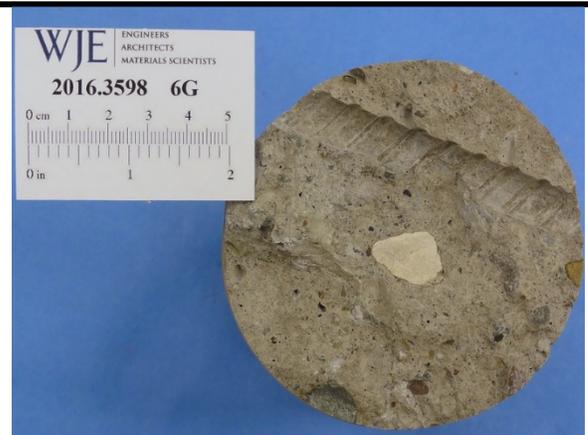
Figure 3. Core 6G. Bottom surface

<b>Dimensions</b>	Diameter: 3.7 inches Length: 5.4 inches
<b>End Surfaces</b>	Abraded, tined or saw-grooved top surface with worn coarse aggregate particles exposed; fractured bottom surface exhibits rebar impression.
<b>Reinforcement</b>	Imprint of No.4 rebar on bottom surface. No evidence of corrosion was observed.
<b>Consolidation</b>	Generally well consolidated. A few scattered entrapped voids.
<b>Distribution of Constituents</b>	Aggregate and paste are uniformly distributed.
<b>Cracks, Joints</b>	Full-depth crack approximately 0.010 inch wide in the top 1 inch of the core mainly passes around CA particles.
<b>General Observations</b>	The concrete is mainly composed of siliceous natural sand and gravel aggregates uniformly dispersed in air-entrained cementitious paste.

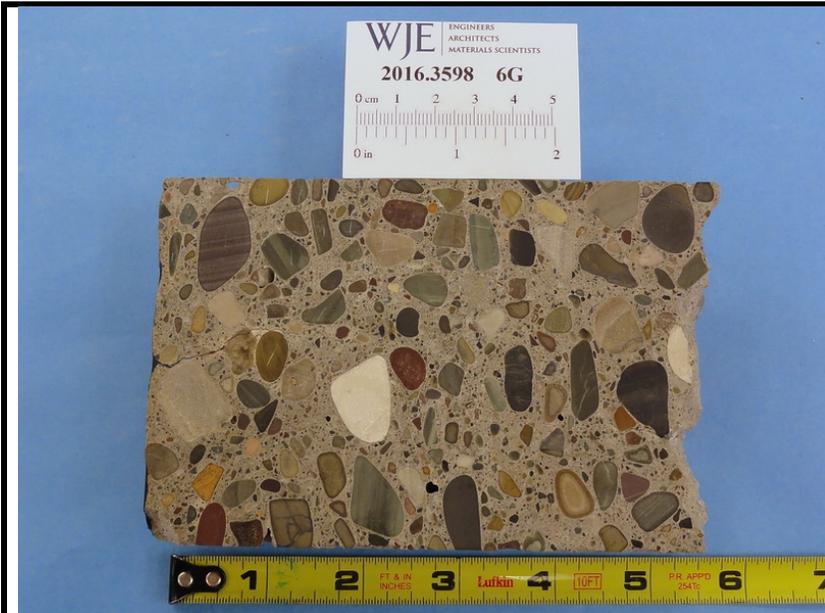
<b>Distinctive Features</b>	The aggregates in 6G contained more carbonate and argillaceous, fine-grained clastic components compared to 1D, 1I, and 2C. The long axis of elongate aggregate particles was frequently parallel to the top surface.

*Figure 4. Lapped cross section showing the appearance and condition of the concrete. The long axis of aggregate particles was frequently parallel to the top surface (on left).*

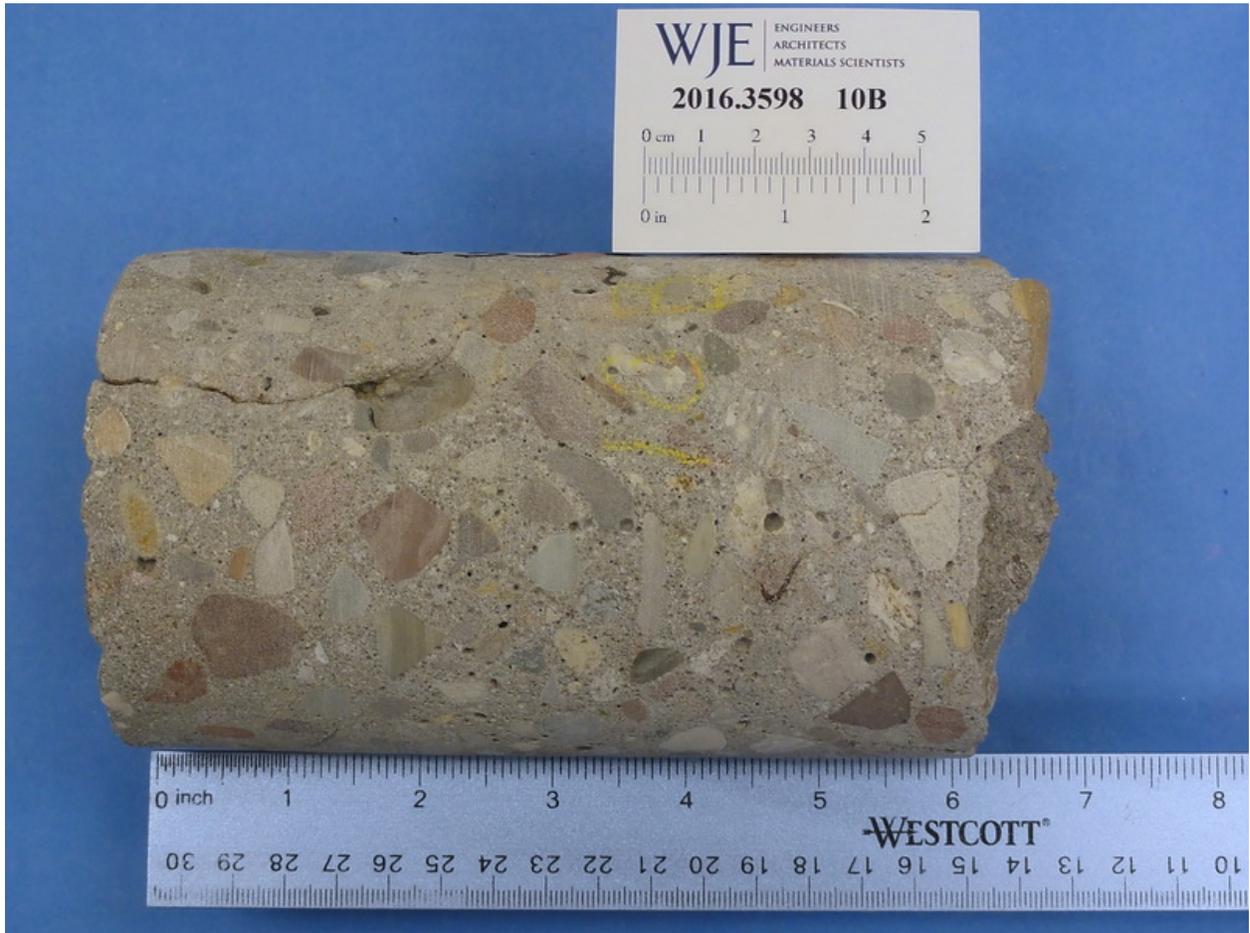
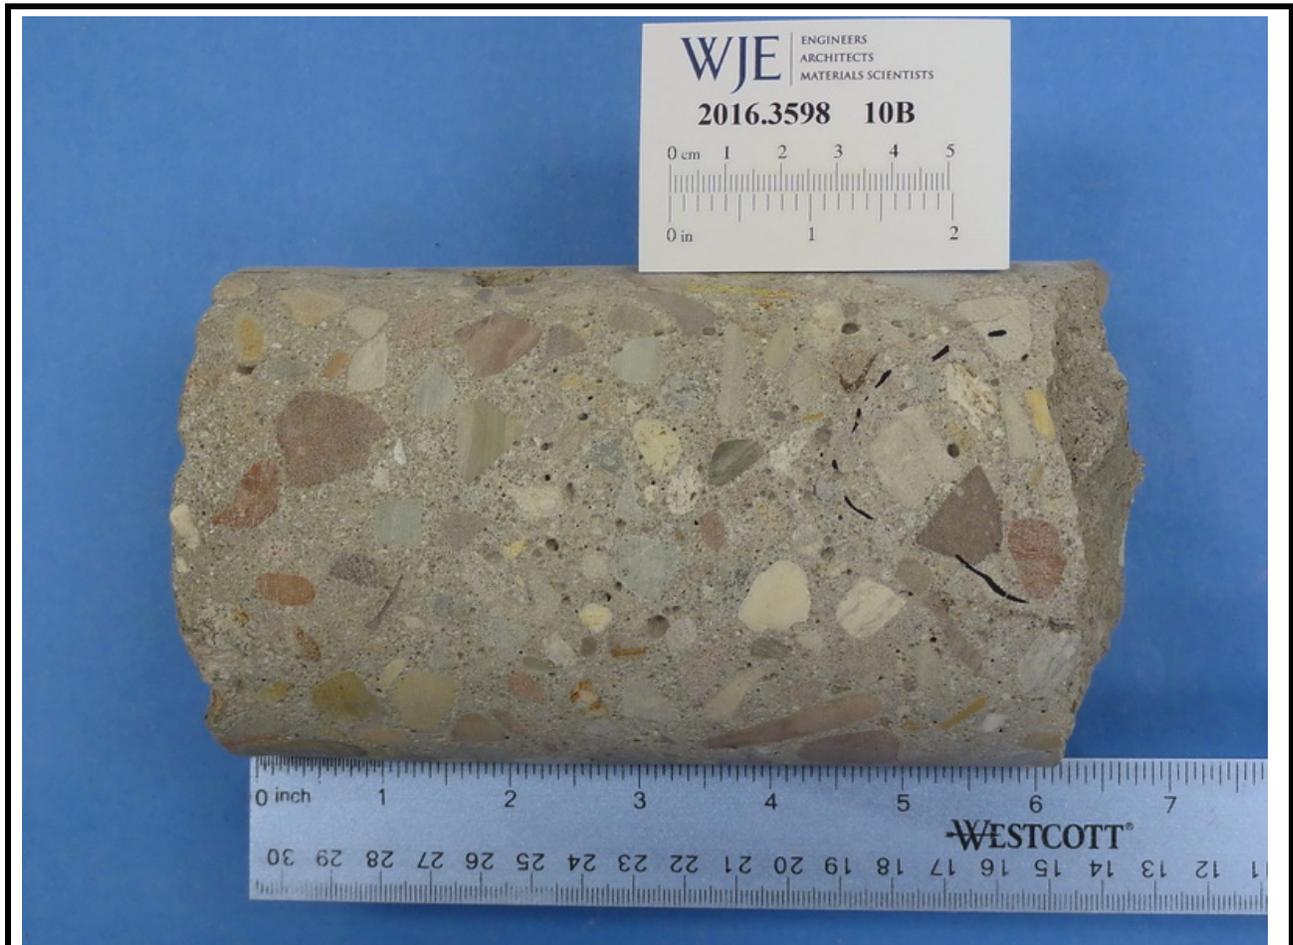
Figure 1. Core 10B. Side views. Wearing surface is on left.

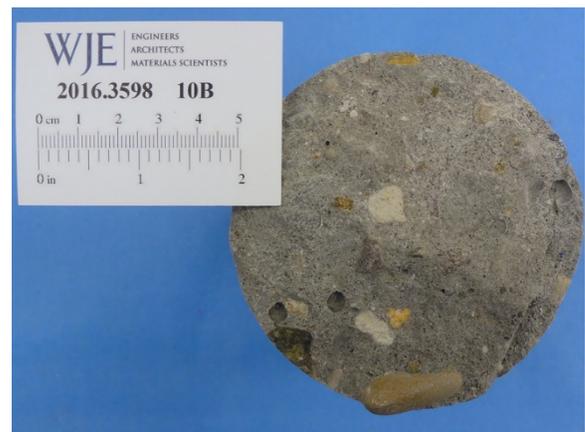
Figure 3. Core 10B. Bottom surface

<b>End Surfaces</b>	Slightly abraded saw-grooved top surface. Uneven fractured bottom surface mainly broke off around coarse aggregate particles.
<b>Reinforcement</b>	None in core.
<b>Consolidation</b>	Well consolidated. Entrapped air void 0.7 inch across was observed at a depth of approximately 2 inches.
<b>Distribution of Constituents</b>	Aggregates and paste are uniformly distributed.
<b>Cracks, Joints</b>	Diagonal crack approximately 0.01 inch wide extended from the wearing surface and terminated at a depth of 3.5 inches. The crack transected one coarse aggregate particle at a depth of approximately 2 inches.  A hairline crack extends from the top surface to a depth of 0.7 inch and a horizontal hairline crack connects the vertical crack with the major crack.  A hairline crack at the bottom surface extended 1.5 inches from the bottom surface.
<b>General Observations</b>	The concrete is mainly composed of siliceous natural sand and gravel aggregates uniformly dispersed in air-entrained cementitious paste.

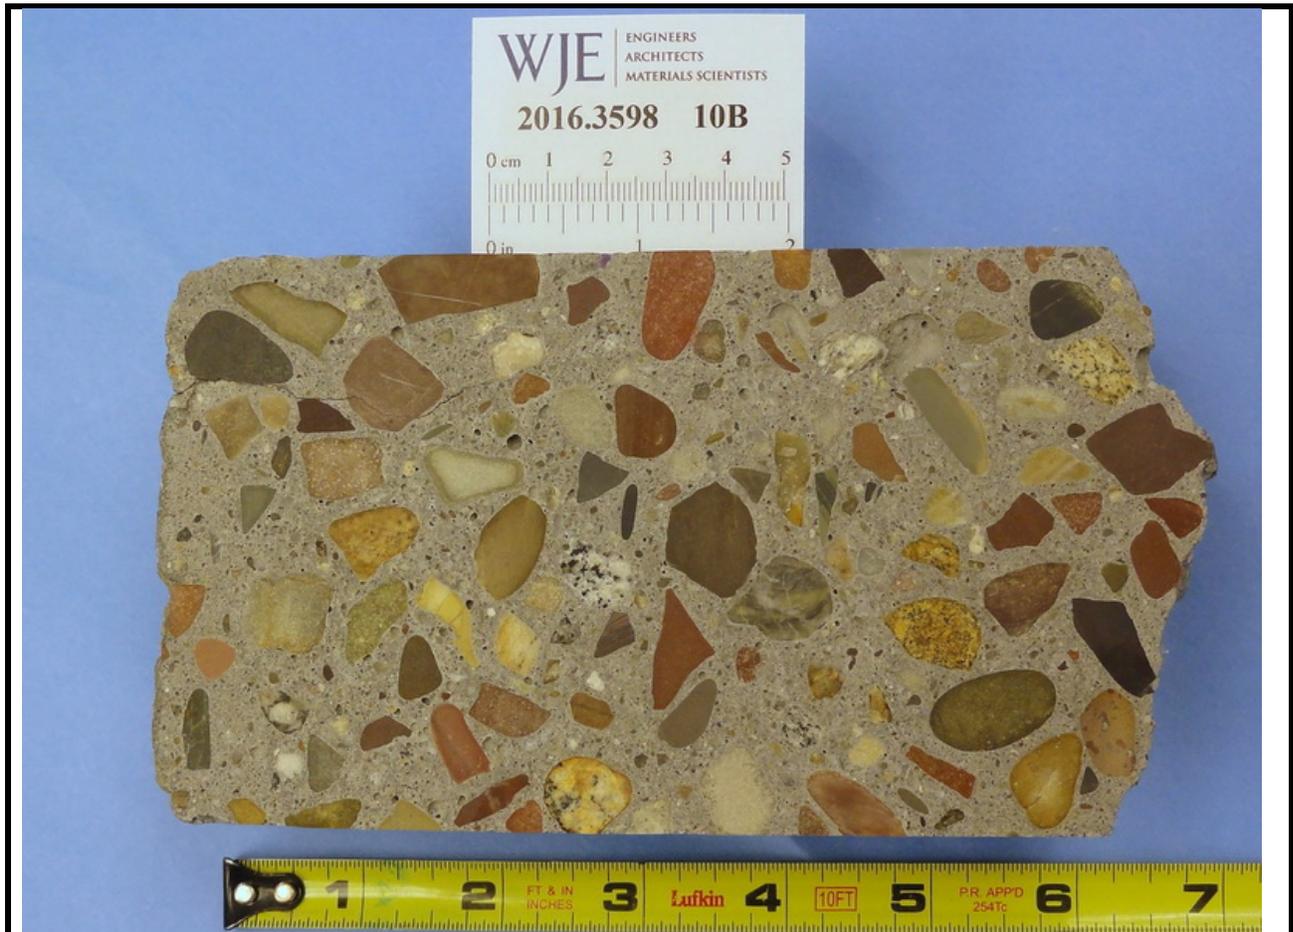
<b>Microcracks</b>	The body of the concrete contains infrequent microcracks that extend between aggregate particles. Microcracking is not excessive.
<b>Distinctive Features</b>	The major crack is lined with dark brown-gray fine-grained deposits to a depth of 2 inches.

Figure 4. Lapped cross section showing the appearance and condition of the concrete. Wearing surface is on the left.

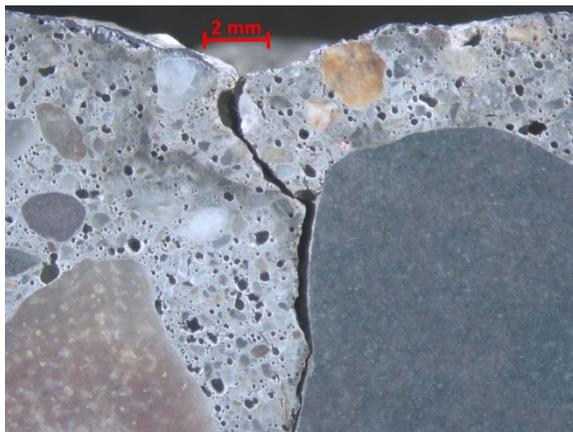
Figure 5. Close-up view of top region.

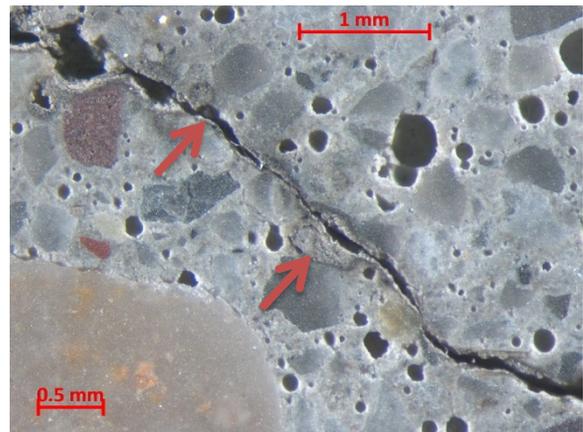
Figure 6. Close-up view at approximately 1 inch depth. Arrows show dark-colored fine-grained deposits lining the crack.

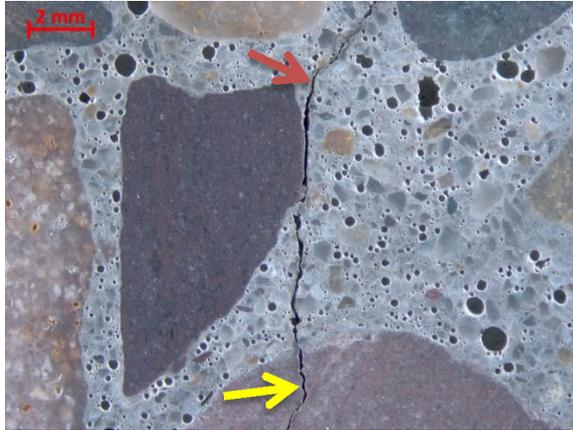
*Figure 7. Close-up view at approximately 1.3 inches depth. Major crack transects a coarse aggregate particle at the bottom of the view (yellow arrow). Red arrow shows dark deposits lining the crack.*

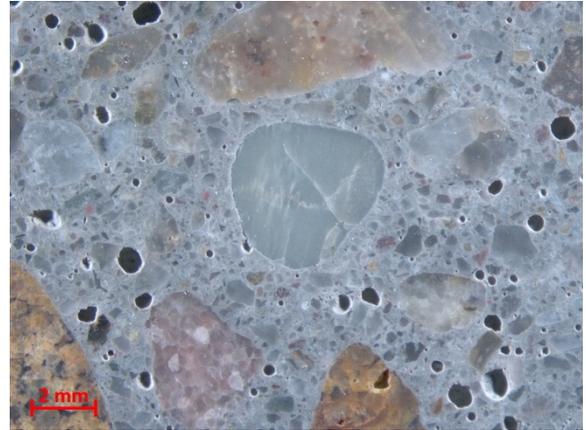
<b>Water-Cementitious Materials Ratio</b>	Estimated at 0.45 to 0.50 based on physical characteristics. No thin section was prepared.
<b>Carbonation</b>	Approximately 0.04 inch.
<b>Air-Void System Characteristics</b>	Air-entrained. The distribution of air voids is non-uniform, varying from estimated 10 to 12% to locally 4 to 6%. Air content is higher and the air voids are generally smaller in the top half of the core compared to the bottom half.  The air-void system appears to be adequate to protect the concrete against cyclic freeze-thaw distress, despite of the nonuniform distribution of voids.
<b>Secondary Deposits</b>	None observed in stereomicroscope examination.

*Figure 8. Close-up view at approximately 4.6 inches depth shows a region of low air content.*

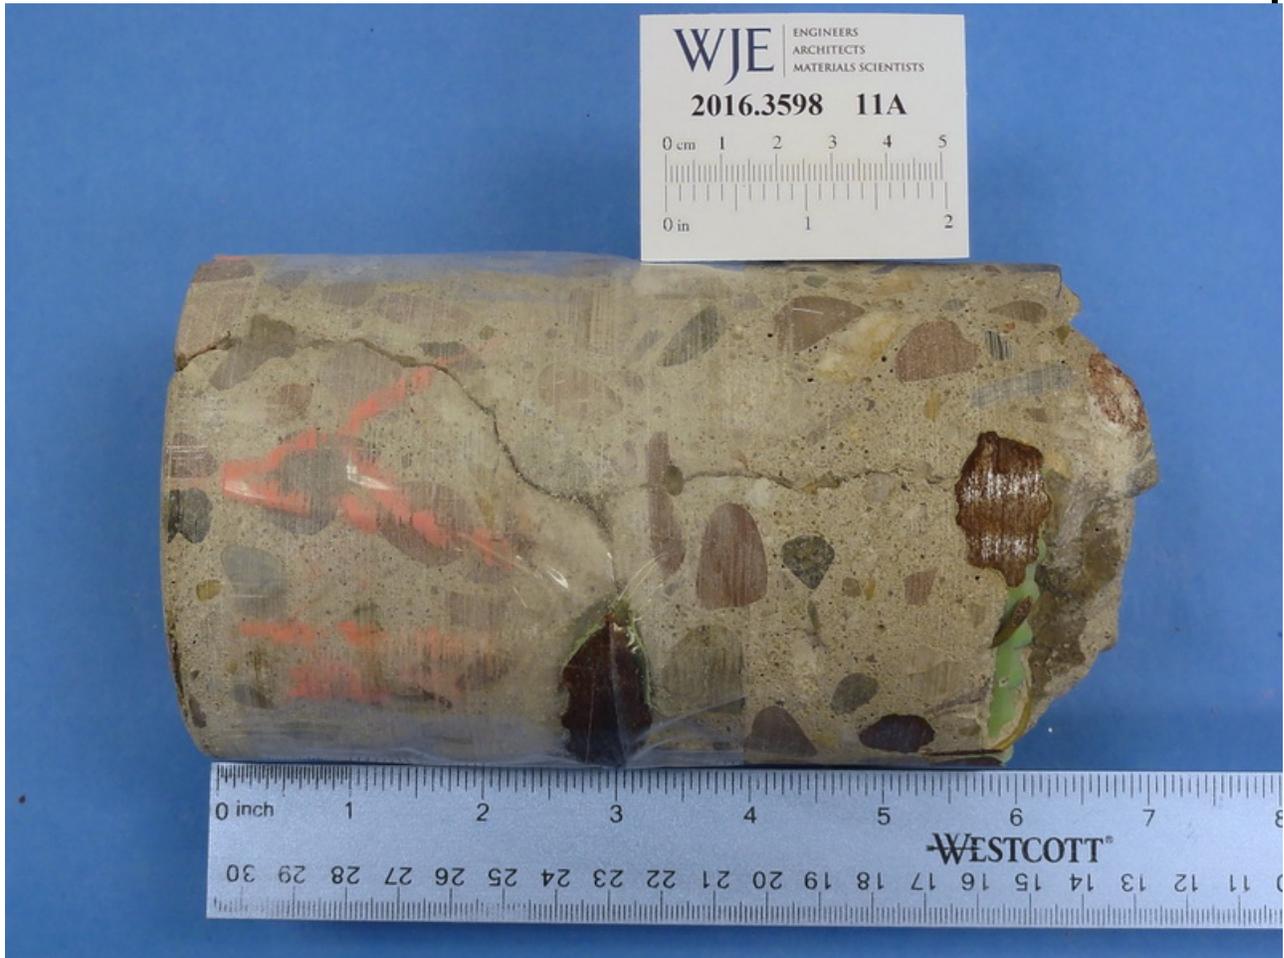
Figure 1. Core 11A. Side view. Top surface is on the left.

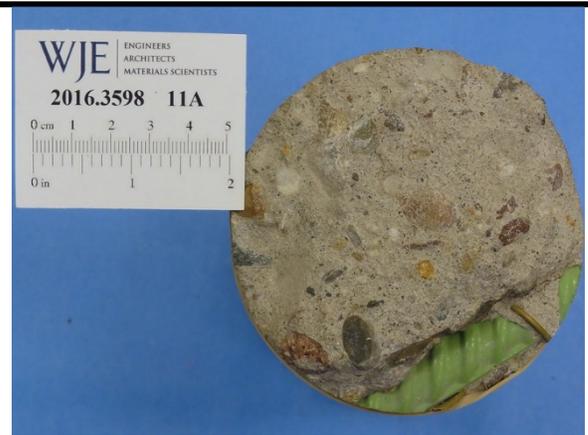
Figure 3. Core 11A. Bottom surface

<b>Dimensions</b>	Diameter: 3.7 inches Length: 5.5 to 6.5 inches
<b>End Surfaces</b>	Saw-grooved and abraded top surface; fractured bottom surface.
<b>Reinforcement</b>	No. 5 rebars with 2.6 and 5.3-inch cover; No. 4 rebar with 4.7-inch cover (above the bottom No. 5 bar and oriented perpendicular each other in the horizontal plane).
<b>Consolidation</b>	Generally well consolidated.
<b>Distribution of Constituents</b>	Aggregate and paste are uniformly distributed.
<b>Cracks and Depth of Penetration of Crack Repair Material</b>	Full-depth crack. Resinous (possibly epoxy) repair material penetrated to a maximum depth of 0.8 inch from top surface. Below this depth, and to the bottom of the crack, brown fine-grained material was observed lining the crack. This material appears to be debris that has washed into the crack and is similar to the fine-grained material lining the crack in Core 2C. The dark deposits also line the upper portion of the crack that was filled with the resinous repair material.  No lapped cross section or thin section were prepared.
