**MONTANA DEPARTMENT OF TRANSPORTATION  
(MDT)  
Investigation of Bridge Decks**

**Final Report**  
April 21, 2017  
WJE No. 2016.3598

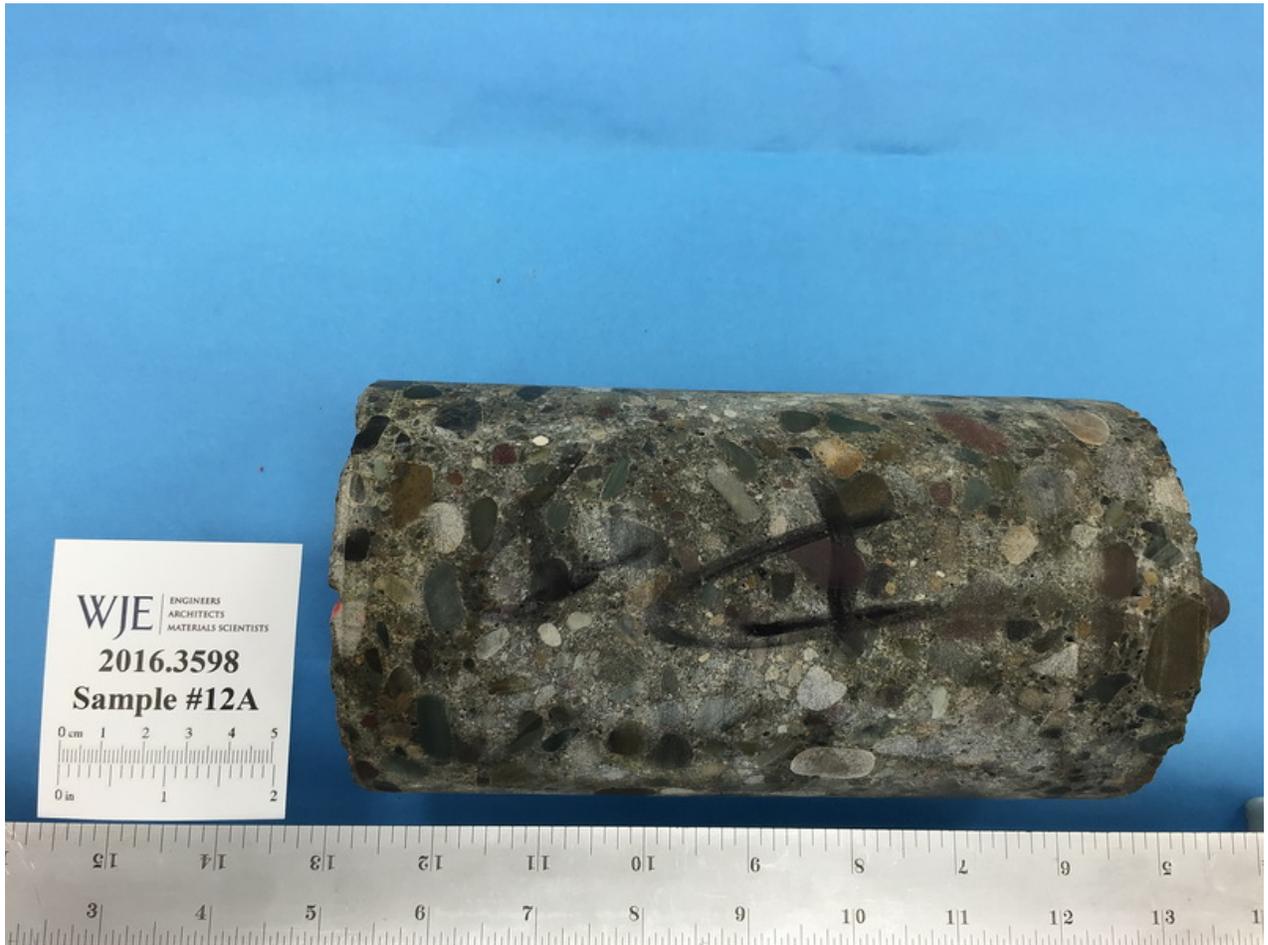
Figure 1. Core 12A. Side view. Red arrows indicate aggregate particles that exhibited evidence of minor ASR.

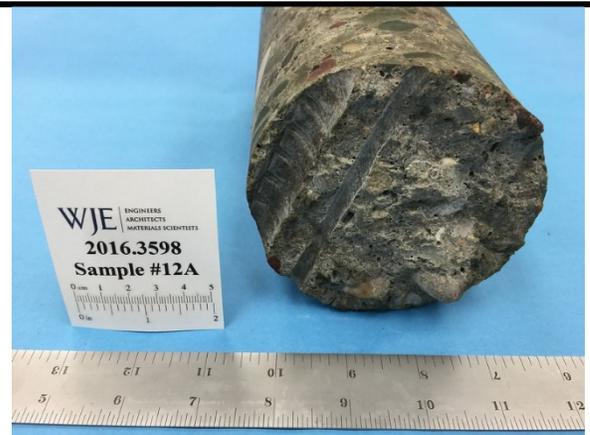
Figure 3. Core 12A. Bottom surface

<b>Dimensions</b>	Diameter: 3.7 inches Length: 6.8 to 7.8 inches
<b>End Surfaces</b>	Saw-grooved wearing surface. Uneven bottom surface broke around coarse aggregate particles and had an impression of a deformed rebar (No. 4 or No. 5) and a smooth wire (diameter approximately 0.25 inch).
<b>Reinforcement</b>	No reinforcement was embedded in the core. Impressions of steel reinforcement as described above. Impressions were clean; no evidence of corrosion.
<b>Consolidation</b>	Well consolidated. No large air voids observed.
<b>Distribution of Constituents</b>	Aggregate and paste are uniformly distributed.
<b>Cracks, Joints</b>	A vertical hairline crack approximately 0.003 inch wide extends to a depth of 4.5 inches. The hairline crack becomes a microcrack at a depth of approximately 1.5 inch. The crack/microcrack passes through a few aggregate particles.
<b>General Observations</b>	The concrete is mainly composed of siliceous natural sand and gravel aggregates uniformly dispersed in air-entrained cementitious paste.

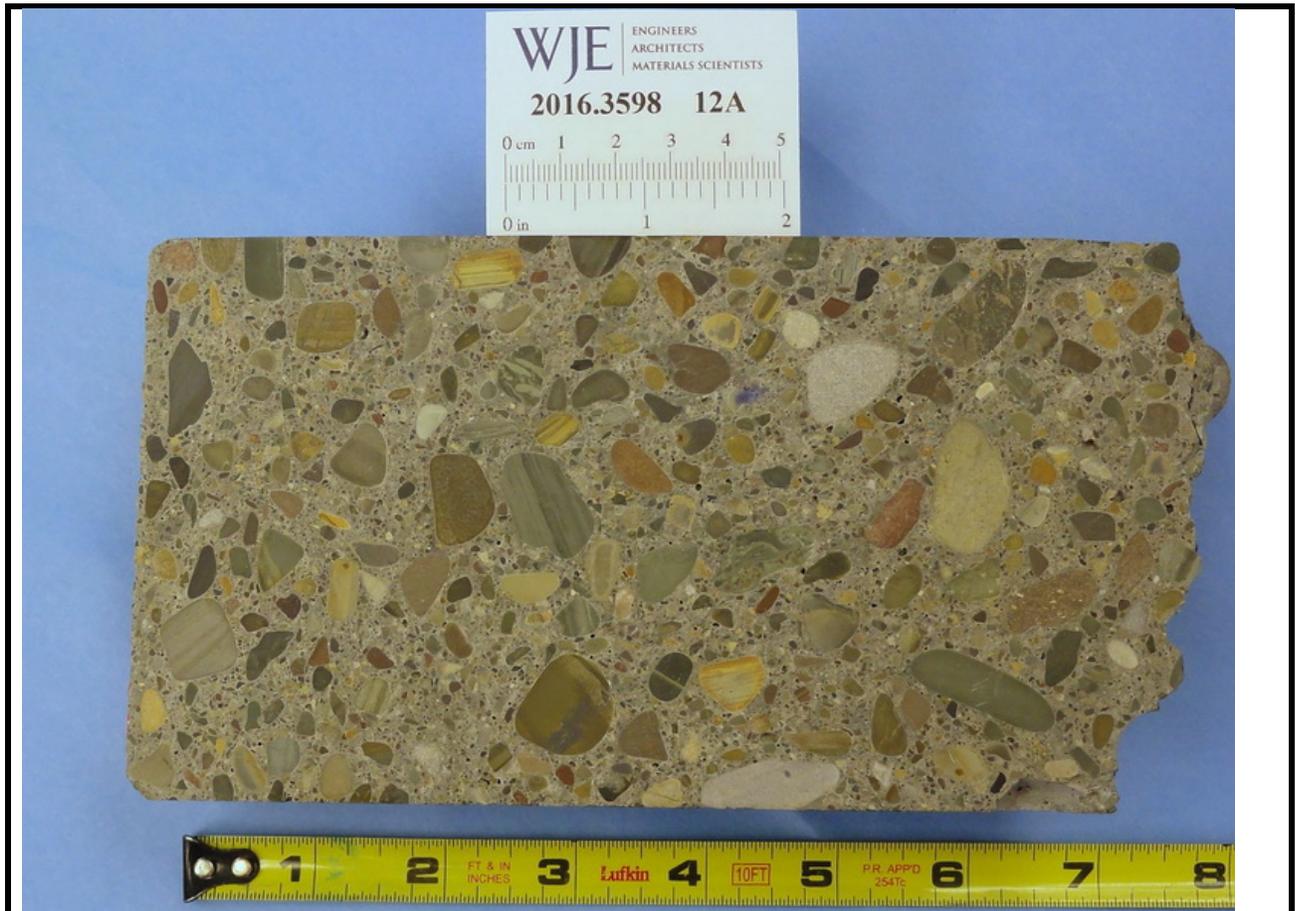
<b>Distinctive Features</b>	The proportion of fine-grained clastic sedimentary rocks is high.

Figure 4. Lapped cross section showing the appearance and condition of the concrete. Wearing surface is on the left.

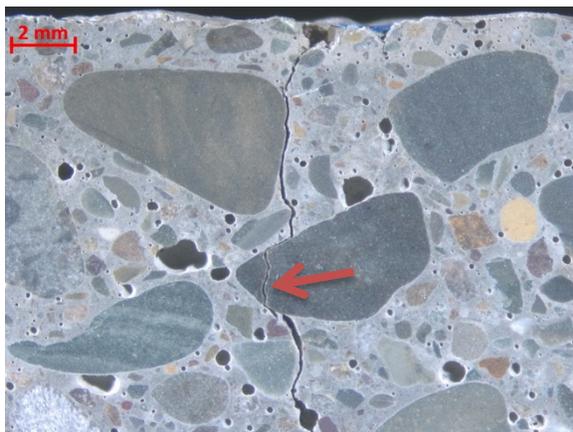
Figure 5. Close-up view of top region. Arrow shows the crack passing through an aggregate particle.

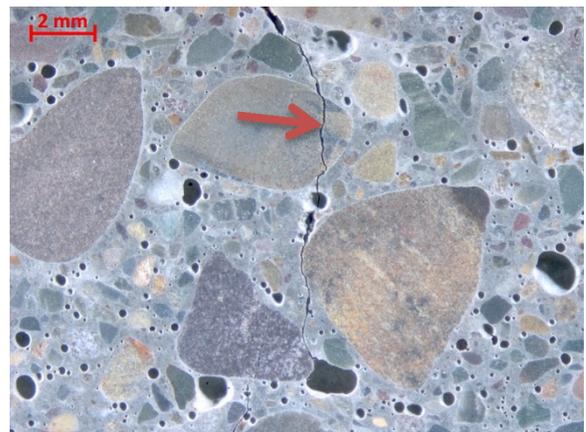
Figure 6. Close-up view at a depth approximately 1.3 inches. Arrow shows the crack passing through an aggregate particle.

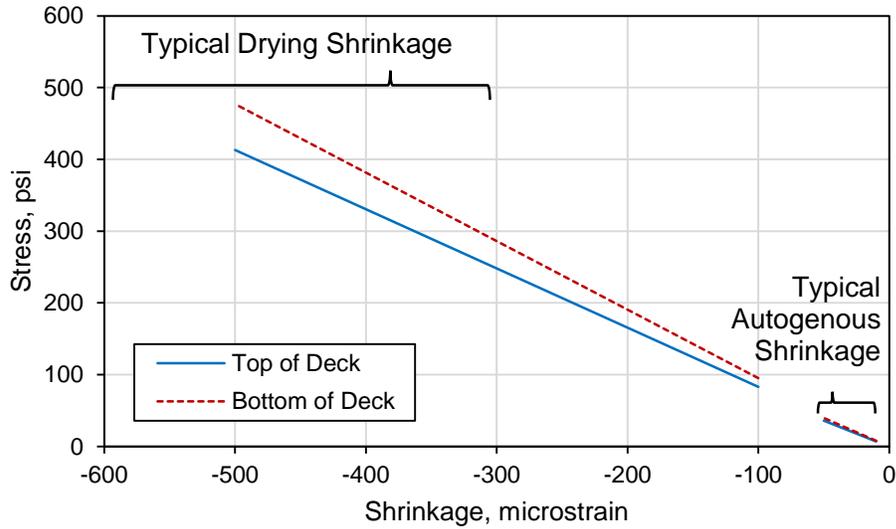
- Uniform autogenous shrinkage (Figure 1): Autogenous shrinkage generally has a small impact on the tensile stresses developed in the deck at very early ages. At an assumed compressive strength of 1500 psi, a uniform shrinkage of 10 microstrain results in 7 psi tensile stress at the top of the deck and 8 psi tensile stress at the bottom of the deck. Autogenous shrinkage values between 0 and 40 microstrain would be anticipated at early ages for the three bridge decks investigated in this study; for Bridge 1, such strains would generate tensile stresses of up to 28 psi and 32 psi at the top and bottom of the deck, respectively.

- Uniform drying shrinkage (Figure 1): Drying shrinkage generally has a much greater impact on the tensile stresses developed in the deck at later ages due to its greater magnitude. At an assumed compressive strength of 7370 psi, a uniform 500 microstrain of drying shrinkage (typical for mature concrete) results in tensile stress of 413 psi and 477 psi at the top and bottom of the deck, respectively. As drying shrinkage is a slow process, concrete creep will reduce actual stress levels significantly. Stress due to drying shrinkage alone are likely not adequate to cause cracking of mature concrete but is a primary contributor.

Figure 1. Modeled stresses in Bridge 1 deck due to uniform drying or autogenous shrinkage.

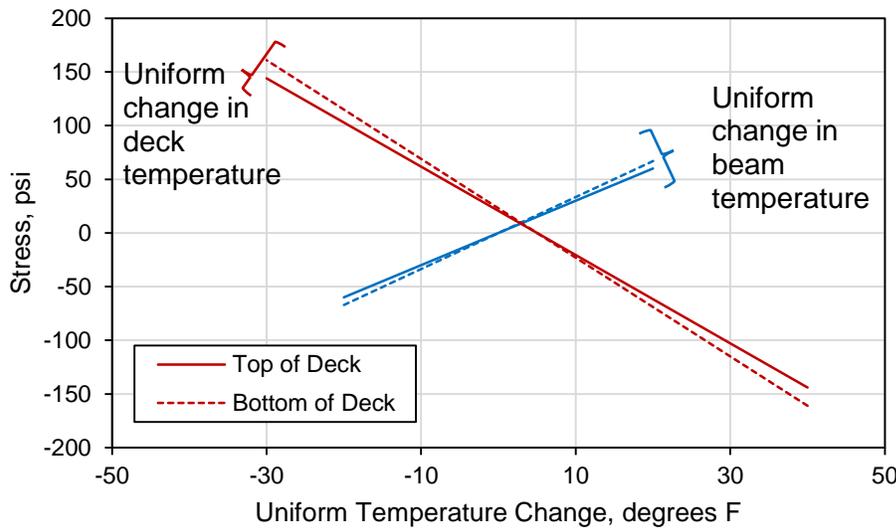
Figure 2. Modeled stresses in Bridge 1 deck due to uniform temperature changes in deck and beam.

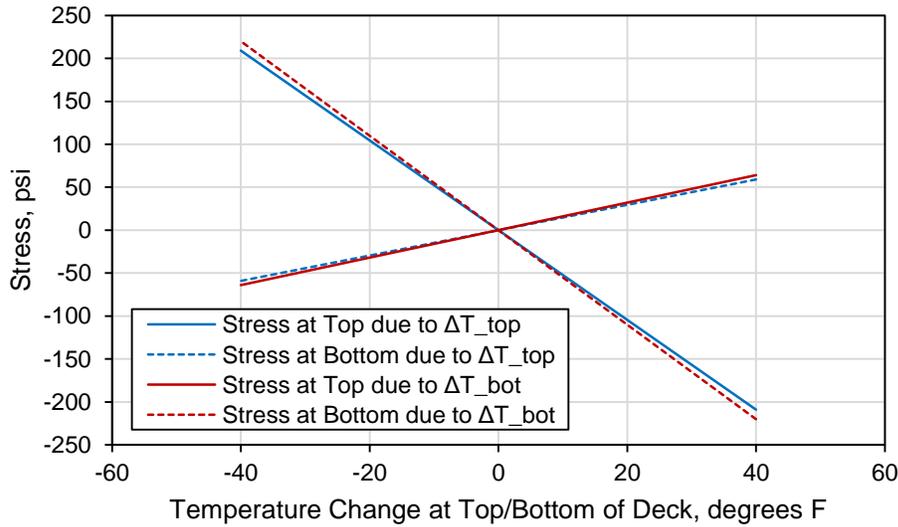
- Linear temperature change in deck (Figure 3): A linear temperature change through the deck generates a linear strain profile, with the side of the deck experiencing the greater temperature increase (or smaller temperature decrease) experiencing greater *compressive* stresses. A temperature gradient typically generates larger stresses in the deck than a uniform temperature change, making the deck more susceptible to cracking. A 10 °F decrease in temperature at the top of the deck (and no change in temperature at the bottom of the deck) generates tensile stresses of approximately 50 psi at the top of the deck (compared to 36 psi for a uniform temperature change) and compressive stresses of

Figure 3. Modeled stresses in Bridge 1 deck due to linear temperature changes in deck. Blue lines show effect of changing only the temperature at the top of the deck ( $\Delta T_{bot} = 0$  °F); red lines show effect of changing only the temperature at the bottom of the deck ( $\Delta T_{top} = 0$  °F).

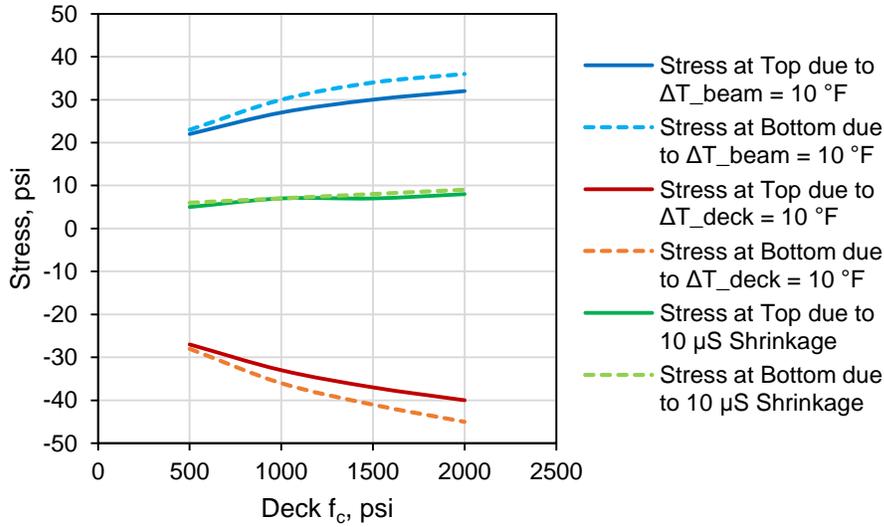
Figure 4. Modeled stresses in Bridge 1 deck due to change in compressive strength of concrete.

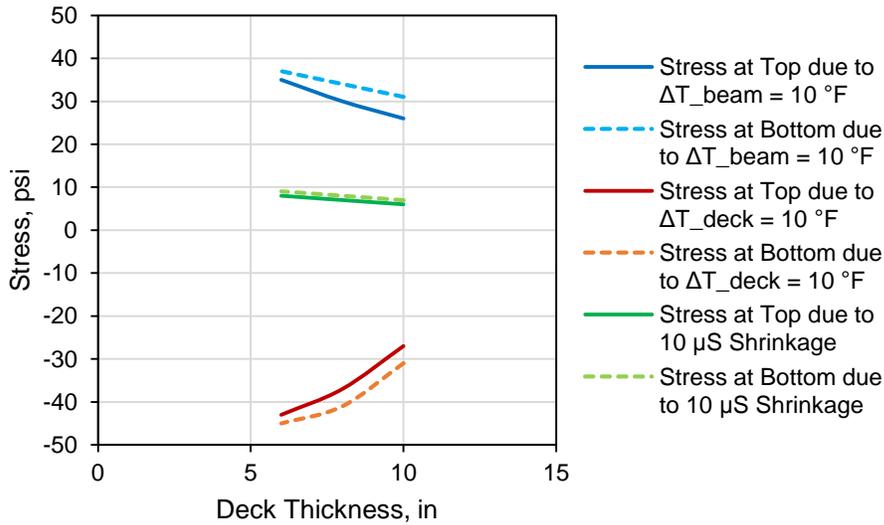
Figure 5. Modeled stresses in Bridge 1 deck due to change in deck thickness.

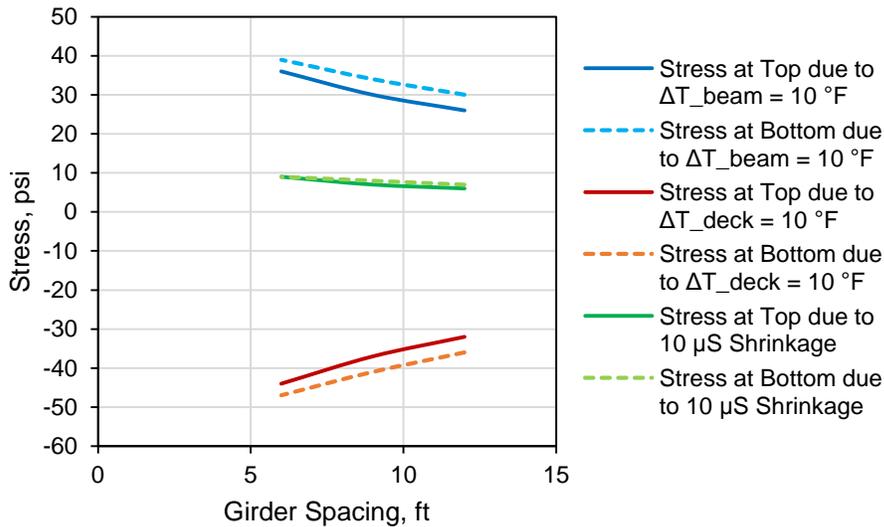
- Girder spacing (Figure 6): Increasing the girder spacing also reduces the magnitudes of the stresses that are generated in the bridge deck. Increasing the spacing of the Bridge 1 girders from 9 feet to 12 feet reduces the magnitude of the stresses by 10-15%, while reducing the spacing to 6 feet generally increased the magnitude of the stresses by 15-20%. Increased girder size will likely offset some of the change in stresses.

Figure 6. Modeled stresses in Bridge 1 deck due to change in girder spacing.
