Gold Creek

Safety Rest Area Study

Summary Report

December 2017

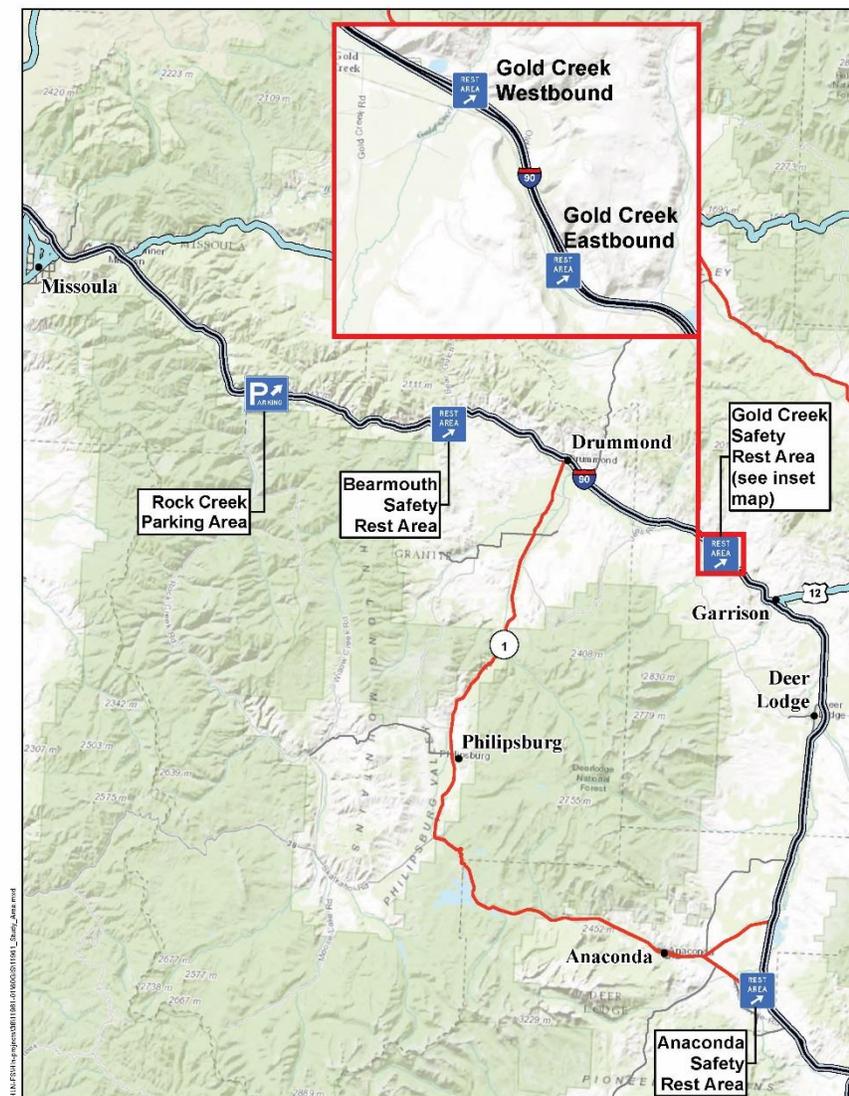
Figure 1: Study Area

Figure 1 illustrates the Gold Creek Safety Rest Area location in reference to the communities of Drummond and Garrison along Interstate 90 (I-90). Network spacing criteria from the Montana Rest Area Plan characterized the Gold Creek Safety Rest Area as potentially redundant due to its proximity to the Bearmouth Safety Rest Area (approximately 25 miles to the northwest) and the Anaconda Safety Rest Area (approximately 40 miles to the south). The Gold Creek Safety Rest Area was closed in conjunction with the reopening of the newly reconstructed Bearmouth Safety Rest Area in April 2015.

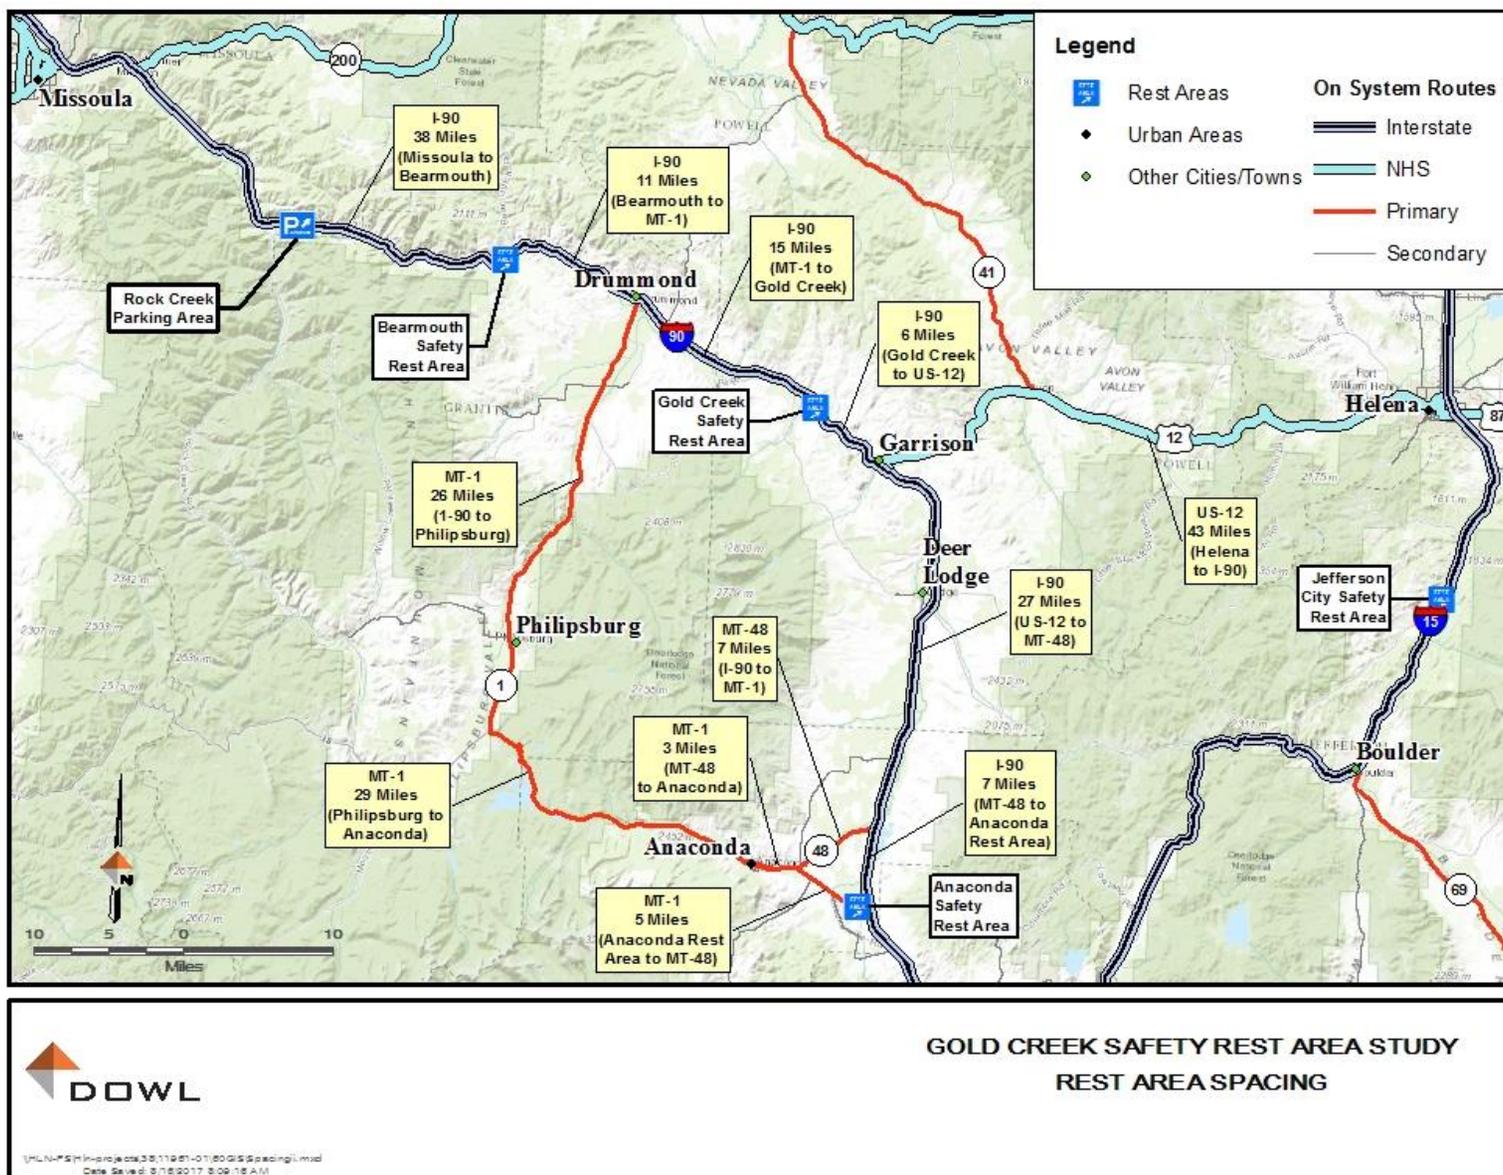
Figure 2: Gold Creek Safety Rest Area Spacing Analysis

The Montana Rest Area Plan recommends approximately one hour of travel time between safety rest areas. This generally equates to a distance of approximately 70 miles. Table 1 and Figure 2 provide a summary of spacing distances between safety rest areas and urban areas in the vicinity of the Gold Creek Safety Rest Area measured according to the most direct route (i.e., shortest mileage). The analysis considers spacing only along Interstate, National Highway System (NHS), and Primary routes. Currently, the Anaconda and Bearmouth Safety Rest Areas are open year round. The Gold Creek Safety Rest Area is temporarily closed but has operated as a seasonal facility in past years.

- The distance between the Bearmouth and Anaconda Safety Rest Areas is 66 miles, indicating the Gold Creek Safety Rest Area is redundant along Interstate 90.
- Distances slightly exceed 70 miles between Helena and Anaconda, the Anaconda Safety Rest Area, and the Bearmouth Safety Rest Area.
- The presence of the Gold Creek Safety Rest Area has no effect on the distances between Helena and the Anaconda urban area or Anaconda Safety Rest Area as routes to these locations do not pass by the Gold Creek Safety Rest Area.
- The distance between Helena and the Bearmouth Safety Rest Area is only slightly higher than the 70-mile target. A 75-mile distance is not sufficient to warrant an additional full-service safety rest area.

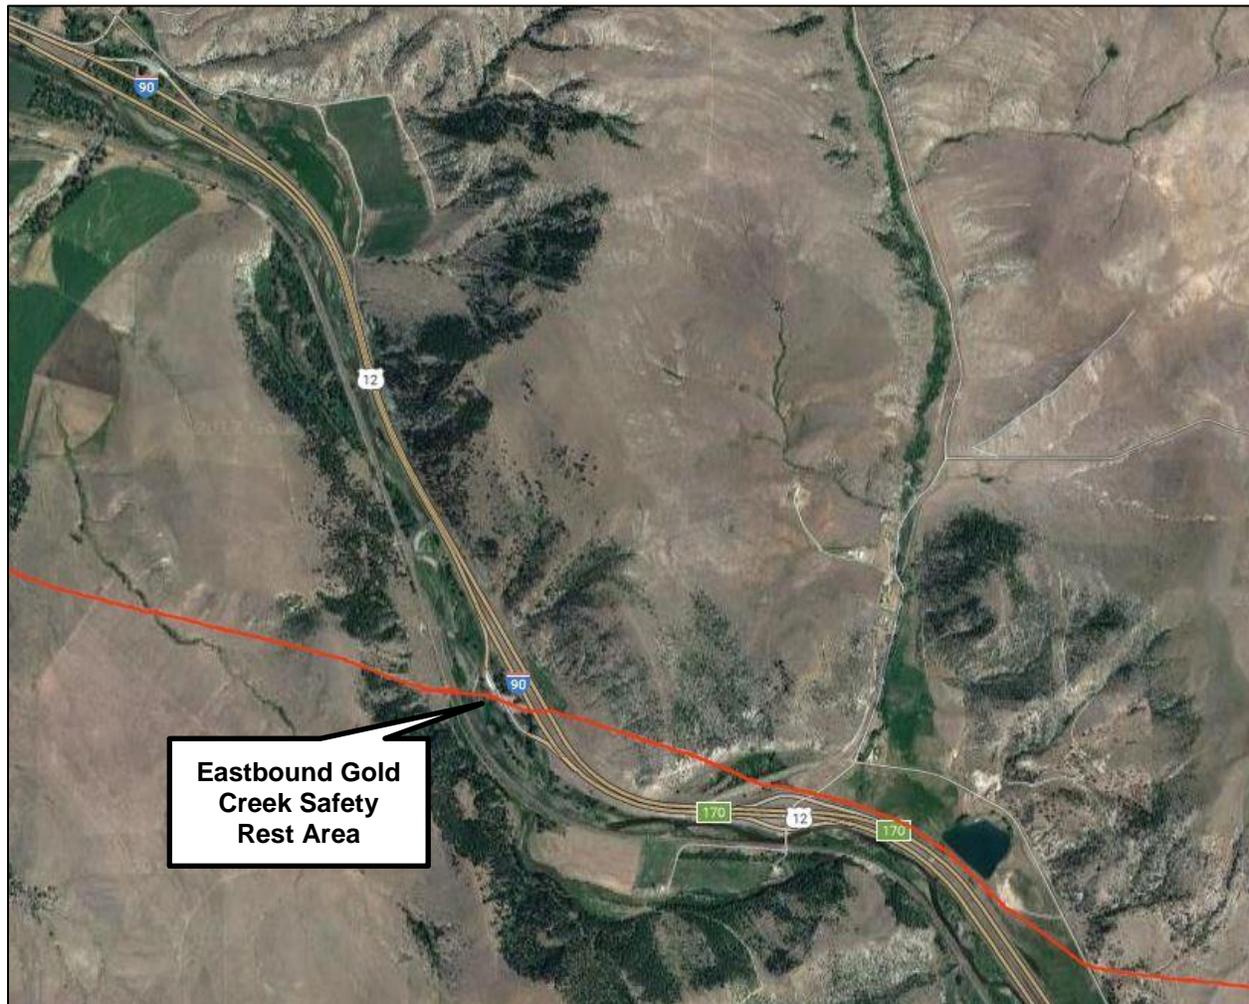
Figure 3: Phillips 66 Yellowstone Pipeline

Based on available DEQ information, there are no underground storage tank (UST) sites, petroleum release fund claims, hazardous waste handler sites, abandoned or inactive mine sites, or open cut permits within or directly adjacent to the two sites. The National Pipeline Mapping System shows one pipeline designated as a hazardous liquid pipeline crossing the eastbound site from east to west. The pipeline is designated as part of the Yellowstone Pipeline and is owned by Phillips 66 (Figure 3).
