Bridger Canyon Corridor Planning Study

April 2015

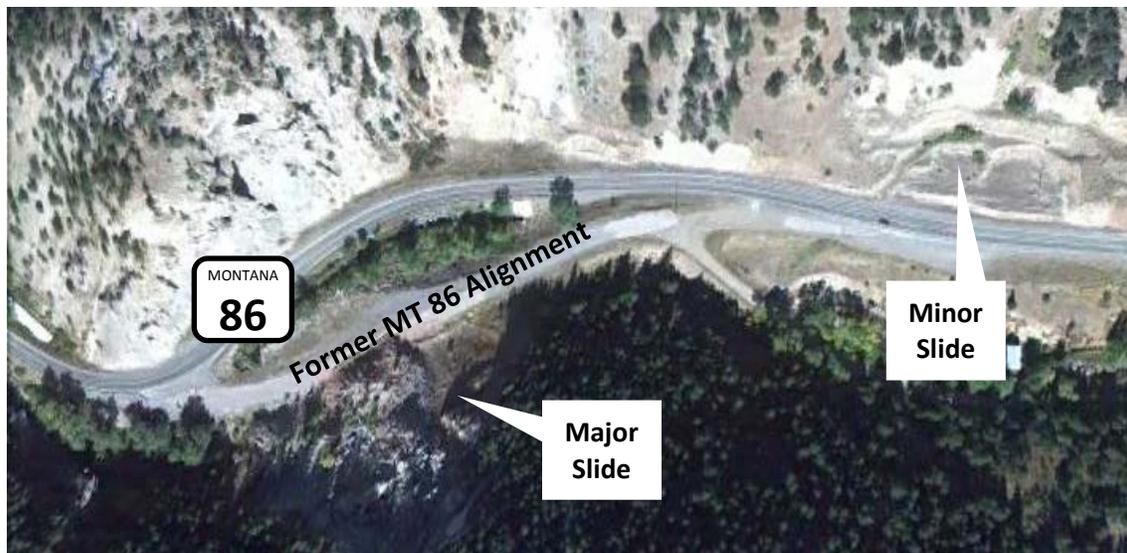
Figure 2 Slide Area

Figure 2 illustrates the major and minor slide locations. Additional slope stability evaluation may need to be conducted on slopes immediately adjacent to MT 86 for any improvements forwarded from this study.

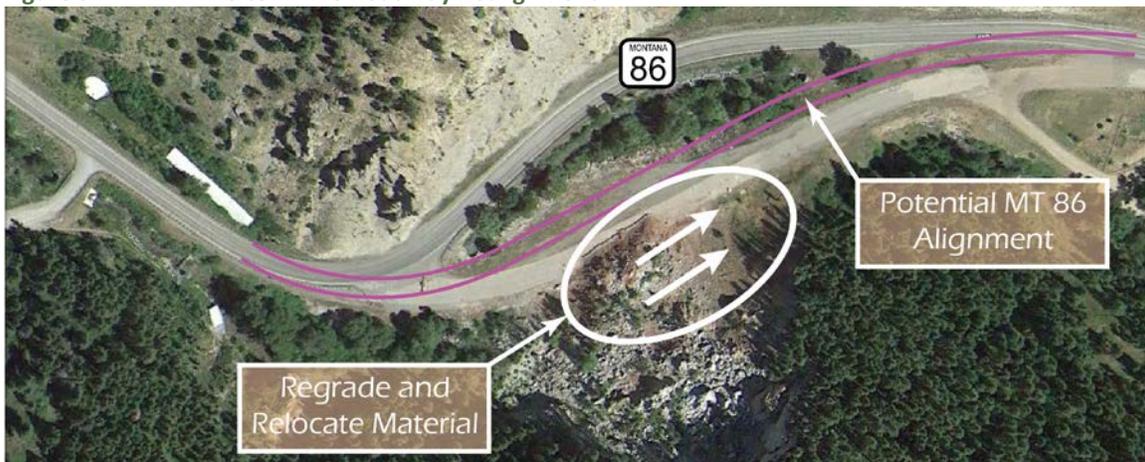
Figure 9 RP 4.3 to RP 4.6 Roadway Realignment

Figure 9 illustrates one potential configuration, where MT 86 would follow an alignment between the original alignment and the current detour route. Other options could include a couplet (with one-way traffic along the original and detour routes), as well as other curve configurations.

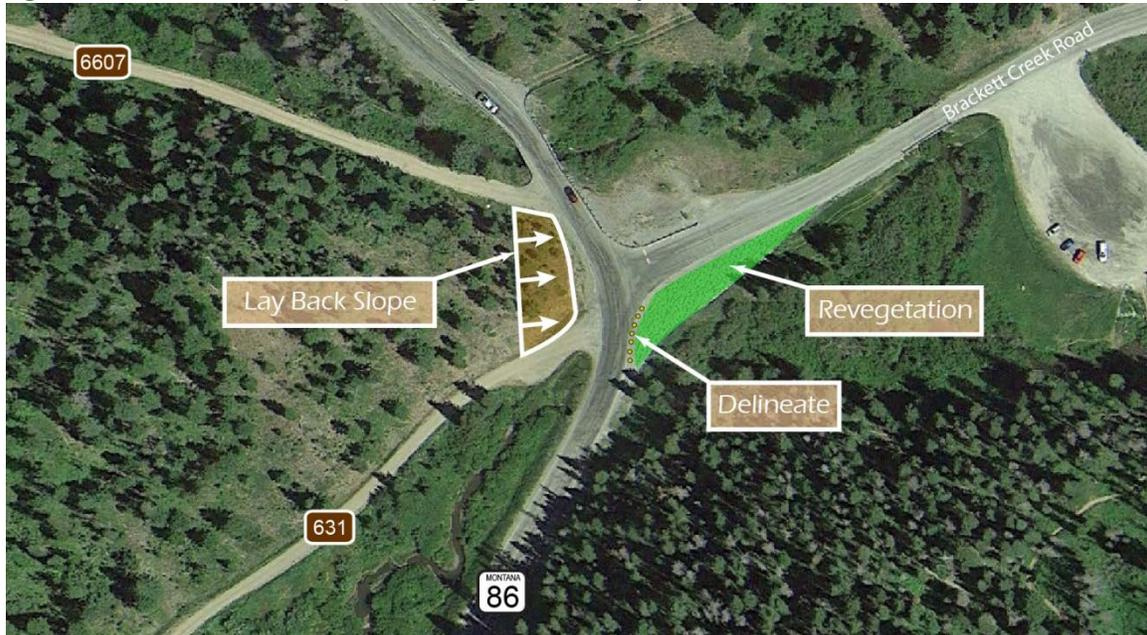
Figure 10 Brackett Creek (RP 18.8) Sight Distance Improvements

Additionally, potential improvements at RP 18.8 (Brackett Creek) include installation of delineation to guide traffic along the primary route, and re-vegetation alongside the roadway to reduce confusion of travelers, as indicated in Figure 10.

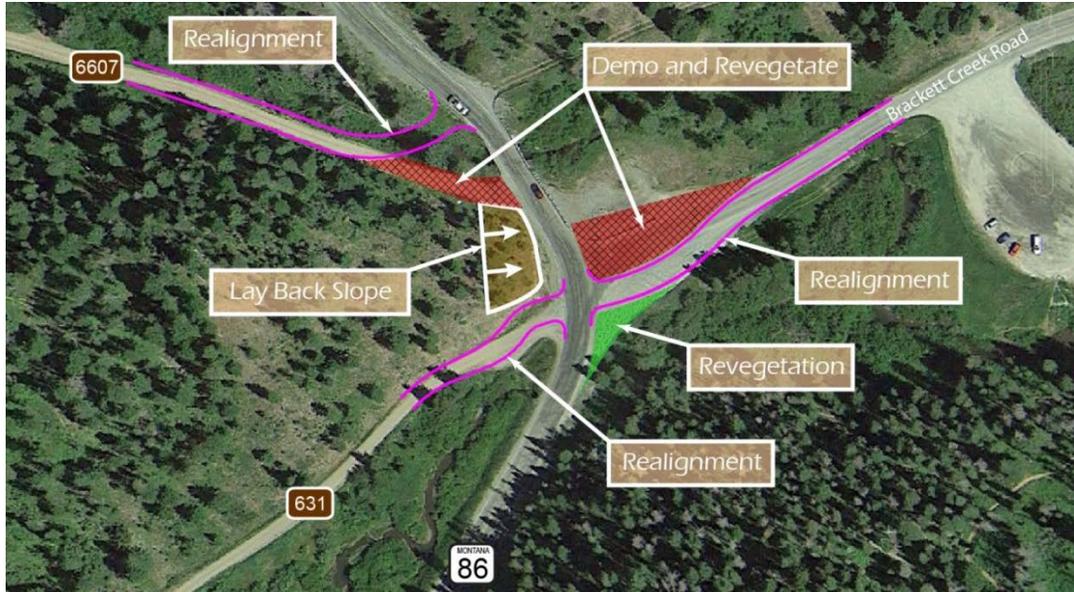
Figure 11 Brackett Creek Road Intersection Improvements

delineation to guide traffic along the primary route; re-vegetation alongside the roadway to reduce confusion of travelers; and realignment of approaches to provide additional distance between approaches and to improve alignment in relation to each other and to the primary route. These improvements are depicted in Figure 11.

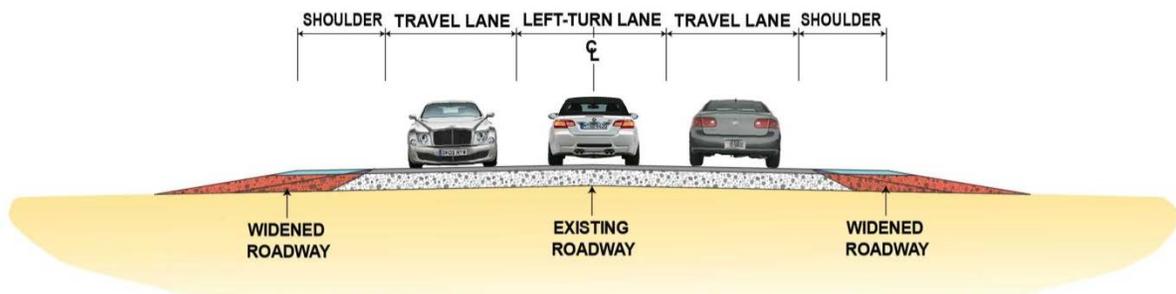
Figure 13 Left-turn Lane Typical Section

An example left-turn lane typical section shown in Figure 13 assumes widening (shown in red) on both sides of the existing MT 86 roadway (shown in white) to achieve a desired road width. Figure 14 depicts a plan view of a left-turn lane layout. A traffic study would be required before installing a turn lane at the locations identified in this study.
