MONTANA DEPARTMENT OF TRANSPORTATION STREAM MITIGATION MONITORING REPORT

*Foy's Bend Fisheries Conservation Area
Flathead County, Montana*

YEAR 2013

MDT Project Number: NH-MT 5-3(50) 109F
Control Number: 20380013

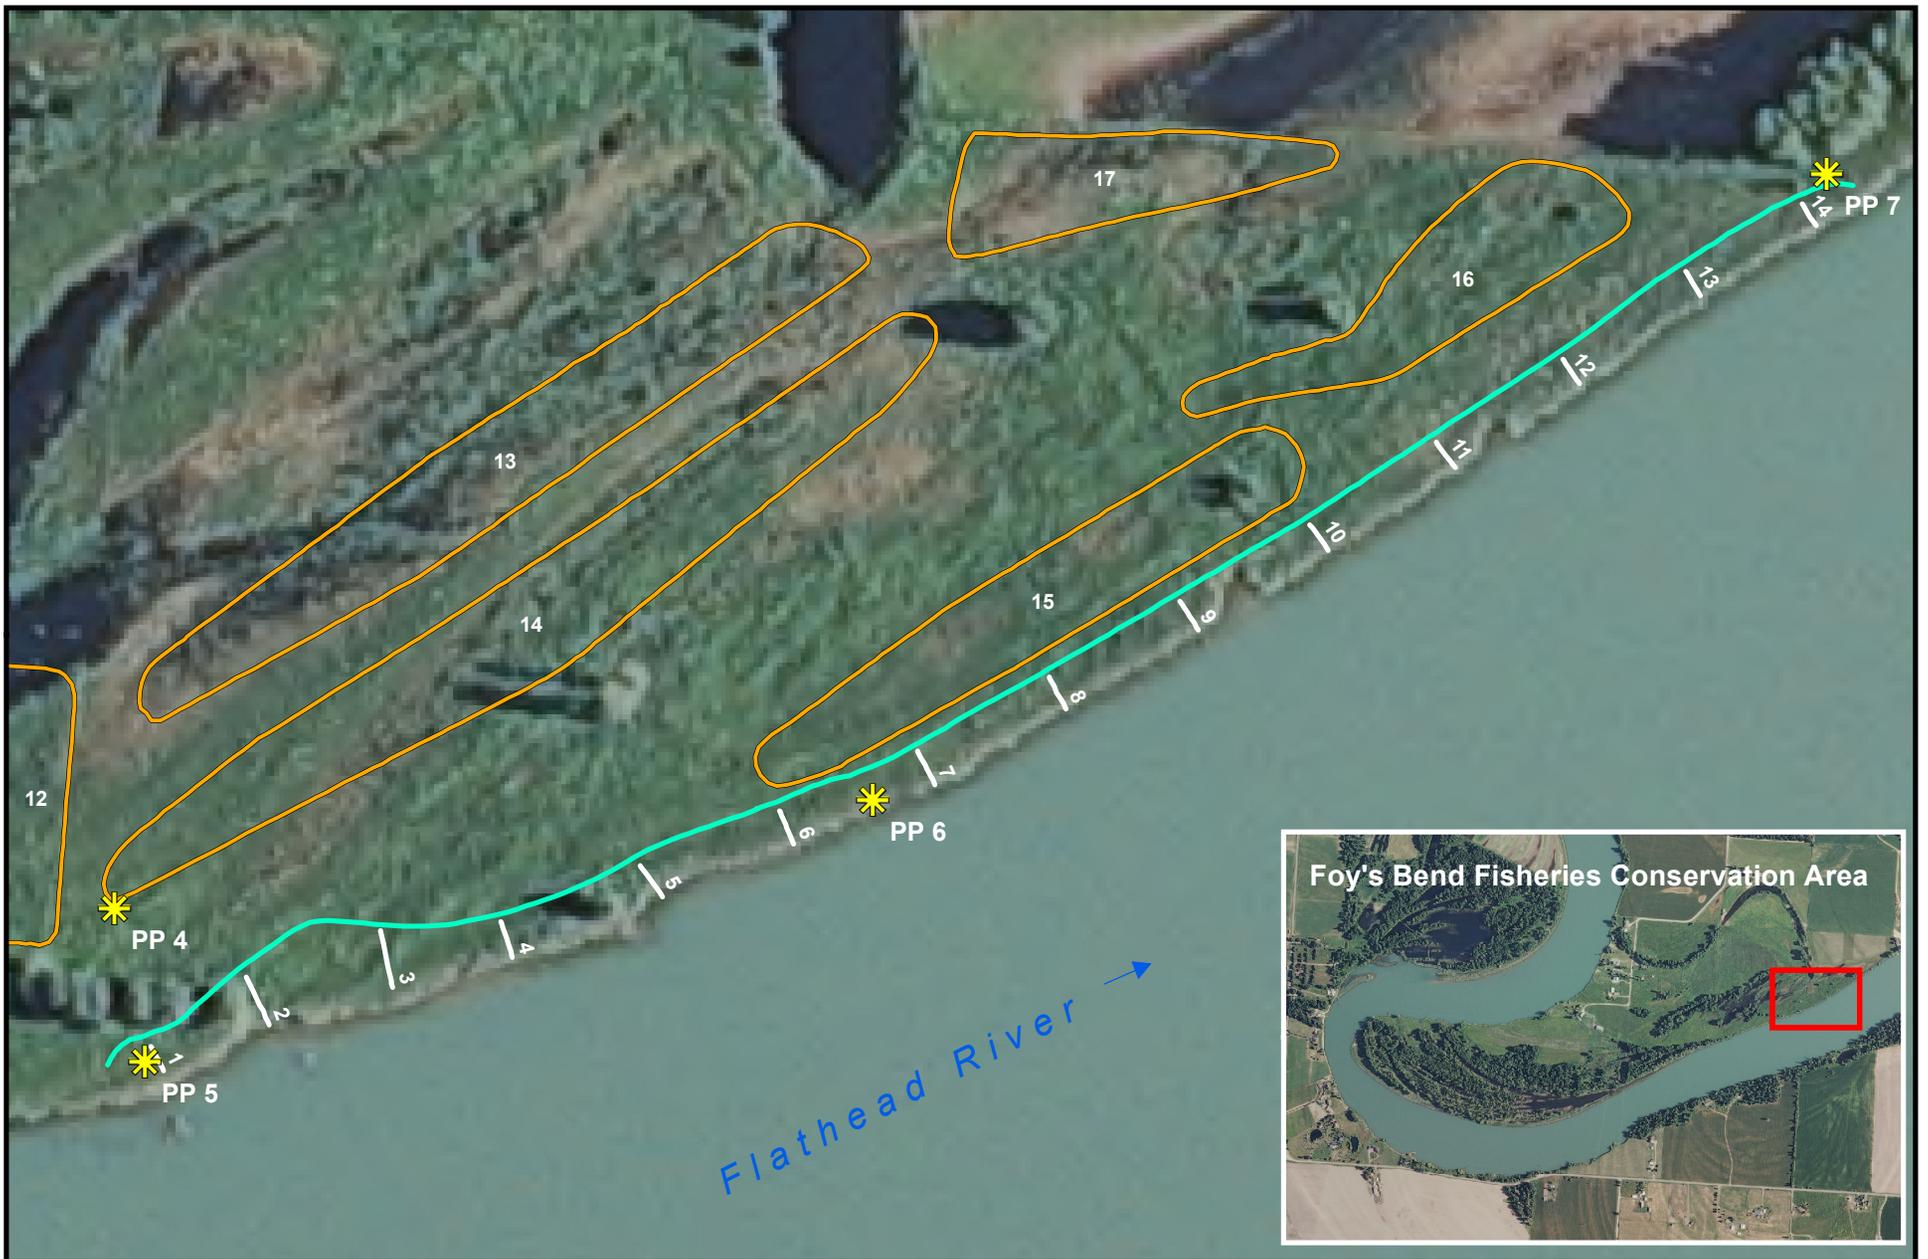
Figure 4

Fourteen bank pins were installed along the enhanced streambank to measure bank retreat rates (locations shown in Figure 4, Appendix A). No erosion was noted along the reconstructed bank in 2013; therefore the surveyed bank profiles provide a baseline for future erosion monitoring. Results of the 14 surveyed bank profiles are provided in Appendix B.

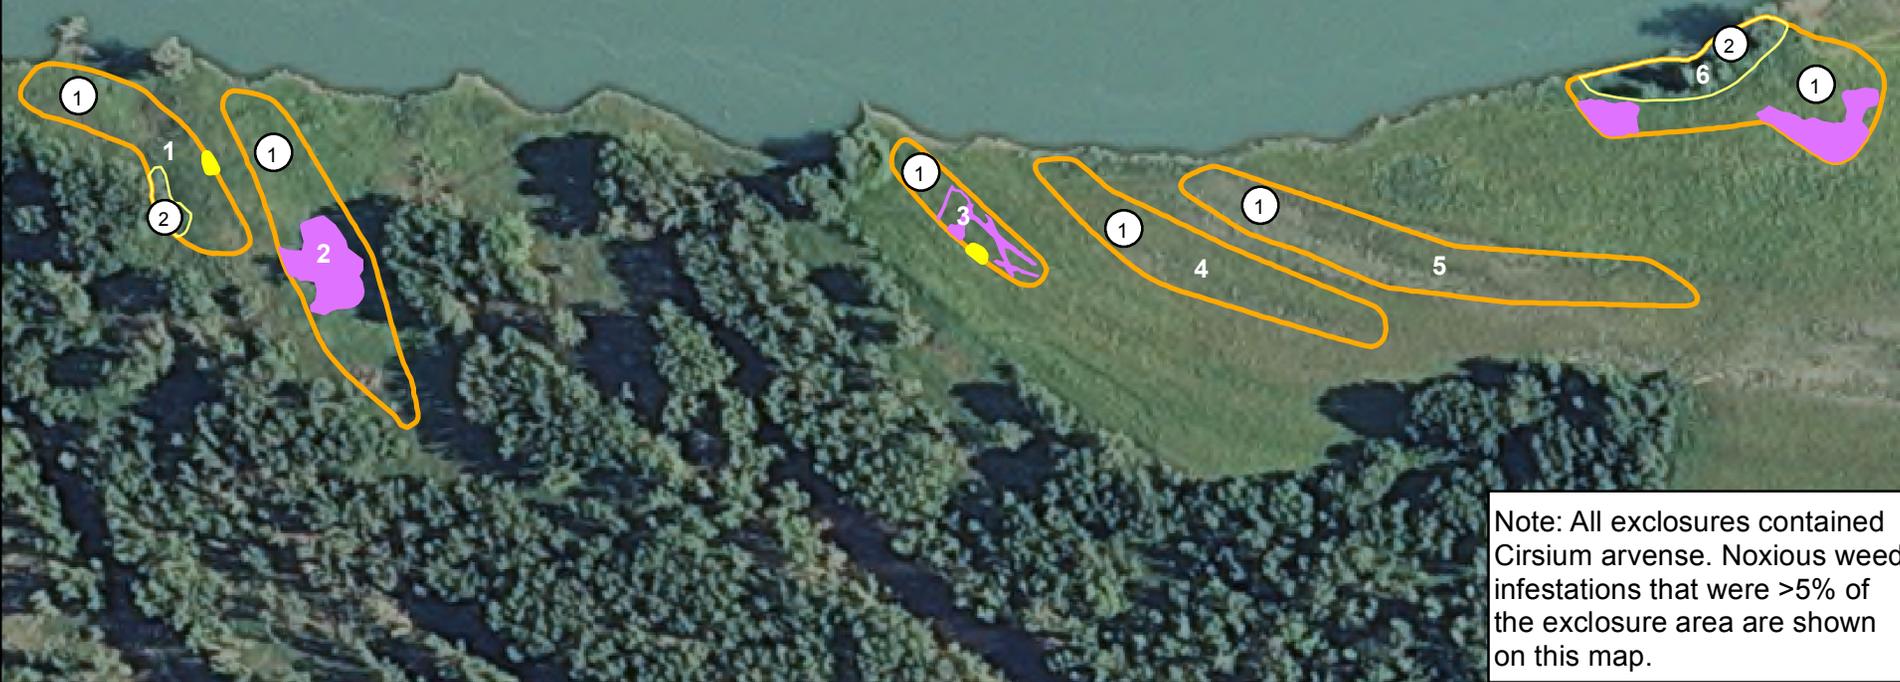
Figure 5
Date: 12/09/2013
X:MDT_.007/mains

This monitoring report includes documentation of four noxious weed species within the Foy's Bend mitigation site. Although all planted exclosures had Canadian thistle within them, significant infestations of Canadian thistle and butter and eggs were mapped (Figures 5 and 6, Appendix A) if they covered greater than 5% of the exclosure. Isolated occurrences of houndstongue and field bindweed were also observed, but were not mapped.

Note: All exclosures contained *Cirsium arvense*. Noxious weed infestations that were >5% of the exclosure area are shown on this map.

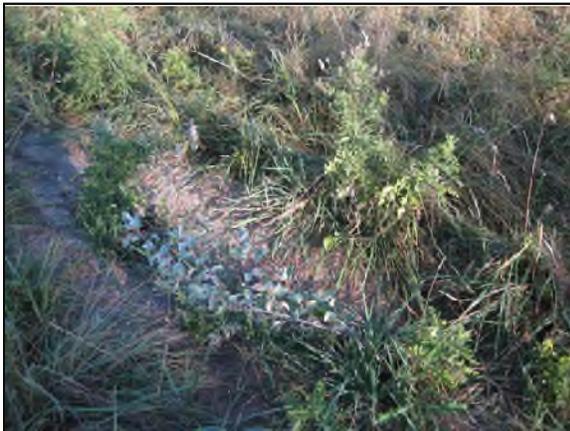
Photo 1 - Thistle along burlap edge and in pots.

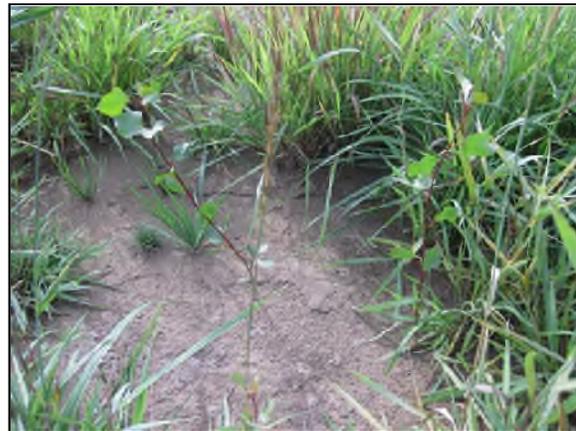
Photo 4 - Cottonwood regeneration in silt deposits along streambank.

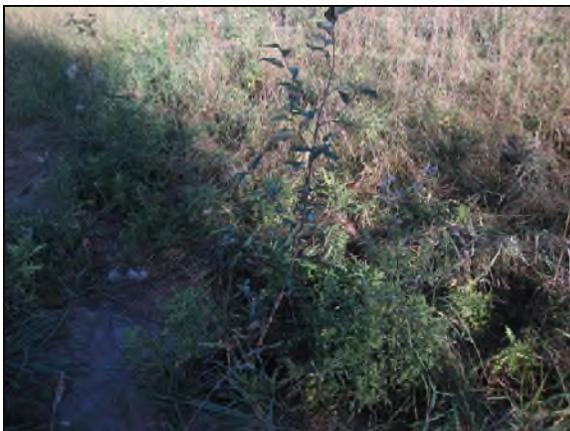
Photo 2 - Thistle along burlap edge and in pots.

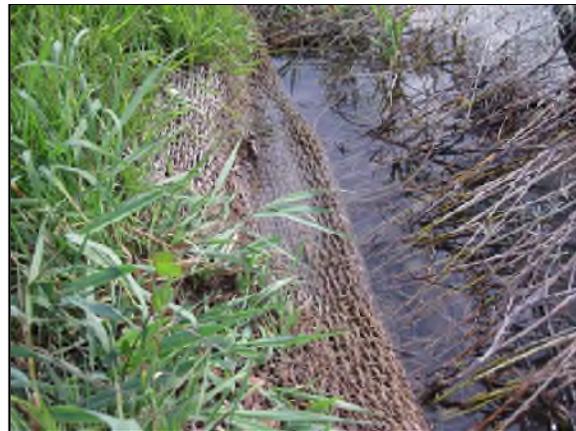
Photo 5 - Fine soil materials sucked out of coir fascine.

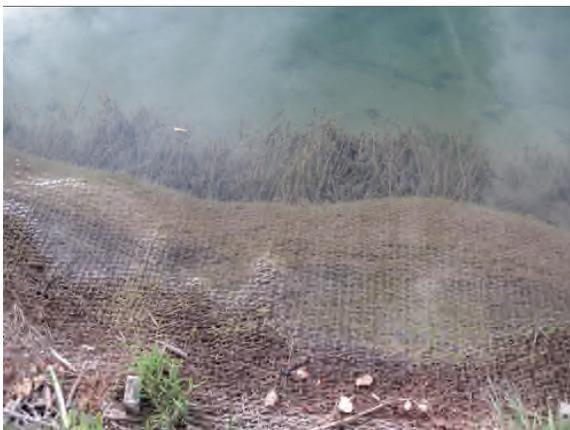
Photo 3 - Willow sprigs with leaves under water.

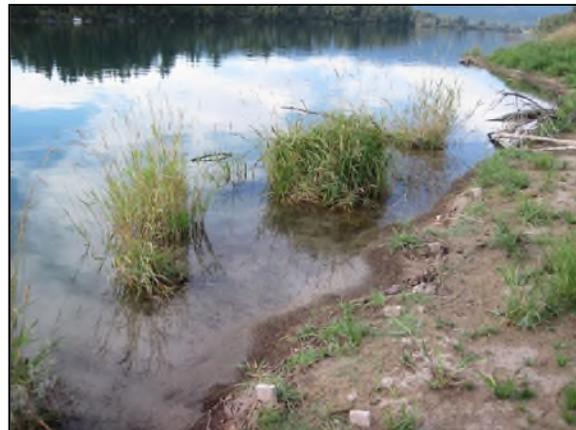
Photo 6 - Phalaris and Carex growth at edge of silt deposits.

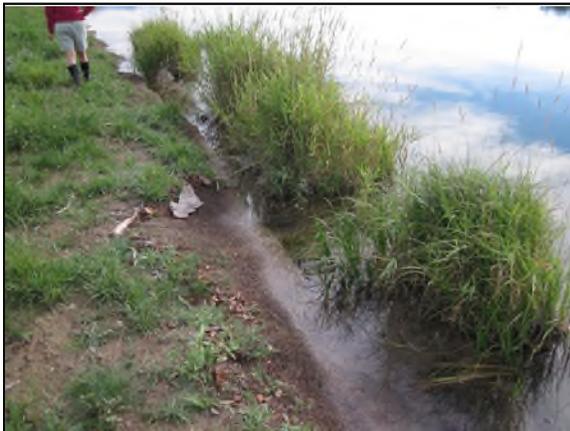
Photo 7 - Large clumps of wetland sod along restored streambank.

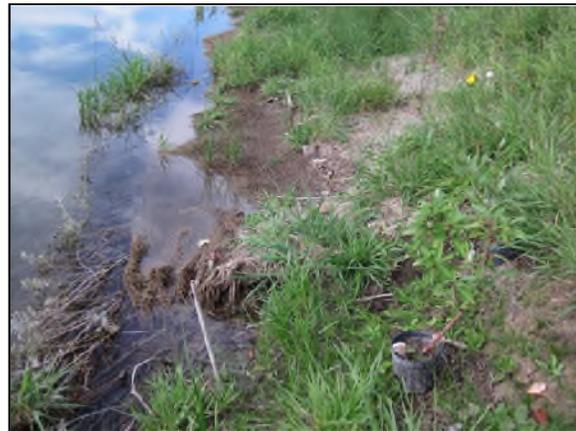
Photo 8 - Upstream end of coir fascine not keyed in with wetland sod surrounding.

Fine soils placed within protective coir may be secured if a second, finer layer of coir fabric is placed between the outer coir layer and the soil. This second layer is often used in bioengineered stream banks to prevent fine soil loss when the bank is submerged. The recommended fabric to achieve this goal is North American Green, product #125-BN. This product includes a fine coir mesh and biodegradable reinforcement twine.

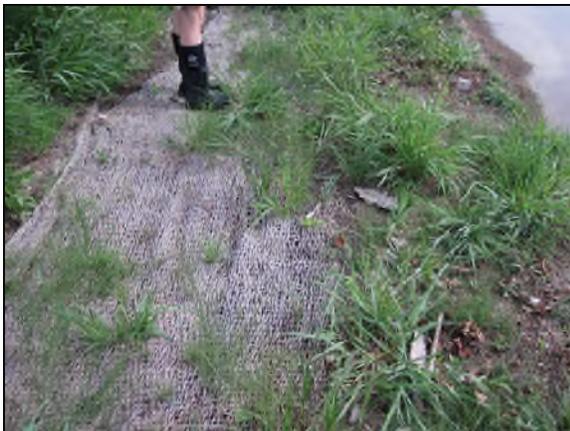
Photo 9 - Less vegetation establishment on coir without silt deposits.
