MONTANA DEPARTMENT OF TRANSPORTATION STREAM MITIGATION MONITORING REPORT

*Foy's Bend Fisheries Conservation Area
Flathead County, Montana*

*Project Completed: 2013
Monitoring Report #2: December 2014*

MDT Project Number: NH-MT 5-3(50) 109F
Control Number: 20380013

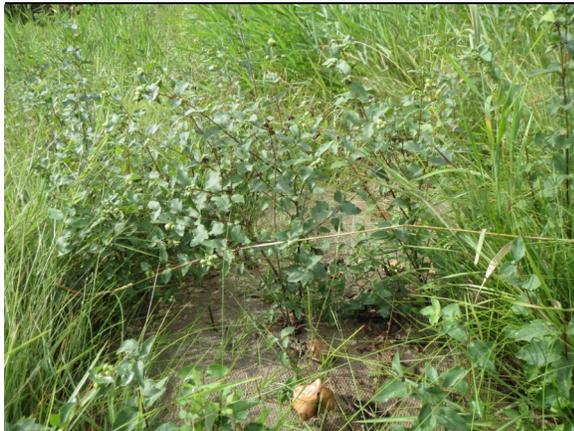
Photo 1 - Snowberry emergence through coir fabric.

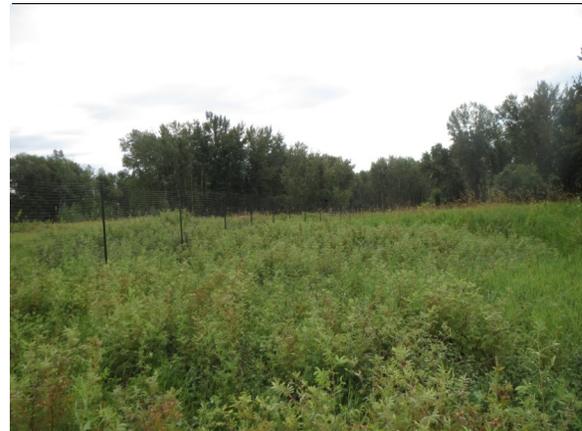
Photo 2 - Snowberry and Wood's rose colonization in Exclosure 1.

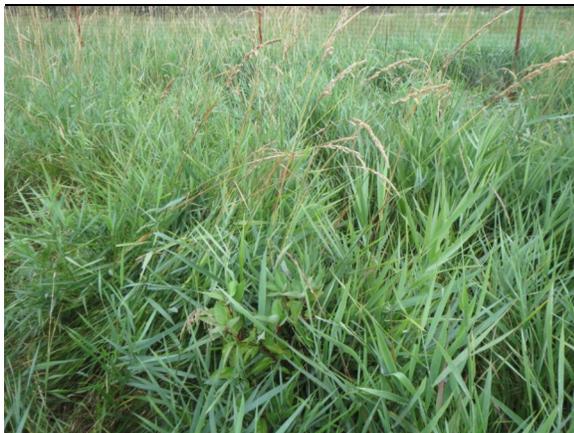
Photo 3 – Planted dogwood in a sea of *Phalaris*.

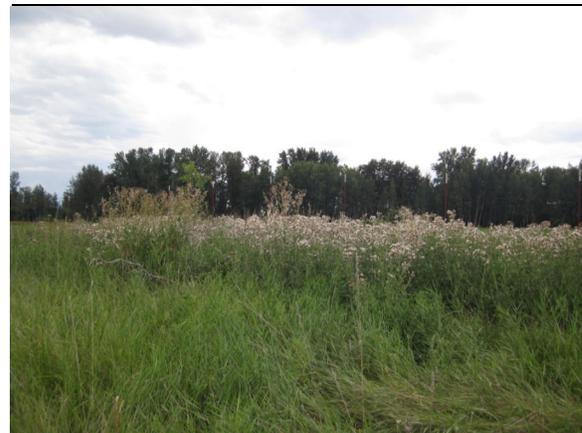
Riparian exclosures planted with woody species consistently exhibited occurrences of Canadian thistle. The majority of thistle appeared to generate along the edges of the burlap rows and soil within plant pots. Canadian thistle was observed in all exclosures, but was particularly dense in the planted exclosures. Aggressive combat of thistle colonization is recommended to continuously meet the performance criteria for noxious weed cover across the Foy's Bend project site. Weed spraying did occur in June 2014 and will continue to be treated as part of a joint weed management plan with MDT and MFWP.

Photo 4 – *Cirsium arvense* population in Exclosure 6.

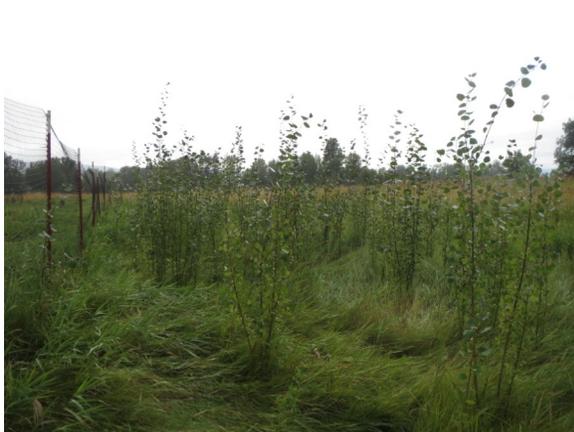
Photo 5 – Aspen colonization in Exclosure 6.

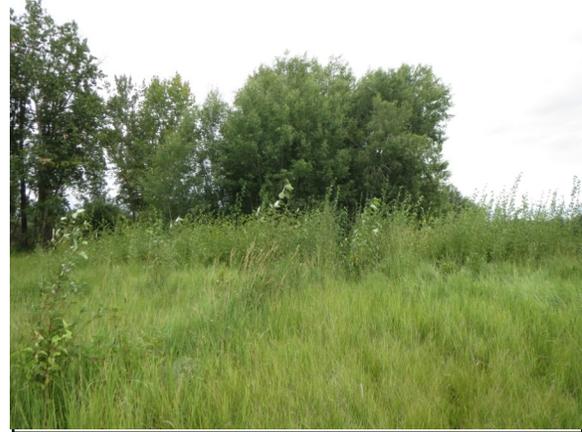
Photo 6 – Aspen colonization in Exclosure 10.

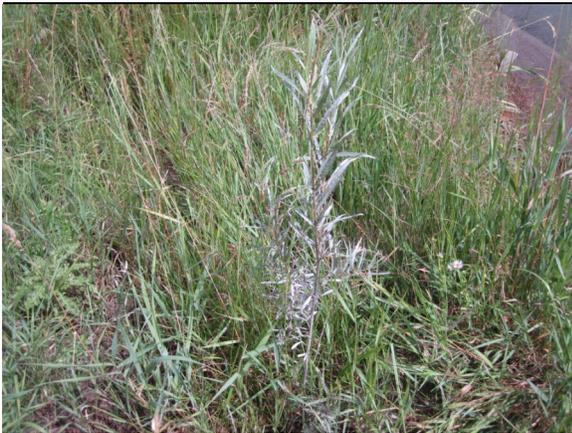
Photo 7 - Willow growth along streambank.

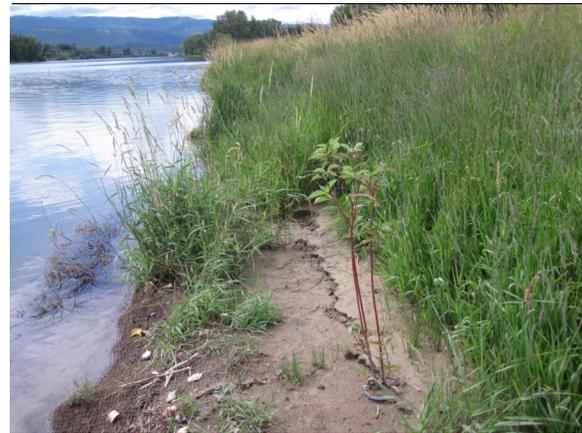
Photo 8 - Dogwood growth and sediment along streambank.

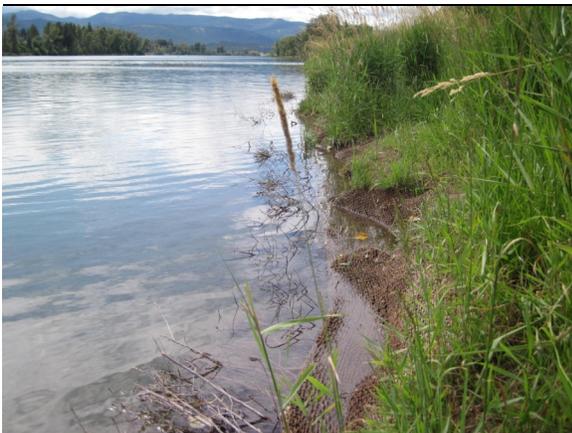
Photo 9 – Coir fabric sagging due to lack of sediment.

Fine soils placed within protective coir may be secured if a second, finer layer of coir fabric is placed between the outer coir layer and the soil. This second layer is often used in bioengineered stream banks to prevent fine soil loss when the bank is submerged. The recommended fabric to achieve this goal is North American Green, product #125-BN. This product includes a fine coir mesh and biodegradable reinforcement twine.

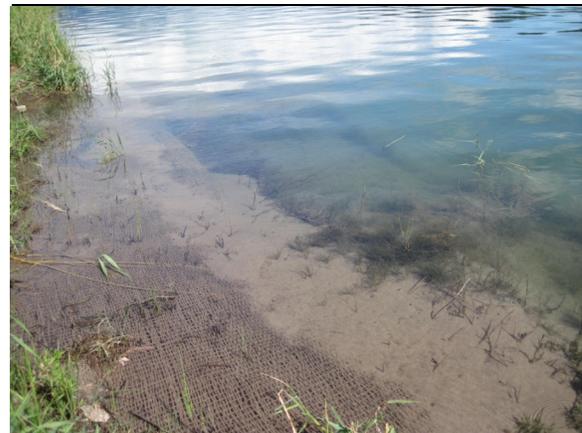
Photo 10 – Fine sediment accumulation on top of willow bundles along streambank.

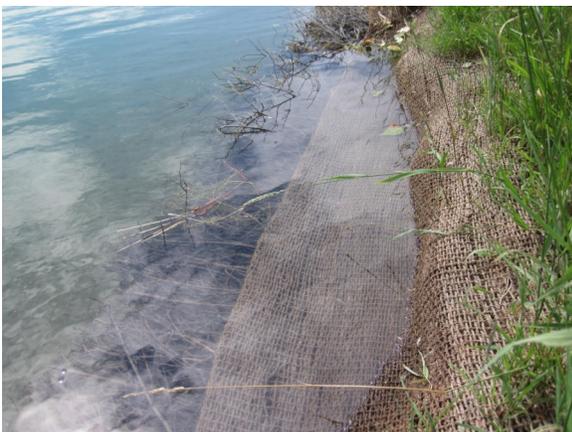
Photo 11 – Coir slumping due to lack of sediment.

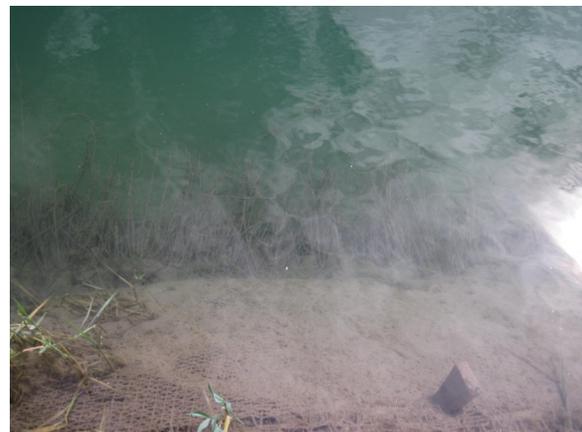
Photo 12 – Evidence of erosion beneath willows and coir.

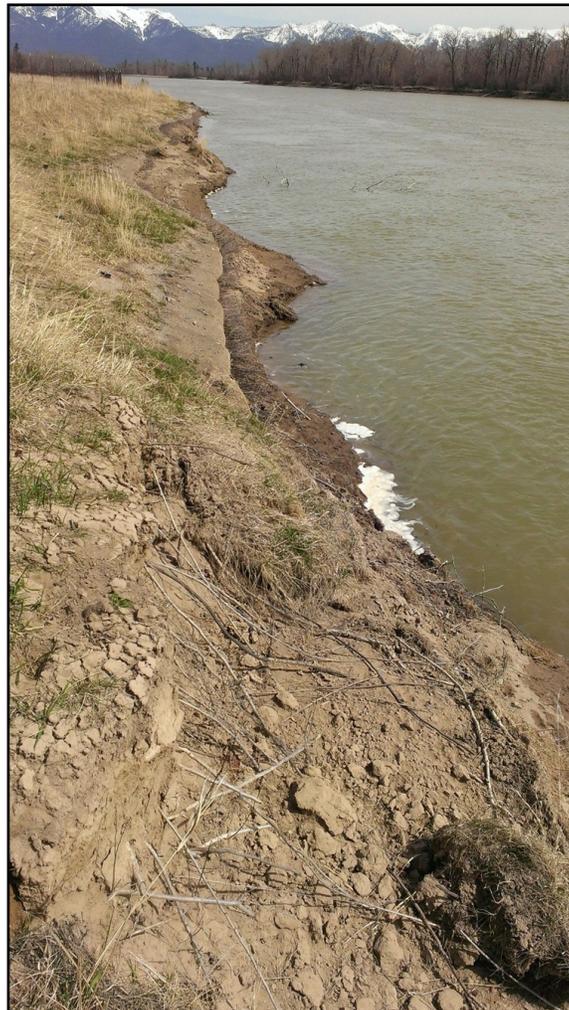
Photo 13 – Project site taken from the upstream end of the bank treatment. (Photo taken in April, 2014).
