MONTANA DEPARTMENT OF TRANSPORTATION STREAM MITIGATION MONITORING REPORT

*Mill Creek
Ravalli County, Montana*

*Project Constructed: 2011
Monitoring Report #2: December, 2014*

STREAM MITIGATION MONITORING REPORT #2

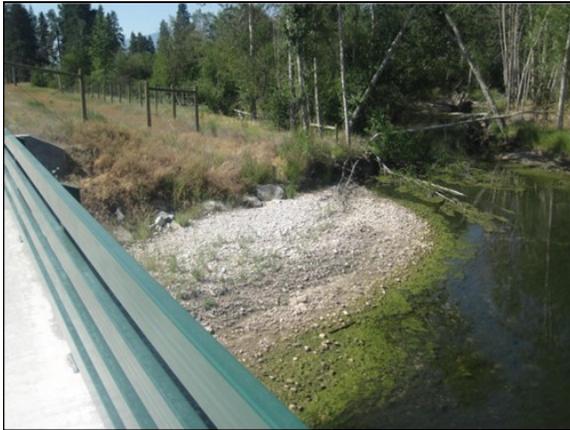
Photo Point 5.1—2013

Description: View looking upstream of south bank taken from bridge. **Compass:** 248 (West-Southwest)

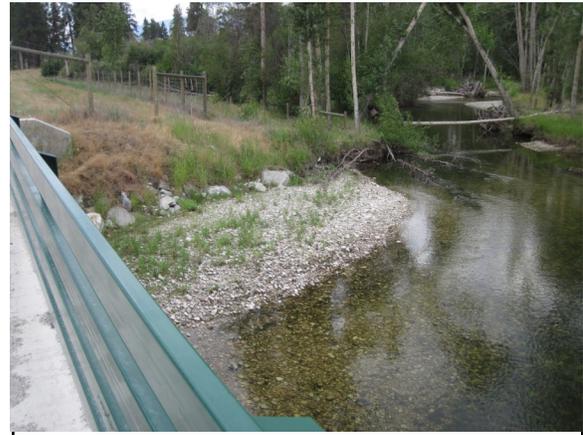
Photo Point 5.1—2014

Description: View looking upstream of south bank taken from bridge. **Compass:** 248 (West-Southwest)

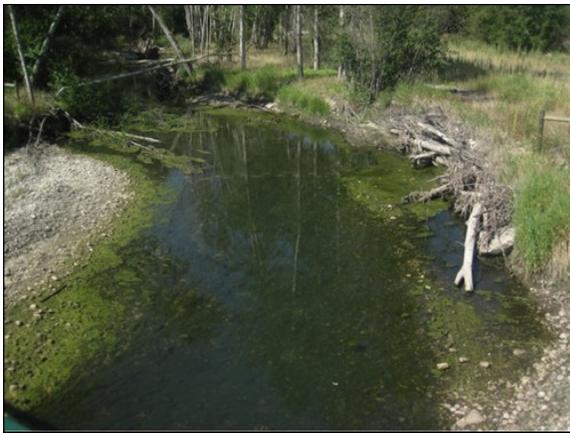
Photo Point 5.2—2013

Description: View looking upstream from bridge. **Compass:** 203 (South-Southwest)

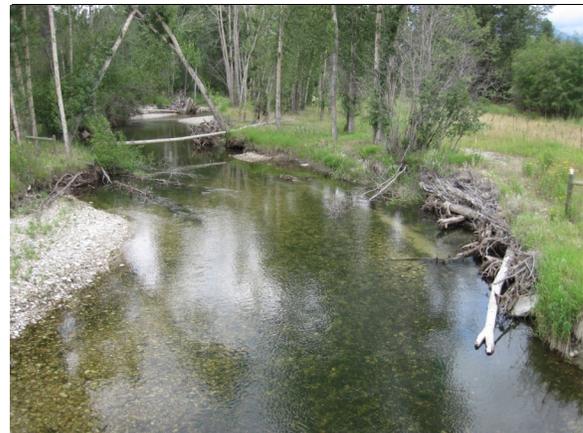
Photo Point 5.2—2014

Description: View looking upstream from bridge. **Compass:** 203 (South-Southwest)

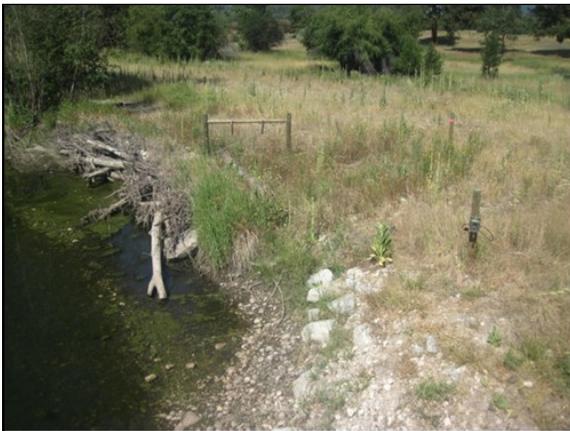
Photo Point 5.3—2013

Description: View of north bank from bridge. **Compass:** 270 (West)

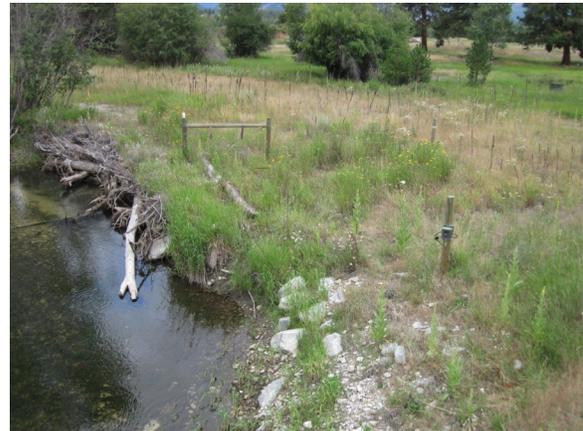
Photo Point 5.3—2014

Description: View of north bank from bridge. **Compass:** 270 (West)

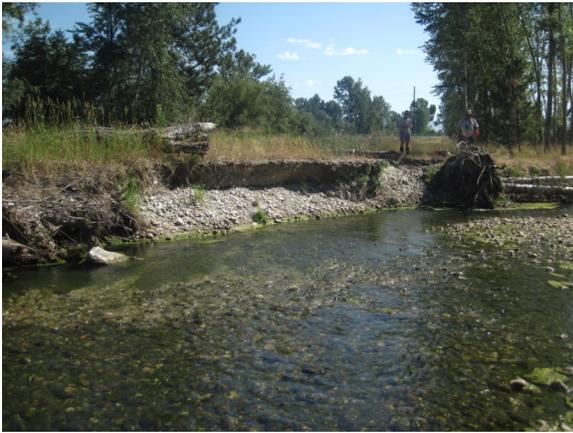
Description: Eroding streambank L3 in 2013.

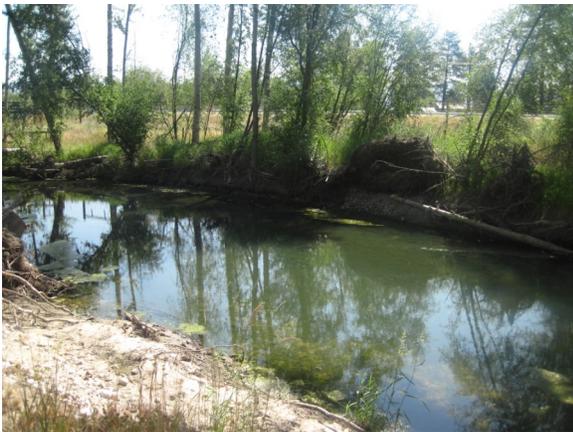
At eroding bank EBR1, several trees have fallen into the channel due to undercutting directly across the channel from EBL4. Trees have also fallen away from the channel, providing evidence of undercutting and block failure, or blow down. The bank appeared more stable during the 2014 monitoring event than in 2013. The vegetation community along this bank consists of cottonwood, alder, smooth brome, and birch. Bank erosion severity along this 58-foot segment is considered low.

Description: Eroding streambank R1 in 2013.

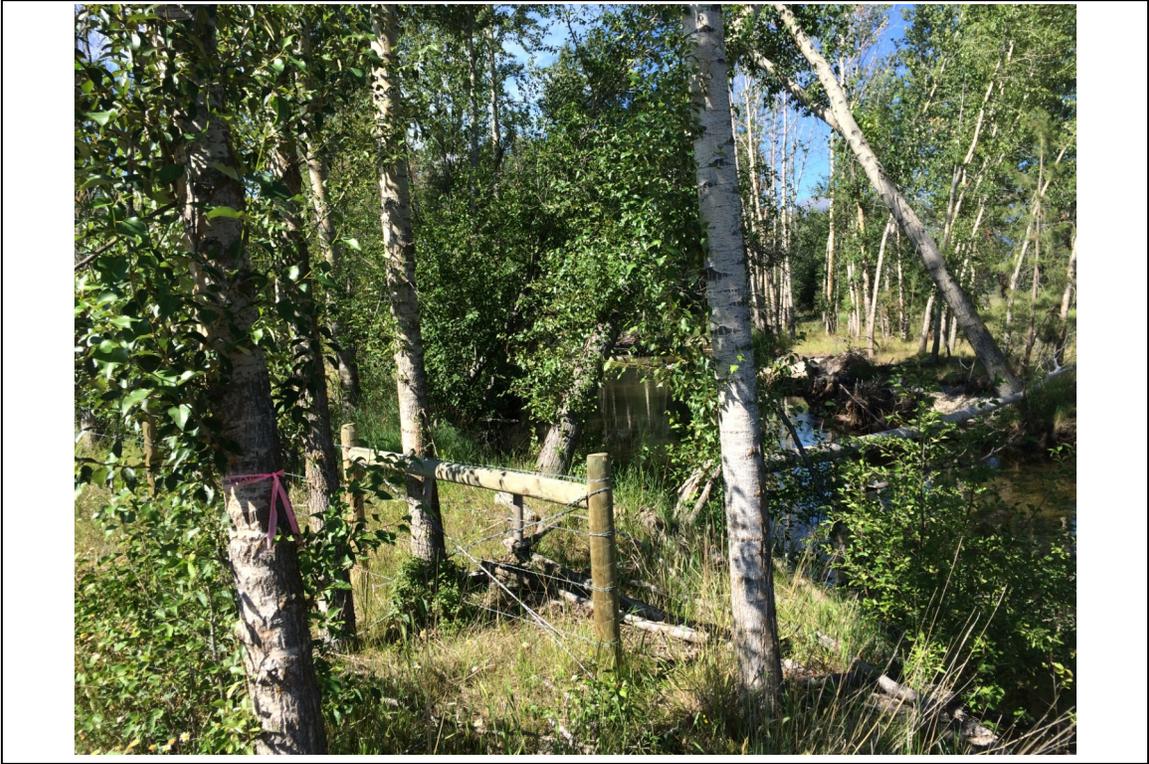
T4 LOOKING UPSTREAM FROM RIGHT BANK

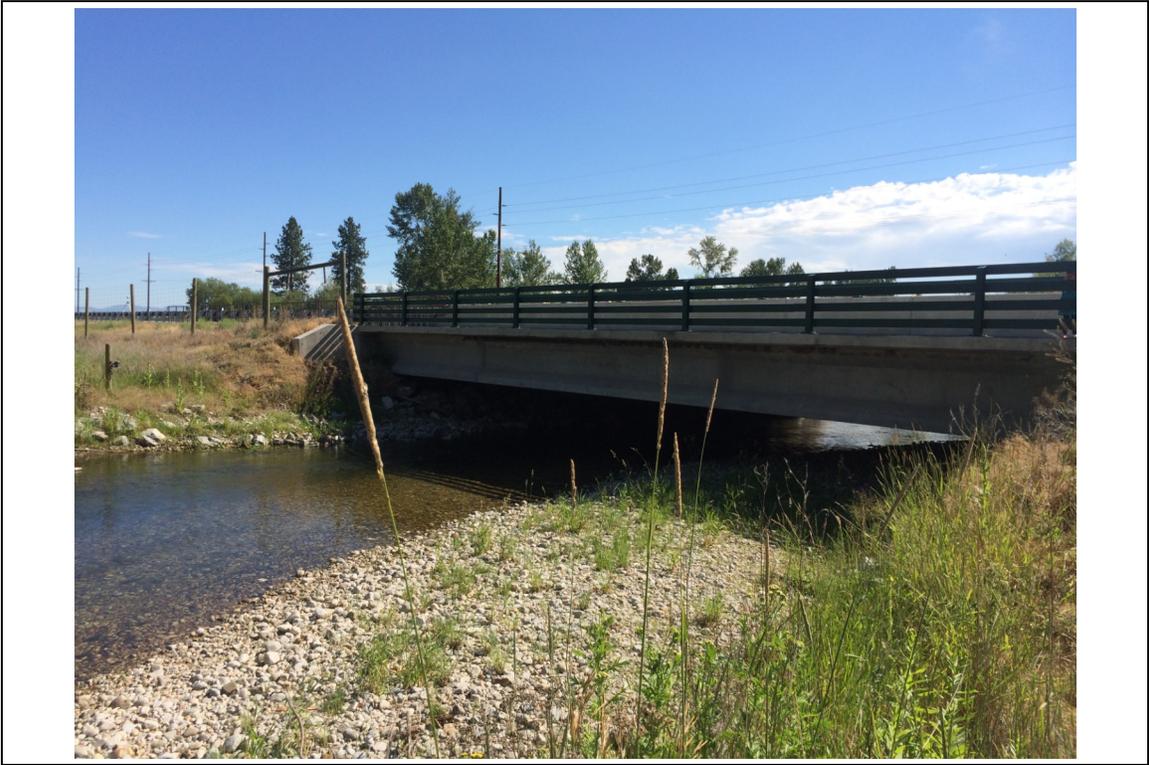
T4 LOOKING DOWNSTREAM FROM RIGHT BANK

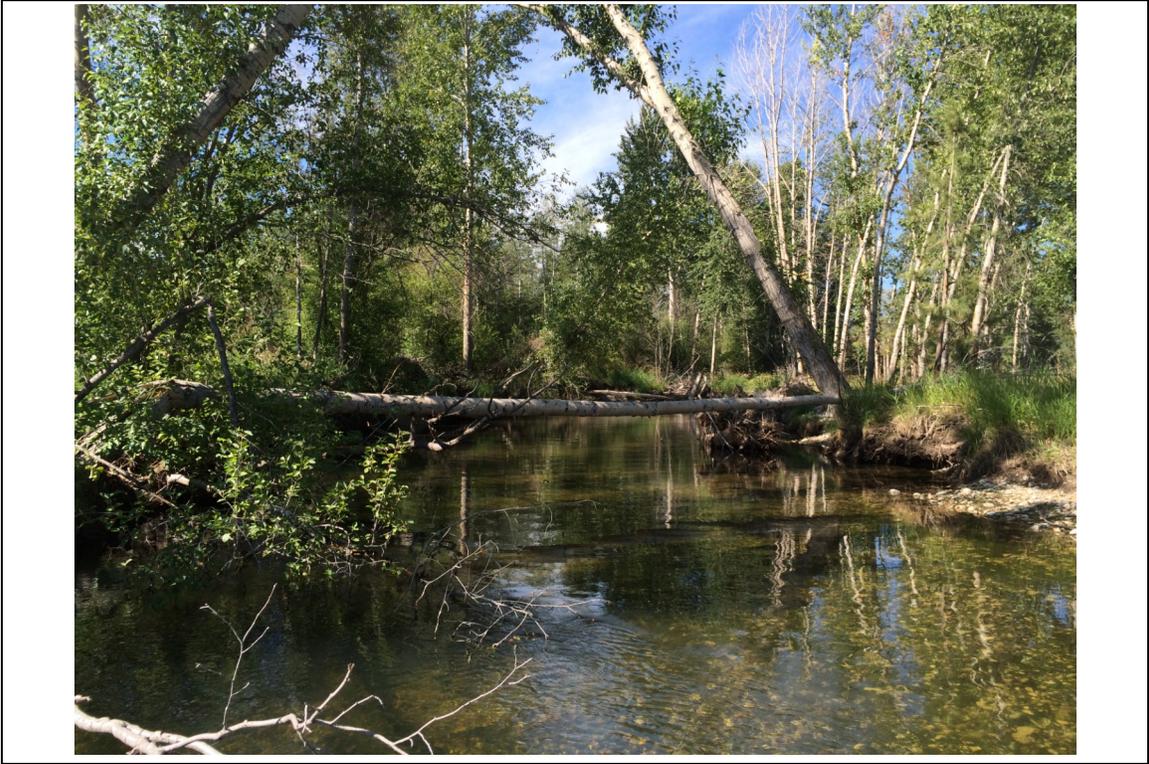
T4 LOOKING UPSTREAM FROM MIDDLE CREEK

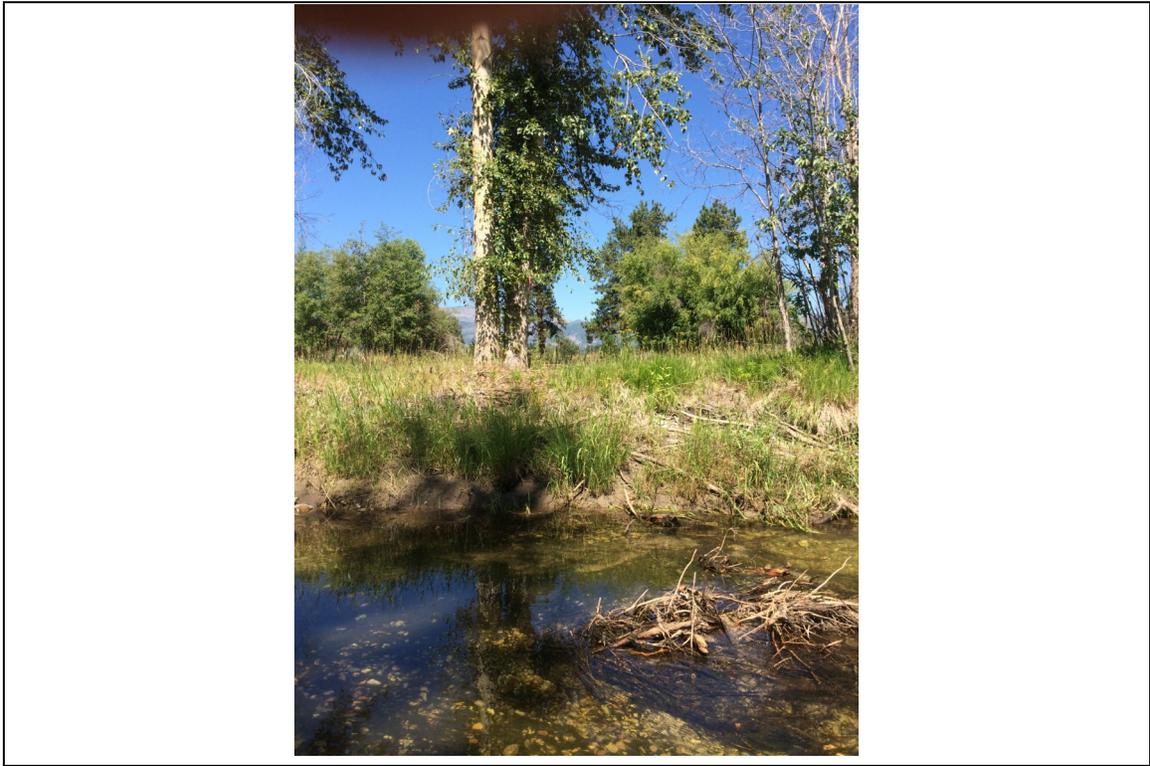
T4 LOOKING NORTH FROM MIDDLE CREEK

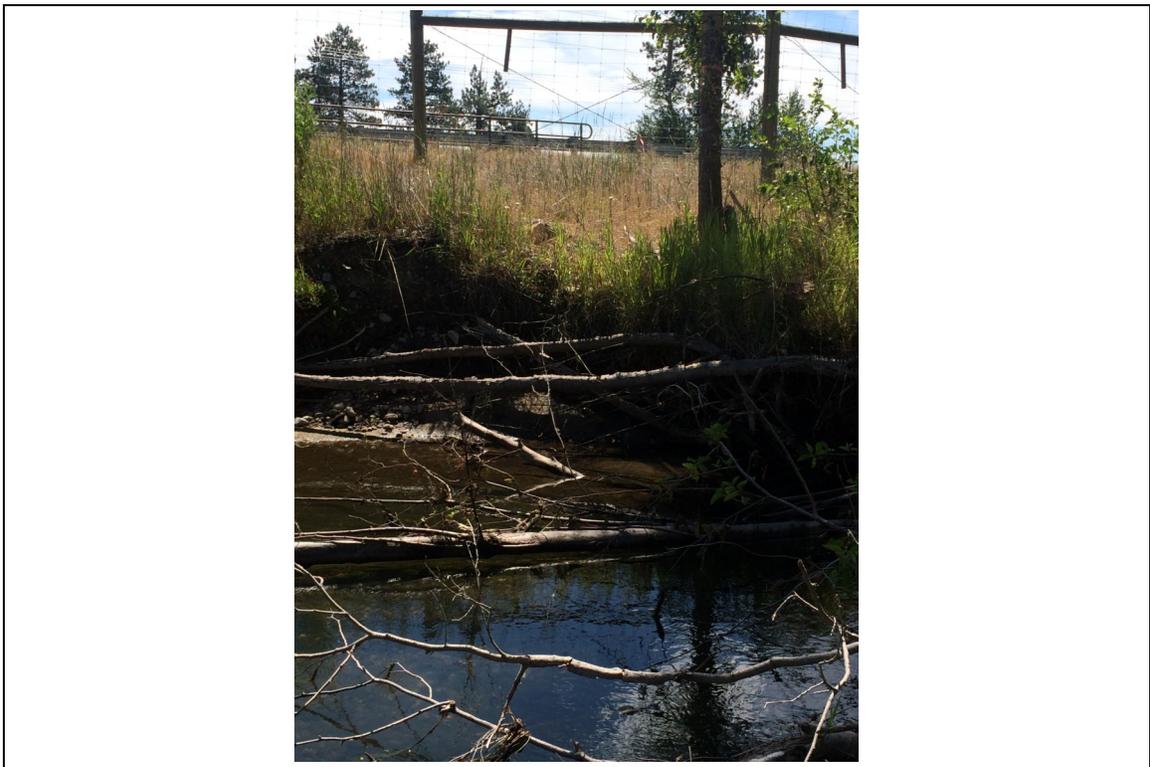
T4 LOOKING SOUTH FROM MIDDLE CREEK

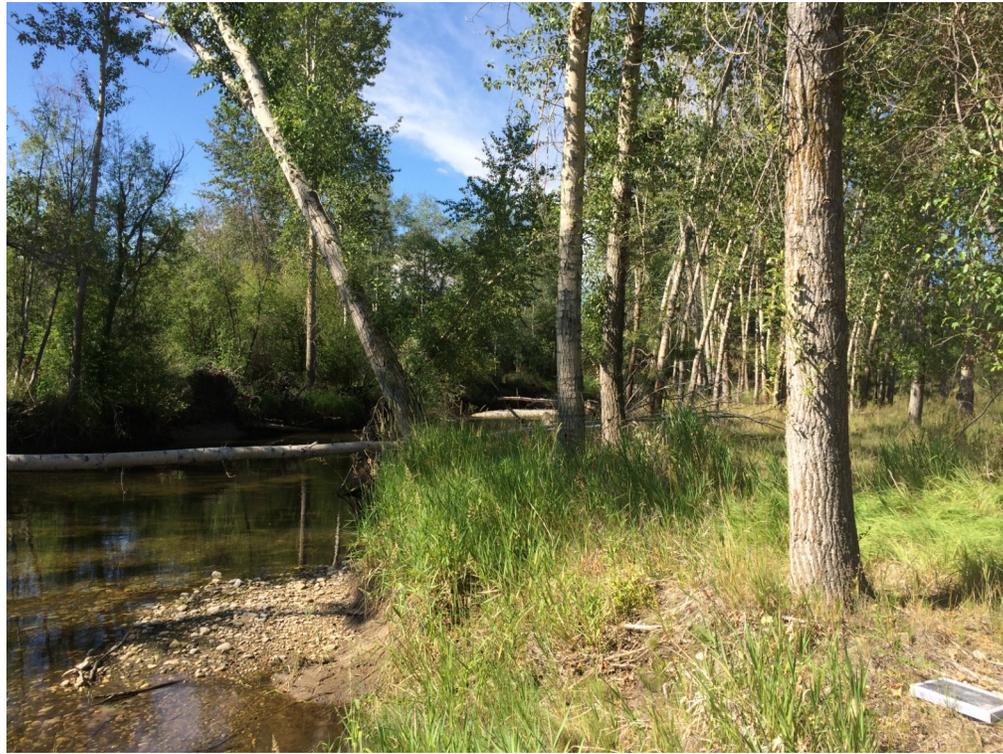
T4 LOOKING UPSTREAM FROM LEFT BANK

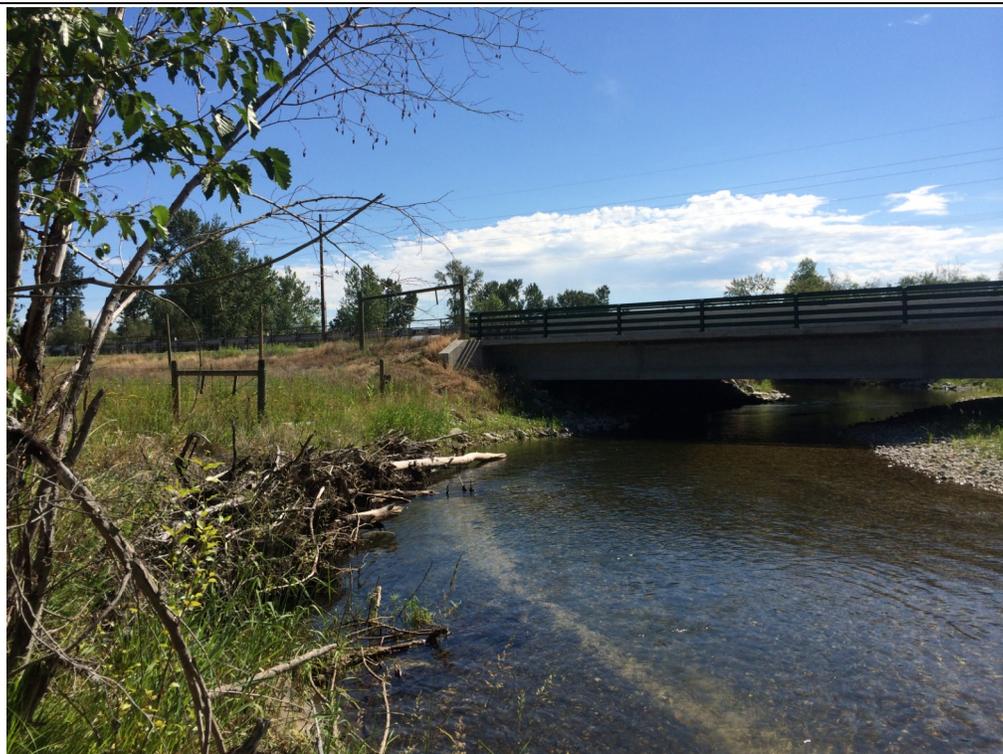
T4 LOOKING DOWNSTREAM FROM LEFT BANK
