MONTANA DEPARTMENT OF TRANSPORTATION STREAM MONITORING REPORT

*Little Rock Creek at Judith Slide Repair
Fergus County, Montana*

*Project Completed: 2013
Monitoring Report #4: December, 2017*

MDT Project Number: STPS 426-2(12) 15
Control Number: 7726000

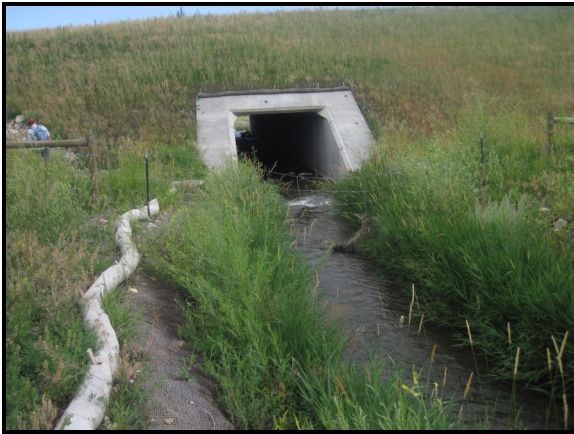
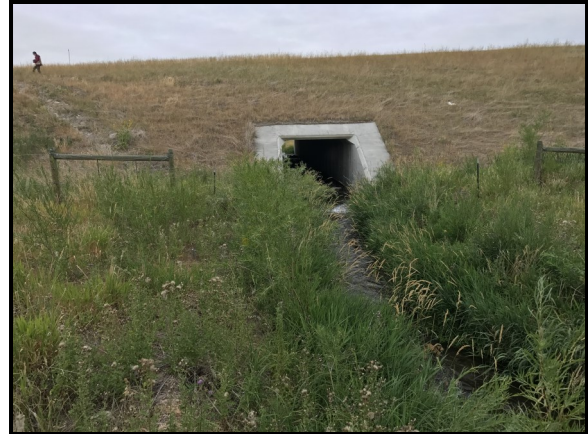
2014
Photo Point 1: Upstream end of project looking downstream. **Compass:** 0 (North)

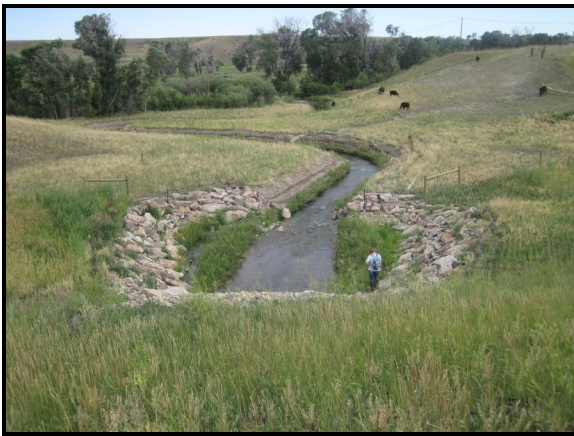
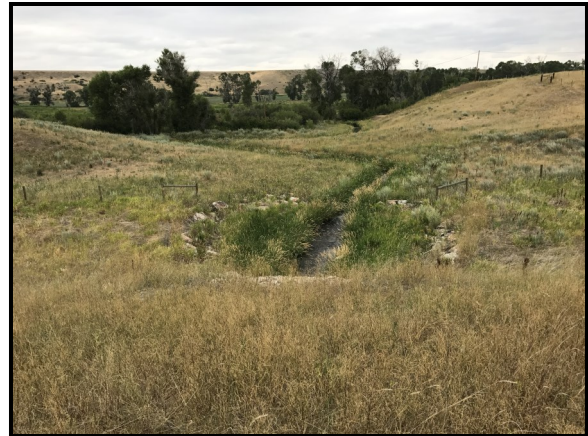
2014
Photo Point 2: Above culvert outlet, looking downstream. **Compass:** 0 (North)

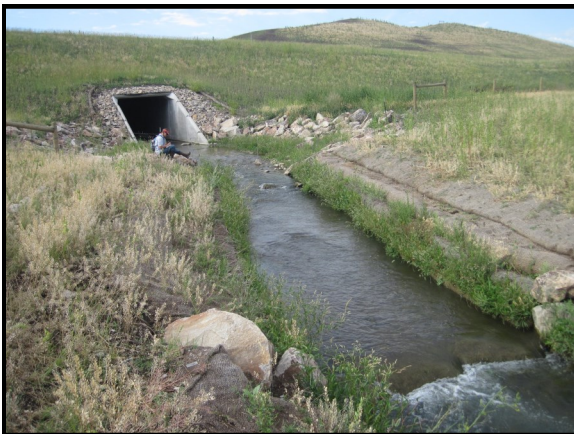
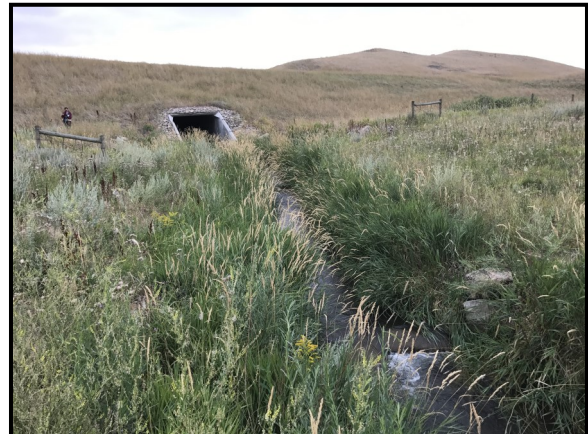
2014
Photo Point 3.1: First bend in channel, looking upstream. **Compass:** 180 (South)

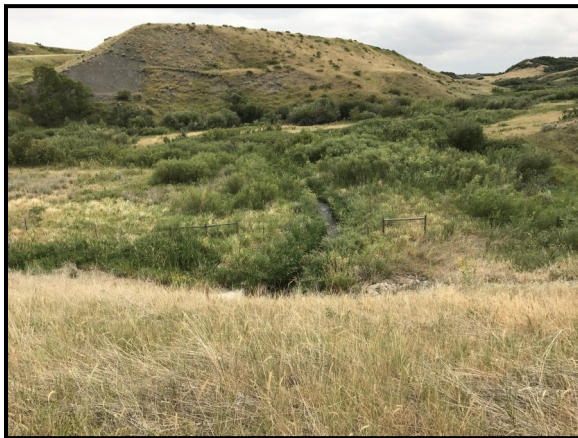
Additional Photo 1: 2017

Both riparian vegetation transects are located downstream of the box culvert, and are representative of the reconstructed channel and associated riparian zones below the culvert outlet. Total percent cover of vegetation decreased from 88% in 2016 to 85% in 2017. Total percent woody cover decreased from 17% in 2016 to 15% in 2017. Percent cover of Montana State-listed noxious weeds increased from 4% in 2016 to 5% in 2017 (See Section 4.3). Vegetation upstream and downstream of the culvert is establishing well, with a diversity of stream bank and riparian vegetation developing on both sides of the channel (See Photo Point 1 and Additional Photo #1 in Appendix C).

Description: View looking upstream of reconstructed channel immediately upstream of culvert.

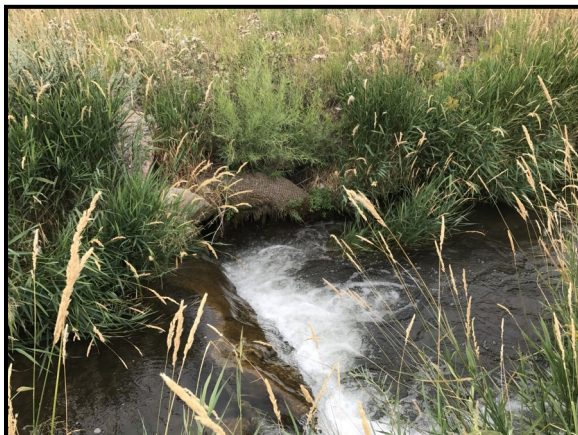
Additional Photo 3: 2017

A short, 6-foot eroding bank segment was observed in 2017 just downstream from one of the rock plunge pool structures installed at Station 11+20 (see additional photo 3 in Appendix C). Erosion along this bank appears due to the dynamic hydraulics at play in the vicinity of the rock plunge pool structure, which has resulted in a short segment of coir lift separating from the bank. The eroding bank segment remains relatively short and as a result, no corrective actions are necessary at this time.

Description: 6' eroding bank immediately downstream of rock plunge pool structure.

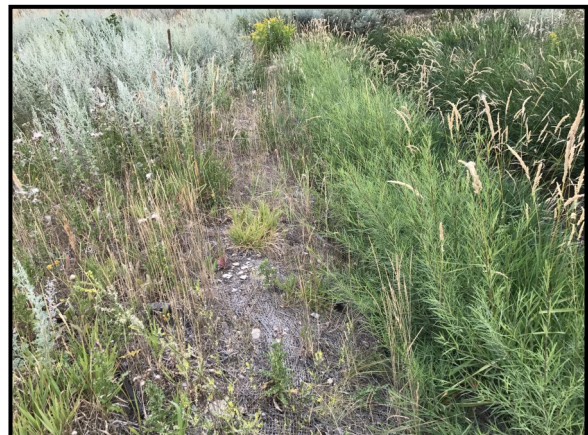
Additional Photo 4: 2017

11. As noted in previous monitoring reports, vegetation establishment along the upper coir fabric lifts remains relatively limited. Much of the coir fabric surfaces remain bare or have been colonized by undesirable and weedy species (See additional Photo 4 in Appendix C). Potential causes include 1) an improper seed mix, or 2) no seeding applied to this area. The design calls for seeding the area above the uppermost lift with a wetland seed mix, which may have been inappropriate for such a dry zone. The design does not call for seeding of native

Description: Sparse revegetation along upper coir lifts

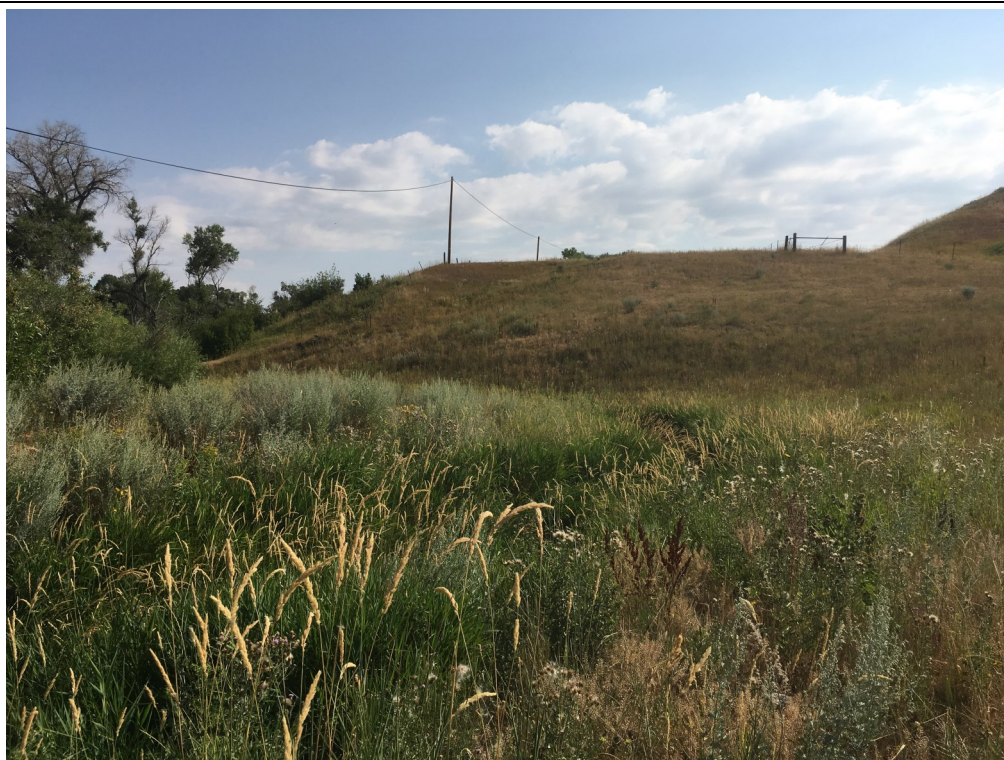
T4 RT: LOOKING DOWNSTREAM EAST
